UNITED STATES AIR FORCE
AIRCRAFT ACCIDENT INVESTIGATION
BOARD REPORT

C-130J-30 Super Hercules, T/N 04-3144

LOCATION: Forward Operating Base Shank, Afghanistan

DATE OF ACCIDENT: 19 May 2013

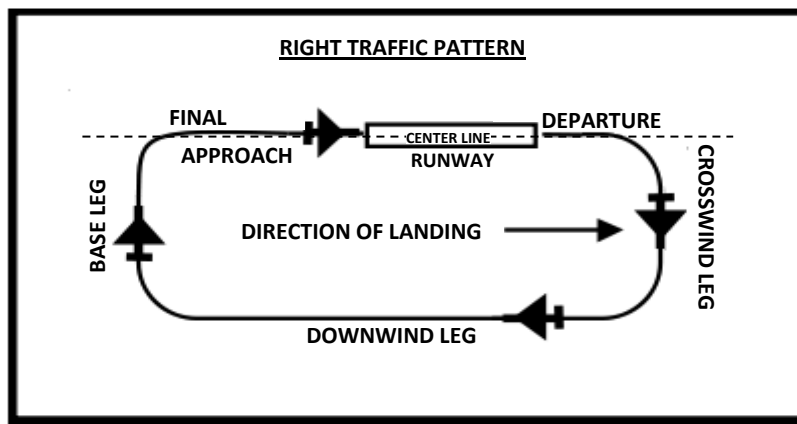
Figure 2. Photo of Right Traffic Pattern

At 9:48:35Z, while the MA was on a 160 degree heading (downwind leg), tower reported winds 250 degrees at 23 gusting to 28 knots, a straight crosswind (Tab N-20 and N-21). MP2 later testifies that the HUD indicated a quartering tailwind for final, but does not verbalize the indication (Tab V24.10 and V24-12). Shortly thereafter, prior to turning right (base leg), MP1 decided to fly a 50% flap approach due to the high crosswinds (Tabs N-21, N-22 and V21.7). Although 100% flap approaches are the normal landing configuration for a C-130J, 50% flap approaches improve roll control in high crosswind conditions. Landing with flaps set at 50% is carried out in a similar fashion to a 100% flap landing, however longer landing distances are required (Tab BB-41). Just after the MA turns base leg, tower broadcasts new winds to another aircraft within the air traffic control area. Those winds were reported as 230 degrees at 19 gusting to 28 knots (Tab N-22). This created a tailwind component of approximately 10 knots, but there is no evidence that the crew took note of the reported wind shift (Tabs N-22 thru N-24 and DD-63). Additionally, the aircraft's flight data recorder showed the MA experienced an approximate 17-knot tailwind component at touchdown (Tab DD-9 and DD-10).

As the MA turned for landing, MP1 overshot the extended centerline of the runway and had to correct back in order to line-up with the runway (final approach). When the MA was established on final approach, the aircraft was approximately .5 miles from the runway (Tab V24.10).

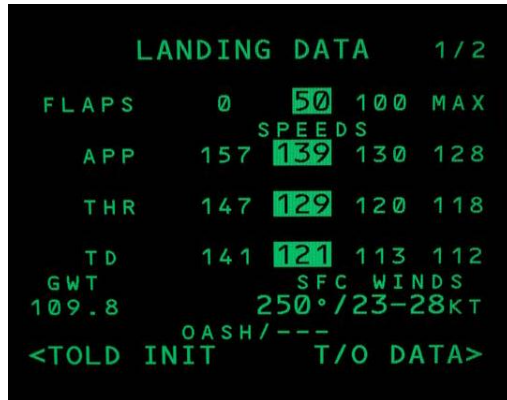
Figure 3. Recreation photo of CNIMU displaying 50% flap approach speeds

Once established on final, MP2 testified everything looked good except the MA was not slowing and was approximately 20 KIAS too fast (Tab V24.10). Note, KIAS is airspeed as reported to the pilots on the primary airspeed indication system (Tab V16.1). Just prior to touchdown MP2 stated, "100 ft, you're fast." No reference to how fast was verbalized (Tab N-24). At 0950:31Z, the MA speed was 148 KIAS (169 knots true airspeed and 187 knots ground speed) and made initial touchdown with the aft main landing gear only, 27 KIAS faster than the computed touchdown speed of 121 KIAS (Tabs V24.13, V24.14, Z-13 and DD-10). Touchdown was light, approximately 1,500 ft past the approach end of the runway, slightly long, with 5,500 ft of runway remaining (Tabs V11.2, V21.10, DD-9 and DD-12).

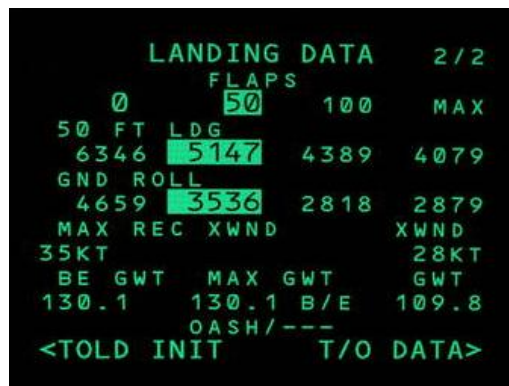
Figure 4. Recreation photo of CNIMU displaying 50% flap landing distance

With crew-entered winds of 250 degrees at 23 gusting to 28 knots, the computed landing distance for a 50% flap landing, was 5,147 ft (Tabs J-15 and Z-15). The crew-entered runway distance available, was 6,827 ft (Tab J-15). The MC concluded that they had enough available runway distance to land (Tabs N-21, V21.7 and V24.11).

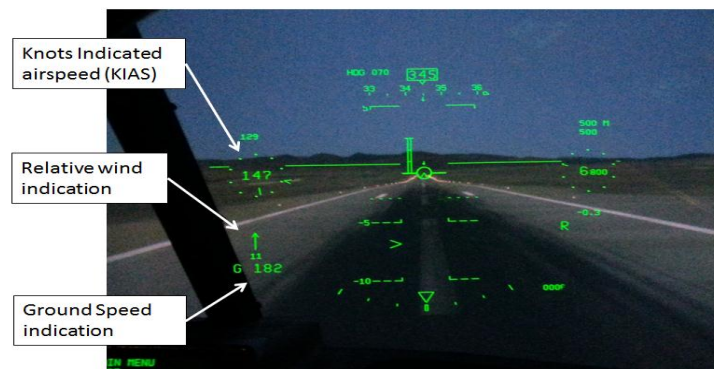
Figure 5. Recreation of the C-130J HUD showing a fast touchdown with tailwind

After the main landing gear touched down, MP1 held the nose wheel up for approximately four seconds and delayed maximum antiskid braking for approximately eight seconds after the nose wheel came down (Tabs V16.4, V24.14, DD-9 and DD-10).

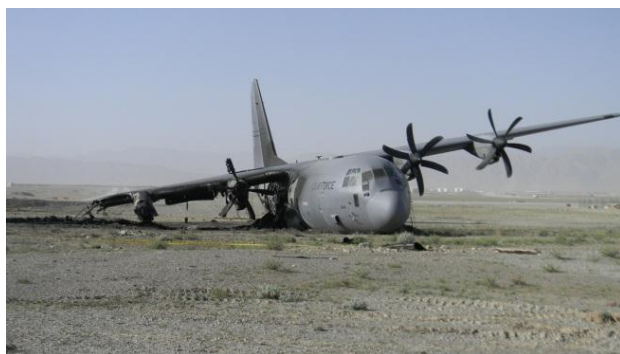
Figure 6. Photo of the MA at the crash site.

At 0950:55Z, the MA departed the paved runway surface traveling at approximately 49 KIAS, and 69 knots ground speed (DD-9 and DD-12). It traveled approximately 440 ft before it struck a ditch, which collapsed the nose gear and ripped the right main landing gear from the fuselage (Tabs V20.6, DD-7, DD-9, DD-10 and DD-12). The right outboard engine struck the ground, and pressurized fuel and oil lines broke, fluid sprayed over the cracked engine casing and the right wing caught fire (Tab V9.1). The aircraft came to a complete stop approximately 544 ft past the end of the paved runway surface (Tab DD-8, DD-9, DD-12 and DD-13).

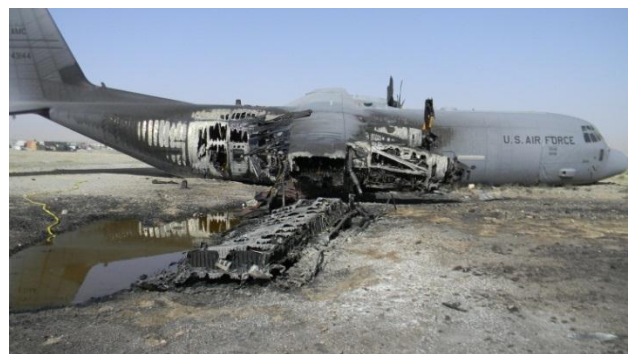
Figure 7. Photo of the MA at the crash site.

Because of the MA's impact with the ditch and subsequent fire, many parts were badly damaged or unrecoverable (Tab DD-29). None of the parts recovered and tested showed any indication of a malfunction (Tabs J-3, J-4 and V15.1). There was no indication that the pre-crash condition of any of the aircraft systems and structures was a factor in the mishap (Tab DD-32 thru DD-33 and DD-54).
