UNITED STATES AIR FORCE
AIRCRAFT ACCIDENT INVESTIGATION
BOARD REPORT

HH-60G T/N 91-26354

33RD RESCUE SQUADRON
18TH WING
KADENA AIR BASE, JAPAN

DATE OF ACCIDENT: 5 AUGUST 2013

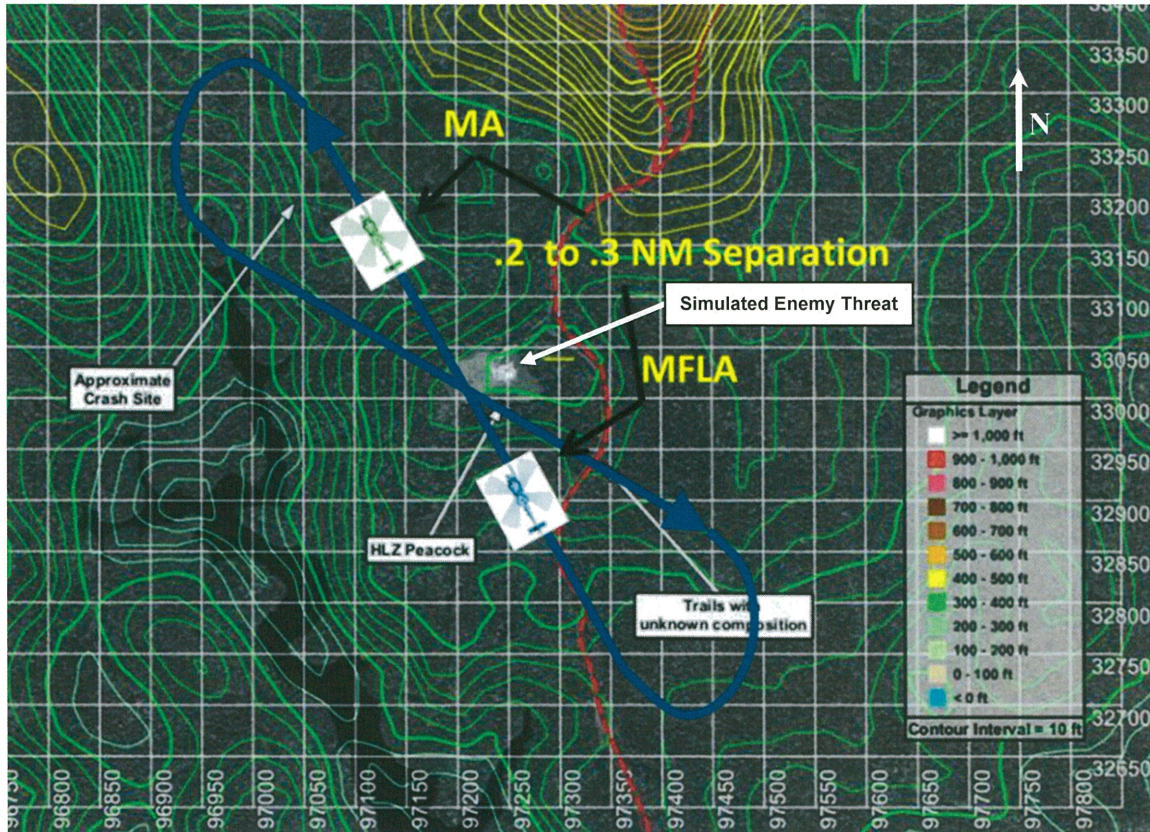
Figure 1. Desired Turn Reversal Racetrack (Tab Z-3)

MFLP's game plan, upon arrival at the IP, was to fly a racetrack pattern between the SDH and any potential threat (Tab V-1.9, V-2.12 and V-4.10 to V-4.12) (see Figure 1). Upon arriving at the terminal area and before dropping off the CRO and PJs near the SDH survivor, MF entered into a northwest-southeast oriented gun-pattern racetrack initially planned for 300 feet above ground level (AGL) with MFLA in the formation lead position (Tab V-2.12, V-4.12 to 4.15, V-4.30 and V-4.39).

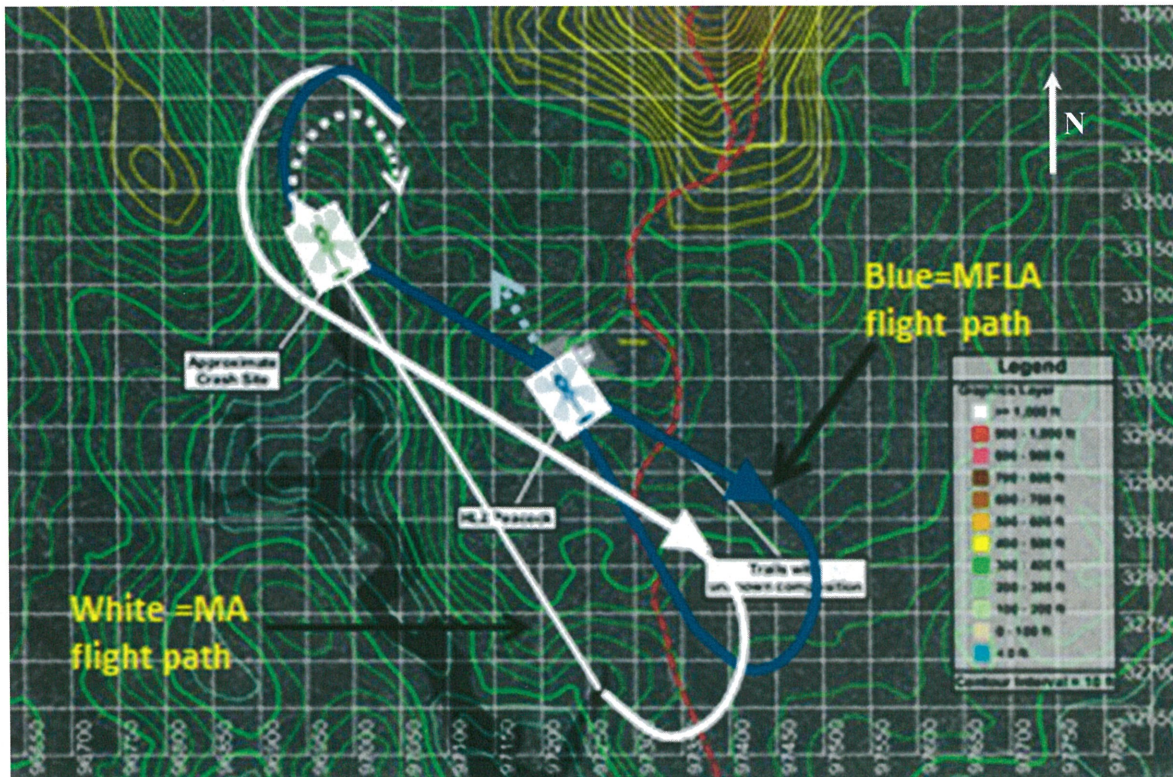
Figure 2. Mishap Aircraft and Mishap Flight Lead Aircraft Separate Ground Track (Tab Z-5)

MF continued to fly racetrack patterns, in between the last known enemy threat area and the friendly ground forces. In order to maximize target effect and keep MF between friendly ground forces and the last known enemy threat, MFLP continued to reverse the turns at each end of the racetrack (Tab V-4.12 to V-4.14). MF conducted approximately four to six gun patterns in this manner (Tab V-1.14, V-2.13 and V-4.25). While executing these patterns, the MA, under the control of MCP, allowed its ground track to shift to the west, thus placing the friendly ground forces between the MA and the last known threat area (Tab V-2.14 to V-2.15, V-4.15, V-5.17 to V-5.18 and V-6.3 to V-6.4) (See Figure 2). As noted by MFLP, MA had a weapons engagement conflict or area where they were unable to fire weapons because of the location of the survivor (Tab V-4.15). Therefore, on the last southeast leg of the racetrack, MFLP directed the

MA to correct their pattern by shifting back to the east, to once again place MA between friendly forces and the last known threat area (Tab V-4.15 to V-4.16 and V-6.3 to V-6.4). The pattern shift was acknowledged by the MC (Tab V-4.19 to V-4.21). At the same time, MFLA continued to follow the ground track between survivor and anticipated threat, thus placing it east of MA (Tab V-4.15, V-4.30 and V-5.17 to V-5.18). After the MF turned right to a northeast heading, MFLP noted that MA was still west of desired ground track and MFLP again directed a pattern correction to the east, which again the MC acknowledged (Tab V-4.15 to V-4.16). During all racetracks, the MFLA, flying in the trailing formation position, maintained the desired ground track, which was between the SDH survivor and simulated threat and to the east of the MA ground track on the last racetrack. In order for MFLA to maintain the desired ground track, they had to fly at the seven o'clock position of MA when flying southeast and at the five o'clock position when flying northwest, while maintaining .2 to .3 NMs separation (Tab V-1.32, V-2.34, V-4.15 to V-4.16 and V-4.31). Flying within the 5 o'clock to 7 o'clock position is where MP and MCP stated they would have expected the trailing aircraft to be (Tab V-1.32 and V-2.34).

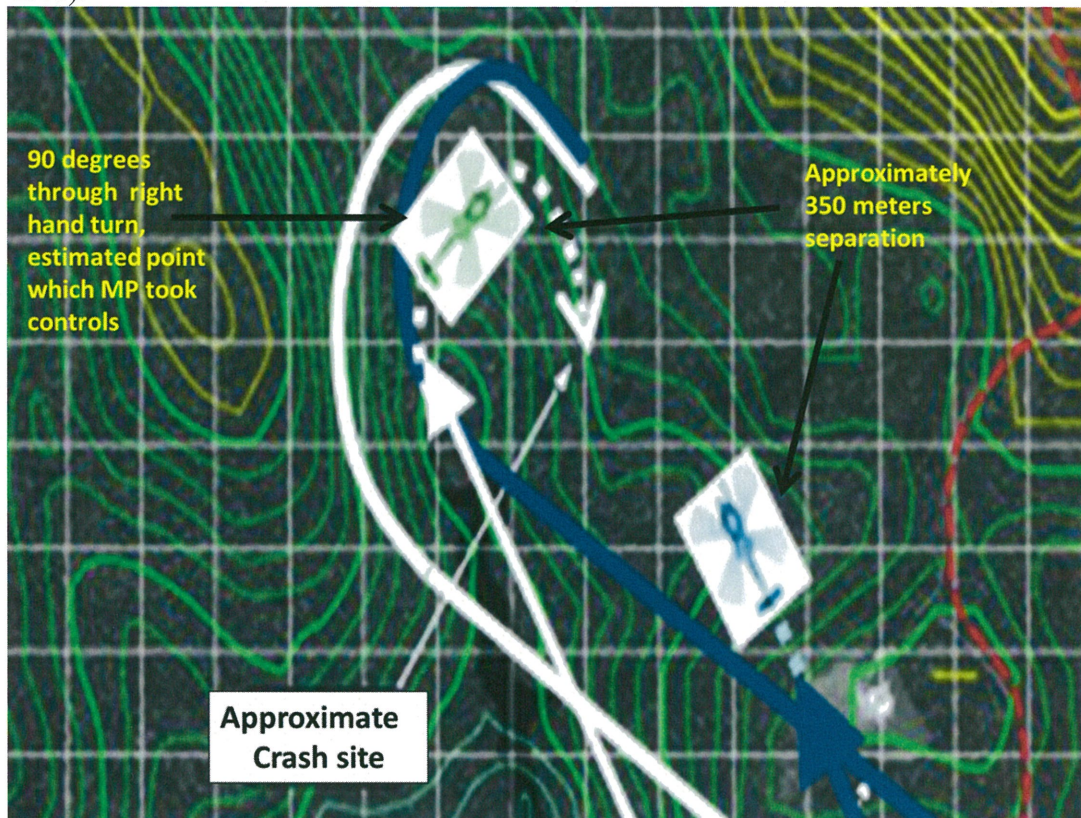
Figure 3. Mishap Pilot's Perceived Conflict Approximate Location (Tab Z-7)

It is at this point, approximately 90 degrees through the maximum performance (turning as fast as possible with the smallest radius possible for a specified airspeed) right turn, MP saw MFLA through the green house window (the window in the ceiling), which was not where MP expected to see MFLA (Tab V-1.14, V-1.30 and V-1.32 to V-1.33) (See Figure 3). MP perceived that MFLA was closing on the MA and there was danger of a midair collision (Tab V-1.14 and V-1.30). However, MFLP, MFLCP, and MFLFE indicated otherwise (Tab V-1.14, V-1.30, V-4.34, V-5.18, V-6.4 and V-7.4). While MFLP acknowledged that had he done nothing with MFLA there would have been a conflict, which is normal for this type of pattern, MFLP negated this conflict by turning to the left, with subsequent intent to follow MA in the right turn (Tab V-4.32). Further MFLP, MFLCP and MFLFE reported no sense of urgency and stated that MA and MFLA remained .2 to .3 NM distance apart (Tab V-4.34, V-5.18 and V-6.4). In addition, the MP stated the MFLA was approximately 1,000 feet at the time he first saw the MFLA (Tab V-1.33).

As a result of his perception, MP took the flight controls from MCP and increased the angle of bank from the 40-50° to an unspecified steeper angle. MP also decreased the collective (the collective changes pitch of the main rotor blades causing an increase or decrease in lift) by approximately 3-4 inches (Tabs V-1.14, V-1.16 to V-1.17, V-1.35, V-2.14 and BB-14). MP's intent was to avoid MFLA's flight path by tightening MA's turn in order to break phase and plane (turn through MFLA's flight path in a descending turn) and reversing the turn to continue around until MA would eventually rejoin behind MFLA in the gun pattern (Tab V-1.15, V-1.30 and V-1.35). While every aircraft ultimately has a responsibility for collision avoidance, in HH-60G gun patterns, the formation lead aircraft is responsible for ground track while the wingman is primarily responsible for spacing and collision avoidance (Tab BB-7). Although MP intended to descend during this maneuver, upon rolling out, MA was lower than MP anticipated (Tab V-1.15, V-1.30 and V-1.38). Realizing MA was about to hit the trees, MP pulled in as much collective as he could but described MA as "mushing through" or "didn't have enough power" in his efforts to stop the descent (Tab V-1.15). At some point during the maneuver, MP and MCP
