UNITED STATES AIR FORCE
AIRCRAFT ACCIDENT INVESTIGATION
BOARD REPORT

QF-4E, T/N 74-1629

DETACHMENT 1, 82D AERIAL TARGETS SQUADRON
53RD WING
HOLLOMAN AIR FORCE BASE, NEW MEXICO

DATE OF ACCIDENT: 7 FEBRUARY 2014

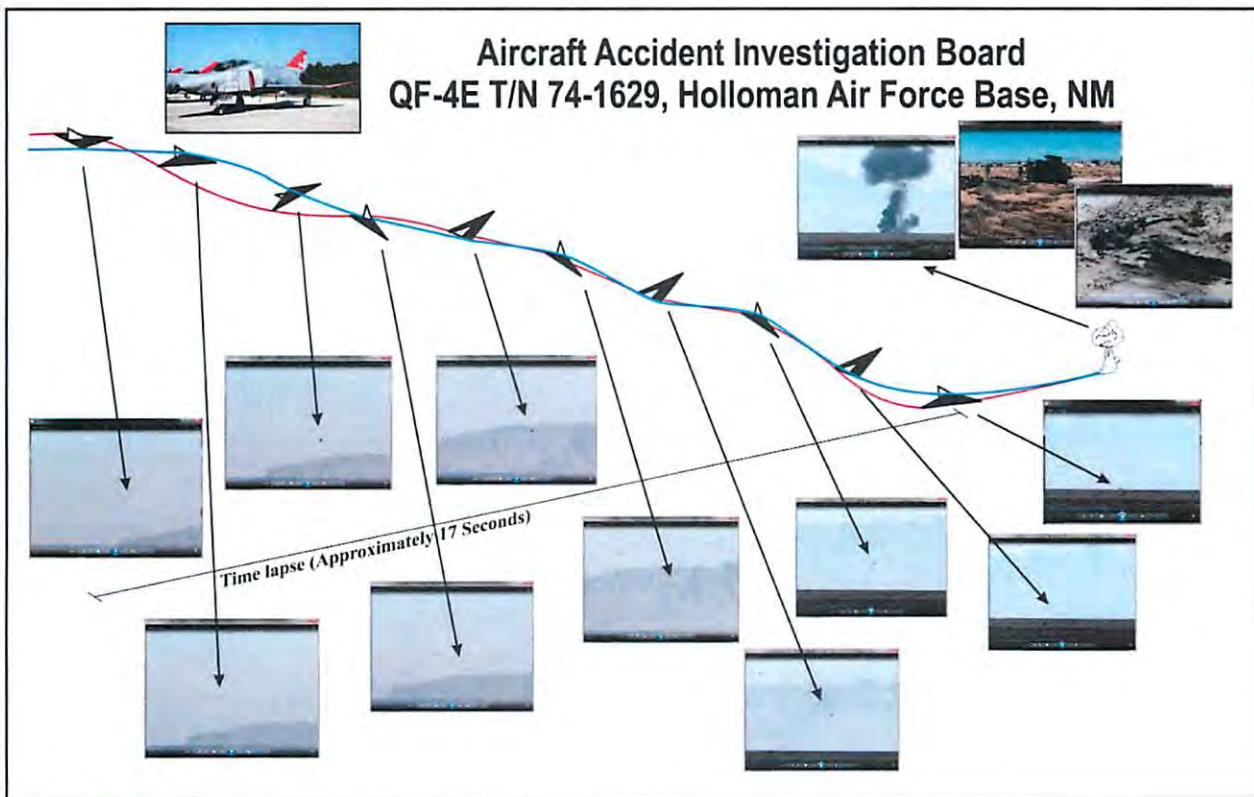
Figure 1: Graphic Illustration of Mishap Sequence (Tab Z-2.1)

At 16:06:48Z, and about seven miles from Holloman AFB, the Chase Pilot (CP) notified the MC that “we’re rocking a little bit,” which was not uncommon on an automatic recovery flown by the MA’s autopilot (Figure 1; Tab N-7; Tab S-9; Tab V-1.3 through V-1.5; Tab V-2.1 through V-2.2). However, when the MC crosschecked the flight instruments on the WITS Operating Console right screen the wings appeared level (Figure 2; Tab N-7; Tab V-1.3 through V-1.5; Tab V-2.1 through V-2.2). At 16:07:03Z, the MA made an aggressive left roll to approximately 70 degrees angle of bank, which caused the MA to lose altitude, turn left and then roll out wings level (Figure 1; Tab N-7; Tab S-9; Tab V-2.2; Tab V-4.2; Tab V-9.3; Tab EE-1.2 through Tab EE-1.13). The CP called “a big left turn,” followed by “roll out” four seconds later, describing what he saw the MA doing (Tab N-7; Tab V-1.4). The MC responded “it’s level” as a result of crosschecking the MC’s attitude indicator on the WITS Operating Console right screen, which showed straight and level flight parameters (Tab N-7; Tab V-1.4; Tab AA-1.8; Tab AA-1.14). However, the MC did note the MA was left of the automatic approach heading, and determined that he needed to take manual control of the MA, turn the MA back towards the WSMR, and troubleshoot the missed landing approach (Tab V-1.4; Tab V-1.6). At 16:07:17Z the MC switched the MA into manual control mode (Figure 3; Tab V-1.4; Tab AA-1.15; Tab AA-3.2).

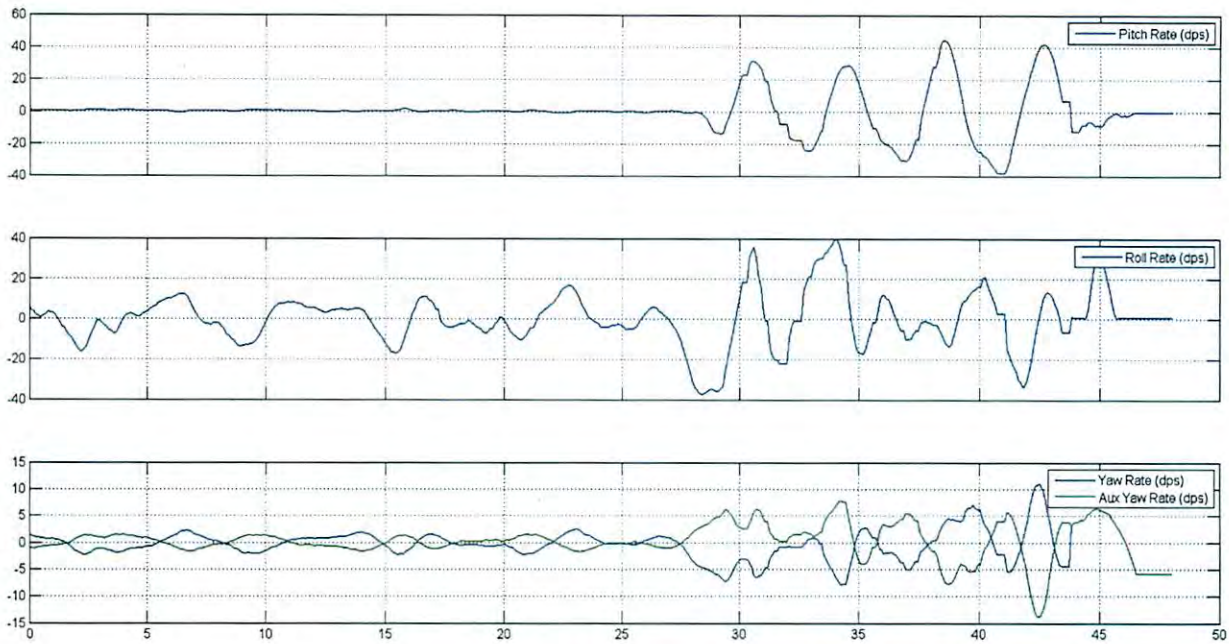
Figure 6: WITS Downlink Rate Gyro Data (Tab EE-1.7)

A detailed review of the WITS data was conducted for the MA (Tab EE-1.1 through Tab EE-1.13). An analysis of the WITS data demonstrated that there were no failures detected in the communication between WITS and the MA (Tab EE-1.1 through Tab EE-1.13). The MA was in an automatic landing mode in which the Automated Flight Control Computer (AFCC) controlled the pitch attitude, roll attitude and the heading (Tab EE-1). At approximately 1,000 feet above ground level (AGL), 180 knots indicated air speed (KIAS), and 15 units angle of attack (AOA), the aircraft suddenly rolled left, then appeared to somewhat recover the roll axis, but was then followed quickly by an unstable pitch axis (Tab EE-1.3). The MC correctly commanded AAR in an attempt to stabilize the aircraft (Tab EE-1.3). The roll axis appeared to stabilize itself but the pitch axis went through a series of limit cycle instabilities, which were induced by the stall feedback and rate limits associated with the AFCC pitch attitude control loop (Figure 6; Tab EE-1.3).

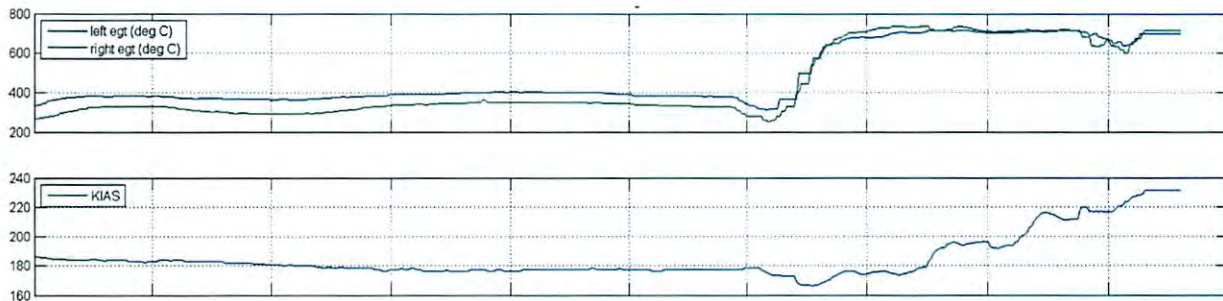
Figure 7: WITS Downlink Flight Data (Tab EE-1.6)

The MA engines were in afterburner (AB), as demonstrated by the increase in the temperature of the engines and the increase in the KIAS; however, the pitch gyrations caused the MA to continue its descent faster than before causing the MA to impact the ground approximately 17 seconds after the instability started (Figures 6-7; Tab EE-1.3 through Tab EE-1.4).

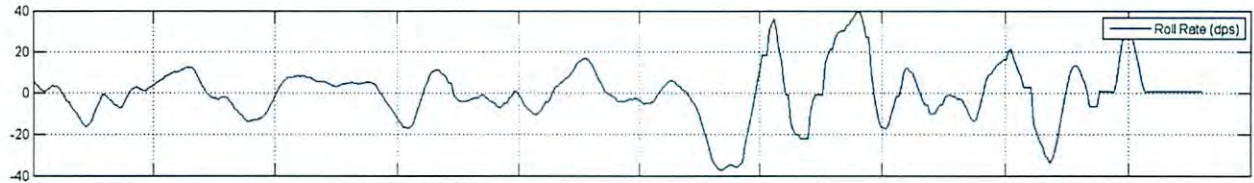
Figure 8: MA Rate Gyro Roll Data (Tab EE-1.7)

The rate gyro downlink data demonstrated that at or about 26 seconds on the rate gyro roll data plot the aircraft started a left roll, as demonstrated by a trough of approximately -38 degrees per second (Figure 8; Tab EE-1.4; Tab EE-1.9). Additionally, at about 28 seconds on the rate gyro pitch plot the MA started pitching down as demonstrated by a trough of approximately -10 degrees per second (Figure 9; Tab EE-1.4; Tab EE-1.9).

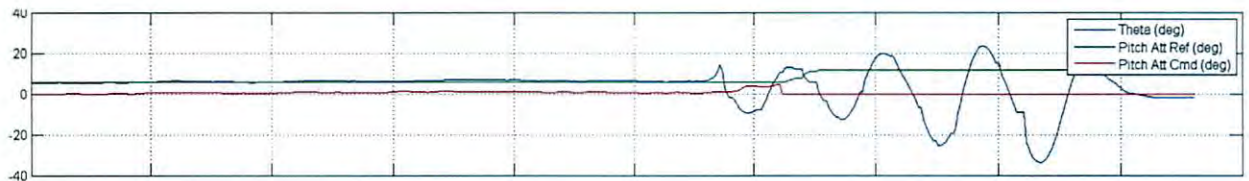
Figure 10: MA Attitude Gyro Pitch Data (Tab EE-1.7)

However, the attitude gyro downlink data showed a large right roll demonstrated by a peak of approximately 10 degrees on the attitude gyro pitch plot, and a large pitch up demonstrated by a peak of approximately 50 degrees on the attitude gyro roll plot, at 26 seconds and 28 seconds respectively (Figures 10; Tab EE-1.4; Tab EE-1.10). Therefore, the rate gyro roll and rate gyro pitch of the MA and the attitude gyro roll and attitude gyro pitch conflicted (Figures 6-11; Tab EE-1.4; Tab EE-1.9 through Tab EE-1.10).

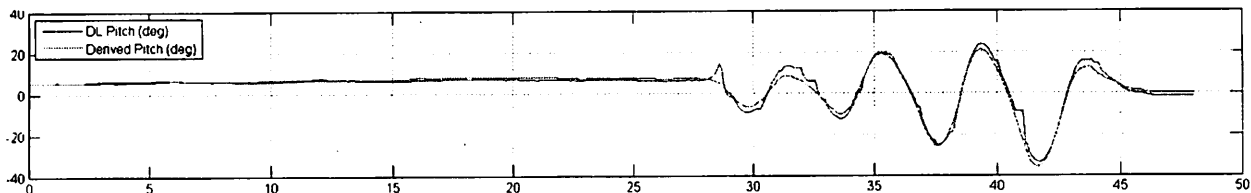
Figure 12: Calculated MA Pitch Performance vs. Attitude Gyro Pitch Downlinked Data (Tab EE-1.10)

An analysis comparing the calculated pitch and roll of the MA compared to the attitude gyro downlink data identify a 2-3 second “glitch” at approximately 26 seconds where the attitude gyro pitch and roll downlinks conflicted with the actual flight performance of the MA (Figure 12; Tab EE-1.5; Tab EE-1.4). After the 2-3 second glitch, the attitude gyro downlink data closely mirrored what the MA actually did (Figure 11; Tab EE-1.5; Tab EE-1.4). Additionally, after the 2-3 second glitch in the attitude gyro downlink data, the roll axis appeared to stabilize, but the attitude gyro pitch axis began to go unstable (Figures 12-13; Tab EE-1.5; Tab EE-1.4).

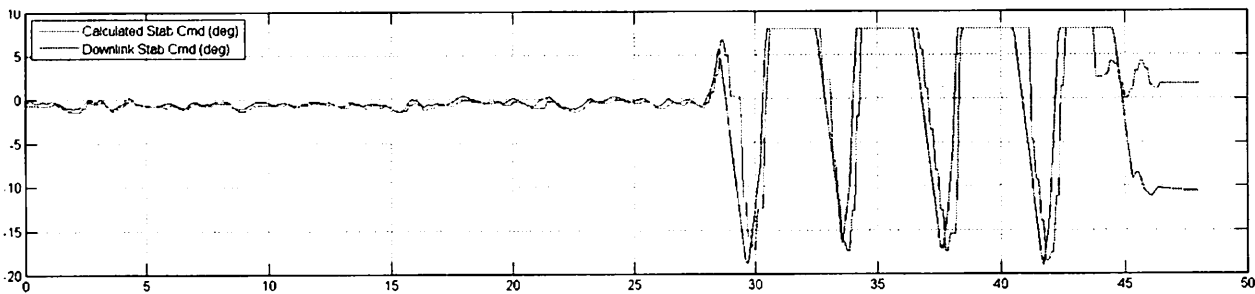
Figure 14: Calculated Stabilator Command vs. Actual Stabilator Command (Tab EE-1.10)

An analysis of the attitude gyro pitch demonstrated the pitch instability was caused by large initial erroneous attitude errors at low speeds while the aircraft was in an automatic landing sequence. (Figures 12-13; Tab EE-1.4). The source of the error could not be determined. (Tab DD-3.1). The MA subsequently responded by driving the stabilator, the aircraft component that moves the aircraft up and down, into a stall prevention mode as quickly as possible resulting in a continuous cycle of overcorrection of the MA’s pitch and an increase in pitch oscillations (Figure 14; Tab EE-1.4 through Tab EE-1.5).

The instability, once started, would have only been corrected by either switching the MA to BUAFCS or enabling manual flight control with the addition of a very small pitch rate inputs (Tab EE-1.6). These pitch stick out (PSO) inputs would have put the MA into a pitch rate mode, thus eliminating the large oscillations that were a result of the MA attempting to maintain a
