UNITED STATES AIR FORCE
AIRCRAFT ACCIDENT INVESTIGATION
BOARD REPORT

MQ-1B, T/N 02-3098
11TH RECONNAISSANCE SQUADRON
432D WING
CREECH AIR FORCE BASE, NEVADA

LOCATION: CREECH AFB, NV
DATE OF ACCIDENT: 04 APRIL 2014
BOARD PRESIDENT: LT COL CALVIN B. POWELL

SUMMARY OF FACTS AND STATEMENT OF OPINION
MQ-1B, T/N 02-3098
04 April 2014

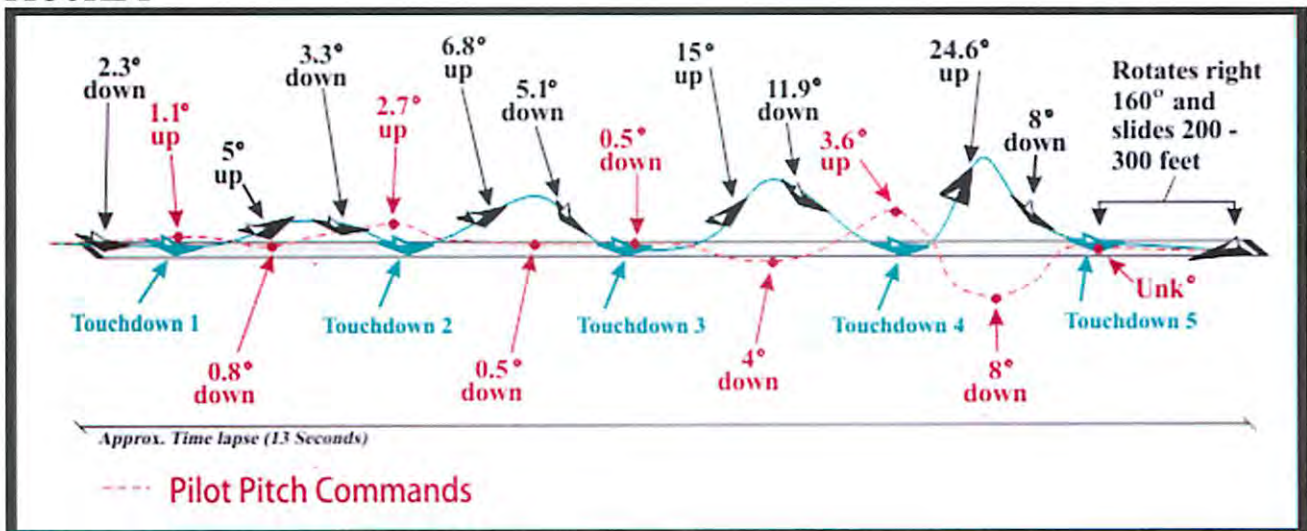
FIGURE 1

Beginning at 2322:05GMT, the MRPA had five touchdowns, or ground impacts, during the mishap landing sequence, with the nose of the MRPA pitching higher after each touchdown (Tab EE-5 thru EE-6). After each touchdown, as the MRPA bounced off the runway and its upward pitch angle increased, the MUP reacted by decreasing the pitch command (see Table 1 and Figure 1) (Tab EE-5 thru EE-6). Approaching each touchdown, the MUP attempted to adjust the downward pitch angle of the MRPA with an increase in pitch command (see Table 1 and Figure 1) (Tab EE-5 thru EE-6). This caused an overcorrected pitch angle so the nose of the MRPA came down and struck the runway with increasing force at each touchdown, until the final touchdown when the MRPA no longer had any landing gear (Tab EE-6; Tab S-2). Then the MRPA rotated 160° to the right and skidded along the runway until it came to a stop at 2322:24GMT (Tab DD-6; Tab EE-6; Tab N-13 thru N-15).

Table 1 and Figure 1 illustrate the series of pitch angle changes and countering pitch commands, which characterize the Pilot Induced Oscillation (PIO) in this case (Tab EE-5 thru EE-6).

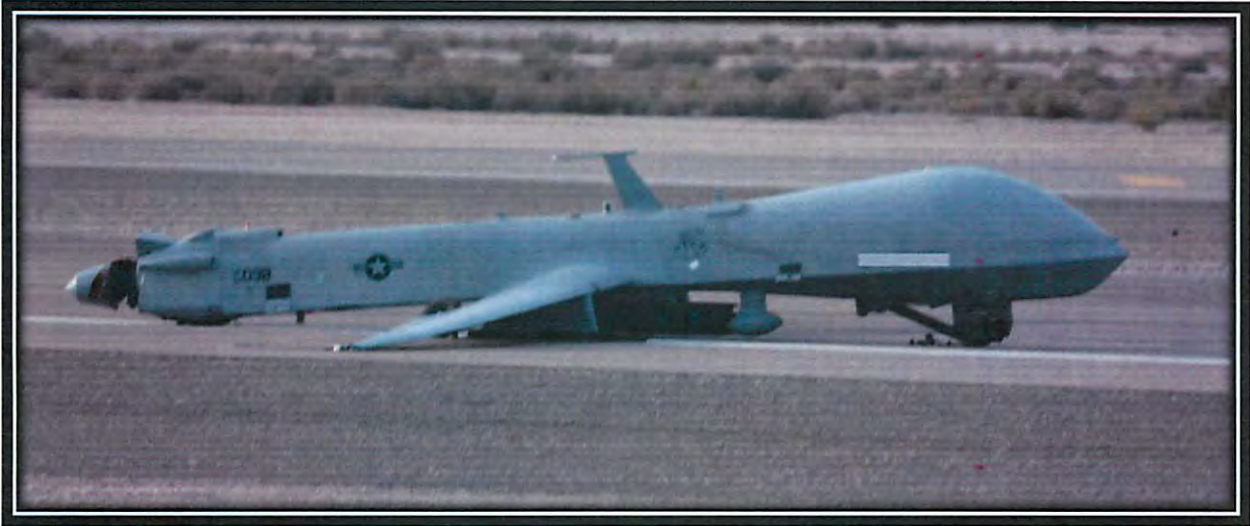
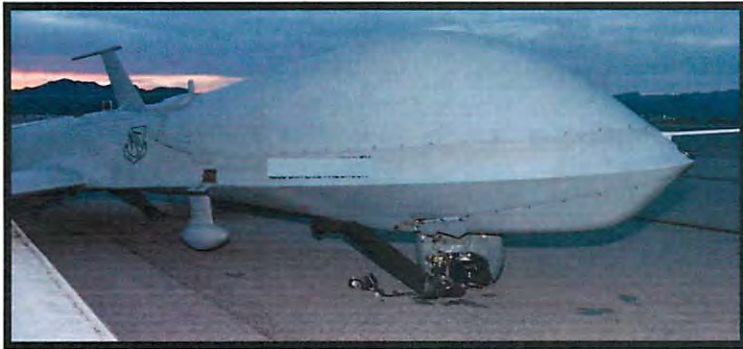
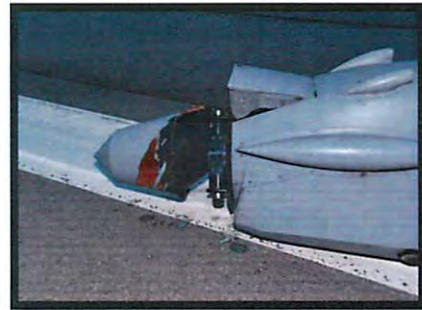
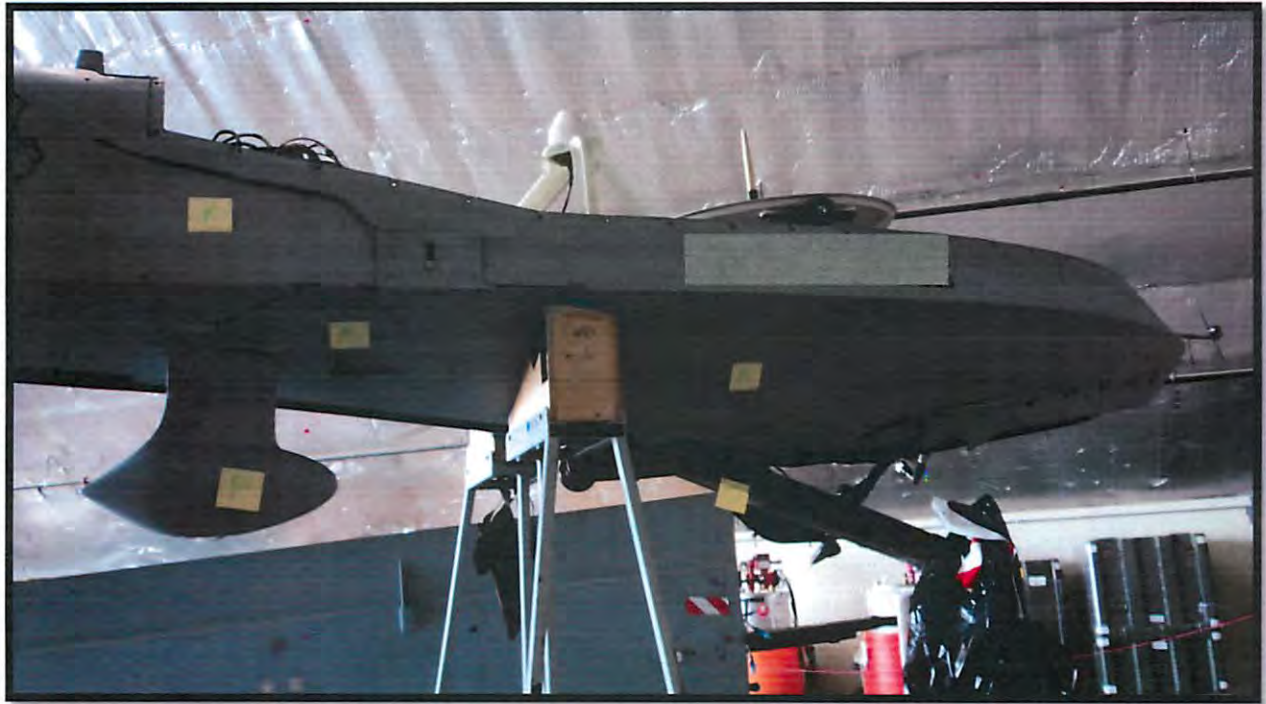
During the mishap, the MRPA sustained significant damage (Tab S-2). Specifically, the tails, both propellers, and all three landing gear were sheared off (Tab S-2 thru S-6). Furthermore, the wings and body had multiple holes and cracks as a result of the crash (Tab S-6).
