UNITED STATES AIR FORCE
AIRCRAFT ACCIDENT INVESTIGATION
BOARD REPORT

F-16CJ, T/N 92-3890

UNITED STATES AIR FORCE AIR DEMONSTRATION SQUADRON
57th WING
NELLIS AIR FORCE BASE, NEVADA

DATE OF ACCIDENT: 2 JUNE 2016

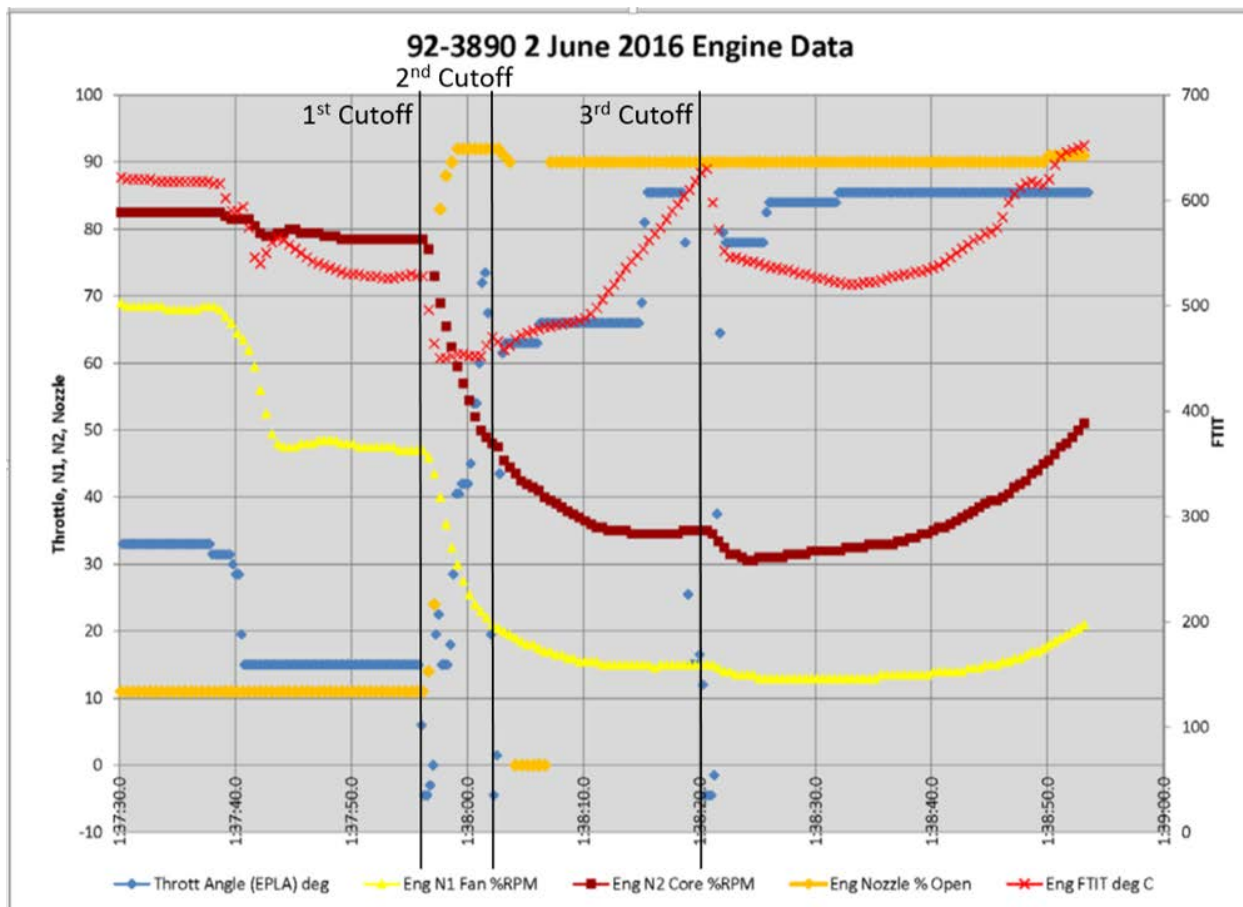
Figure 1: MA Engine Data (Tab EE-15)

At the initial placement of the throttle to the cutoff position (1st Cutoff), the MA was at too low an energy state (a combination of airspeed and altitude) for engine restart prior to ground impact (Tabs BB-6 and EE-29). If an aircraft is at an altitude between 4,000 and 10,000 feet AGL (MP was at approximately 2000 AGL), there is probably time for one airstart prior to minimum recommended ejection altitude (Tabs BB-5 and EE-29). Additionally, at this first movement of the throttle to cutoff, the MA was already at too low an energy state to glide to the runway (Tabs V-1.7 and BB-11 to BB-12). At 12:59:44L, due to RPM decreasing below idle, the MP exercised efforts to restart the engine (Tabs V-1.4 and EE-13). IAW airstart procedures, he intentionally placed the throttle to cutoff (2nd Cutoff) (Tabs V-1.3, V-1.4, V-1.23, V-1.24, BB-9, and EE-13). To restart a failed engine (Pratt & Whitney 229) in flight, the throttle must be placed to cutoff position, then placed midrange, followed by actuation of the Jet Fuel Starter (JFS) (Tab BB-9). While executing those Critical Action Procedures (CAPs), the MP recalled “there was no hang ups on the hump [idle cutoff stop] or anything like that” in reference to moving the throttle to the cutoff position the first time, and “I don’t remember if there was anything weird about the lever [throttle trigger]” in reference to trigger switch actuation, though admitting that the throttle trigger was not the focus of his attention at the time (Tabs V-1.23 to V-1.24).

See Figure 1 (below), for a visual depiction of the MA's engine systems for approximately the last minute and a half prior to impact (Tab EE-15). The blue data points ["Thrott Angle (EPLA) deg"] indicate throttle placement fore and aft in angular degrees, with lower numbers meaning a throttle position further aft, and vice versa (Tab EE-15). At lines "1st Cutoff", "2nd Cutoff" and "3rd Cutoff", the blue data points go below "0", showing that the throttle was pulled aft to the cutoff position (Tab EE-15).

The dark red data points, ("Eng N2 Core %RPM"), show the RPM of the engine as a percentage, with a higher percentage meaning greater thrust (~70 - ~80% RPM indicates idle thrust) (Tabs V-1.3, EE-15). After the line noted as "1st Cutoff", the RPM drops rapidly, representative of an engine shutdown (Tabs BB-8 and EE-15). The red data points begin to stabilize just prior to the line labeled "3rd Cutoff", indicating an engine beginning to restart (Tabs BB-6, BB-7, and EE-15). The increasing RPM after "3rd Cutoff" is indicative of an engine in the process of restarting; however, the engine would not have regained usable thrust, prior to ground impact (Tabs BB-5 to, BB-7, and EE-13).

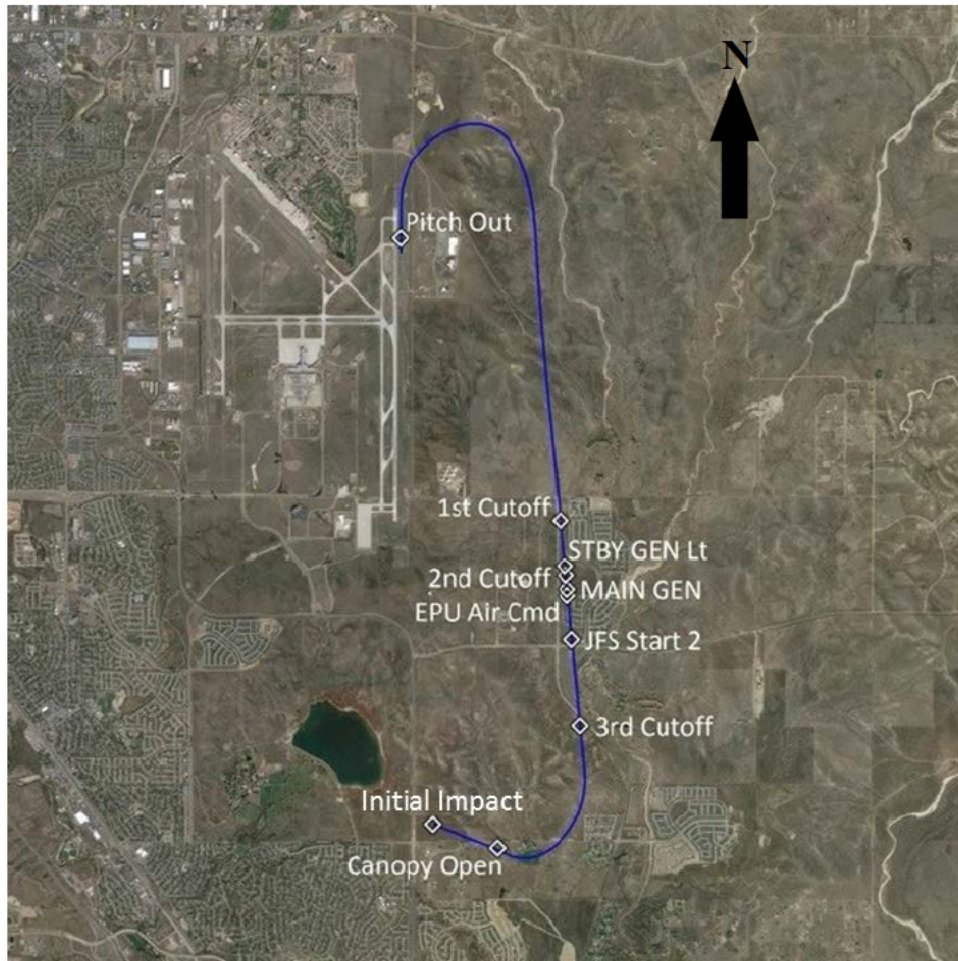
Figure 2: MA Ground Track (Tab EE-8)

Figure 2 (below) depicts the final moments of the MA flight path from a satellite view (Tab EE-8). The MA began the 180 degree turn to parallel the runway, flying back to the approach end of Runway 35R (Tab EE-8). Once the MA completed the turn and climbed to the appropriate altitude, it was established southbound on the downwind leg (Tab EE-8). Abeam the approach end of Runway 35R, the MA experienced the first movement to the cutoff position, designated in Figure 2 as “1st Cutoff” (Tab EE-8). Figure 2 depicts aircraft continuation on its downwind heading, to include the second movement to cutoff (“2nd Cutoff”), the activation of the JFS (“JFS Start 2”), and a third movement to cutoff (“3rd Cutoff”) (Tab EE-8). The MP started a right-hand turn just after the 3rd Cutoff ejecting at the position labeled “Canopy Open” (Tab EE-8). The MA impacted at the position labeled “Initial Impact” (Tab EE-8).

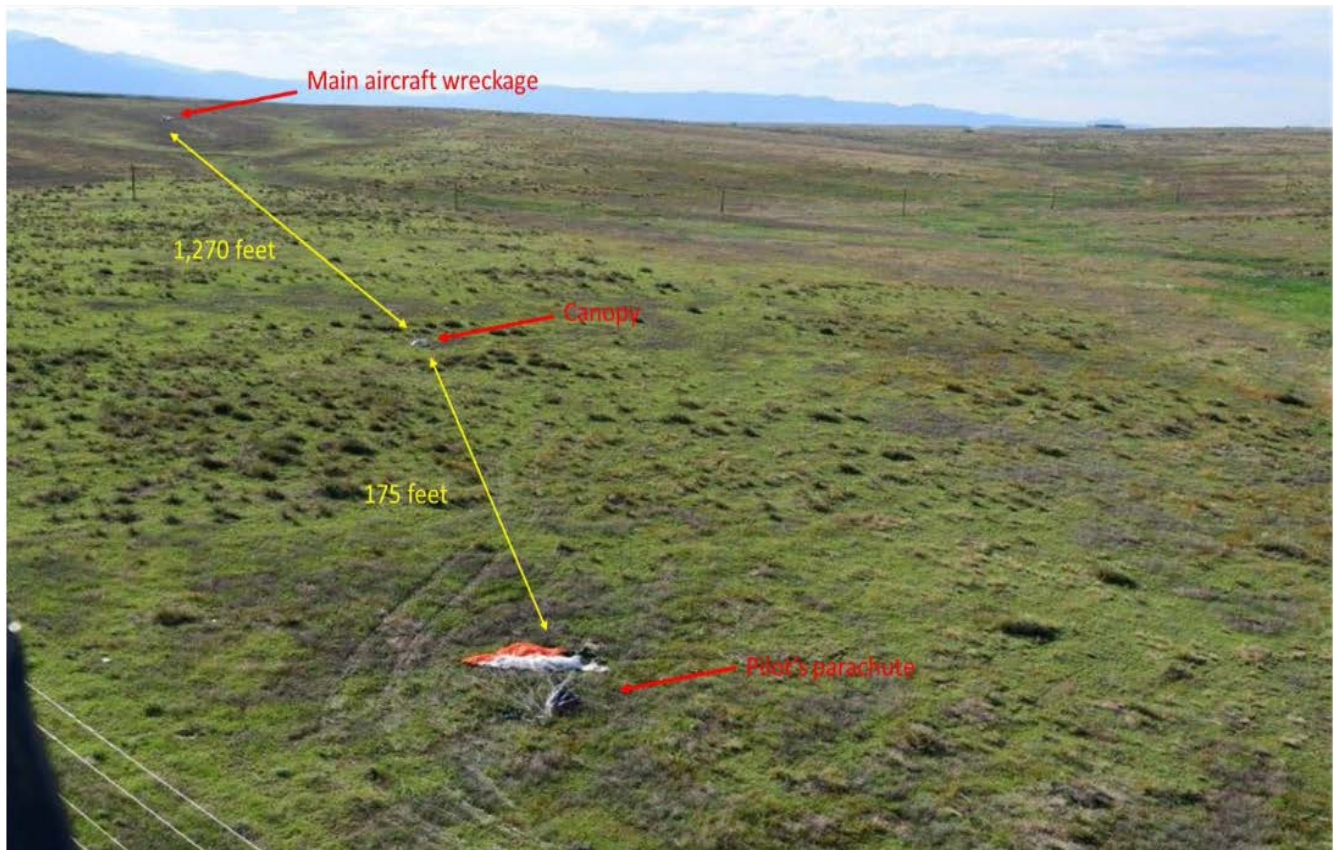
The MA impacted the ground at 13:00:36L in an open grassy field, off-base (Tabs Q-5, S-2, EE-6, and EE-14). The MA impacted at relatively wings level, slightly nose high, and came to rest 1,240 feet from initial impact on a slight uphill slope (Tabs S-2, EE-6 and EE-9). The MP's parachute was found 1,450 feet southeast from the initial impact point (Tabs EE-6 to EE-7). The impact area was two miles south of Runway 35R at Peterson AFB, and just to the north of a residential area (Tabs S-2 and EE-8). Figure 3 shows the impact area and Figure 4 shows the aircraft after impact (Tab S-2).

Figure 3: MA Crash Site Looking Northwest. (Tab S-4)

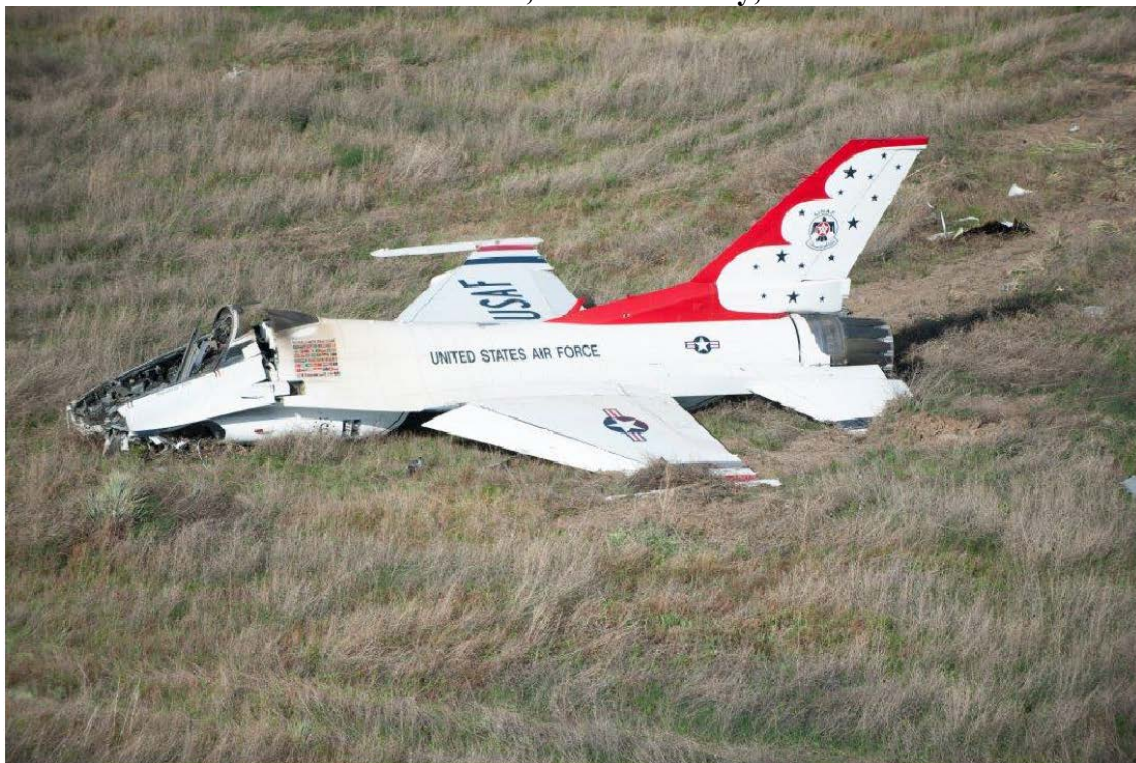
Figure 4: MA post impact (Tab S-2)

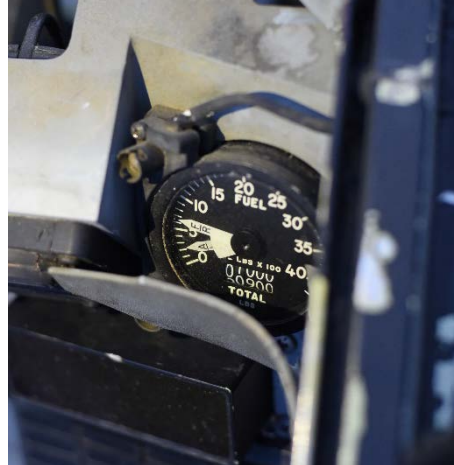
Figure 5. Fuel gauge for the MA indicating approximately 900 pounds of fuel in the fuel tanks after impact (Tab Z-13)

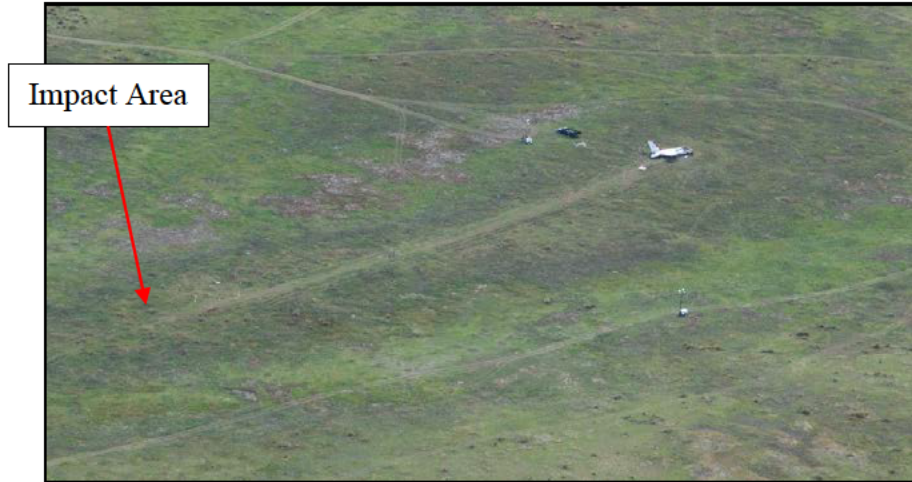
The MA impacted the ground (grass field) wings level from a relatively level attitude (Tabs S-2 and EE-9). All of the MA debris was contained within a narrow trajectory from the point of impact to the point of resting, an approximate distance of 1,240 feet (Figure 6, Tabs S-4 and EE-6 to EE-7). Most of the sustained damage was on the undercarriage of the MA due to its low-angle flight path upon impact (Tabs Z-3, Z-2, EE-9, and EE-37 to EE-38).

Figure 6. Photo of grassy field indicating impact area, narrow debris field, and MA at rest position (Tab Z-12)

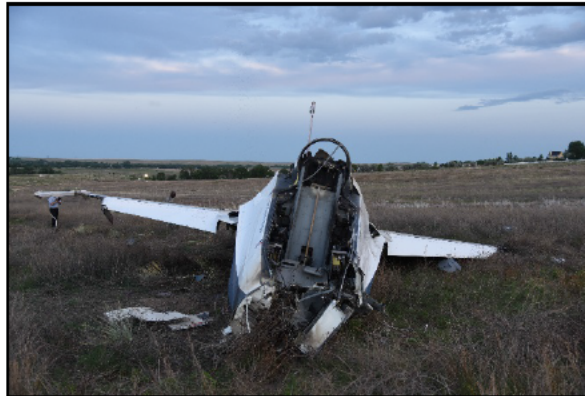
The forward fuselage module (nosecone) sustained damage upon impact and separated from the aircraft (Figure 7, Tab Z-2). The cockpit structure sustained damage upon impact and was partially separated just forward of center fuselage (Figure 8, Tab Z-4). The engine intake module sustained damage upon impact (Figure 9, Tab Z-5). The right main landing gear was twisted and bent rearward after the landing bay doors were torn from the undercarriage (Tab EE-37). The aft engine access cover sustained damage and was found in the debris trail (Figures 10 and 11, Tab Z-6).

Figure 7. Front view (looking aft) of MA showing damage to cockpit and right and left wings (Tab Z-2)

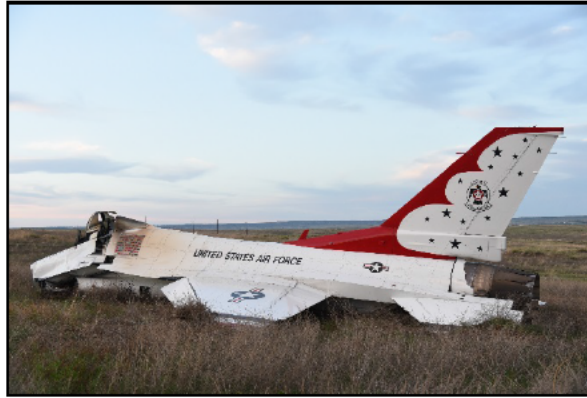
Figure 8. Left view of MA showing partial cockpit separation and damage to tail section of engine bay (Tab Z-3)

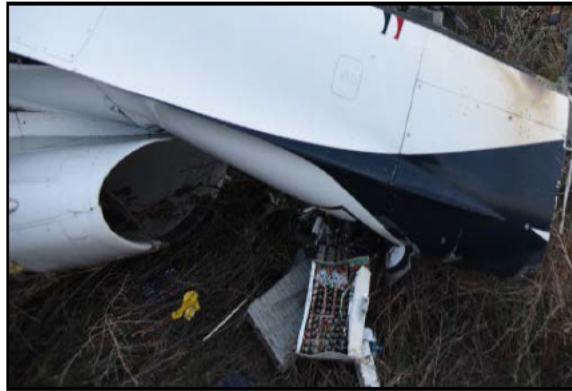
Figure 9. MA Engine intake and cockpit (Tab Z-4)

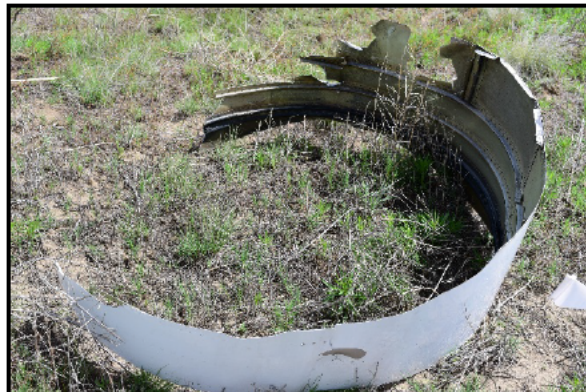
Figure 10. MA Engine bay access cover in debris field (Tab Z-6)

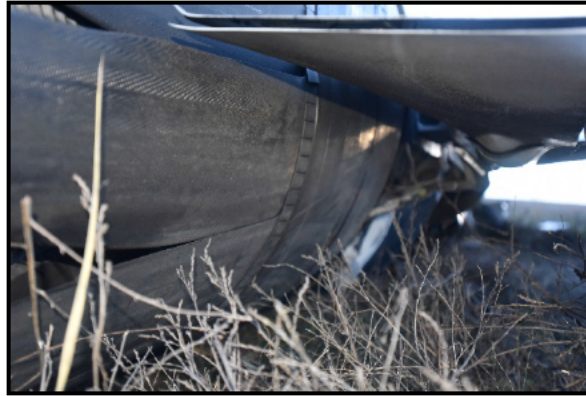
Figure 11. MA Right aft tail section under speedbrake (looking forward) (Tab Z-7)

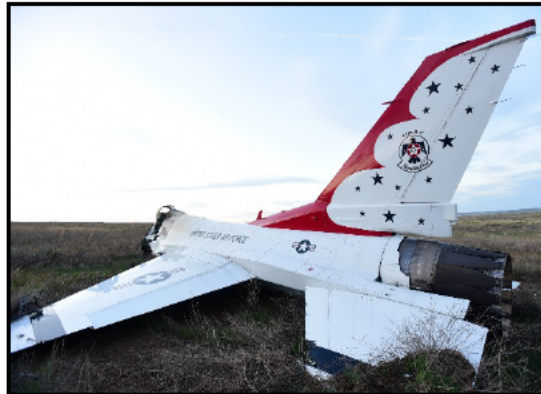
All of the control surfaces remained attached to the MA after impact (Figures 12 and 13, Tabs Z-3, Z-4, and EE-37). The left and right wing tip sustained damage after impact (Figure 13, Tab EE-38). Based on the DAS, the MA flight control system was responding properly to inputs until impact (Tab EE-38).

Figure 12. MA Left horizontal stab damage (Tab Z-8)

The left horizontal stabilizer sustained damage from impact but remained attached to the aft portion of the fuselage, while approximately half of the outer portion of the right horizontal stabilizer had detached (Tabs Z-9 and EE-38).

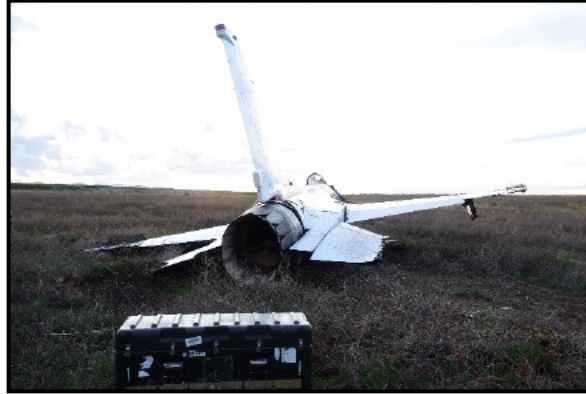
Figure 13. Photo showing damage to MA right horizontal stab, right and left wing tips (Tab Z-9)

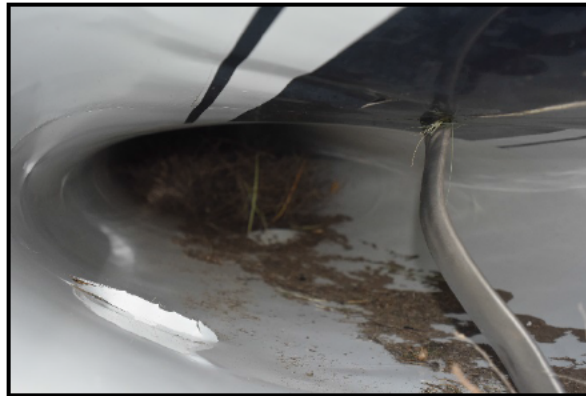
The lower portion of the engine and engine exhaust sustained damage from impact (Figures 14 and 15, Tabs Z-4, Z-5, Z-6, Z-7, and Z-10). The engine was operating and responding as expected until the point of impact (Tab EE-31).

Figure 14. Damage to MA engine intake (Tab Z-5)

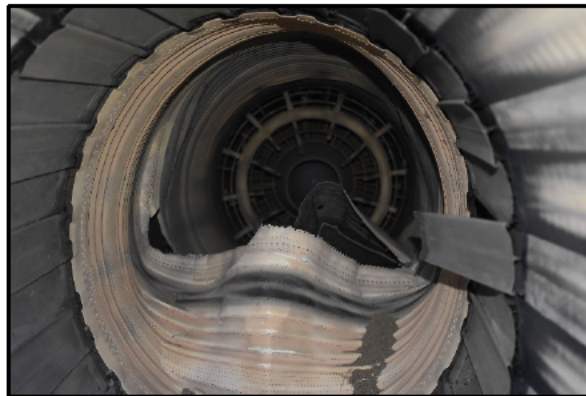
Figure 15. Damage to MA engine exhaust (Tab Z-10)

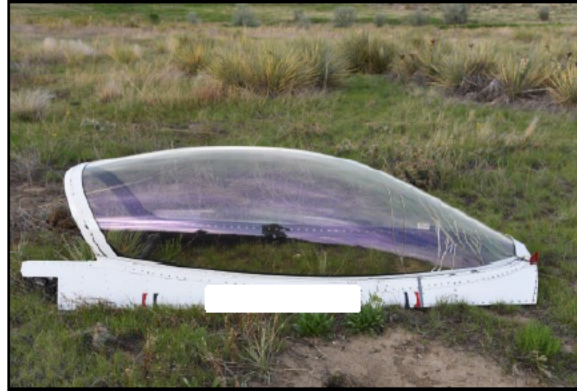
The canopy sustained damage after ejection from the aircraft (Tab S-3). The canopy was found approximately 1,270 feet southwest from the initial impact point (Figure 16, Tab S-4).

Figure 16. Photo of MA canopy (Tab S-3)

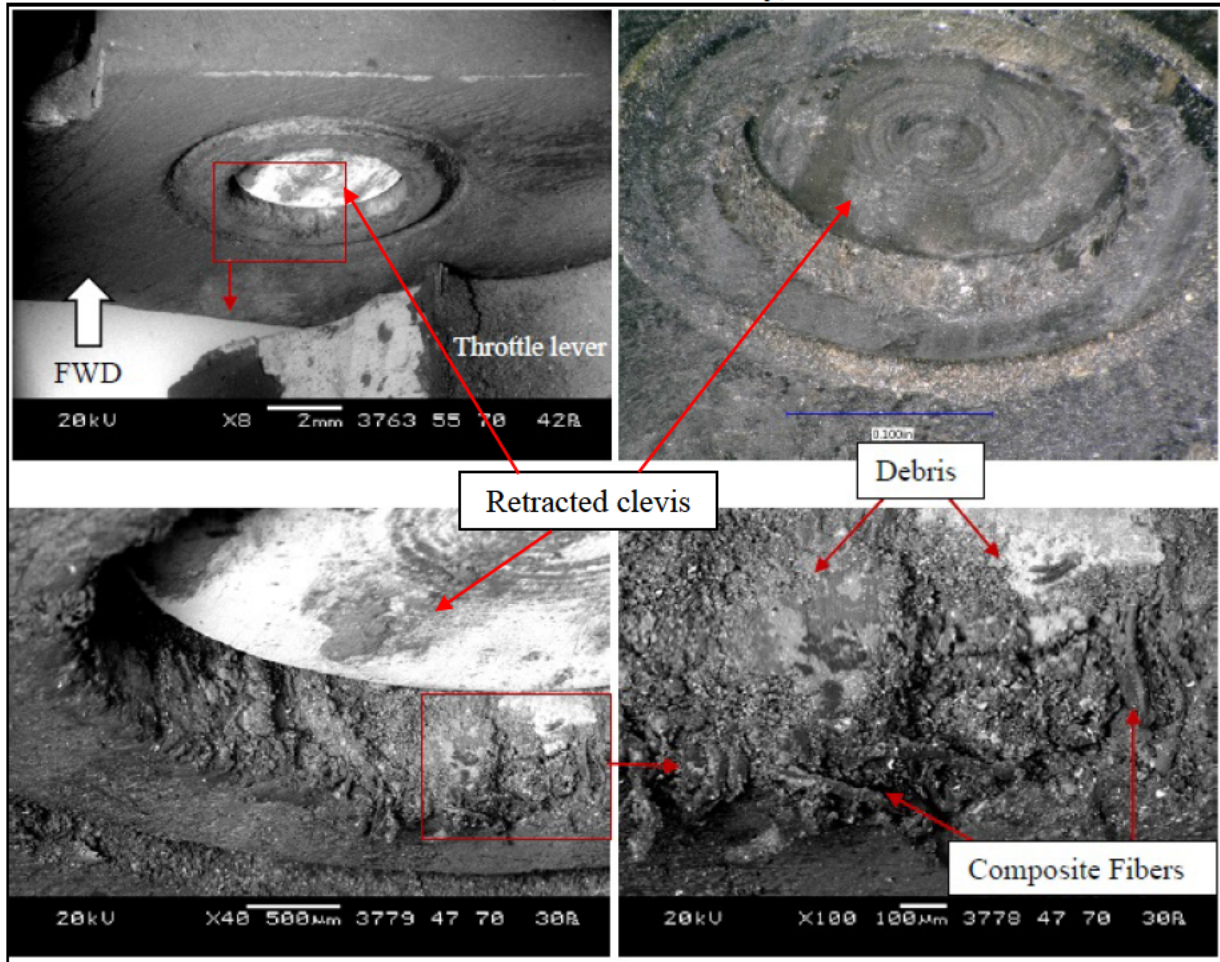
The bushing was inspected with the throttle trigger clevis pin in the retracted position (Tab FF-8). A significant amount of debris was present within and around the bushing and broken composite fibers protruded from the bushing (Figure 16, Tab FF-8). Debris contamination and damage to the throttle trigger bushing due to throttle trigger clevis pin misalignment (not visible to the naked eye), caused friction between the throttle trigger clevis pin and the throttle trigger bushing (Tab FF-9). The debris was analyzed by electroscopic dispersive spectroscopy and composition was consistent with a mixture of aluminum, steel (consistent with wear debris from throttle lever), dirt, and a lubrication compound (molybdenum disulfide) (Figure 16, Tabs FF-8 and FF-19).

Figure 17. Contamination of the MA's throttle trigger clevis bushing evident with the pin in the retracted position (Tab FF-19)

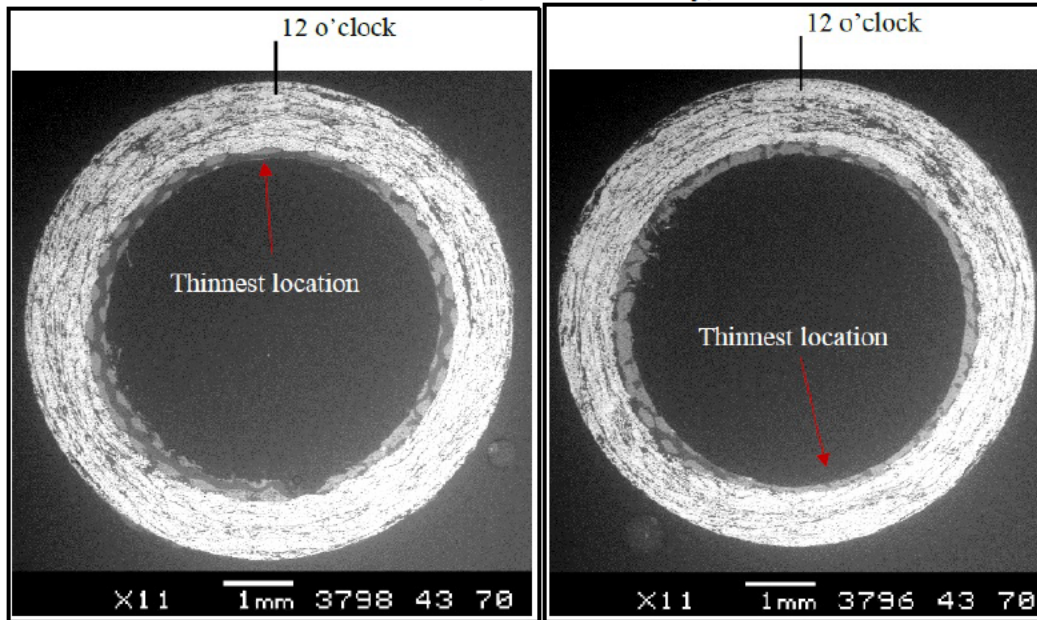
Transverse cuts of the excised bushing were measured for diameter thickness discrepancies (Tabs FF-8, FF-19, and FF-22). Measurements indicated the alignment of the throttle trigger clevis pin was angularly misaligned causing a thinning of the bushing diameter at the 12 o'clock position near the aft end and 7 o'clock (aft looking forward) position near the forward end (Figure 18, Figure 19, Tabs FF-8 and FF-22.).

Figure 18. Scanning electron microscope images of the section 0.01 inches from the aft/forward portions of the MA's throttle trigger clevis bushing showing variation in thickness (Tab FF-22).

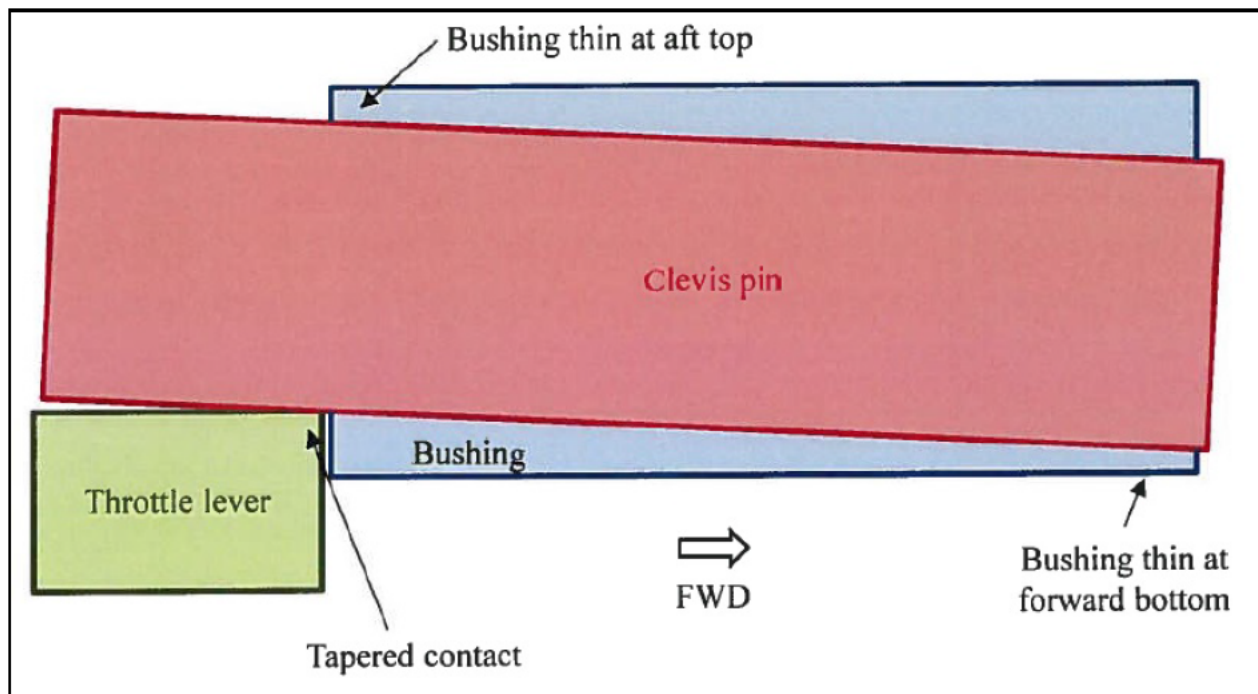
Figure 19. MA Misalignment throttle trigger clevis pin in bushing (Tab FF-22)

During replacement of the throttle trigger, alignment of the throttle trigger clevis pin is critical; however, “best alignment” as described by a maintenance member is “trial and error” since the Removal and Installation of the Forward Throttle Grip Assembly highlighted in TO 1F-16CJ-2-94JG-60-2 (-94JG) refers only to allowable clearances for spacing between the throttle trigger and the throttle grip. There is no mention of a check for the alignment of the clevis pin (to include paint wear) in the PR/BPO Inspections or 50-hour Forward Throttle Quadrant Inspection. Consequently, there is no guidance in either the PR/BPO Inspections or the 50-hour Forward Throttle Quadrant Inspection to check for alignment of the clevis pin. AFRL reported that misalignment of the clevis pin in the bushing could account for the throttle trigger sticking in the retracted position.

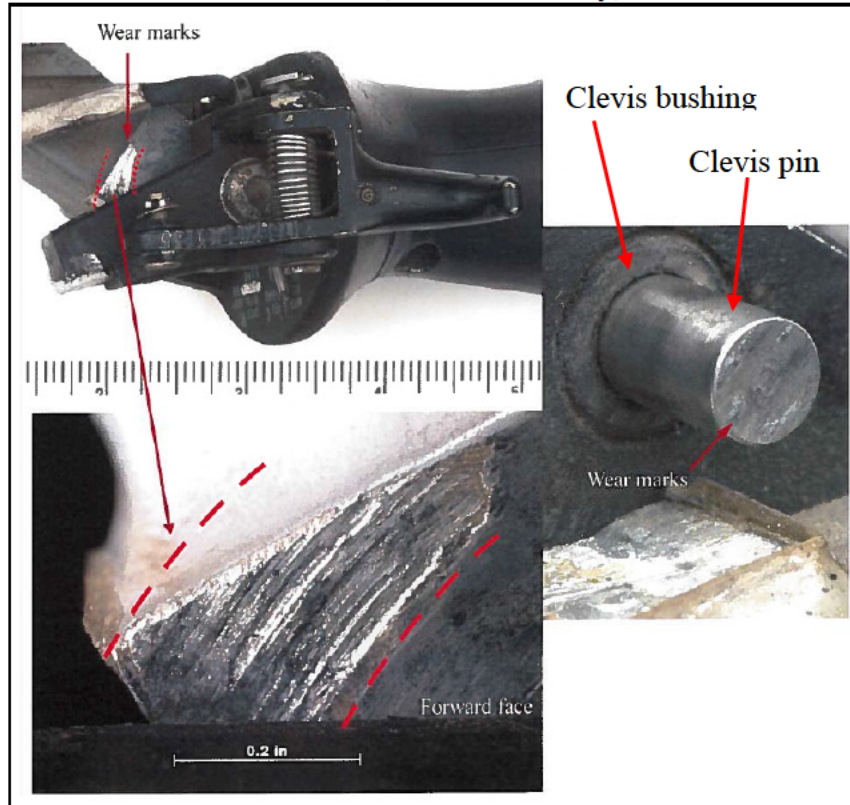
The clearance between the throttle trigger and throttle grip at the spring-loaded pivot was beyond tolerance by 0.002 inches (Figure 20, Tab FF-9). Paint wear on four painted interfaces likely resulted in the clearance outside of tolerance range (Figure 21, Tab FF-9). As AFRL noted in their report, the clearance at this location would affect the likelihood for sticking (Tab FF-9).

Figure 20. Wear between the MA's clevis pin and forward face of the throttle (Tab FF-16)

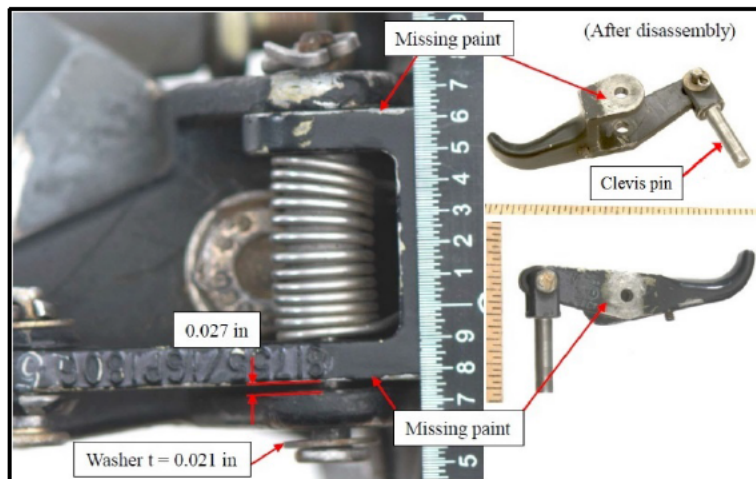
Figure 21. Clearance measurement at the spring-loaded throttle trigger pivot point while assembled, and worn surfaces of the MA throttle trigger observed after disassembly (Tab FF-18)
