UNITED STATES AIR FORCE
AIRCRAFT ACCIDENT INVESTIGATION
BOARD REPORT

C-130H, T/N 74-1692
36TH AIRLIFT SQUADRON
374TH AIRLIFT WING
YOKOTA AIR BASE, JAPAN

**LOCATION: SUBIC BAY INTERNATIONAL AIRPORT,
PHILIPPINES**

DATE OF ACCIDENT: 7 APRIL 2016

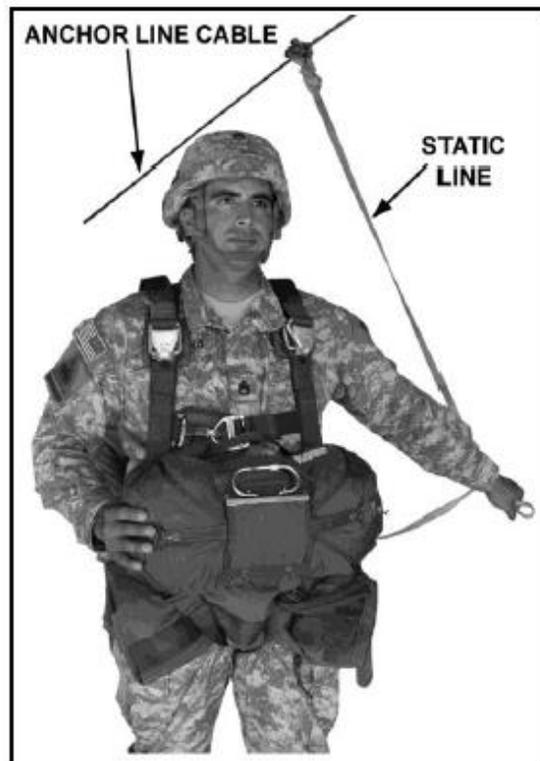
Figure 4-1
(Tab S-10)

Proper Way to Hold Static Line

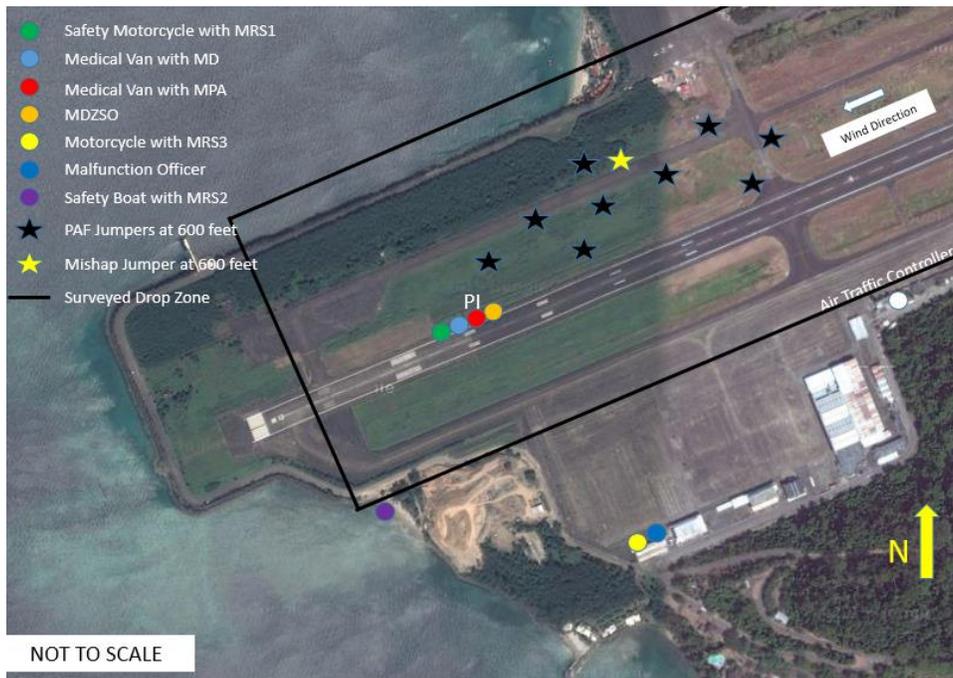
Figure 4-3

(Tabs R-227, S-6 to S-7, S-17, V-13.1, V-24.1 to V-24.2, V-27.1, Z-3, Z-17, and Z-19)
 Location of Ground Party and Jumpers at Approximately 500 feet AGL

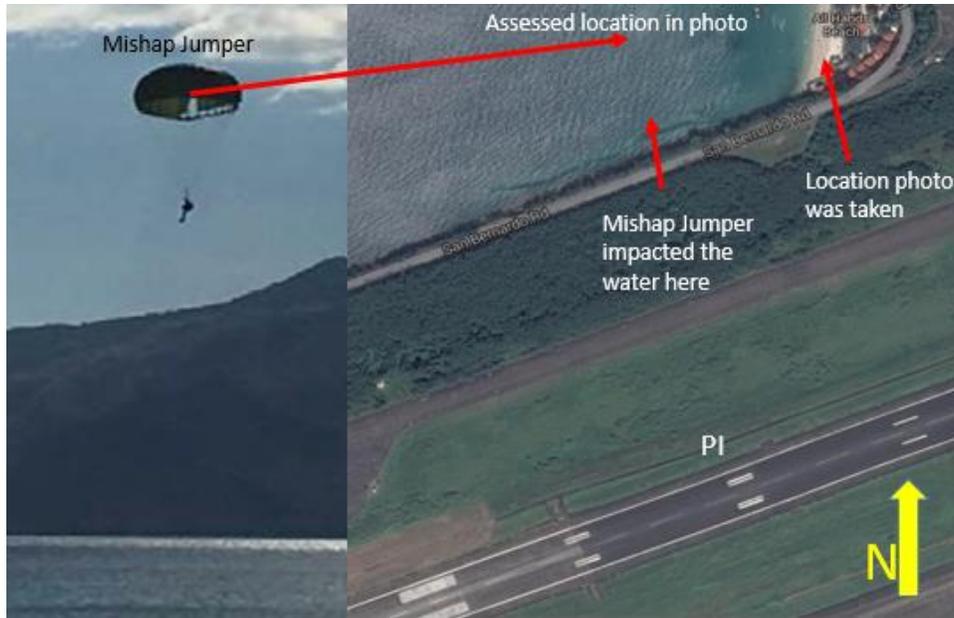
MJ impacted Subic Bay approximately 50 yards from shore and 200 yards from the beach on the northwest side of the DZ at approximately 1536L (Tabs S-3, V-14.9 to V-14.10, V-21.4 to V-21.12, Z-27, and DD-44). This location was inside the surveyed DZ, but approximately 350 yards north of the PI (Tabs S-3, S-17, and Z-27). MJ wore an MC-1-1C parachute with a reserve parachute but no flotation device (Tabs R-85, R-198, V-10.3 and V-24.9).

Figure 4-4
 (Tabs S-3 and Z-23)
 Location of MJ at 150 feet AGL

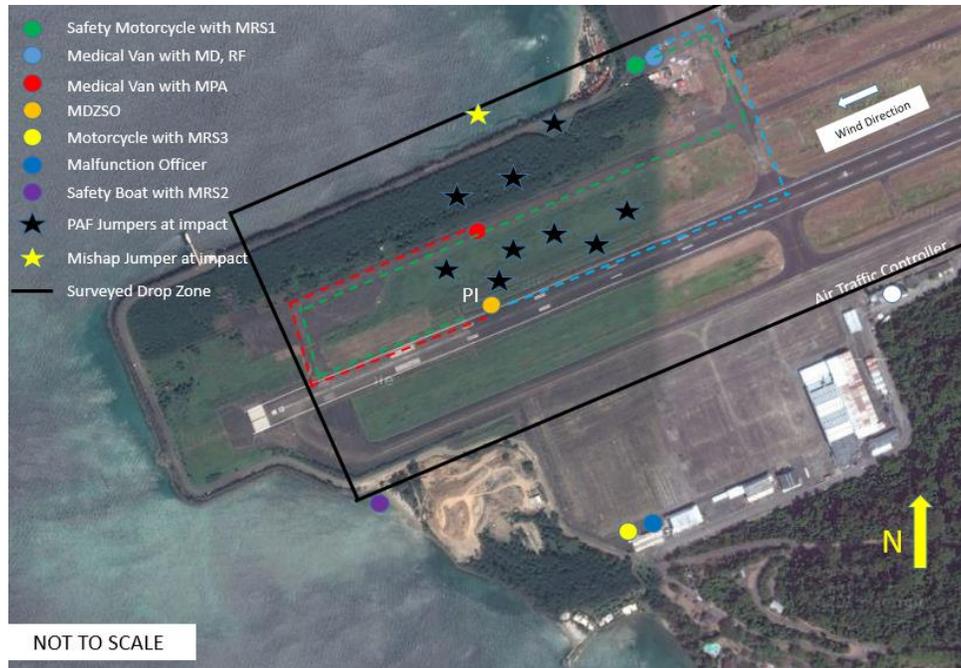
Figure 4-5

Ground Party Initial Movement and Jumpers at Approximate Impact Locations

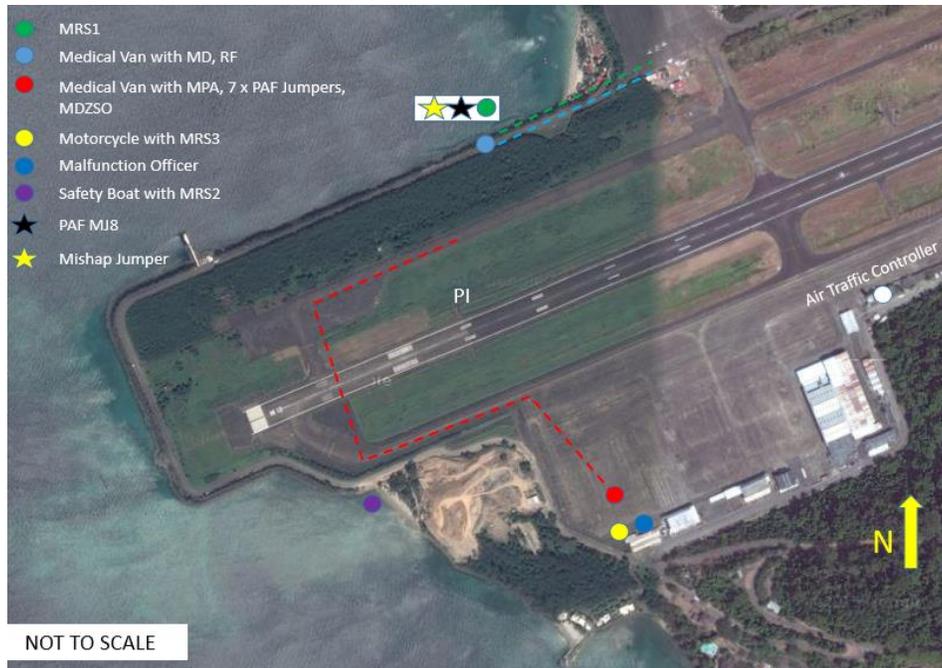
Figure 4-6

(Tabs R-227 to R-228, V-13.1 to V-13.2, V-16.6, V-23.2 to V-23.3, V-24.2, V-26.2, V-27.1 to V-27.3, V-30.2, and Z-23)
 Ground Party Locations Pre-Rescue

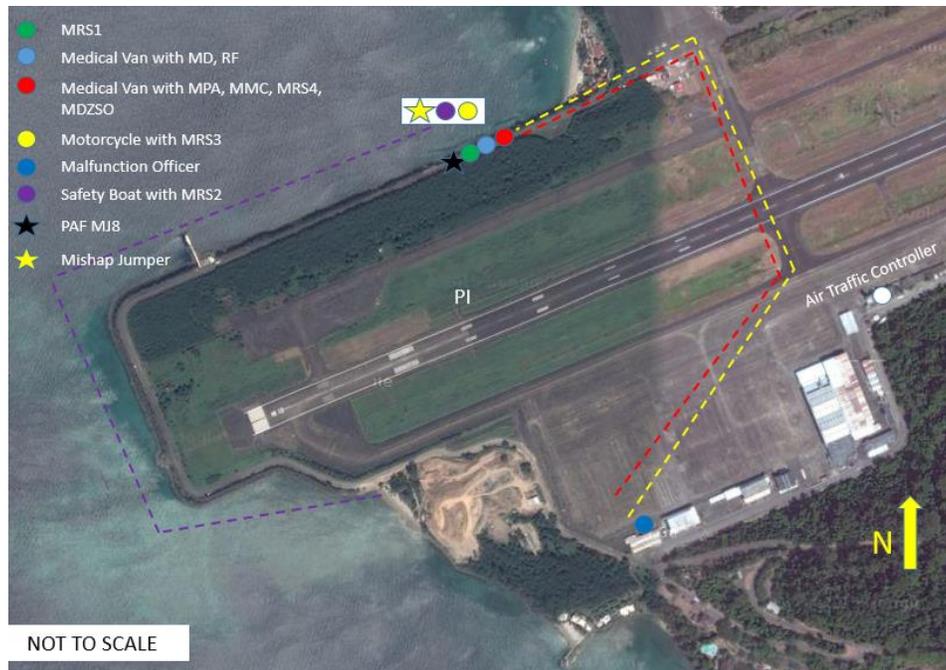
Figure 4-7
 (Tabs V-13.2, V-14.9, V-14.11, V-16.6, V-24.2 to V-24.3, V-24.8, and Z-23)
 Ground Party Locations during Rescue

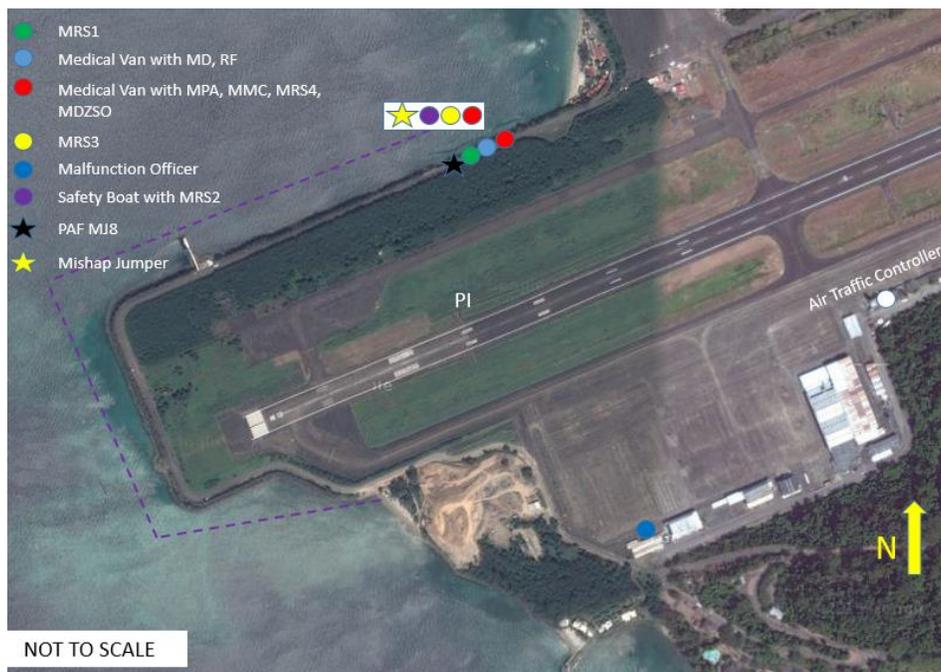
Figure 4-8
(Tabs V-13.3 to V-13.4, V-24.4, V-30.6, and Z-23)
Ground Party Locations during Rescue (continued)

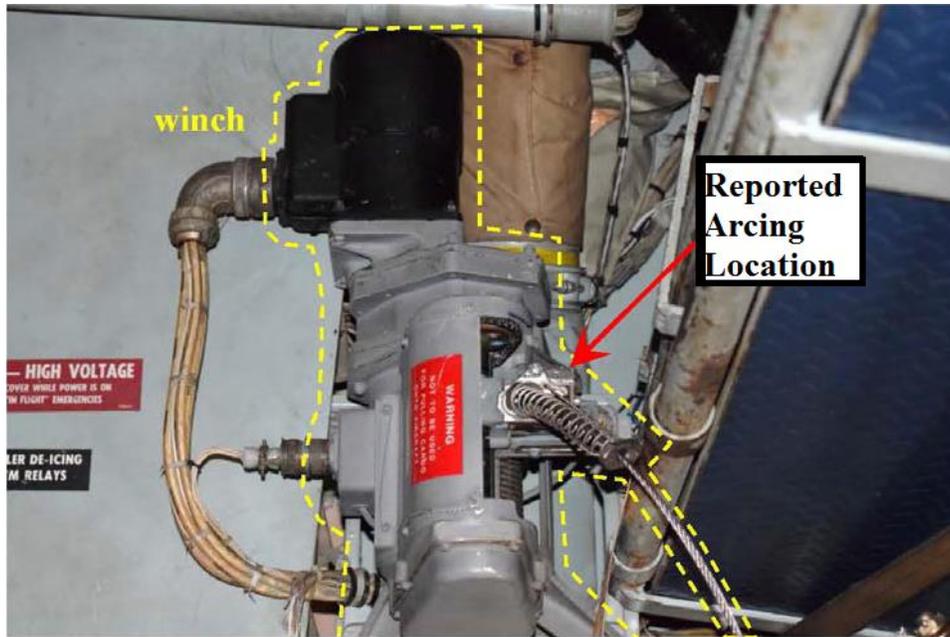
Figure 6-1
(Tab J-11)

The AFRL performed failure analysis on the right hand SL retriever winch (Tab J-7 to J-9). No failures were identified when electrical measurements were performed on the winch, and visual examination showed no evidence of electrical arcing or excessive temperatures (Tab J-4). The winch operated normally through all in-lab tests and the cause of the sparks could not be determined or reproduced (Tab J-4). There is no evidence to suggest that issues with the SL retriever winch were factors in this mishap.

Static Line Retriever Winch before Removal from MA

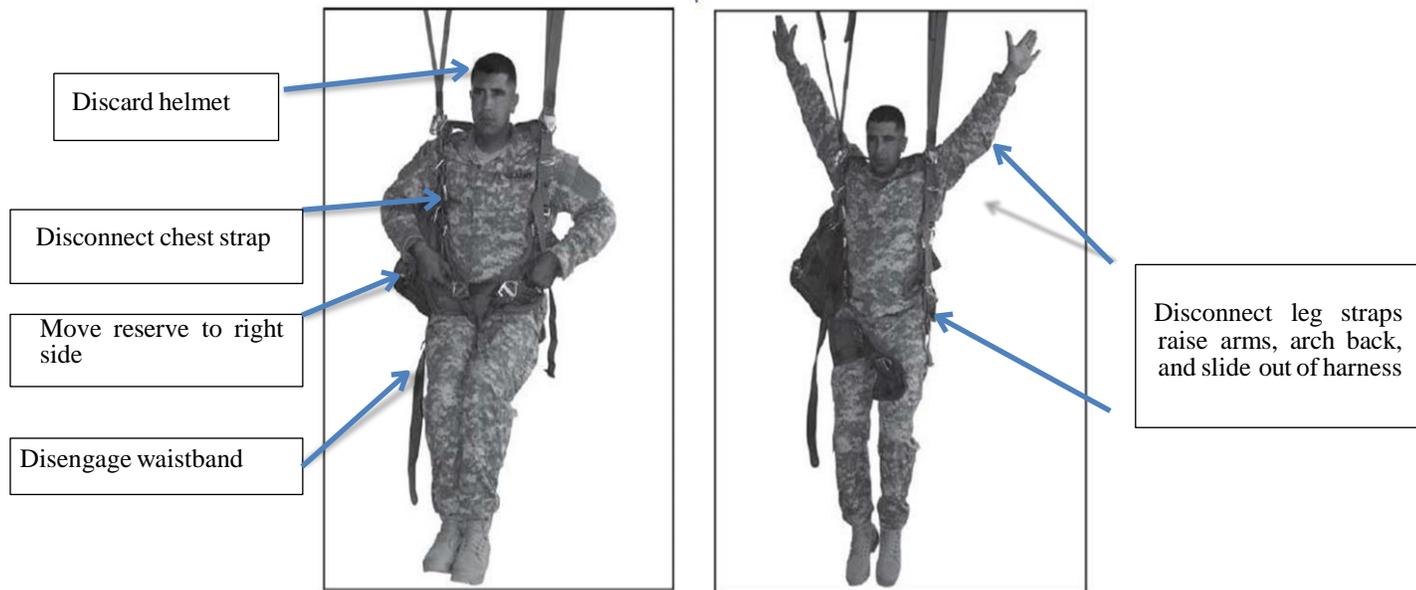
AFMAN 11-420, *Static Line Parachuting Techniques and Training*, dated October 2013, originally a publication by the US Army (FM 3-21.220) adopted by the USAF, US Navy, and US Marine Corps, provides training guidance on military parachuting, and is the same manual used by the PAF (Tabs V-25.3 to V-25.4 and BB-75 to BB-107). Guidance for emergency water landing procedures while wearing an MC-1 series parachute, such as the one worn by MJ, states that if water cannot be avoided, the parachutist should jettison his or her combat helmet, activate the quick release in his or her waistband, disconnect the left connector snap and rotate the reserve to the right, and activate the chest strap ejector snap (Tab BB-102). In this mishap, MJ failed to follow these emergency water-landing procedures, as he was still wearing his helmet, his quick

release waistband and snaps were still engaged, and he did not release his chest strap, which indicated that he did not attempt to comply with any of the mandated performance points (Tabs V-13.4, V-14.12, V-24.4, and BB-102).

Landing without a Life Preserver
Figure 2-1 (Tab S-10)

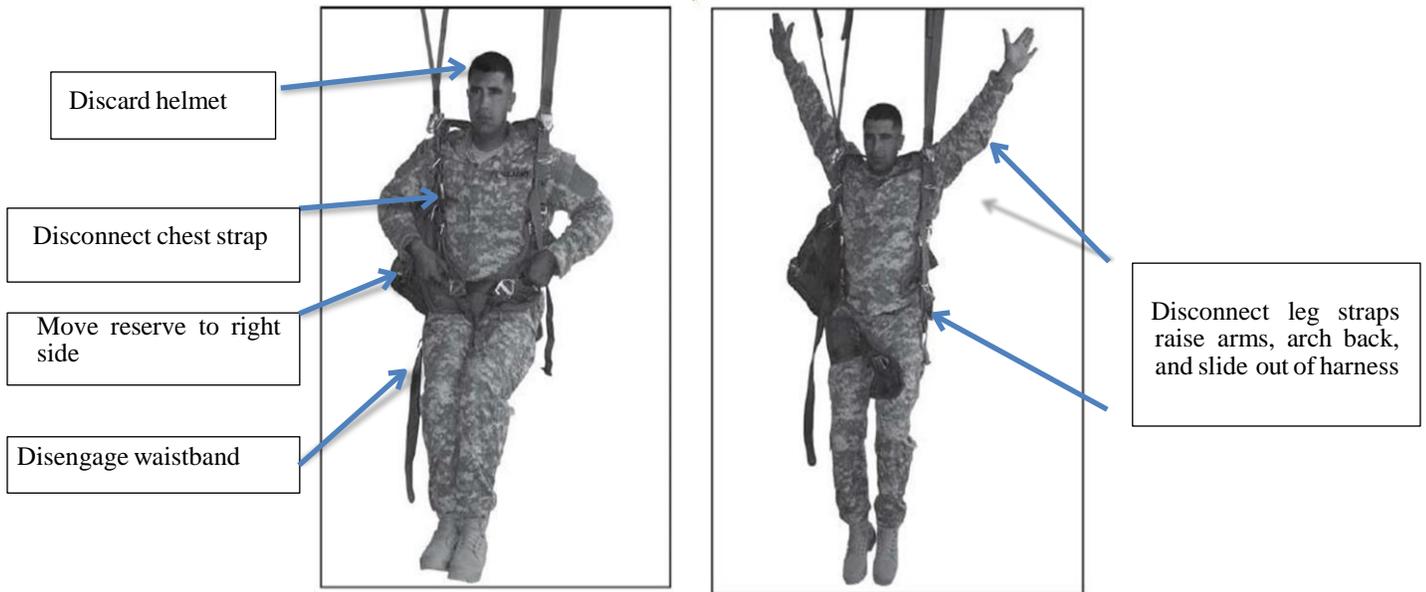
Numerous witnesses stated that MJ was pulled out of the water still connected to his equipment, indicating that he did not execute any of the standard water landing actions required when entering the water without a life preserver, despite the fact that he was reportedly trained on these procedures. MJ was wearing his helmet, did not release his quick release waistband, and was securely fastened in his harness, so he did not release chest strap or leg strap ejector snaps. I find by a preponderance of the evidence that the failure to execute emergency water landing procedures was causal to this mishap.

Landing without a Life Preserver
Figure 2-1
