UNITED STATES AIR FORCE
AIRCRAFT ACCIDENT INVESTIGATION
BOARD REPORT

F-16D, T/N 91-0466

LOCATION: DAYTON, OH

DATE OF ACCIDENT: 23 JUNE 2017

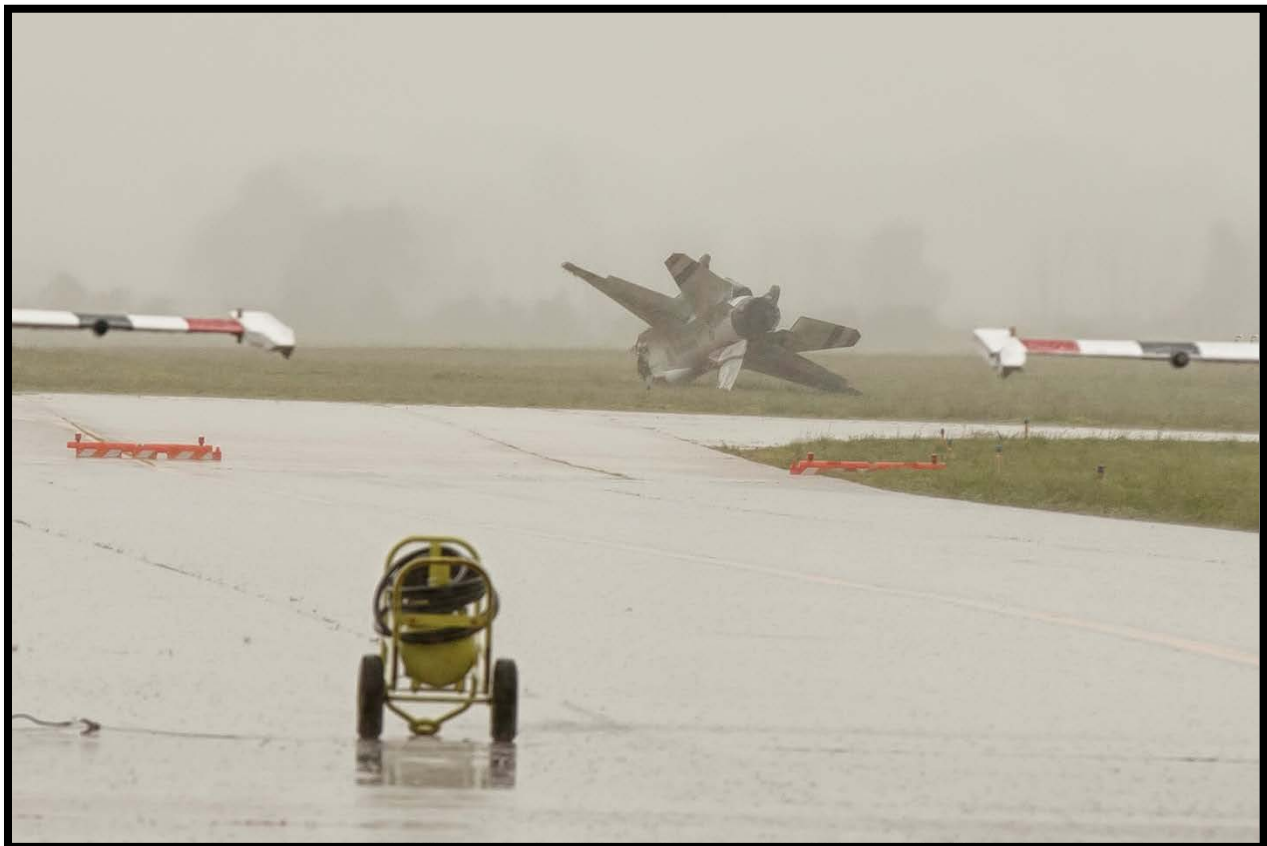
Figure 1 MA prior to emergency crews arriving (Tab S-3)

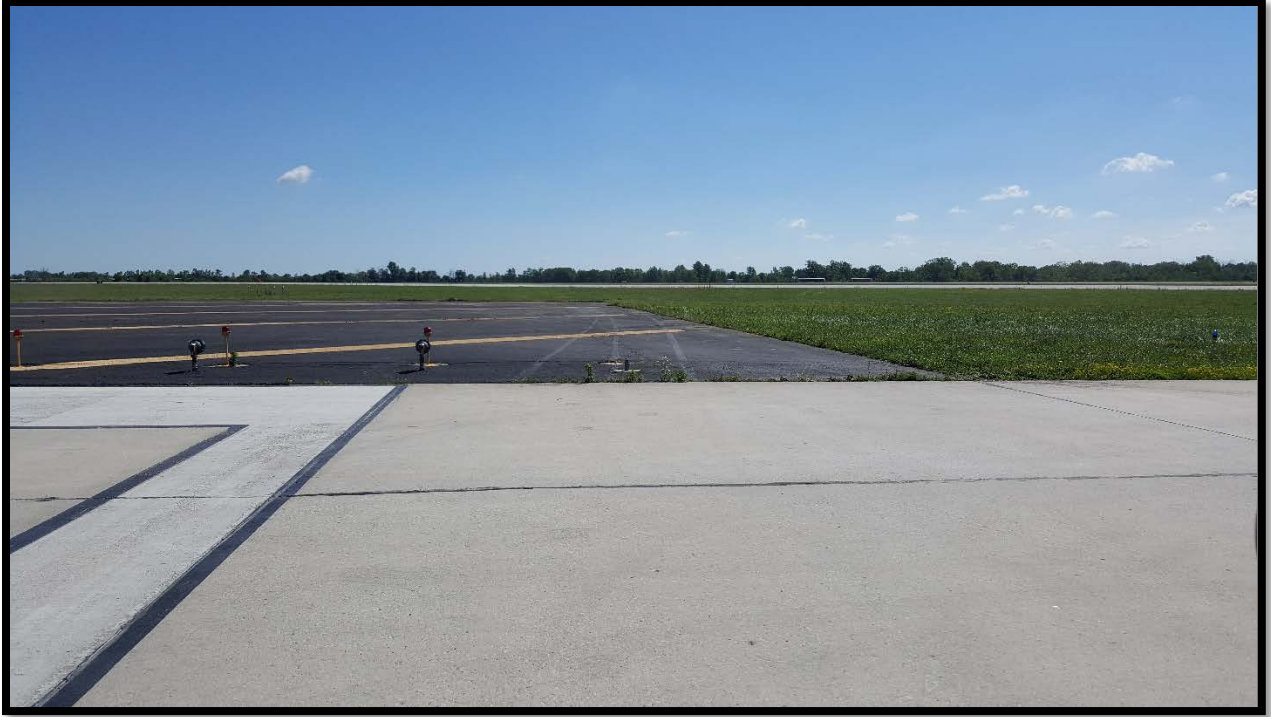
Figure 2 Tracks from MA through overrun (Tab S-2)

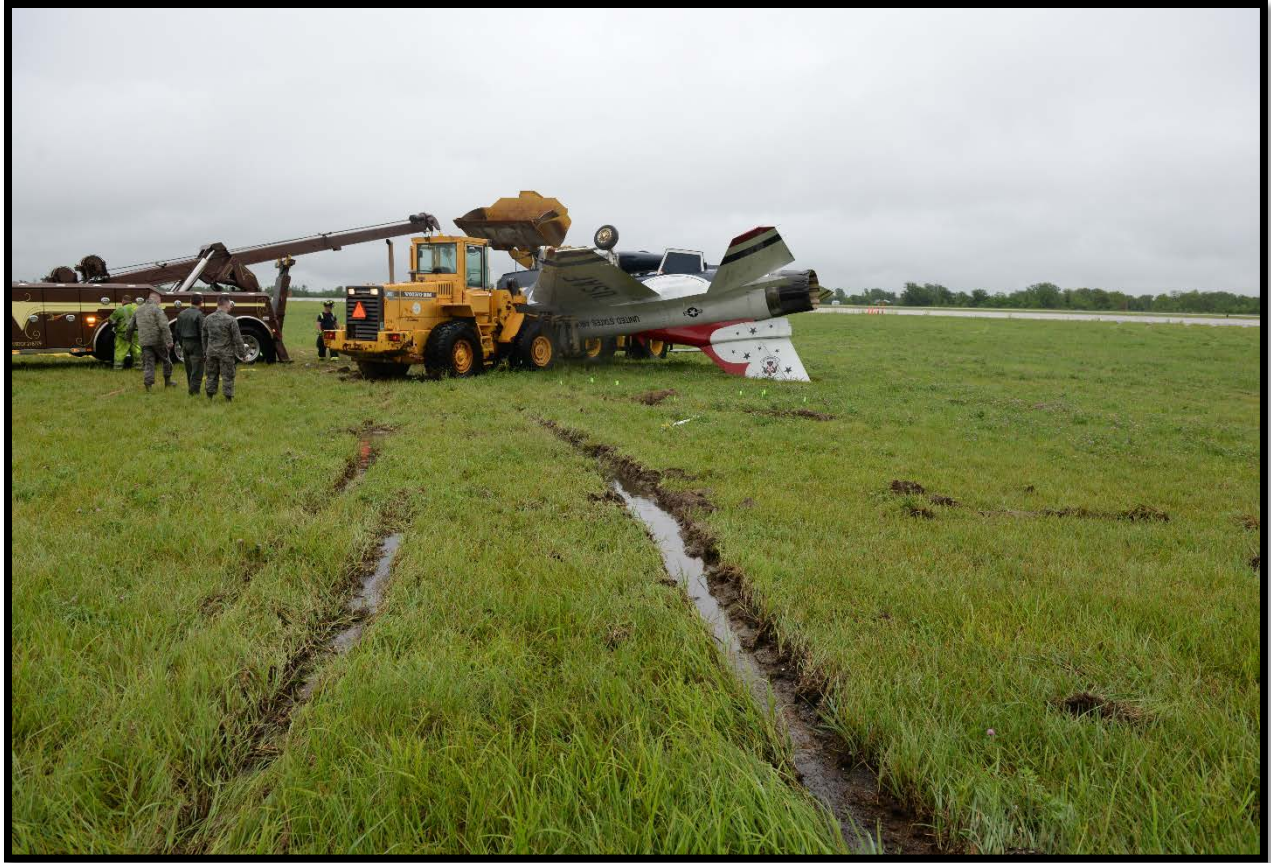
Figure 3. Tracks through grass and Rescue Operations (Tab S-2)

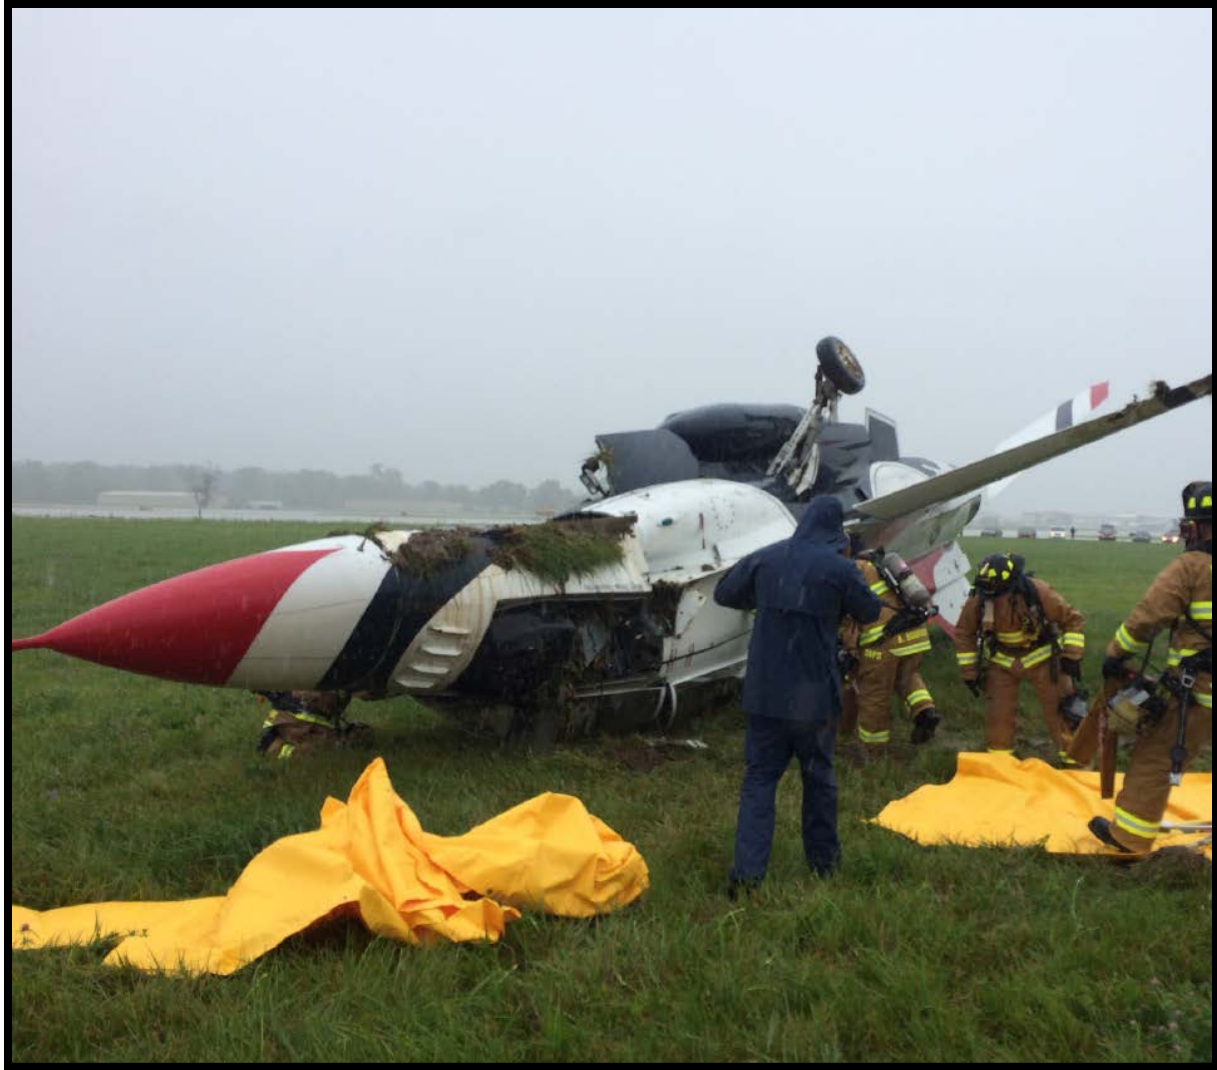
Figure 4. Initial rescue operations (Tab S-5)

The MA overturned in the grass at the end of runway 6L at Dayton International Airport (Tab P-3 and Tab S-2). The canopy was broken when the jet overturned (Tab S-5). The canopy was removed by the rescue team to facilitate aircraft recovery (Tab V-5.5, Tab S-5). During the rollover, the right wing station 9 rail was partially torn off and the vertical stabilizer was folded over (Tab Z-3, Tab S-7). The vertical stabilizer was removed for transport to Wright-Patterson Air Force Base (Tab GG-6 to Tab GG-7). The forward fuselage had partially detached from the rest of the aircraft (Tab S-6). The remainder of the forward fuselage was removed during aircraft recovery (Tab S-7, Tab GG-6). The nose landing gear broke away from the drag brace assembly, causing the nose gear to collapse (Tab GG-18, Tab S-4 to Tab S-5). This damage most likely occurred after departing the prepared surface (Tab GG-18). According to the Lockheed Martin (LM) analysis, all systems operated properly and no faults were recorded which affected braking throughout recorded data (Tab GG-24).

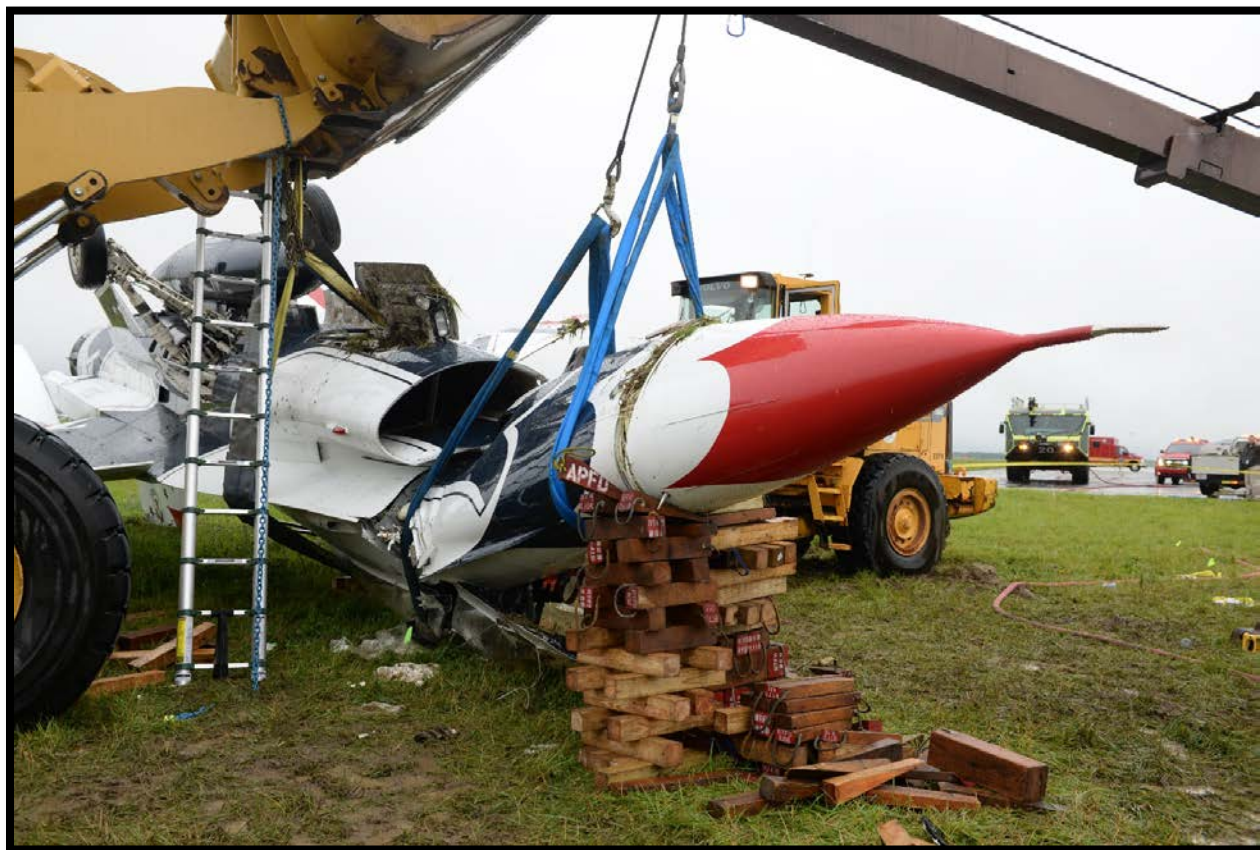
Figure 5. MA stabilized by cribbing and heavy equipment (Tab S-6)
