Appendix B

CRASH SITE AND DAMAGES

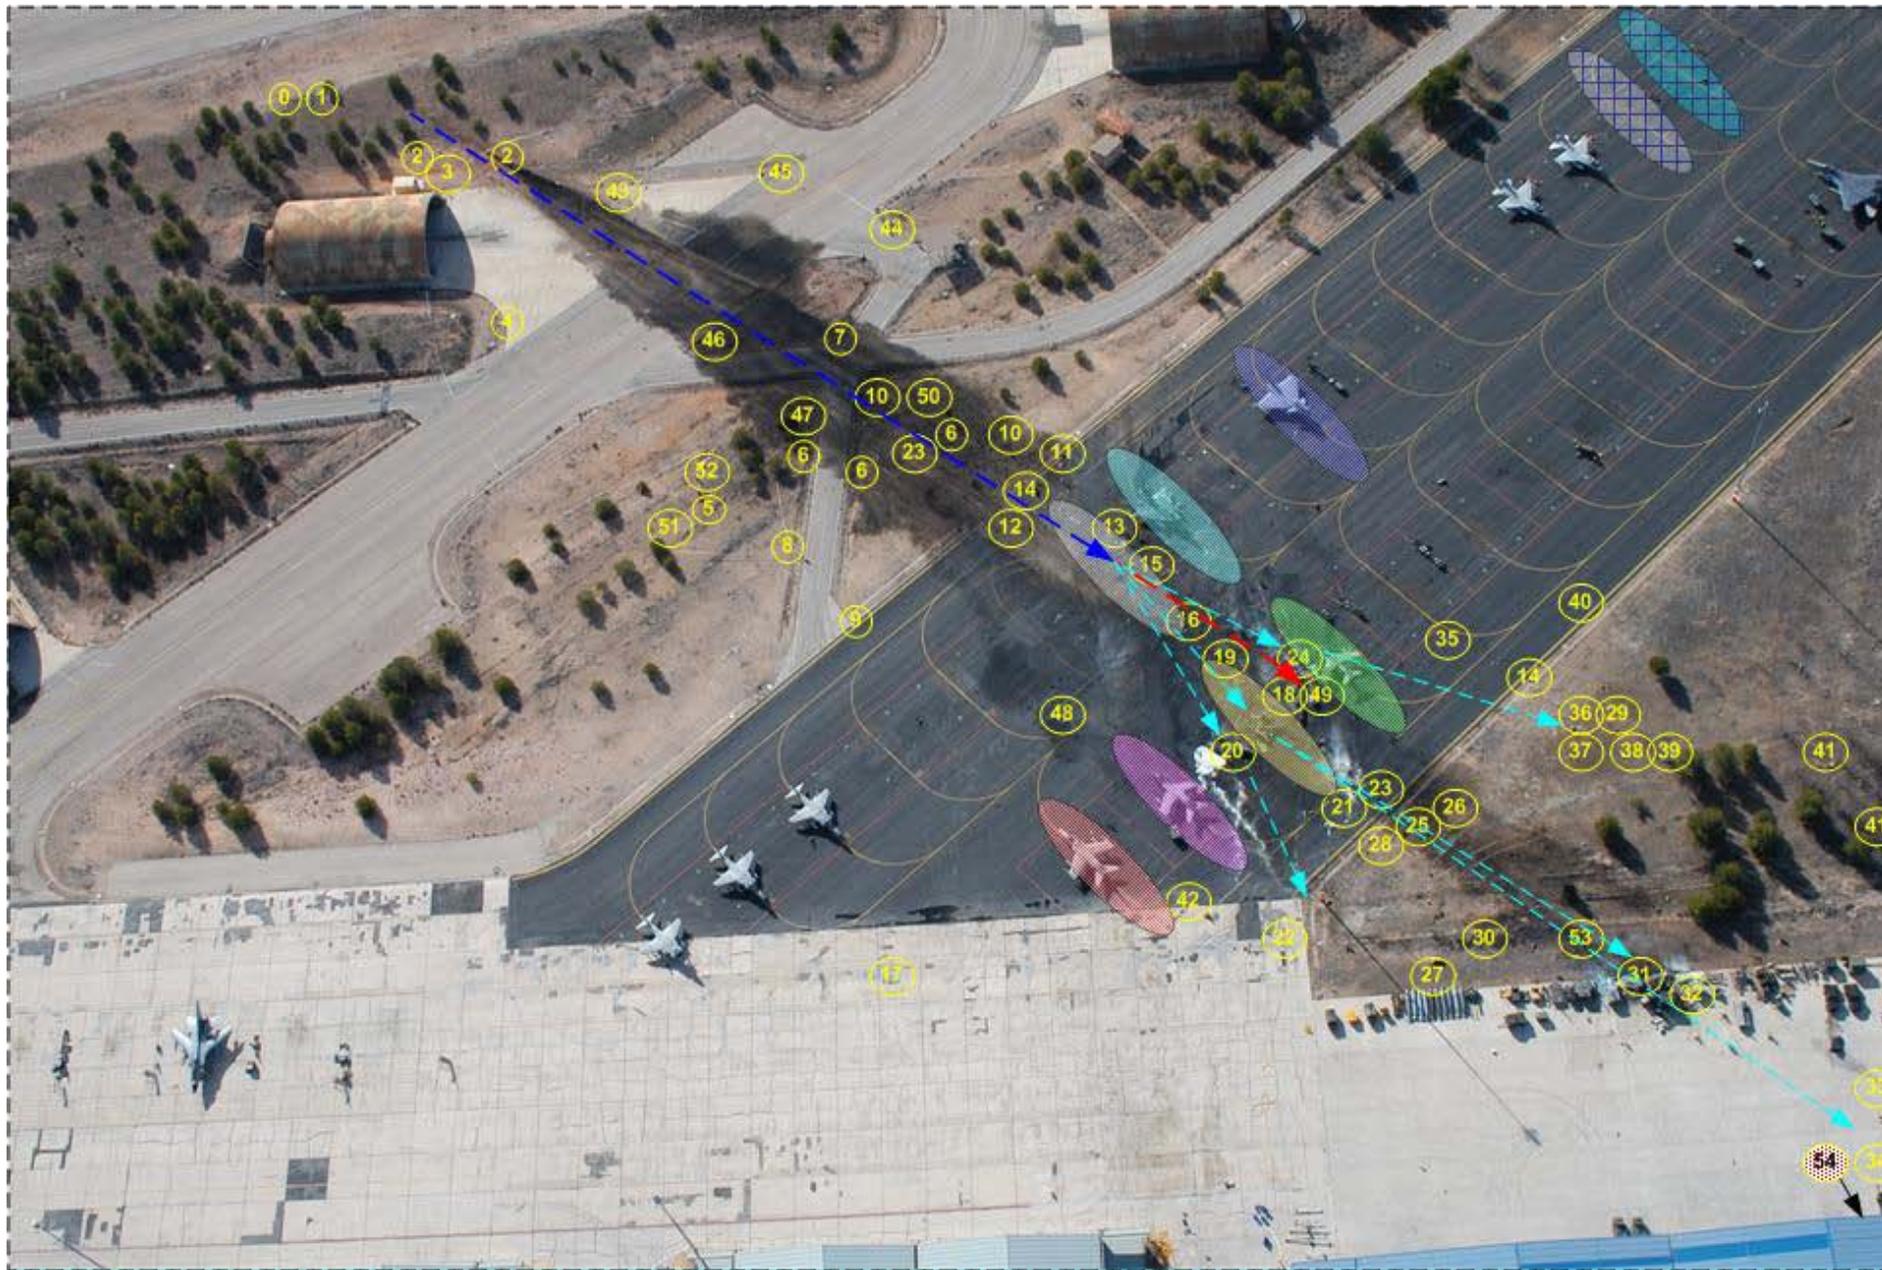
Picture B-2: Aerial view of the wreckage area (for Index please look at the next pages)

- 0: Impact point of MA
- 1: Canopy
- 2: RH leading edge flap rotary actuators (LEFRA) & part of RH LEF
- 3: Recovery parachute (AFT)
- 4: Pitot tube
- 5: FWD Pilot

- 6: Side stick controllers (AFT and FWD)
- 7: RH wing weapon pylon
- 8: Fan Turbine Inlet Temperature (FTIT) indicator
- 9: Taxing light
- 10: Rudder pedals

- 11: RH wing tank
- 12: Data Transfer Cartridge (DTC)
- 13: ACMI pod
- 14: Rudder
- 15: Radome
- 16: LAU-129 (Station 9)
- 17: Part of RH stabilizer and upper surface

- 18: Arresting hook
- 19: Vertical stabilizer
- 20: Engine
- 21: Crash survival memory unit (CSMU)
- 22: Accessory drive gearbox
- 23: Throttle quadrant
- 24: LH horizontal stabilizer

- 25: RH MLG door
- 26: LH LEFRA
- 27: LH speed brake
- 28: LAU-129 & AIM-9 (ST.1)
- 29: AIM-9 guidance section
- 30: M61A1 gun
- 31: LH wing
- 32: Main landing gear (MLG)

- 33: RH wing
- 34: Centerline (C/L) tank
- 35: RH circuit breaker
- 36: RH flaperon
- 37: Electrical power receptacle
- 38: RH stabilizer
- 39: Aircraft Launcher Interface Computer (ALIC)

- 40: Nose landing gear (NLG)
- 41: AGM-88 (HARM)
- 42: AFT frame with MFD panels
- 43: AFT Pilot
- 44: AFT ejection seat parts
- 45: RH asymmetry brake assy

- 46: Mount of RH LEF with LEFRA
- 47: Trim panel
- 48: RH angle gearbox
- 49: Jet fuel starter (JFS) accumulator
- 50: ACMI memory card

- 51: Lower part of FWD ejection seat
- 52: RH wing tip
- 53: Hydrazine tank
- 54: F-15 S/N 202 (USA) parked inside TLP hangar

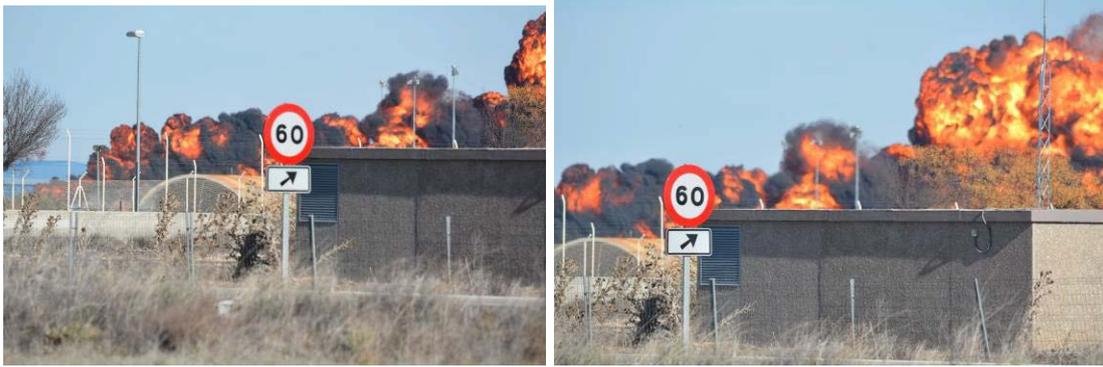
Pictures B-3: View of massive fireball created by the accident (size of the fireball can be compared to the size of the shelter in front of it)

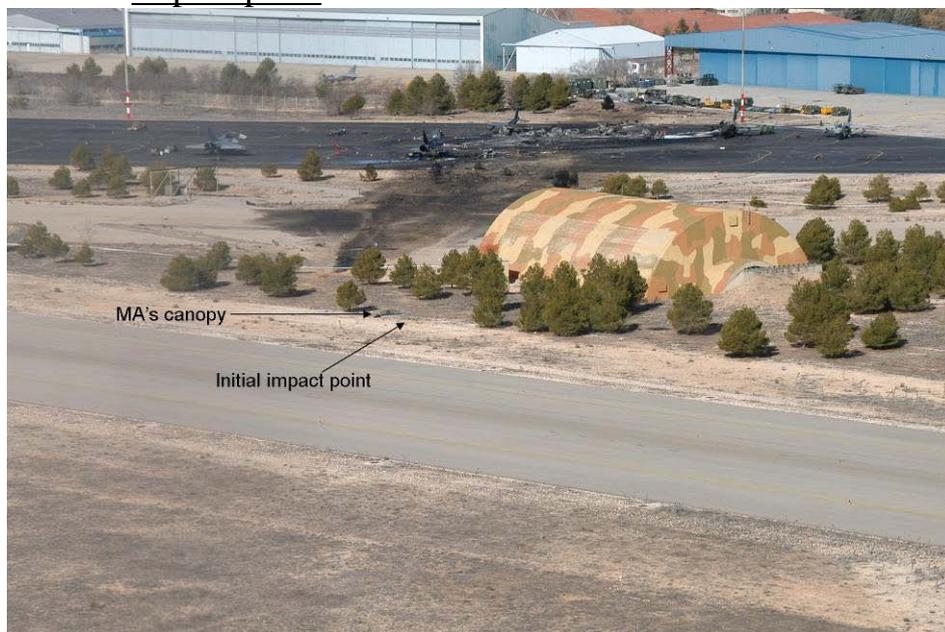
Picture B-4: Aerial view of the crash site as viewed from the runway

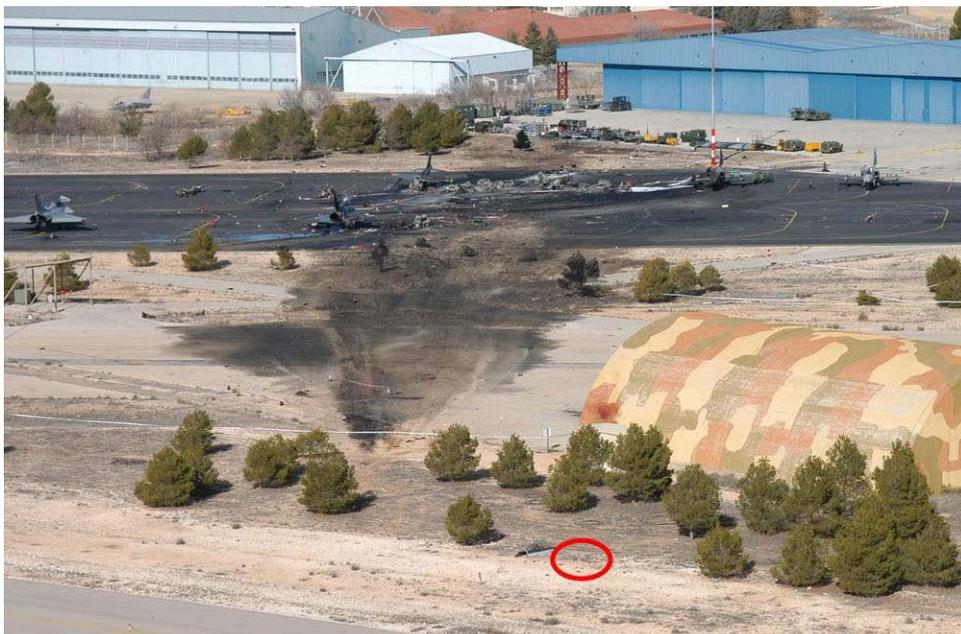
Picture B-5: Close view of the impact point

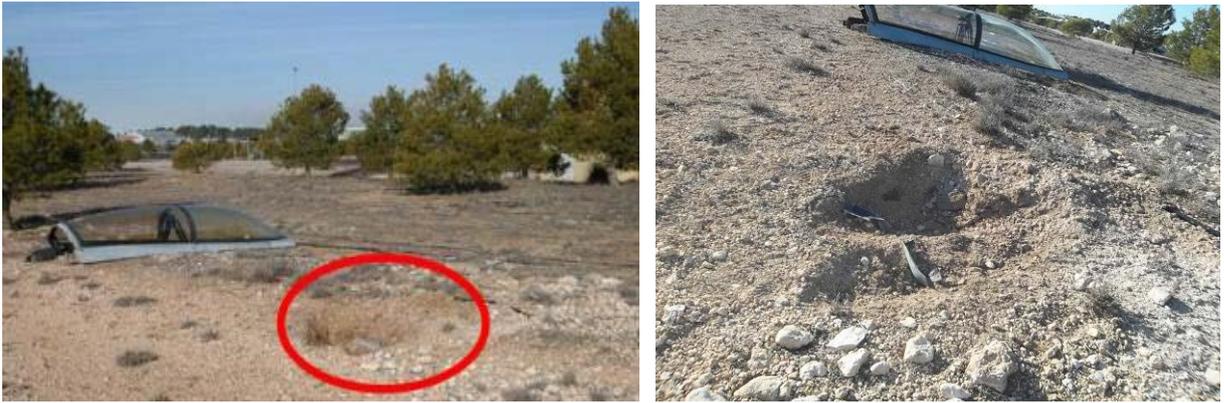
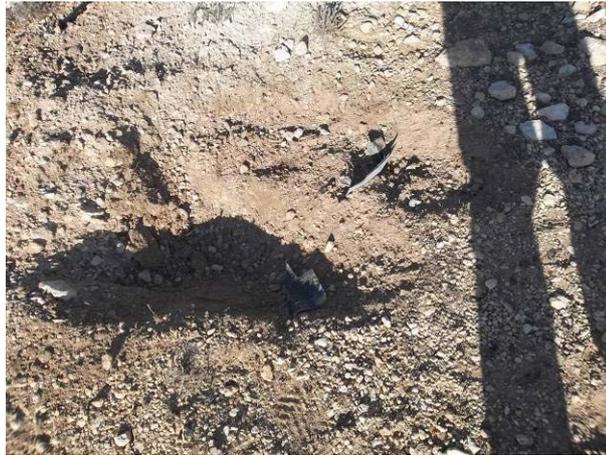
Pictures B-6: Views of the initial impact point

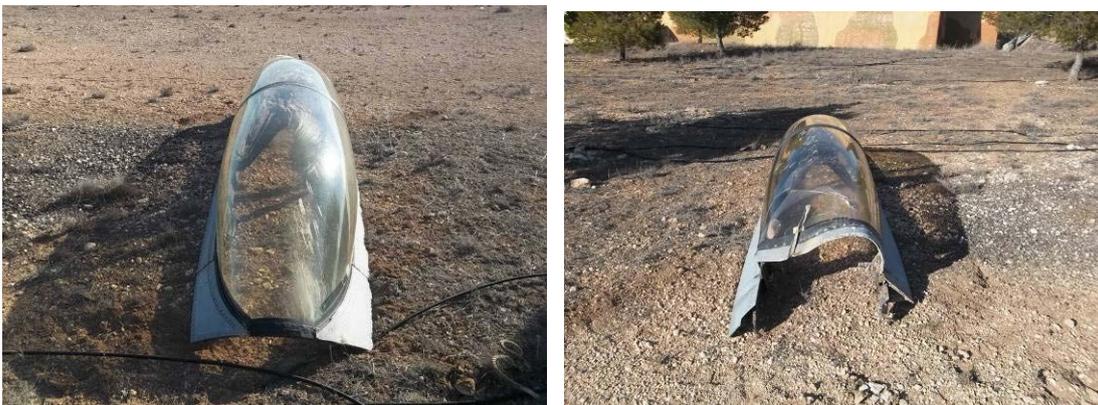
The first part of the A/C found was the canopy (approximately 20m close to the shelter D-4). It was found in good condition whereas canopy remover rocket motors and their detonation transfer assemblies were activated.

Pictures B- 7: Front and rear view of the canopy

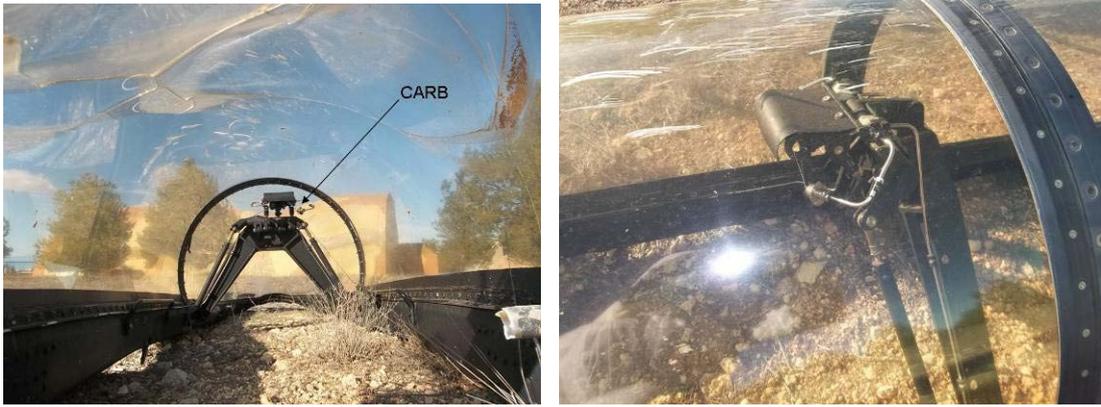
Pictures B-8: Canopy Release Bolt (CARB) properly operated

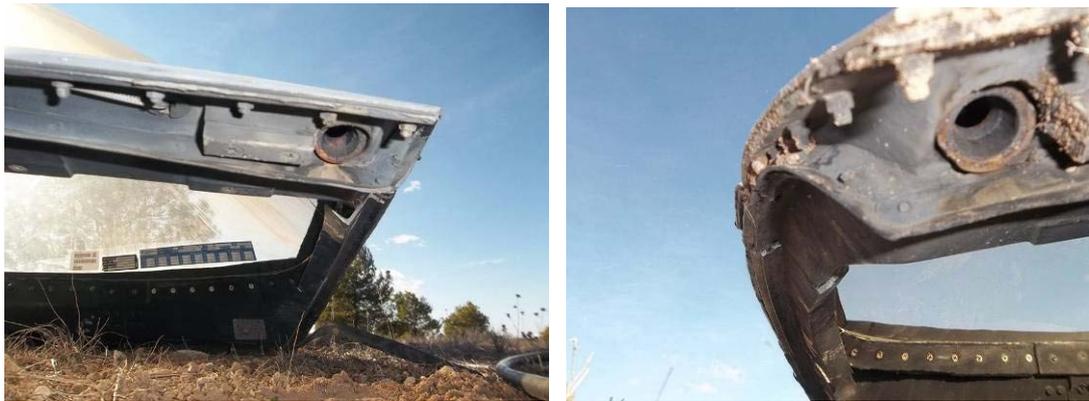
Pictures B-9: Canopy Remover Assemblies properly operated

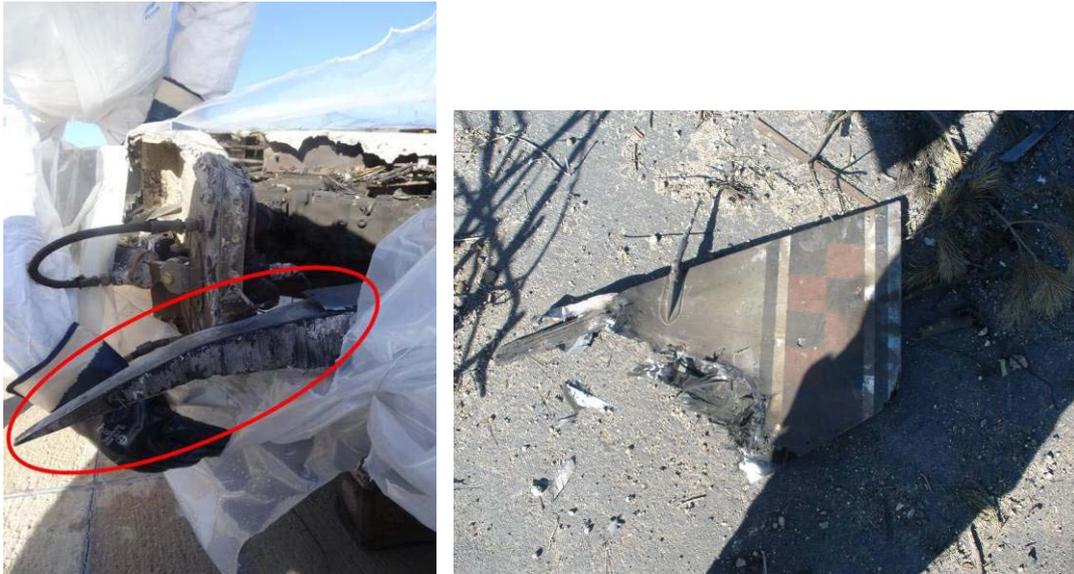
Part of the rudder was found burnt and destroyed just before E2 Parking Rump. However several pieces of it were found at different locations.

Pictures B-10: Parts of the rudder

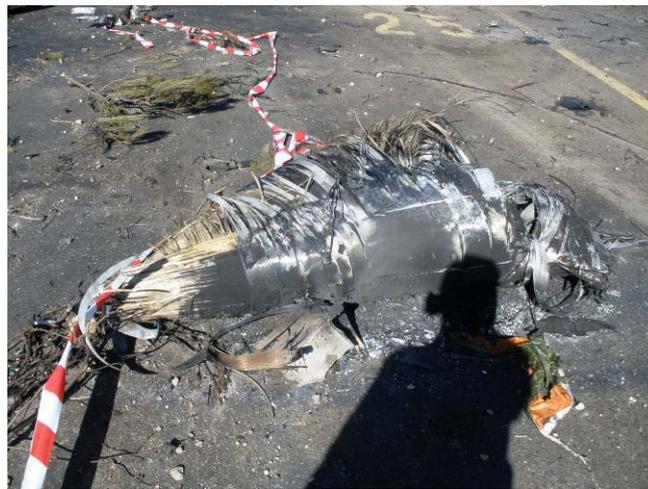
MA's radome was found totally burnt and destroyed at E-2 Parking Rump, next to FRA Mirage 2000-5 S/N 669.

Picture B-11: The radome totally destroyed

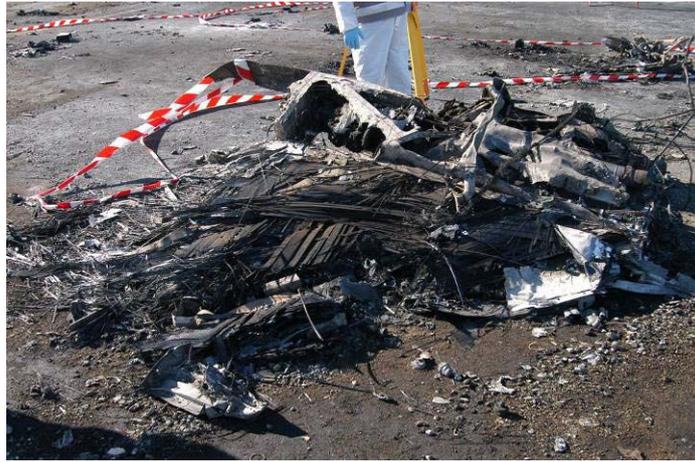
Vertical Stabilizer was found fully burnt and destroyed close to ITA AMX S/N 7193.

Picture B-12: Parts of vertical stabilizer

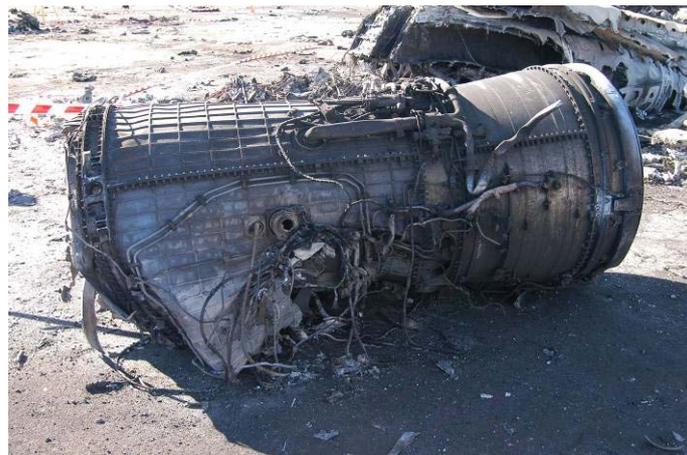
MA's engine was found with serious damages without exhaust nozzles and augmentser close to ITA AMX S/N 7193. In that location, there were debris of the totally destroyed FRA Alpha-Jet S/N E047 and Mirage 2000-5 S/N 651 too.

Picture B-13: Engine general view

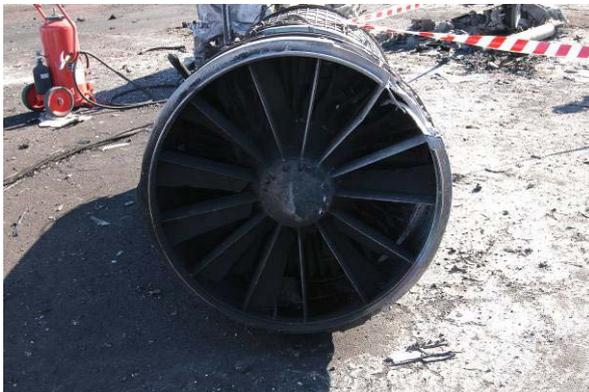
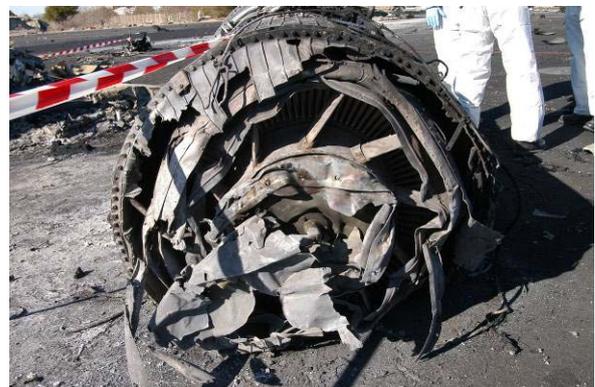
Pictures B-14: Engine forward and rear view

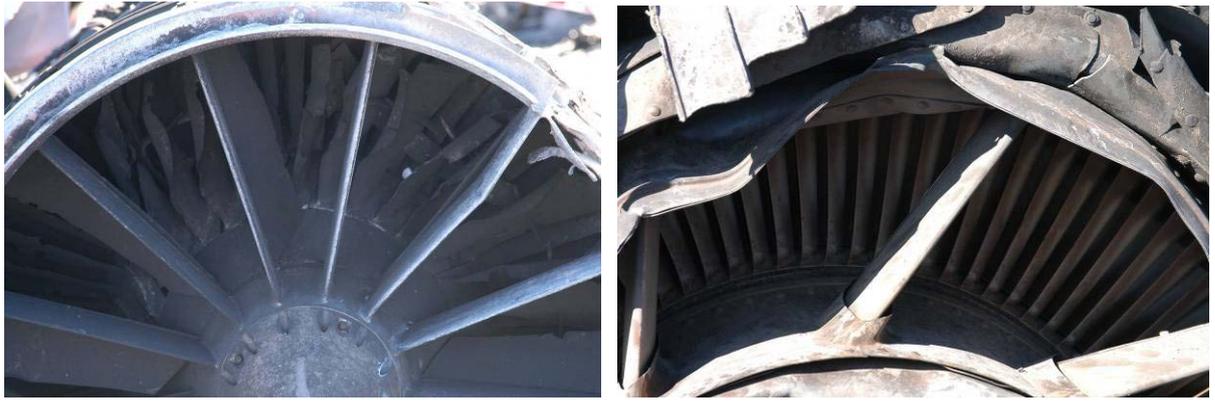
Pictures B-15: Engine forward and rear close view

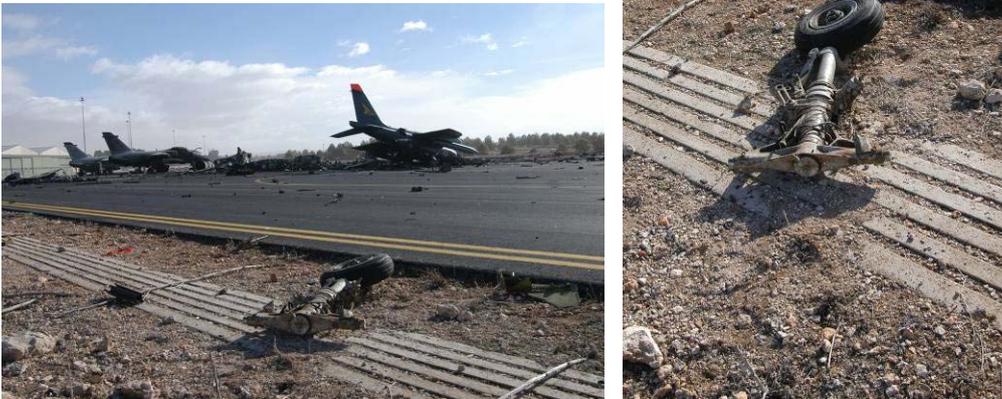
It was found 30 m from the engine but in the same level, perpendicular to the longitudinal axis of A/C crash pattern.

Pictures B-16: NLG assembly

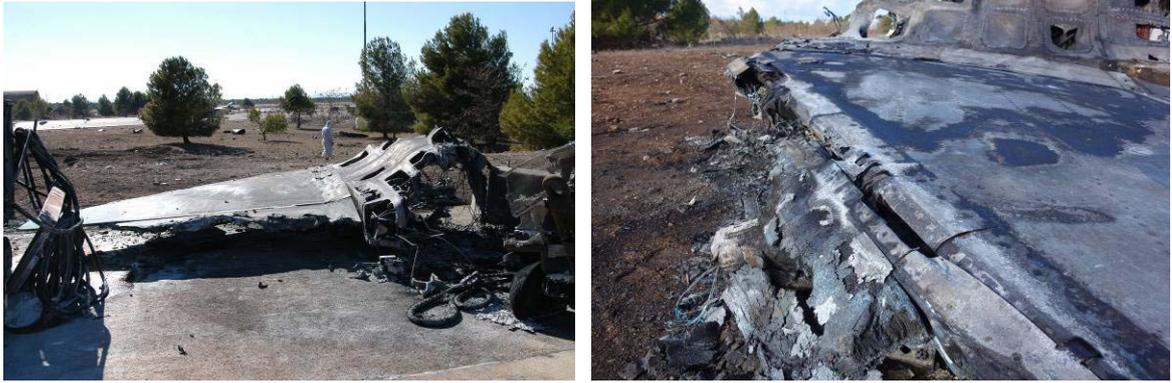
LH Wing was found seriously damaged and burnt, in the area in front of TLP hangar.

Pictures B-17: The LH wing (rear view) and close view of LH Leading Edge Flap

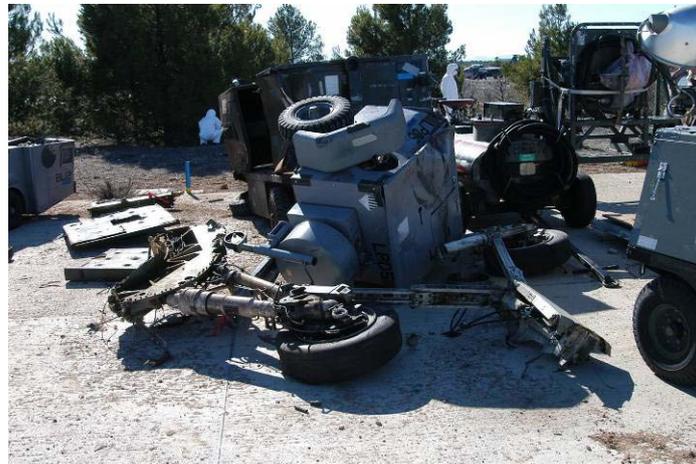
MLG system was found close to LH Wing.

Picture B-18: MLG and drifted ground equipment

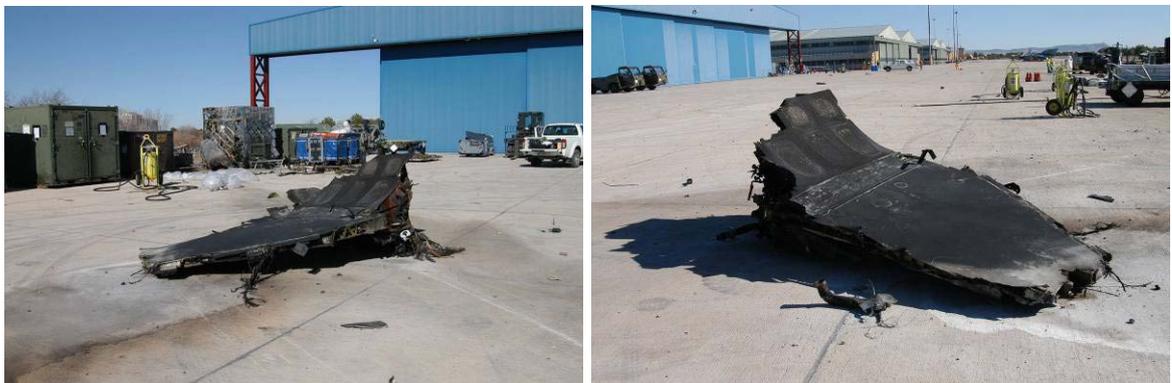
RH Wing joint with part of upper surface were found burnt and damaged in front of the TLP hangar.

Pictures B-19: RH wing totally burnt

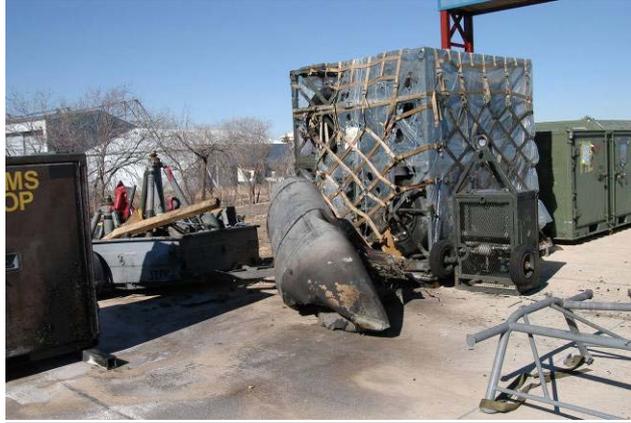
C/L Tank joint with C/L pylon were found totally destroyed and burnt at the very end of maintenance area close to the corner of TLP hangar.

Picture B-20: C/L tank and ground equipment

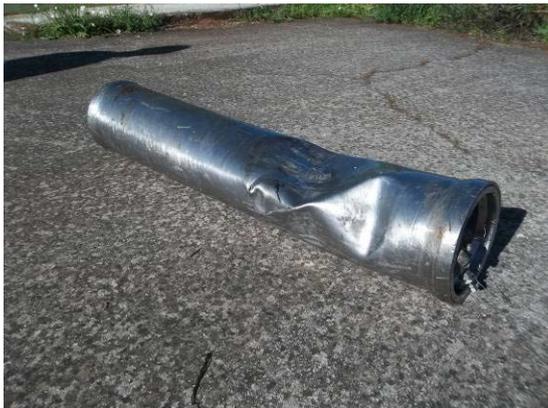
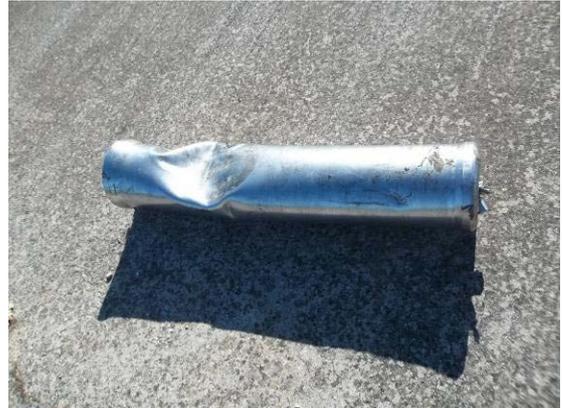
Pictures B-21: View of hydrazine tank's distortion (All Hydrazine tank pictures have been taken in Greece and not at crash site)

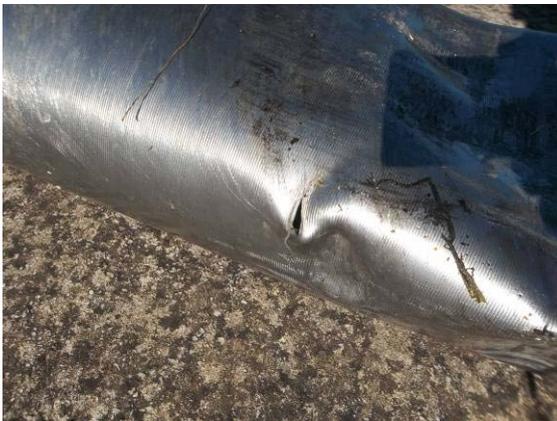
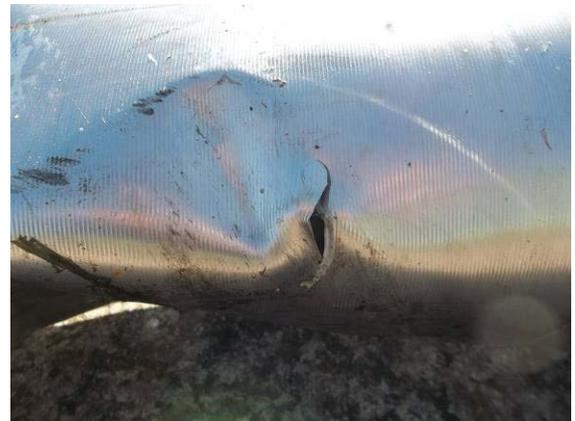
Pictures B-22: Close view of the fracture of the case of hydrazine tank. Hydrazine had been leaked from that point.

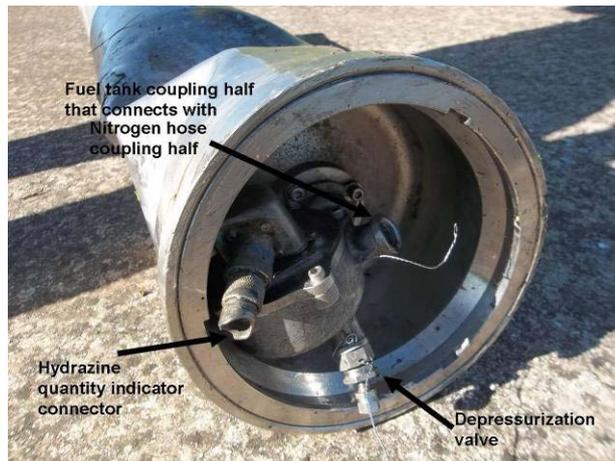
Picture B-23: Damages on FWD section of hydrazine tank.

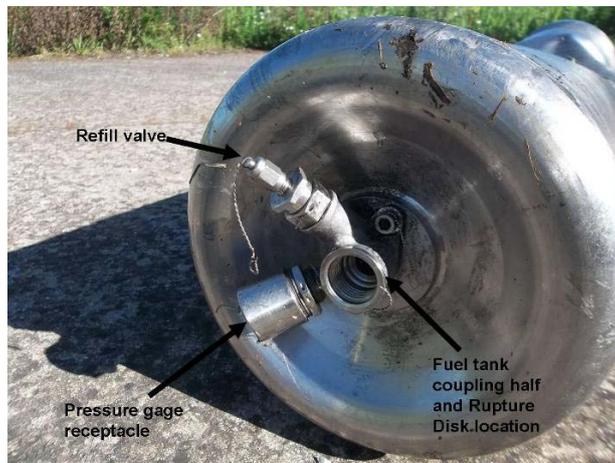
Picture B-24: Damages at AFT section of hydrazine tank. Rupture disk was found broken, however it was activated due to ground impact and not as a result of Emergency Power Unit (EPU) activation

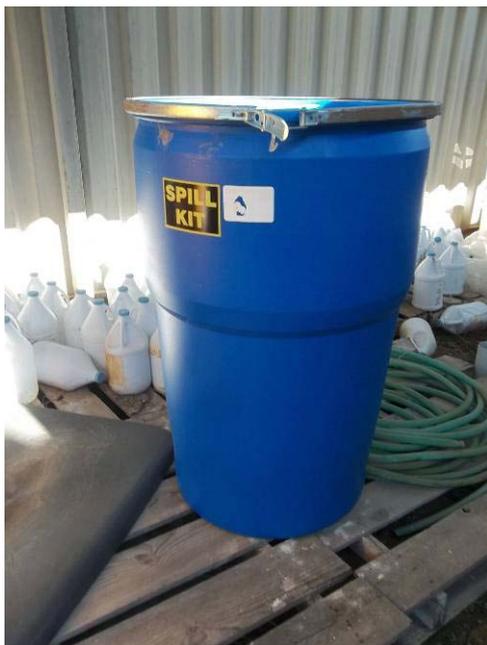
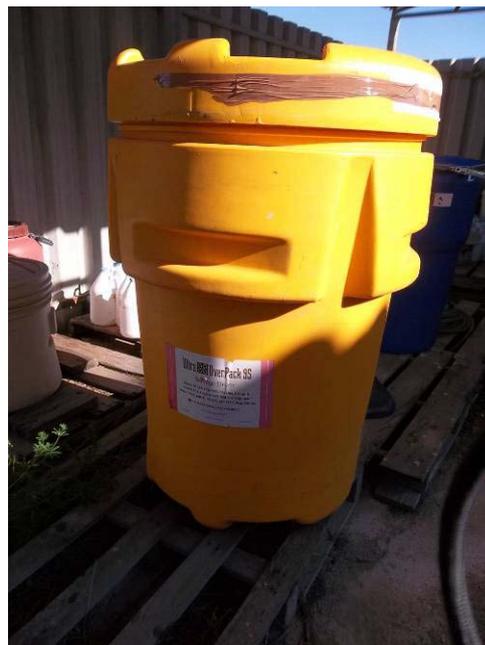
Pictures B-25: Hydrazine contaminated soil collected in special spill kit and hydrazine tank was stored in adequate salvage drum. Due to hydrazine tank's deformation it could not be installed in its appropriate container.

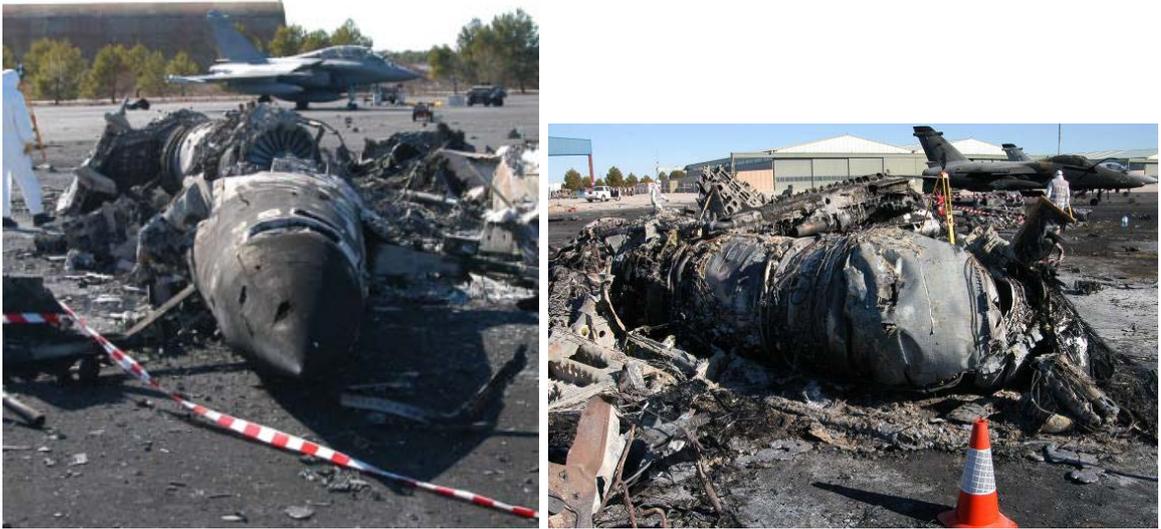
Pictures 26: Mirage 2000D S/N 651

Mirage 2000D S/N 651 absorbed MA's momentum after the crash. It was drifted towards the Alpha-Jets and totally destroyed.

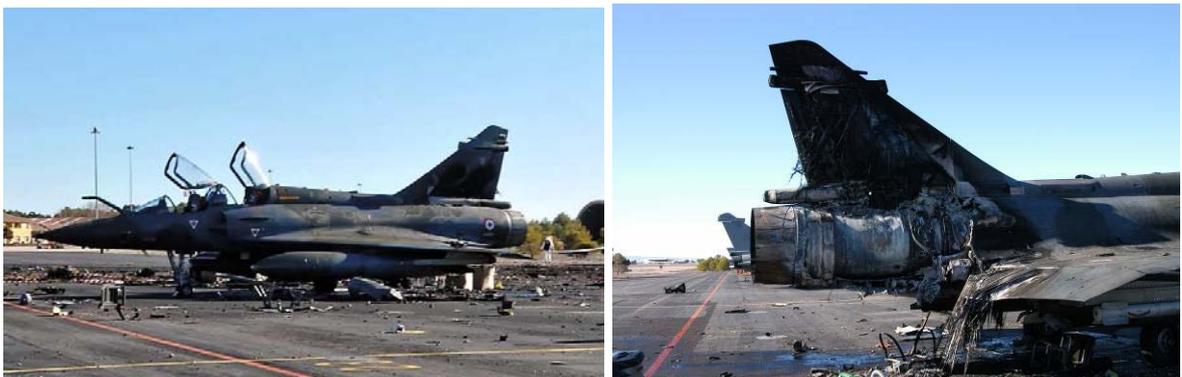
Pictures 27: Mirage S/N 669

Mirage 2000D S/N 669 was located next to Mirage 2000D S/N 651 which substantially absorbed MA's momentum after the crash. In consequence, Mirage 2000D S/N 669 was seriously damaged.

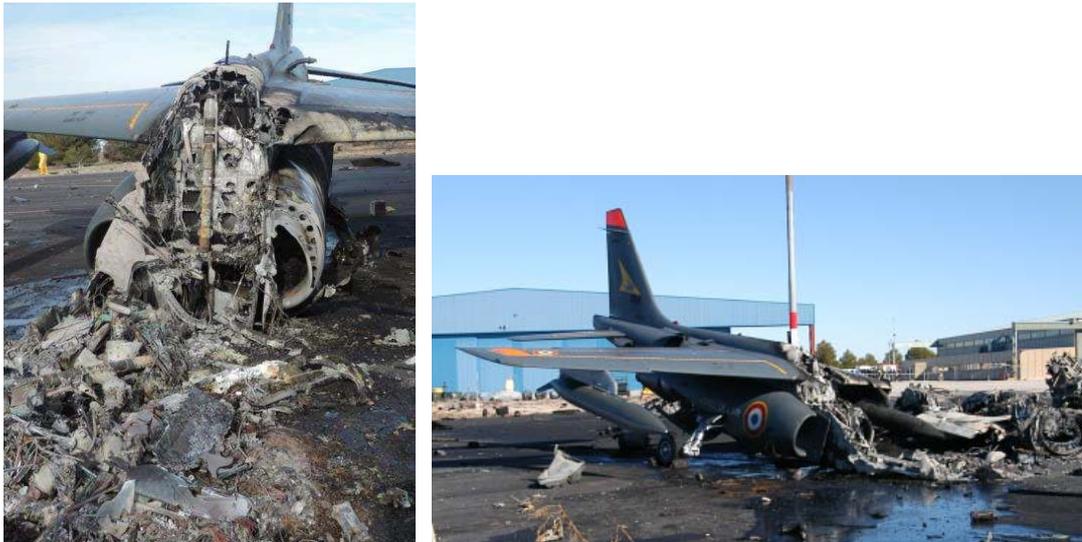
Pictures 28: Alpha-Jet S/N E096

Mirage 2000D S/N 651, drifted by MA and impacted on Alpha-Jets. Alpha-Jet S/N E096 substantially damaged.

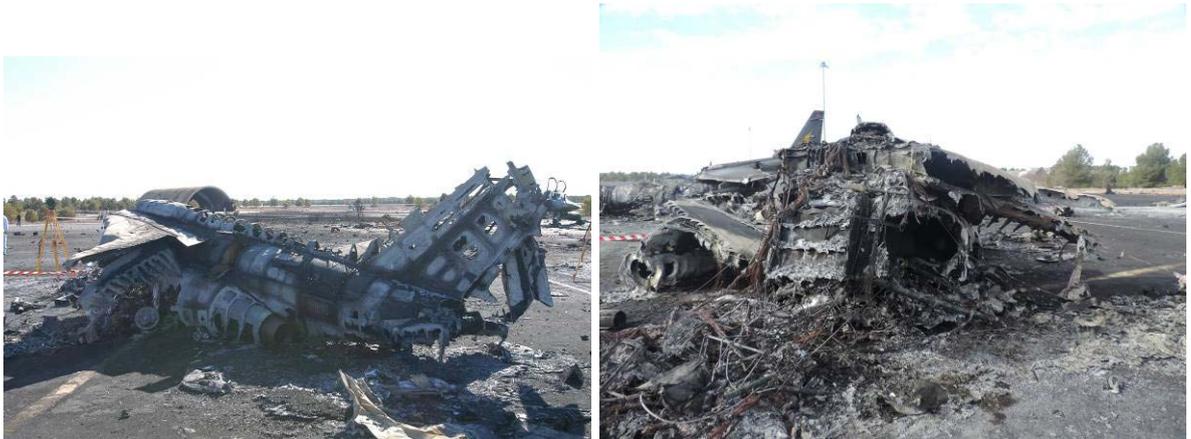
Pictures 29: Alpha-Jet S/N E096

Alpha-Jet S/N E047 was totally destroyed.

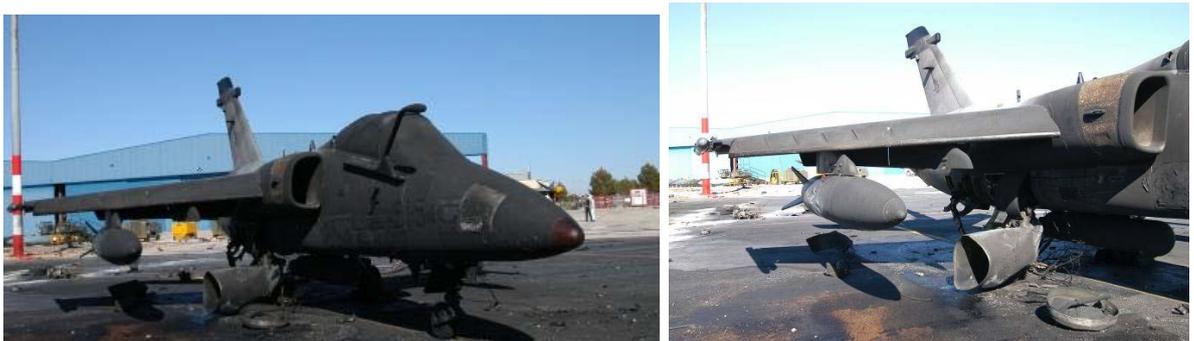
Pictures 30: AMX S/N 7193

It was located next to Alpha-Jet S/N E047 and got totally unserviceable by the fire.

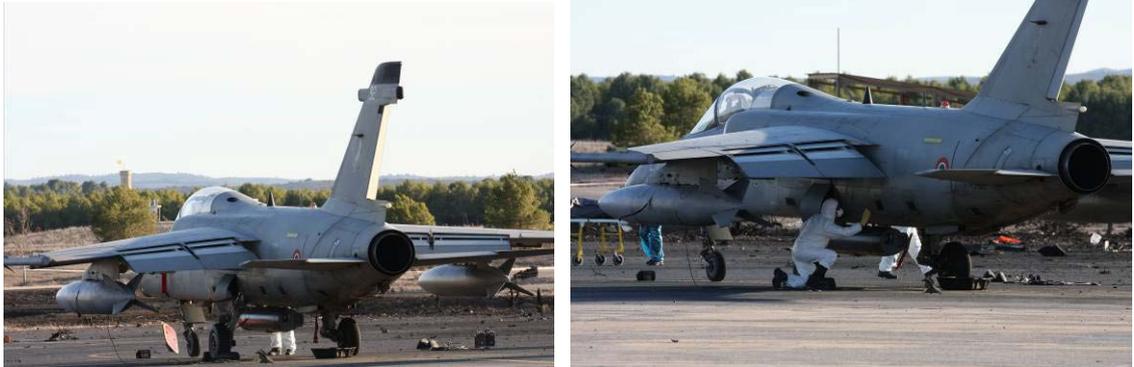
Pictures 31: AMX S/N 7192

It was located next to AMX S/N 7193 and got slightly damaged.

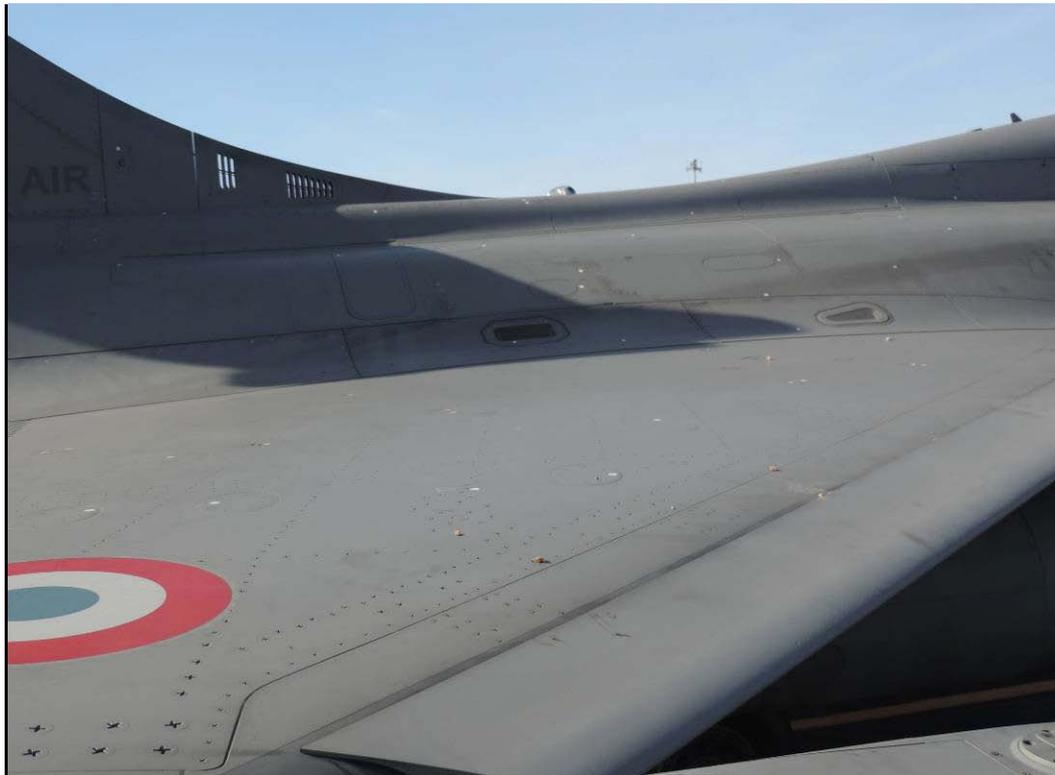
Picture 32: Rafale S/N B335

Rafale S/N B335 was parked next to Mirage 2000D S/N 669 and was slightly damaged due to fragmentation after MA's crash.

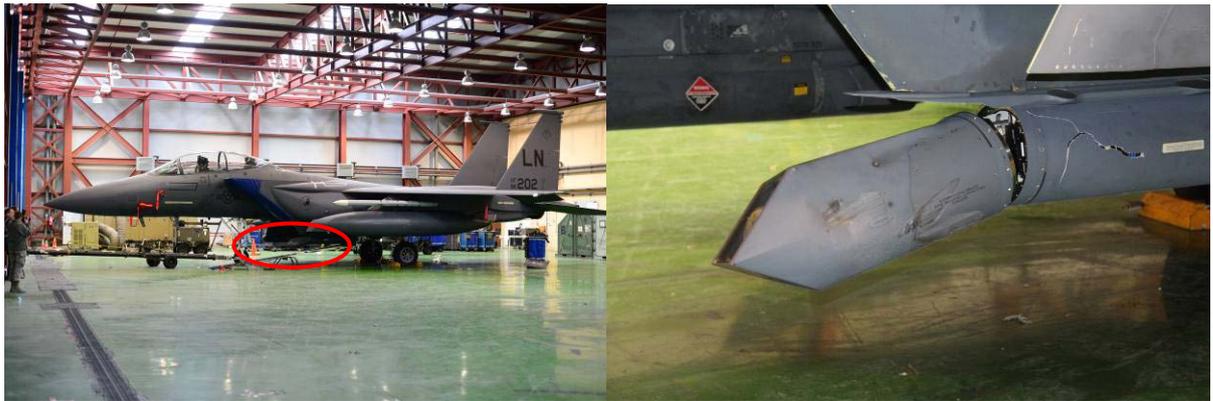
Pictures 33: F-15 S/N 202

The A/C was located inside TLP Hangar and was slightly damaged.

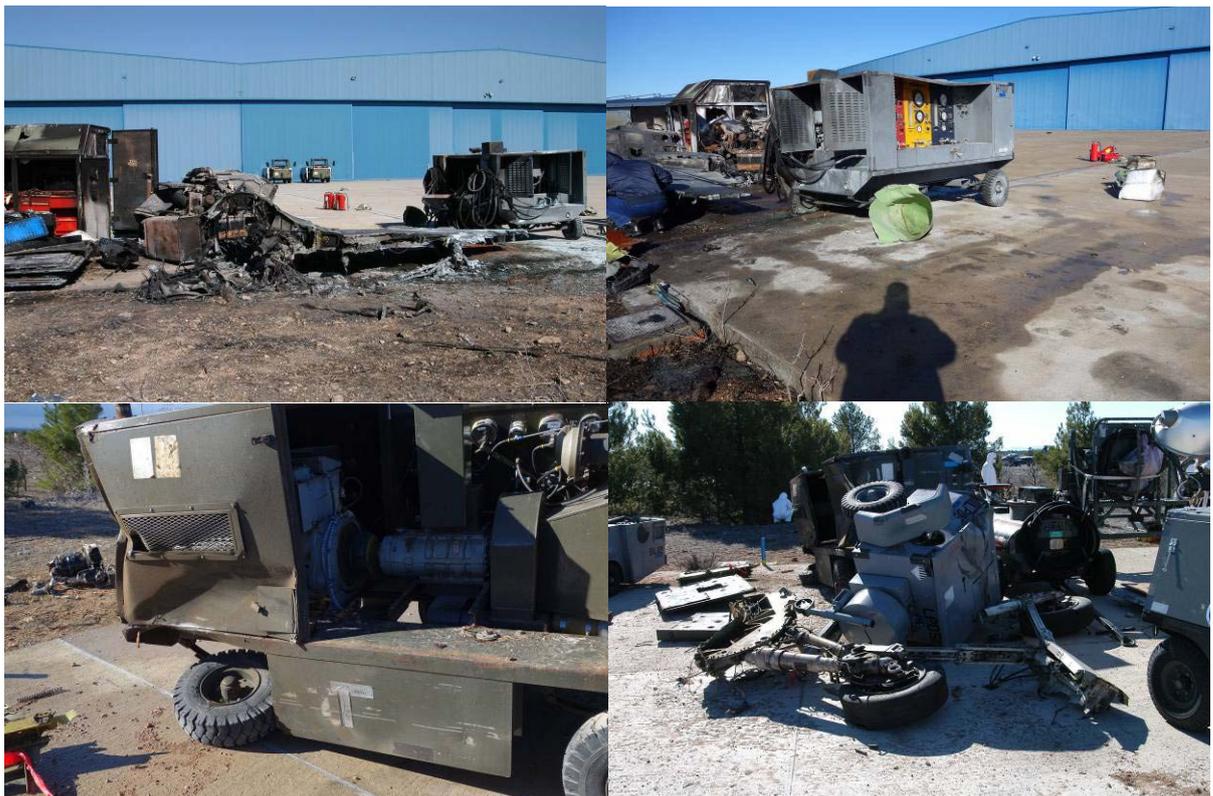
Significant damages were caused to the ground equipment that was located in front of TLP hangar mainly by MLG, RH wing and LH wing of the MA.

Pictures 34: Damages caused by MA's pieces on ground equipment

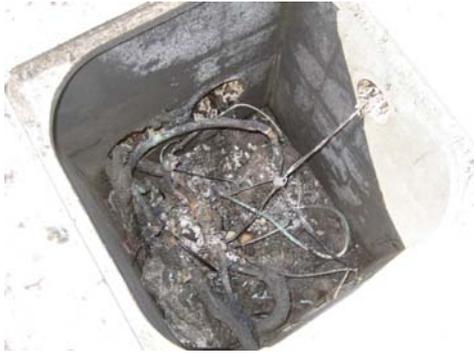
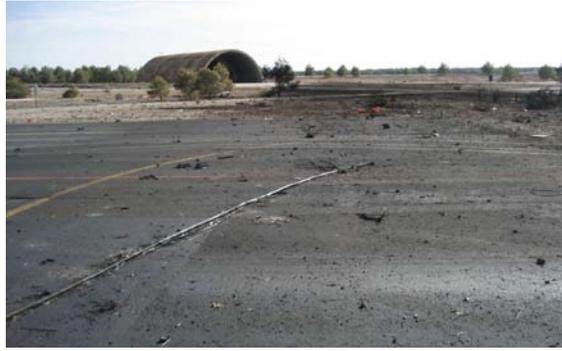
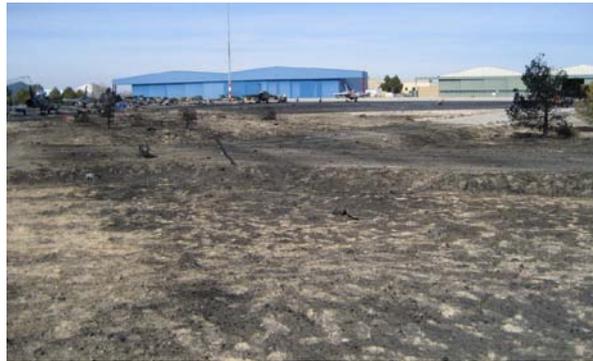
Significant damages were caused to Albacete and TLP infrastructure in front of TLP hangar, E2 apron parking area and the nearby land.

Pictures 35: Damages to Albacete AFB and TLP infrastructure
