**UNITED STATES AIR FORCE**  
**AIRCRAFT ACCIDENT INVESTIGATION**  
**BOARD REPORT**

**F-15C, TAIL NUMBER 86-0157**  
**131ST FIGHTER SQUADRON**  
**104TH FIGHTER WING**  
**BARNES AIR NATIONAL GUARD BASE, MASSACHUSETTS**

**LOCATION:**  
**GEORGE WASHINGTON NATIONAL FOREST, VIRGINIA**

**DATE OF ACCIDENT: 27 AUGUST 2014**

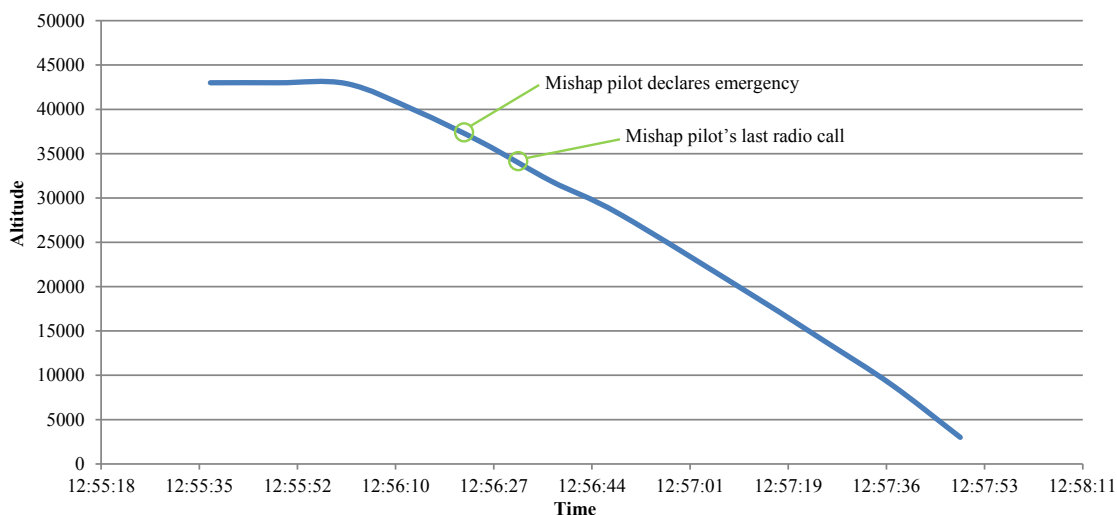
Figure 2: Altitude of Mishap Aircraft Over Time after Leaving Flight Level 430 (Tabs M-2.12 to M-2.13, N-3.12 to N-3.13, and GG-62)

After the initial descent at 12,000 feet per minute, the MA continued to accelerate and descend (Tab M-2.12 to M-2.13). Prior to impact, the MA reached supersonic speed, indicating that no catastrophic structural failure occurred before impact (Tab J-6). Radar data showed no evidence that MP maneuvered to recover the MA between the final call to Washington Center and impact (Tabs M-2.12 to M-2.13 and GG-50). At Flight Level 360, MP was at a sufficient altitude to recover or eject from the aircraft (Tabs H-2 to H-3, V-20.4 to V-20.5, and EE-4).

See Figure 2 for a chart showing the altitude of the MA over time after leaving Flight Level 430.

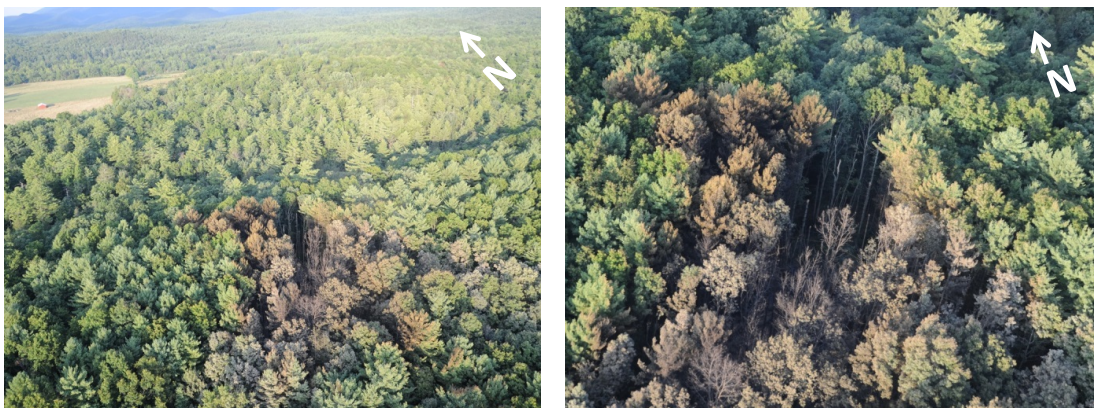
Figure 3: Aerial Images of Crash Site Taken at 1851L on 27 August 2014 (Tab Z-3)

The MA impacted the ground at approximately 0858L in a densely forested area of the George Washington National Forest (Tabs M-2.13, N-3.15, and Z-3). Pieces from all the main sections of the MA were found at the crash site, indicating that there was no catastrophic structural failure prior to impact (Tab J-6). The MA created a large crater (approximately 15 to 20 feet deep) at the point of impact (Tab J-2). At the time of the impact, the MA was inverted between 60 to 70 degrees nose low (i.e., upside down and pointed sharply toward the ground) and traveling at an airspeed greater than 0.83 Mach (Tab J-2 and J-25). The MA's engines were operating normally in a mid-range power setting—the standard power setting at cruising altitude for a cross-country flight—at the time of impact (Tabs J-78.10 and V-22.5).

See Figure 3 for aerial images of the crash site taken at 1851L on the day of the mishap.

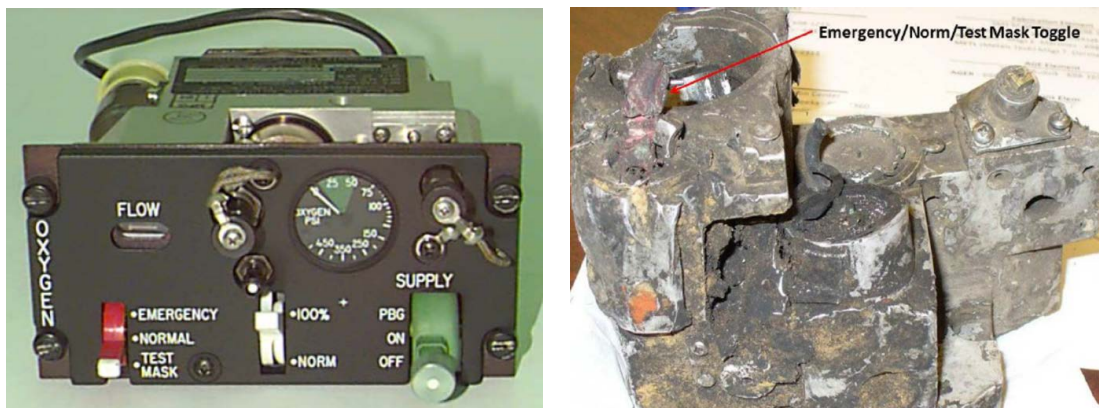
Figure 5: Image of Intact Oxygen Regulator and Image of Damaged Oxygen Regulator from the Mishap Aircraft (Tab J-7 and J-9)

GOX from the heat exchanger is supplied to a cockpit-mounted oxygen regulator, manufactured by Cobham plc (Cobham), for delivery of breathing gas to the pilot (Tabs J-8 and FF-3). On 22 August 2014, the MA's cockpit-mounted oxygen regulator was inspected (Tabs V-14.3 to V-14.5 and FF-3). No defects or non-functioning conditions were noted (Tabs V-14.3 to V-14.5 and FF-3). The MA's oxygen regulator was recovered from the crash site and provided to Cobham for analysis (Tabs J-8 and GG-4). However, due to the severity of damage sustained during impact, Cobham's analysis was inconclusive concerning the status of the regulator prior to impact (Tab GG-3 and GG-37).

See Figure 5 for an image of an undamaged cockpit-mounted oxygen regulator and an image of the MA's cockpit-mounted oxygen regulator recovered from the crash site and analyzed by Cobham.
