**UNITED STATES AIR FORCE**  
**AIRCRAFT ACCIDENT INVESTIGATION**  
**BOARD REPORT**

**C-145A, T/N 12-0331**

**720TH OPERATIONS SUPPORT SQUADRON  
24TH SPECIAL OPERATIONS WING  
HURLBURT FIELD, FLORIDA**

**LOCATION: EGLIN AIR FORCE BASE, FLORIDA**  
**DATE OF ACCIDENT: 3 AUGUST 2015**  
**BOARD PRESIDENT:**  
**BRIGADIER GENERAL VINCENT K. BECKLUND**

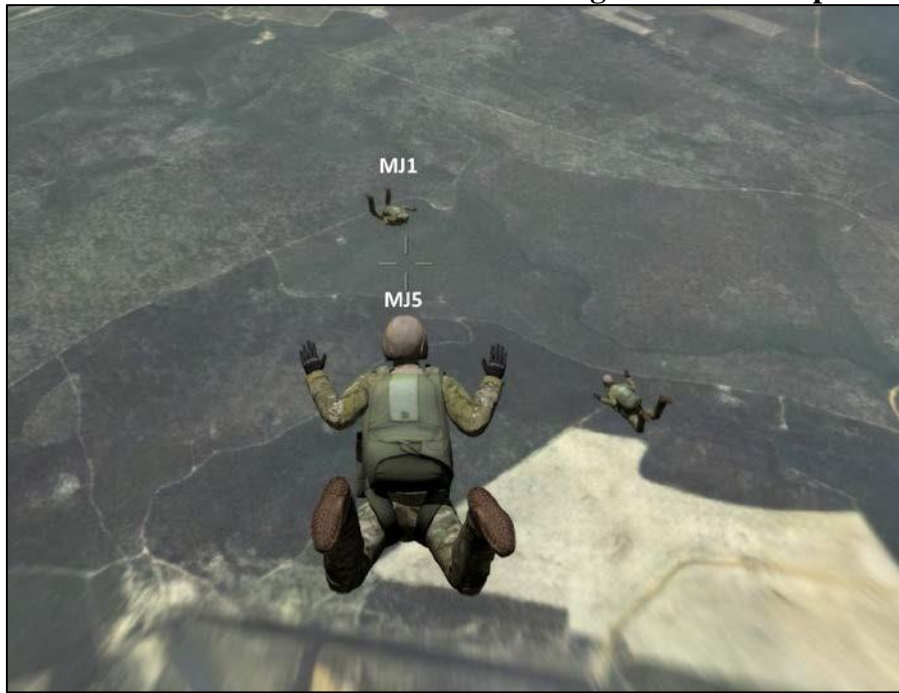
Figure 9: Simulated view from behind MJ5 (Tabs V-6.6, and Z-11).

MJ5 exited in the sixth position (Tabs V-4.8, V-6.6, and V-7.5). MJ5 testified at the two minute warning, he asked the jumper to his left if he was going in front of or behind him (Tabs R-148, and V-6.6). This jumper responded that he was "going to catch someone," so MJ5 told this jumper to exit in front of him (Tabs R-148, R-165, and V-6.6). MJ5 stated he did not want to "get in the way" of this jumper, who MJ5 was unable to identify (Tab V-6.6). After exiting, MJ5 assumed a stable free fall body position and noticed two jumpers below and in front of him (See Figure 9) (Tabs R-141, R-149, and V-6.6). The two jumpers appeared to be in close proximity and looking at one another approximately 30 meters from MJ5 (Tabs R-149, R-166, and V-6.6).

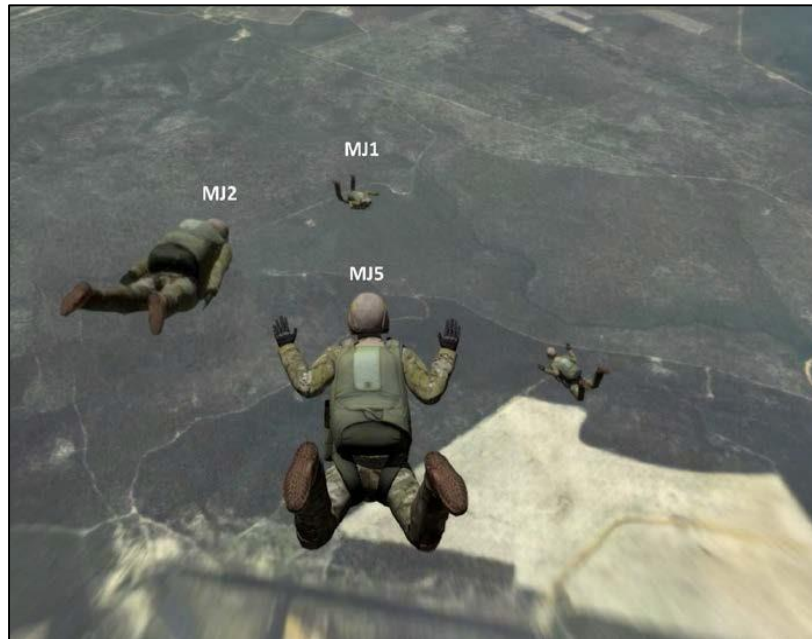
Figure 10: Simulated view from behind MJ5 after MJ2 passed over his left shoulder (Tab Z-12).

he resumed his stable free fall body position (Tabs R-149, and V-6.6). At this time, he recognized one of the jumpers below him to be MJ1 (Tabs R-149, and V-6.6). Almost simultaneously, he noticed a shadow, and then MJ2 pass over his left shoulder moving quickly in a track body position (Tabs R-149, R-166 to R-167, and V-6.6).

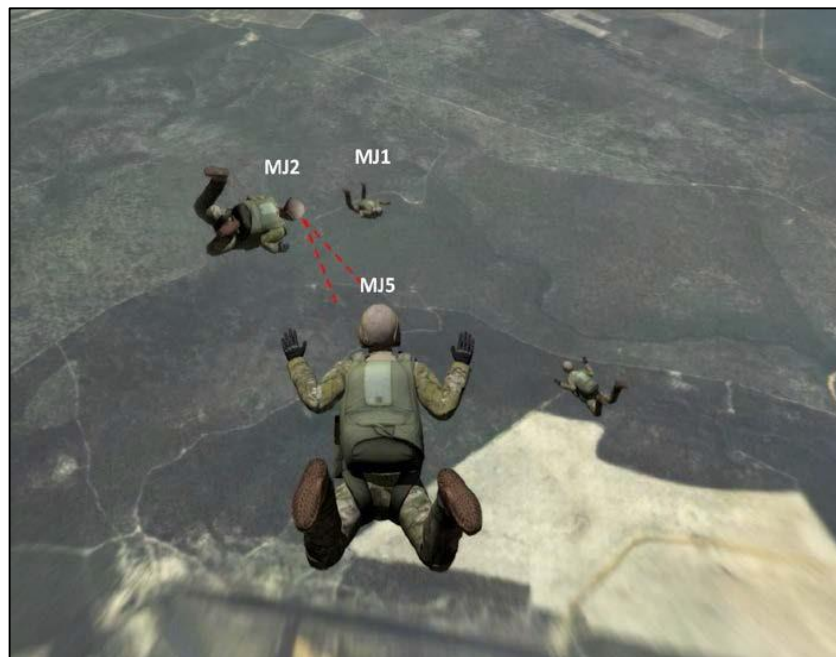
Figure 11: Simulated view from behind MJ5 as MJ2 briefly gets out of his track body position and looks back at MJ5 (Tab Z-13).

MJ5 testified that MJ2 momentarily suspended his track body position, quickly looked back at MJ5, and then immediately resumed this track body position before colliding head-to-head with MJ1 (See Figures 11 and 12 below) (Tab R-158, and V-6.6).

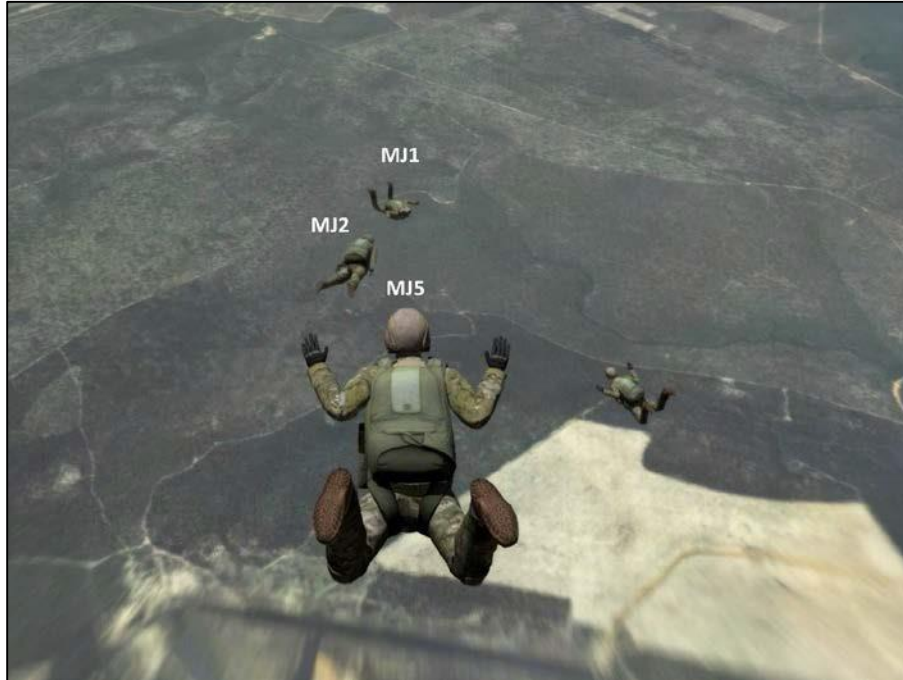
Figure 12: Simulated view from behind MJ5 as MJ2 returns to his track body position (Tabs V-6.6, and Z-15).

MJ5 estimates this collision occurred at approximately 8,000 feet AGL (Tab R-150). Following the collision, MJ5 watched MJ2 flip over MJ1's back, and begin spinning to the right, unresponsive (Tabs R-150, and V-6.7). Additionally, MJ5 watched as MJ1 maintained a stable free fall body position for a split second more, before spinning off to the left, unresponsive (Tab V-6.7). After witnessing the collision, MJ5 testifies the other unidentified jumper below his altitude deployed his parachute canopy (Tab R-150, and V-6.7). Finally, MJ5 then pulled his parachute canopy to avoid any further conflict (Tab R-150, and V-6.7).

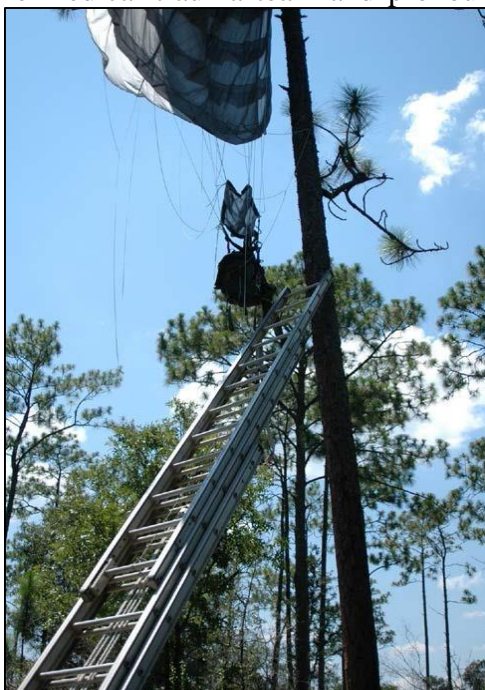
Figure 14: MJ2’s landing site (Tab S-14).

In an attempt to reach MJ2 without a ladder, MAJM and MJ3 tried climbing the tree, and forming a human pyramid with four other ground personnel (Tabs R-34, R-58, R-71, R-76, R-279, and V-4.20 to V-4.21). All attempts to reach MJ2 were unsuccessful (Tab R-58, R-279, V-4.20 to V-4.21, and V-24.1). Additionally, MAJM and MJ3 called 911 to request assistance, and stated their location (Tab R-58, and R-76). At 1214L, MJ2’s situation was reported to the 911 operator by 24 SOW NCO (Tab DD-8). In the interim, Camp Rudder and Eglin Crash Fire Rescue personnel, both located adjacent to Auxiliary Field 6, were notified and proceeded to MJ2’s site (Tabs R-33, and V-11.6). Upon arrival, Eglin Crash Fire Rescue provided a large ladder, which MJM and a fire fighter used to extricate MJ2 out of his suspended parachute harness and then carefully carried him to the ground (Tabs R-6, R-34, R-123, R-183, R-279, and V-1.23). At 1245L, MJ2’s extrication from the tree was complete and medical personnel began attempts to resuscitate him within the wooded area (Tabs R-86, R-123, R-183, and DD-10). Army Ranger personnel provided chain saws and began clearing a path through the wooded area in anticipation of moving MJ2 to awaiting medical transportation (Tabs R-124, R-183, and V- 24.1).

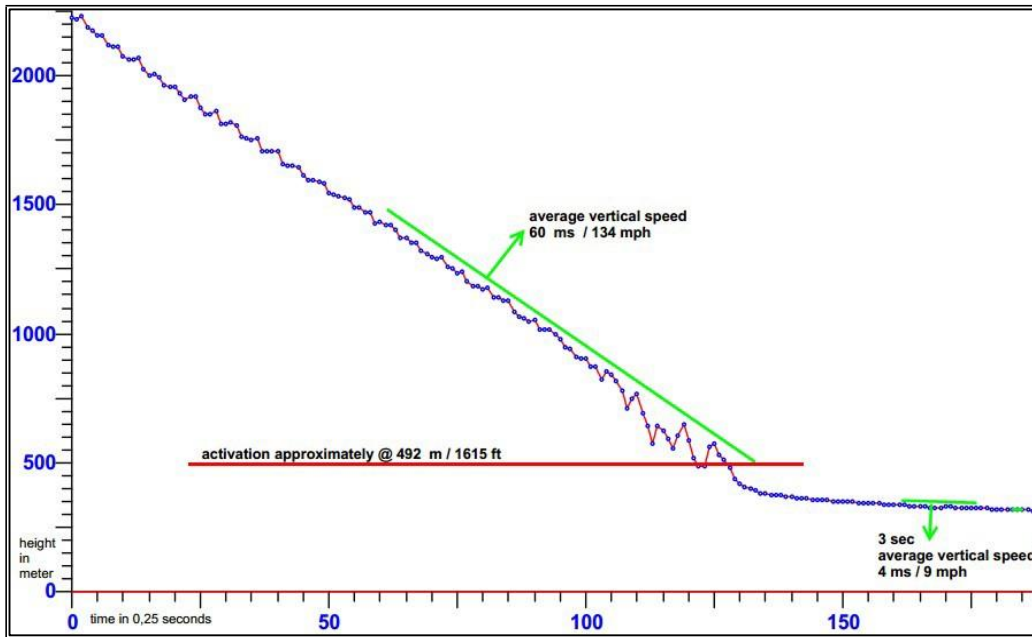
Figure 17: MJ1 CYPRES Data (Tab DD-67).

MJ1's CYPRES attained the activation speed, and began recording at approximately 7,340 feet AGL (Tab DD-66 to DD-67). The CYPRES unit recorded an average falling speed of 134 mph before deployment of the reserve parachute (Tab DD-67). The CYPRES functioned properly, releasing MJ1's reserve parachute canopy at 1,615 feet AGL, which then slowed MJ1's vertical descent to an average of 9 mph before he landed near Auxiliary Field 6 (Tabs H-2, and DD-66 to DD-67).

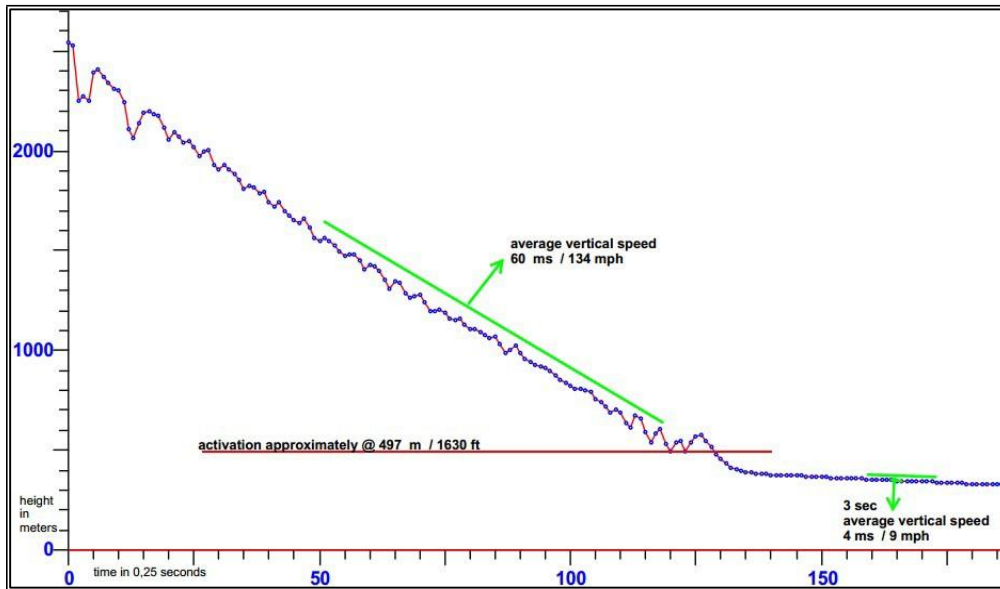
Figure 18: MJ2 CYPRES Data (Tab DD-69).

MJ2's CYPRES attained the activation speed, and began recording at approximately 8,235 feet AGL (Tab DD-68). MJ2's CYPRES unit recorded an average speed of 134 MPH (Tab DD-69). The CYPRES functioned properly, releasing MJ2's reserve parachute canopy at 1,630 feet AGL, which then slowed MJ2's vertical descent to an average of 9 miles per hour before he landed near Auxiliary Field 6 (Tabs H-3, and DD-68 to DD-69).

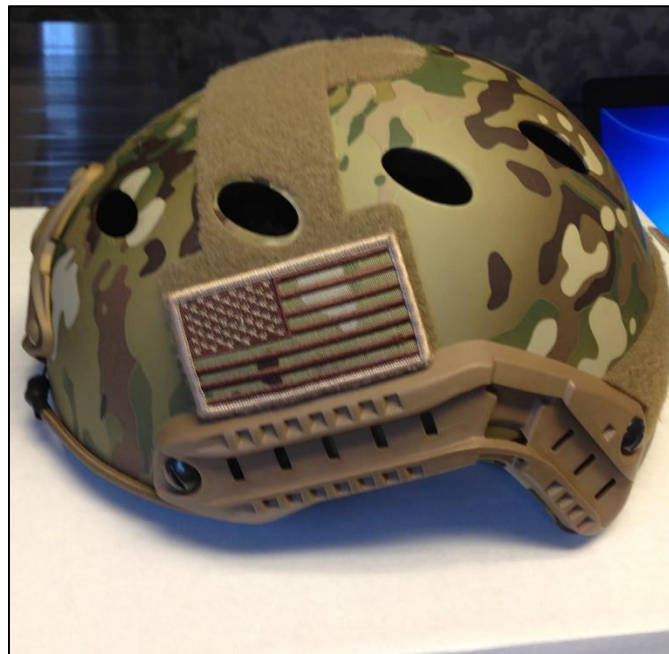
Figure 19: Ops-Core “Carbon Skeleton” helmet (Tab Z-21).

An Ops-Core non-ballistic bump helmet was tested for performance specifications of 17.6 feet per second (fps) impact velocity in varying environmental conditions, including those environmental conditions experienced by MJ1 and MJ2 (Tabs F-2, and J-45 to J-46). In earlier

evaluations, the Ops-Core non-ballistic bump helmet, of the type used by MJ1 and MJ2, performed as well or better than comparable non-ballistic bump helmets (Tab J-45 to J-46). In subsequent analysis of the mishap helmets, each revealed multiple exterior shell fractures (Tabs J-43 to J-44). Additionally, no material or manufacturing defects were noted (Tab J-47 to J-48). Given a closure rate that “could have been in excess of 100 mph or 146 fps,” which greatly exceeds the designed blunt impact protection capabilities of the Ops-Core helmet, it is unlikely any marketed helmet would have altered the outcome of the collision (Tab J-47).
