**UNITED STATES AIR FORCE**  
**AIRCRAFT ACCIDENT INVESTIGATION**  
**BOARD REPORT**

**UH-1N, T/N 69-6603**

**512TH RESCUE SQUADRON**  
**58TH SPECIAL OPERATIONS WING**  
**KIRTLAND AIR FORCE BASE, NEW MEXICO**

**DATE OF ACCIDENT: 27 APRIL 2011**

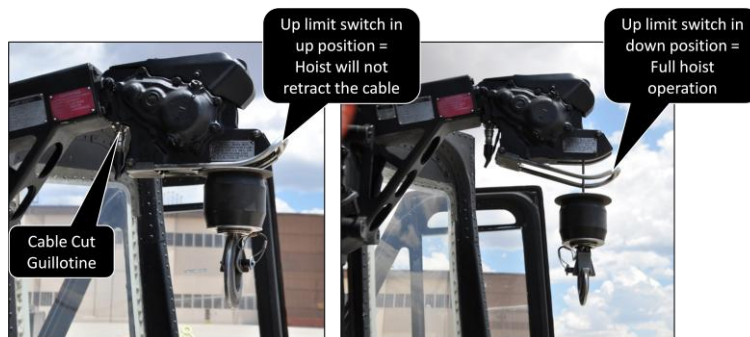
**Figure 6. Hoist Up Limit Switch and Hook**

designed to stop cable retraction once the cable fully retracts. (Tab V-7.8) Holding the up limit switch up prevented the hoist from retracting the cable but allowed it to extend. (Tab V-7.26) In accordance with procedure, MF2 attempted to retract the hoist cable by using his pendant. MF2 noticed that the hoist was not retracting. (Tab V-9.17) MF2 began trouble-shooting the hoist malfunction in accordance with the 512th Standard Operating Procedures. (Tab O-13)

MF2 announced to the MC that the cable was not coming up and asked the MPs if the hoist power was on. (Tab V-9.18) The MPs confirmed that it was on. (Tabs V-8.17 through V-8.18, V-9.18) MF2 then asked the MPs if they could double check their circuit breakers, and it was confirmed that the circuit breakers were in. (Tab V-9.18) MF2 again checked his pendant. (Tab V-9.18) MF2 then misdiagnosed the simulated malfunction as a pendant failure. He then asked MP2 to raise the hoist cable by using the pilot hoist control switch on the pilot's cyclic. (Tab V-9.19) MP2 responded in the affirmative that he was using the pilot's hoist control switch to attempt to retract the cable. (Tabs V-7.28, V-9.19, V-10.14) MF2 announced that "nothing was happening." (Tabs V-7.28, V-9.19)

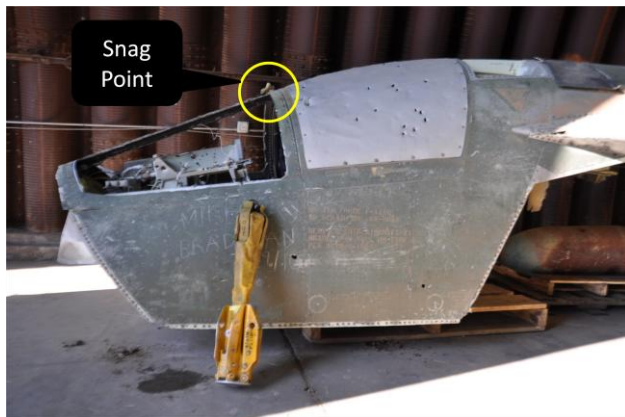
**Figure 7. F-111 Capsule With Snag Point and Forest Penetrator**

While MF2 was focused on the malfunction inside the cabin, the MA had an undetected drift forward and left, positioning the MA 5 to 10 feet west of the capsule. (Tab V-9.21) Upon clearing the simulated malfunction, MF2 looked back outside and noticed that the forest penetrator was already off the ground and swinging. (Tab V-9.20) Within approximately 2 seconds, MF2 saw the penetrator snag in the front left F-111 capsule window. He noticed the cable becoming taut and immediately called "stop up, stop up." (Tabs V-7.28 through 7.29, V-9.23) Neither MP1 nor MP2 heard this call. (Tabs V-8.23, V-10.21)

Due to the snag, the MA experienced a violent jerk, creating a right roll and right yaw. (Tab V-10.15) Based on the unexpected aircraft movement and abnormal control feel, MP2 instinctively pulled up on the collective, which would normally move the MA away from the ground. MP2 glanced inside and noticed the torque showing 100 percent or maximum power available. (Tab V-8.19) Simultaneously, MP1 placed his hand to the right of the cyclic to ensure that control inputs were not causing the right bank. (Tab V-10.19) MP1 noticed that the right bank was not being caused by the cyclic and decided to mirror the controls because of the MA's erratic behavior. (Tab V-10.15)

The F-111 capsule had been on Site 15 for over a decade. (Tab V-1.8) At one point aluminum sheeting covered all the openings, but several panel coverings were missing at the time of the mishap. (Tab S-10) Without these panels, the capsule was an entanglement hazard. (Tab S-10) Previous site surveys noted the F-111 capsule's presence. (Tab K-27) Multiple members in the 512 RQS verified that the capsule was a frequently-used reference point for AIE operations. (Tabs V-8.21, V-10.9, V-10.11) MF1 selected an aim point for the hoist approximately 10 to 15 feet from the capsule. (Tabs V-7.27, V-9.13)

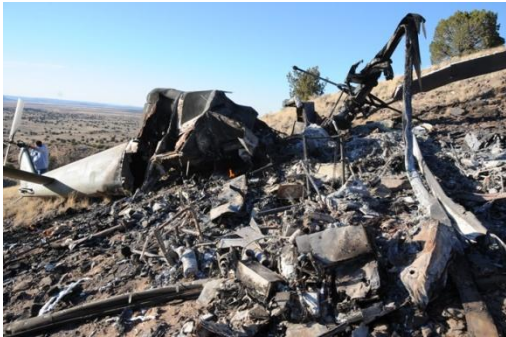
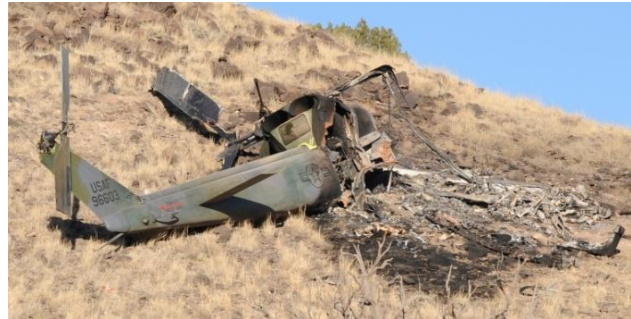
**Figures 11 and 12. Post Mishap Wreckage**

A thorough inspection and evaluation of all the MA's systems was conducted. All aircraft systems, to include the hoist, performed normally up to the time of impact. Most of the airframe forward of the tailboom and all aircraft recording devices were consumed by the post mishap fire. The tail rotor and synchronized elevator systems were relatively undamaged except for the crumpling of the left elevator upon impact. (Tabs J-40 and S-7 through S-15)

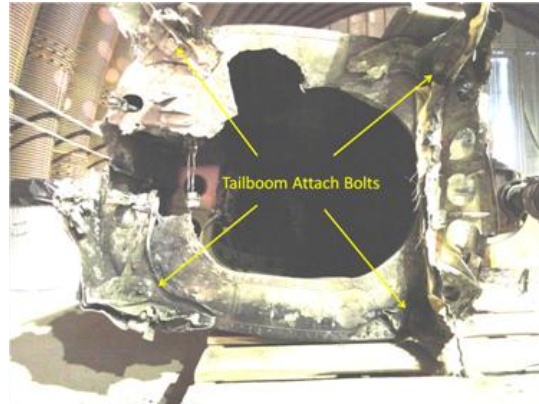
**Figure 14. Tailboom Cross-Section**

The tailboom attachment fittings and hardware at all four locations were still intact with no evidence of tailboom separation from the impact. The tailboom separated from the aircraft during post impact fire. (Tabs J-39 through J-43)

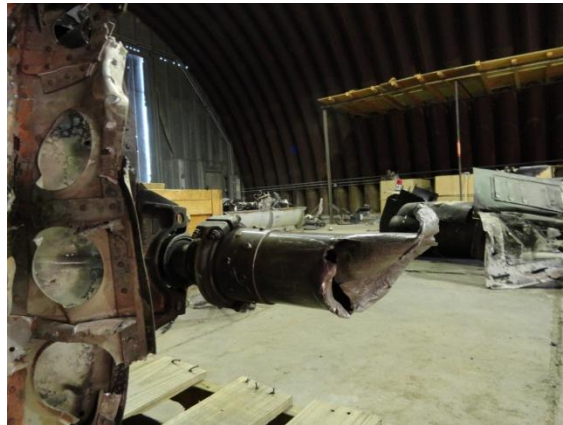
**Figure 15. Tail Rotor Drive Shaft**

The tail rotor driveshaft was torsionally sheared, indicating the tail rotor was rotating when the main rotors contacted the ground. When the main rotors contacted the ground, they stopped rotation of the main drive gearbox and transmission. Oil samples from both the 42 and 90 degree tail rotor gear boxes were taken and showed no discrepancies. The tail rotor blades and attachment points were visually inspected for damage and proper hardware installation, with no discrepancies. The tail rotor blades did not contact the ground. (Tab J-42)

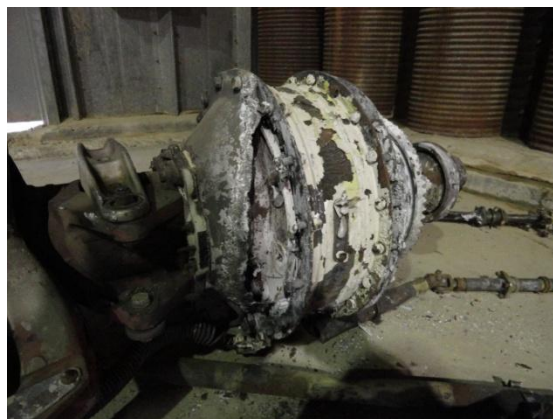
**Figure 16. Main Rotor Gearbox**

Upon ground contact, the red main rotor blade sustained 2 feet of outboard damage, the white main rotor blade sustained 4 feet of outboard damage, and the drive tube disintegrated. Each blade struck the ground only once. As a result of the damage, there was a loss of drive to the rotor system, causing insufficient rotational energy for a second strike. The damage to the main rotor head is consistent with sudden stoppage of the main rotor from ground contact. The main rotor gear box housing was consumed in the post crash fire. Visual examination of the internal gear faces revealed no obvious distress or mechanical failure. (Tab J-40)

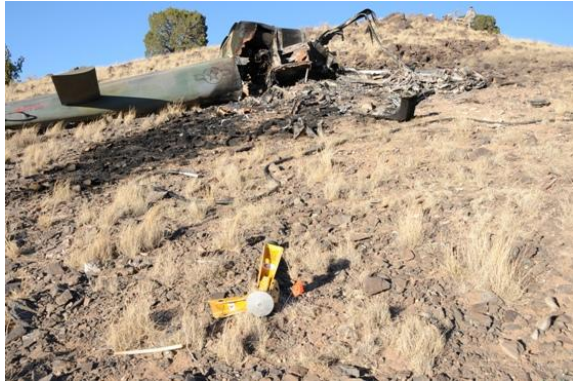
Figure 17. View of Forest Penetrator and MA

The hoist was found in the wreckage with significant fire damage. Clean mechanical cuts on mating ends of the hoist cable indicate the cable was sheared. All but 39 feet of the cable was found on the hoist. The remaining 39 feet of hoist cable led downhill from the MA wreckage to the forest penetrator, which was approximately 35 feet southwest of the MA. The forest penetrator had two seat paddles extended, with the third in the retracted position. The F-111 capsule, located approximately 70 feet to the south of the forest penetrator, had dents and yellow paint transfer on the internal edges of the forward left windshield frame. The yellow paint matched the forest penetrator's paint. (Tabs J-44 and S-15)

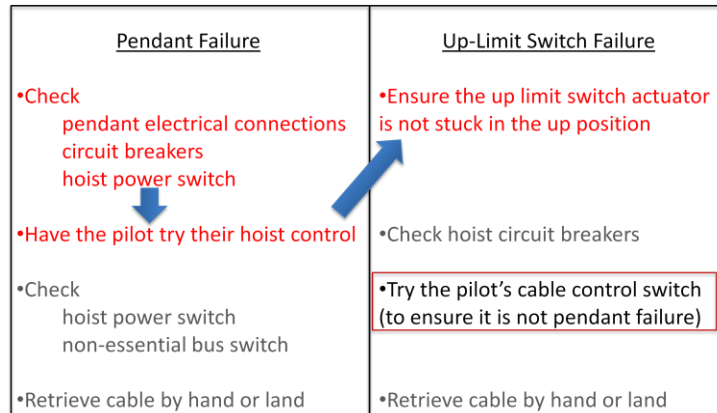
**Hoist Troubleshooting Steps**

The normal trouble shooting sequence for up-limit switch failure has the pilot try his hoist control switch two steps after the FE has already ensured the up limit switch actuator is not in the up position. MF2 executed the first steps of the pendant failure troubleshooting sequence followed by the first step for up limit switch failure. MF2 did not confirm that MP2 had released

the pilot's hoist control switch before clearing the simulated malfunction. This sequence resulted in an unanticipated full rate cable retraction.

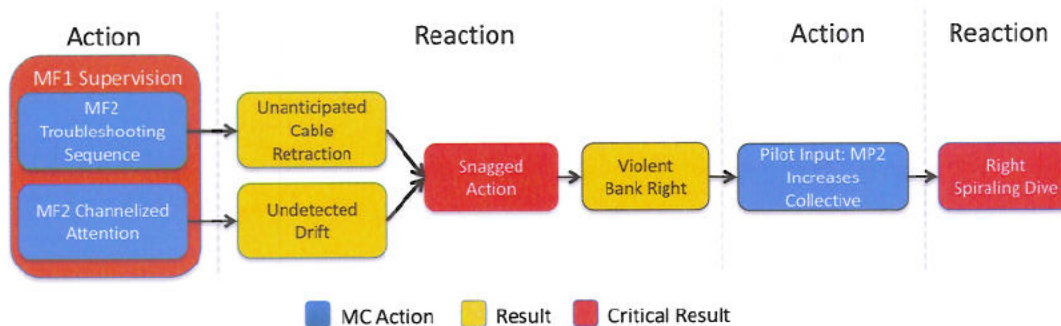
**Mishap Sequence**

MP2's action of increasing the collective while tethered to the F-111 capsule exacerbated the already imbalanced flight characteristics. This caused the MA to increase right yaw, right bank, and forward pitch, resulting in a right spiraling descent until the forest penetrator separated from the F-111 capsule.

None of the aforementioned actions independently caused the mishap. Three actions by two crewmembers created results that caused the improbable snag, which led to the bank, which led to MP2's input, which led to impact. This unique synergistic combination caused the mishap.
