AIRCRAFT ACCIDENT INVESTIGATION
BOARD REPORT

F-16C+, S/N 87-0242

**176TH FIGHTER SQUADRON
115TH FIGHTER WING
TRUAX FIELD, WISCONSIN**

DATE OF ACCIDENT: 7 JUNE 2011

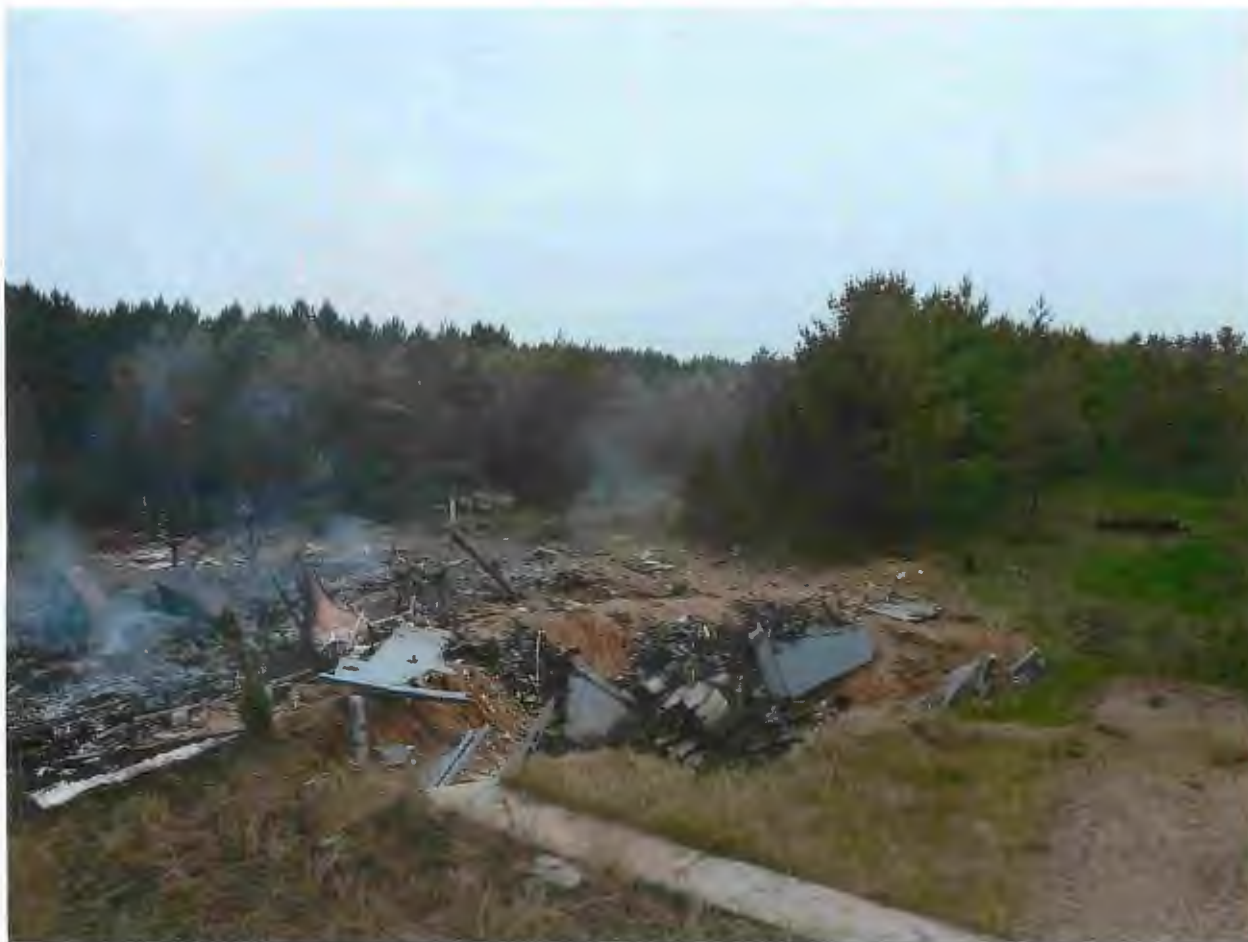
Figure 2: Impact Site

The MA impacted the ground on privately owned land at approximately 1316L (Figure 2), 57 nautical miles northwest (345 degrees True) of Truax Field and was completely destroyed (Tabs S-1 through S-10, H-3). Coordinates were North 43 50’ 51.5”, West 89 37’ 13.7” (Tab S-3). The wreckage field was fan shaped with the majority of wreckage 280-355 degrees True from the crater out to a distance of approximately 820 feet (Tab S-4).

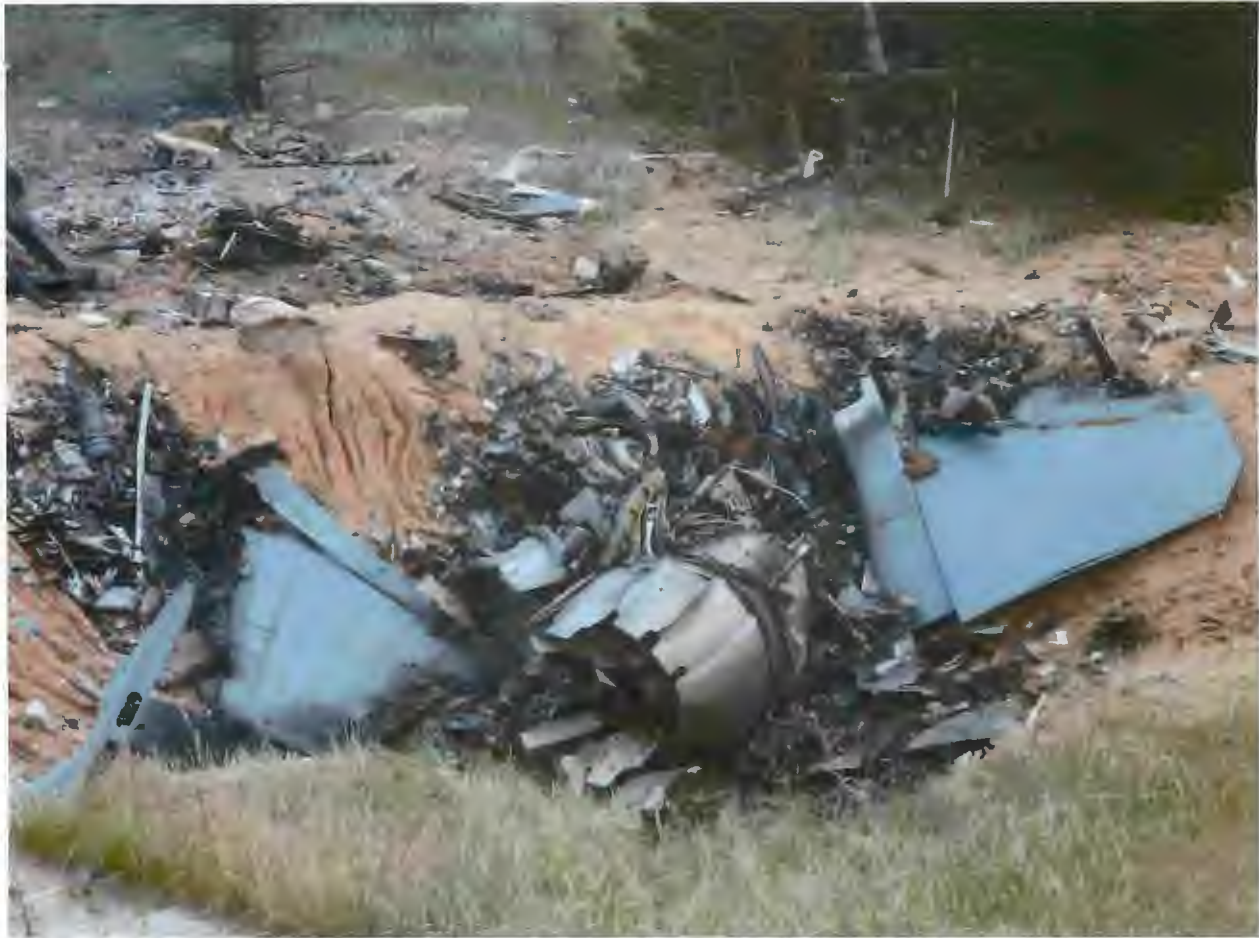
Figure 3: Impact Crater

The MA impact crater (Figure 3) was approximately 9 feet deep and 30 feet in diameter (Tab P-5). The wreckage distribution and condition indicated that the MA was slightly right wing low, approximately 80-90 degrees nose down, and at 285 KIAS on a northwesterly heading at impact (Tab P-5). Following impact, the MA pivoted forward symmetrically about the nose, coming to rest inverted (Tab P-5). Both wings, and the horizontal stabs and vertical tail were separated from the fuselage (Tab P-5). The horizontal stabs remained in the impact crater, the wings were adjacent to the crater and the vertical tail was 117 feet beyond the crater (Tab P-5). Most of the remaining objects from the aircraft dispersed in a fan pattern out to 821 feet from the point of impact covering approximately 6 acres in a 45 degree arc (Tab P-5). Upon impact, fire enveloped the MA and a vacant double wide mobile home (Tab P-5). The vacant double wide mobile home structure was completely destroyed (Tab P-5).

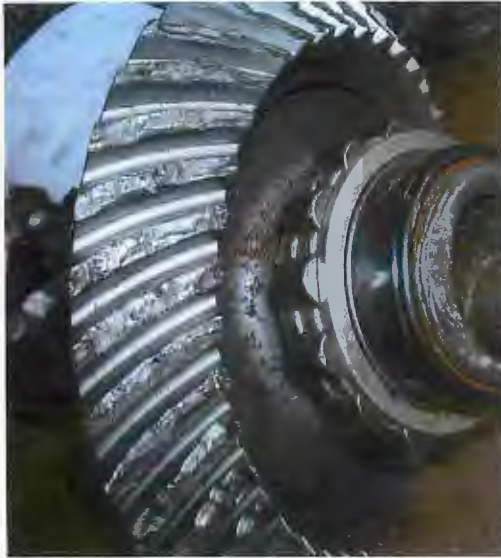
Figure 7: PTO Bevel Gear Teeth

Post-mishap analysis was performed by General Electric Aviation and Tinker OC-ALC Engineers (Tab J-23). The recovered parts were analyzed at the 115th JEIM shop (Tab J-3). Engineering analysis determined that the PTO shaft forward ball bearings were reduced in size allowing PTO shaft movement (Tab J-82). The PTO shaft movement ultimately resulted in disengagement of the mating bevels gears (Figure 7) within the AGB (Tab J-16).

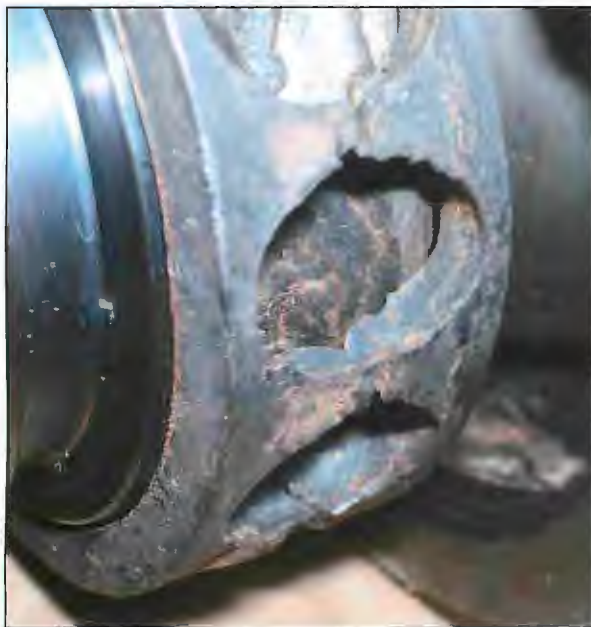
Figure 10: Ball Bearing Cage (Tab J-17)

Analysis of the AGB described the PTO bearing cage damage as a “dull burnt appearance” (Tab J-16). The bearing cage houses the solid ball bearings. The ball bearings were not recovered (Tab J-16). The bearing cage was cracked between the cage pockets (Figure 10), but still intact (Tab J-16). Several pockets on the cage of the ball bearing had raised lips in the direction of rotation indicating bearing decay (Tab J-16). Metal deposits were visible on the surfaces of the cage and the inner and outer races (Figure 11) (Tab J-16). The bearing failure resulted in loss of axial support and the subsequent forward shifting of the PTO shaft during engine operation, allowing the disengagement of the mating bevel gears within the AGB (Tab J-16).

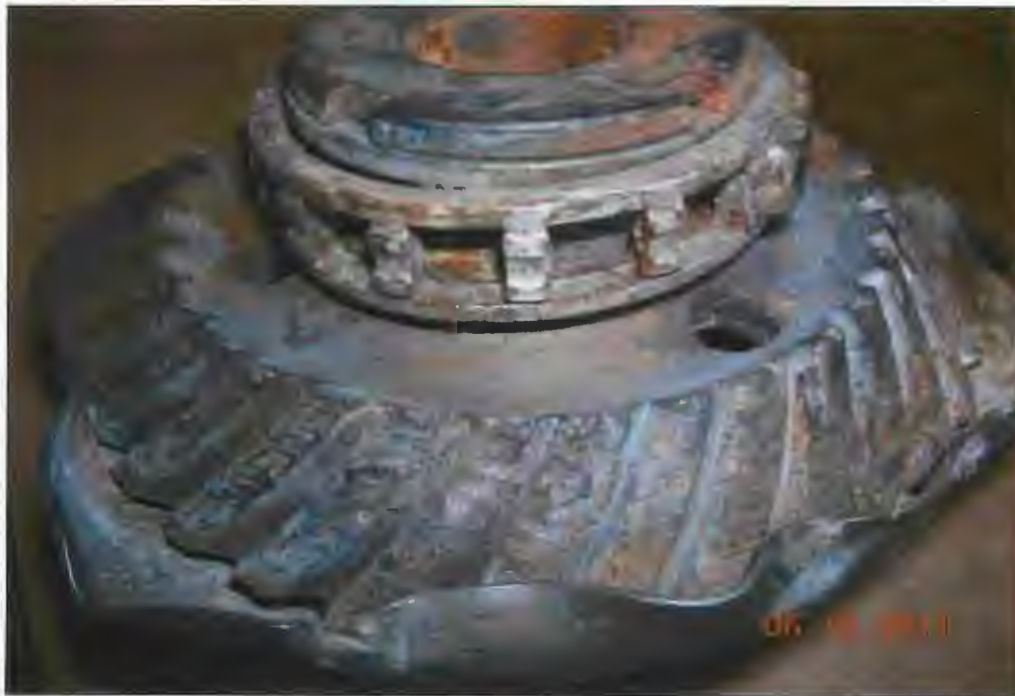
Figure 13: Bevel Gear Teeth (Tab J-19)

The PTO shaft bevel gear (Figure 13) had damage to the top lands of the gear teeth, described as a jagged finish and notable material missing that increases at the center of the teeth (Tab J-15). The forward bevel gear had heat discoloration from contact with the 37-tooth spur gear (Tab J-17). The forward half of the spur gear teeth also showed heat damage (Figure 12) (Tab J-17). The PTO Spur Gear teeth also had a groove worn into the forward face (Tab J-17). The PTO

shaft bevel gear damage was consistent with improper alignment of the PTO shaft during engine operation prior to impact (Tab J-18).

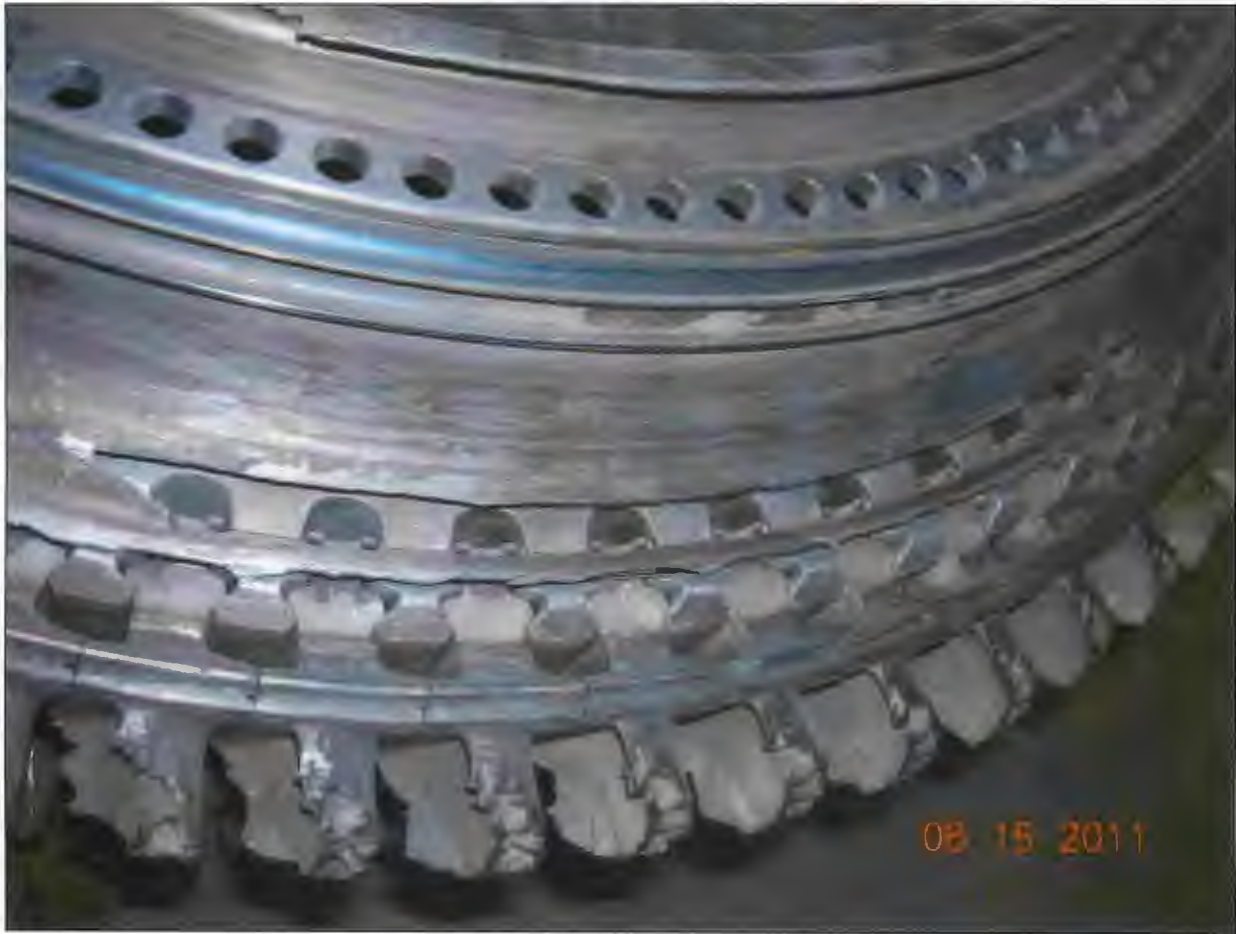
Figure 14: High Pressure Turbine (Tab J-12)

The High Pressure Turbine (HPT) damage to the vanes displayed evidence of some metal splatter and/or slurry accumulation (Figure 14) (Tab J-10). The source of the molten metal is most likely from rotating HPT components damaged late in the mishap sortie by high temperature (Tab J-13). Engineers indicated that the MEC would continue to supply fuel to the engine despite sub-idle positioning of the IGVs and VSVs resulting in exceeding engine operating limits (Tab L-12 @ time 3790, V-8.17).

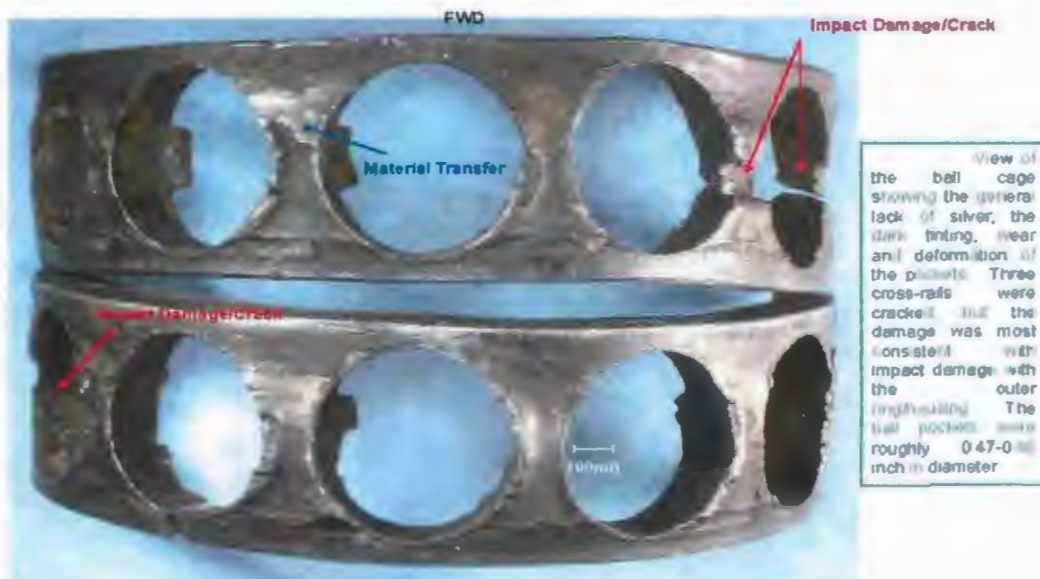
Figure 15: Ball Bearing Cage (Tab J-78)

GE evaluated the AGB components and the HPT Forward Outer Seal (FOS). During analysis of the AGB forward ball bearing assembly, GE reported round indentations on the back side of the inner ring (Figure 21) (the inner portion of the ball bearing cage), consistent with the ball bearings having been present at the time of impact and liberated during the post impact breakup (Tab J-37). The outer ring raceway had indentations consistent with debris roll-over damage (Tab J-37). The overall cage, both inner and outer ring, lost most of the silver plating and the base metal was hardened, consistent with high temperature exposure (Figure 15) (Tab J-37).

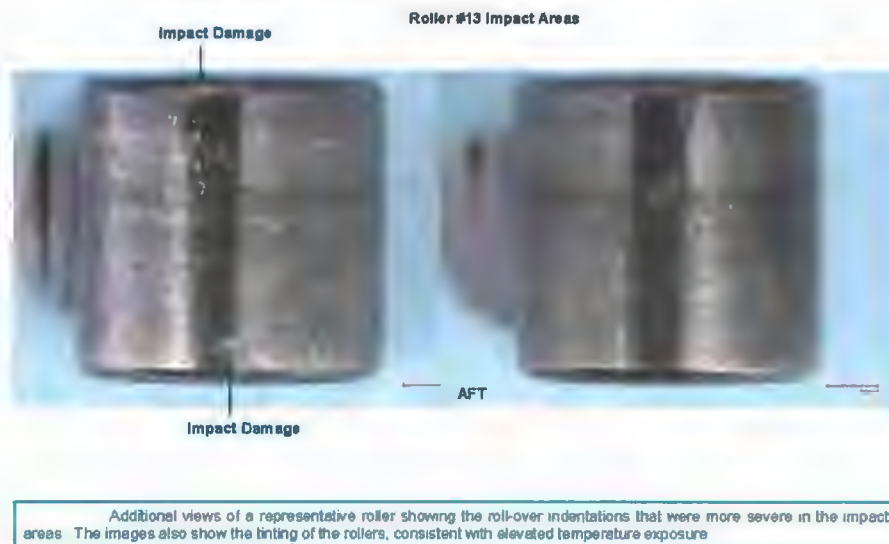
Figure 16: Roller Bearings with Indentations (Tab J-67)

The adjacent roller bearing cage, the bearing forward of the ball bearing, was intact with silver present, but the rollers and raceway showed surface indentations consistent with debris roll-over damage from the adjacent ball bearing (Figure 16) (Tabs J-37, J-39, J-67). The rollers were tinted, consistent with elevated temperature exposure as well (Tabs J-37, J-39, J-67).

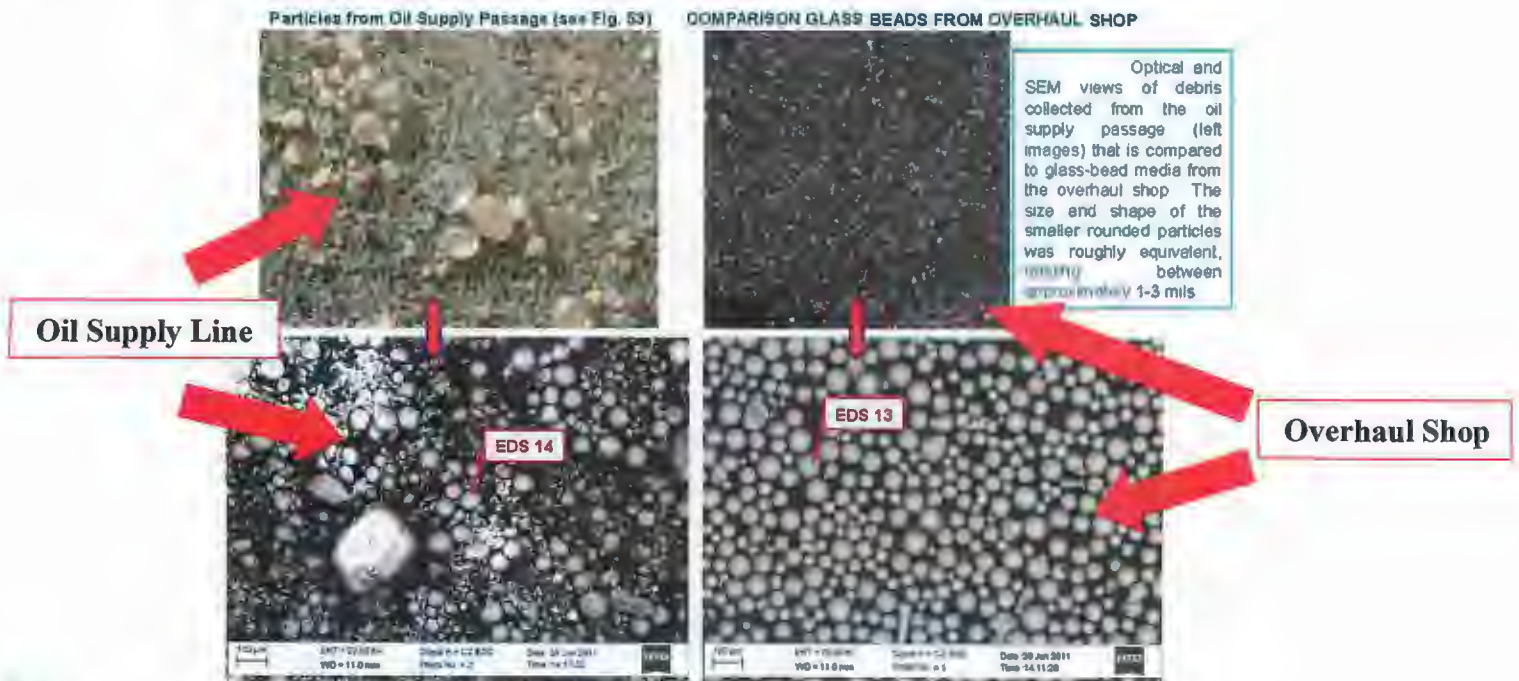
Figure 17: Glass-Bead Media (Tab J-103)

Analysis of filtered debris from the oil supply passage showed that in addition to particles consistent with dirt, sand, and AGB housing material were many particles that had size, shape, and compositional spectra similar to glass-bead media utilized in the AGB overhaul process (Figure 17) (Tabs J-37, J-102).

Supervision – Policy was found to be contributory in this mishap. T.O. 2J-F110-3-4 SWP 00517, *Depot Maintenance Manual, Cleaning and Stripping*, states “Cover all ports, cavities, and tube ends, when applicable, to prevent abrasives from entering areas where an accumulation would be difficult to detect or remove” (Tab BB-4). The “when applicable” guidance required the cleaning technician to determine when it was applicable to “cover all ports, cavities, and tube ends”, if at all, and also required the technician to determine where “an accumulation would be difficult to detect or remove.” A witness testified that he “never found it necessary to mask any ports” (Tab V-9.7). This ambiguous policy resulted in undetected glass-bead media remaining in the AGB assembly and was determined to be contributing factor in this mishap.

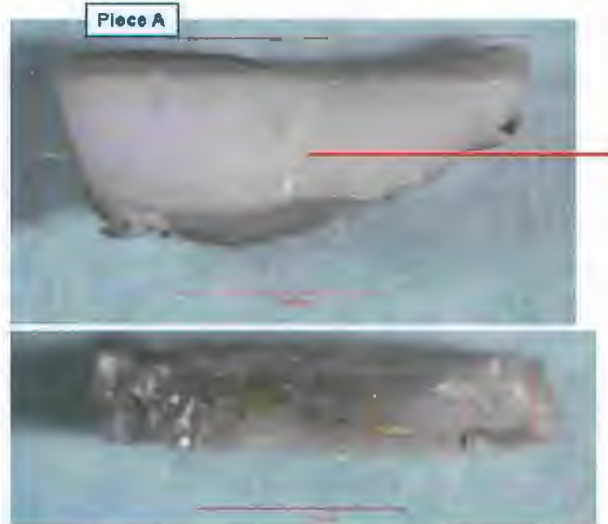
Figure 18: Teflon[®] Piece Close-Up (Tab J-102)

In addition, a piece of white debris consistent with Teflon[®] was found that was approximately 223 millimeters long by 44 millimeters thick and 82 millimeters wide (Figure 18) (Tab J-37 and J-102).

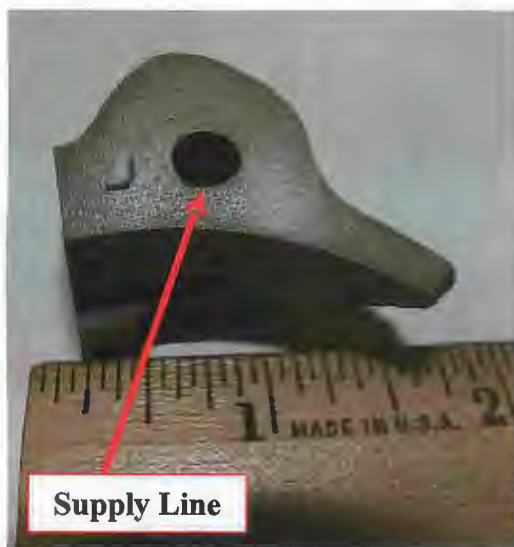
Figure 19: Teflon[®] at Supply Line (Tab Z-5)

As illustrated in Figure 19, the recovered Teflon[®] debris is small enough to travel freely through the 100 millimeter diameter oil supply line. However, the Teflon[®] debris was unable to exit through the 36 millimeter diameter oil supply nozzle as show in figure 20. The Teflon[®] debris is of unknown origin. Engineers testified that the Teflon[®] debris in combination with glass-bead media would be sufficient to clog the oil supply line (Tab V-8.4)

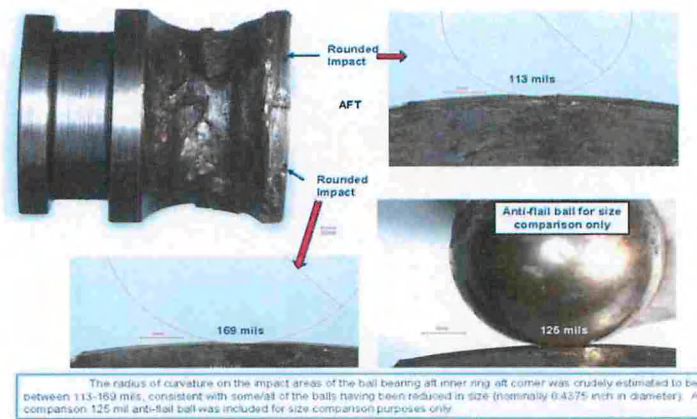
Figure 21: Ball Bearing Impact Comparison (Tab J-82)

GE summarizes their report with the following statement: “The quick bearing degradation time, the lack of observed M50 chips, and the intact cage are characteristics most consistent with having been produced by inadequate lubrication. The intact cage that was found outside of the outer ring assembly and the rounded indentations on the aft side of the ball inner ring were consistent with some/all of the balls having been reduced in size (Figure 21). The loss of ball/inner ring material, the rub damage in adjacent parts, and the fracturing of the bevel gear teeth tips, are all consistent with damage produced by loss of the ball bearing that allowed the shaft to move forward and eventually disengage from the bevel gear” (Tab J-37).
