UNITED STATES AIR FORCE
AIRCRAFT ACCIDENT INVESTIGATION
BOARD REPORT

F-16C, T/N 85-1413

422d TEST AND EVALUATION SQUADRON
53RD WING
NELLIS AIR FORCE BASE, NV

DATE OF ACCIDENT: 28 JUNE 2011

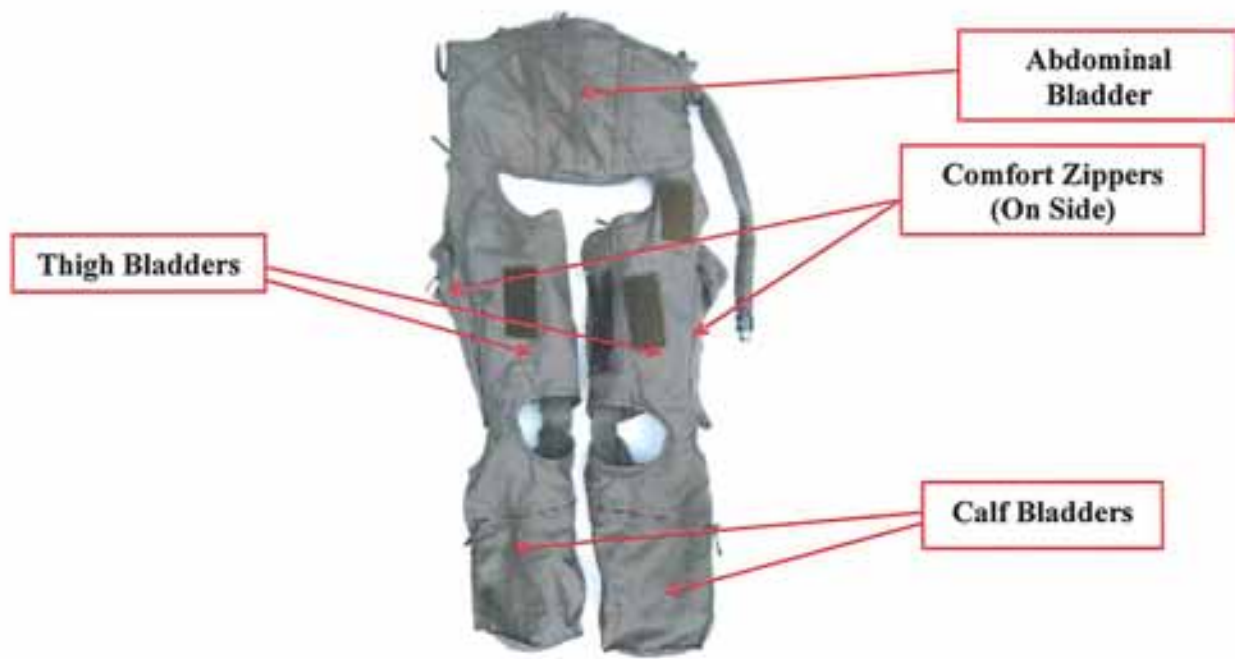
CSU-13 B/P Anti-G Garment

The CSU-13B/P G-suit contains 5 air bladders that cover the legs and abdominal area (see below). The G-suit automatically inflates as needed with pressurized air through a hose connected to the aircraft. It assists the pilot in managing G forces by preventing blood from pooling in the legs under Gs. The suit starts to inflate at 2 Gs and increases pressure as the Gs

increase. The G-suit reduces the amount of blood flow to the legs, which helps maintain positive blood flow to the eyes and brain. This suit increases G tolerance by approximately 1 G.

The MP's G-suit waist zipper was found at the mishap site. The two snaps were still snapped together and the bottom of the zipper was still engaged. This indicates that at the time of mishap, the waist zipper was properly closed. A G-suit comfort zipper in the closed position was also found; however it could not be determined whether it came from the left or right leg of the G-suit. Nevertheless, this indicated that the G-suit was worn properly during the flight. (Tabs H-10 thru H-11)
