**UNITED STATES AIR FORCE**  
**AIRCRAFT ACCIDENT INVESTIGATION**  
**BOARD REPORT**

**A-10C, T/N 80-0282**  
**75TH FIGHTER SQUADRON**  
**MOODY AIR FORCE BASE, GEORGIA**

**DATE OF ACCIDENT: 26 SEPTEMBER 2011**

**BOARD PRESIDENT: COLONEL DOUGLAS H. STANDIFER**

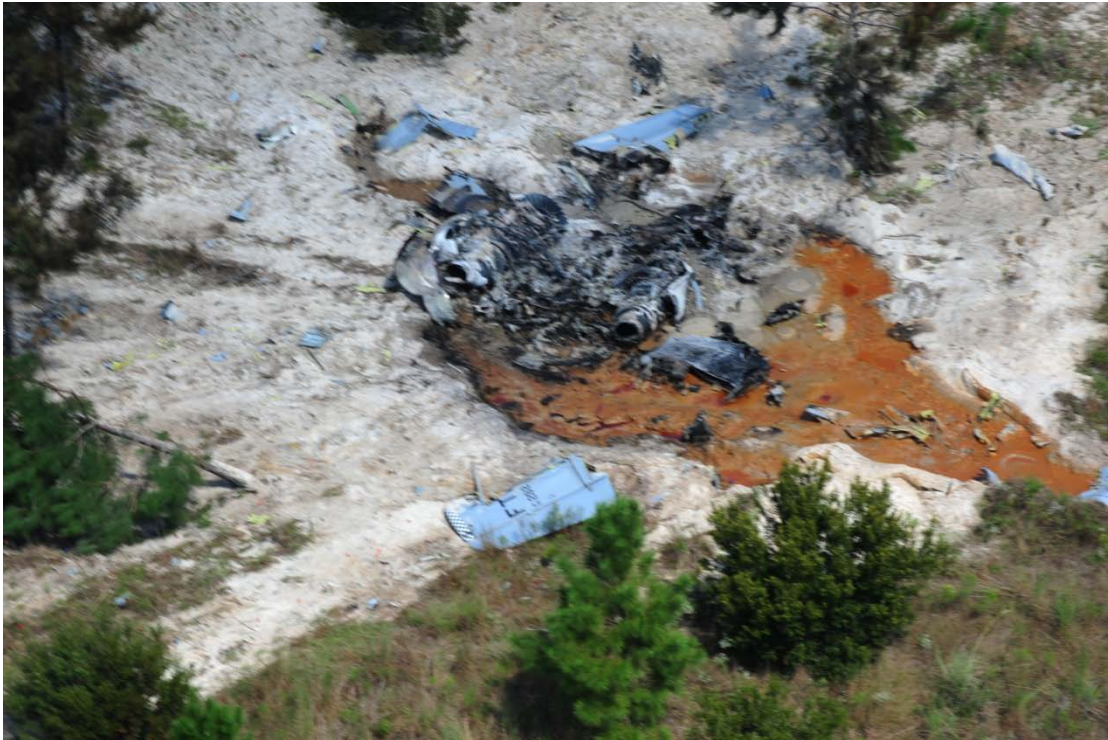
Figure 1. MA at Crash Site

The MA impacted the terrain (See Figure 1) at approximately 1448L about 20 miles northwest of Moody AFB (Tab B-3). The MA was in a clean unarmed configuration for the FCF profile. The impact location was a sandy swamp area, sparsely covered by pine trees (Tab S-5 to S-6).

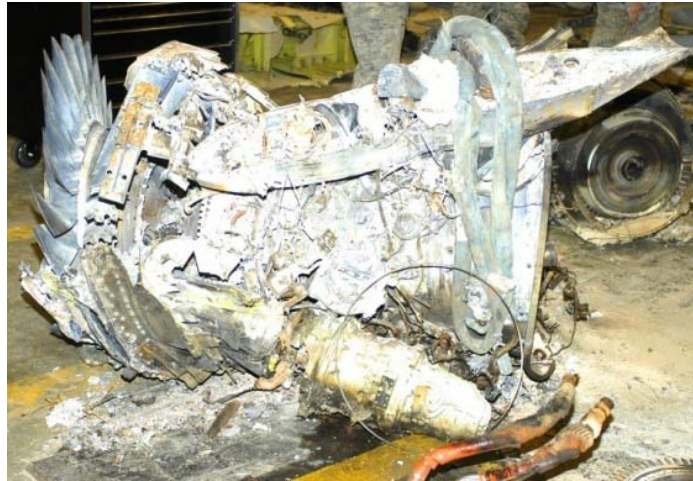
Figure 2. Engine #1

All iron components of Engine #1 (See Figure 2) were oxidized due to the heat from the fire and subsequent water immersion (Tab DD-5). The damage to the spinner, compressed against the front of the fan disc, indicates that the engine impacted the ground nose first, exposing portions of the engine to pooling of molten aluminum. From behind the engine looking forward, the fan blades in the 4 to 6 O'clock positions were broken at the platform, while the fan blades in the 6 to 8 O'clock position were buckled (Tab DD-6).

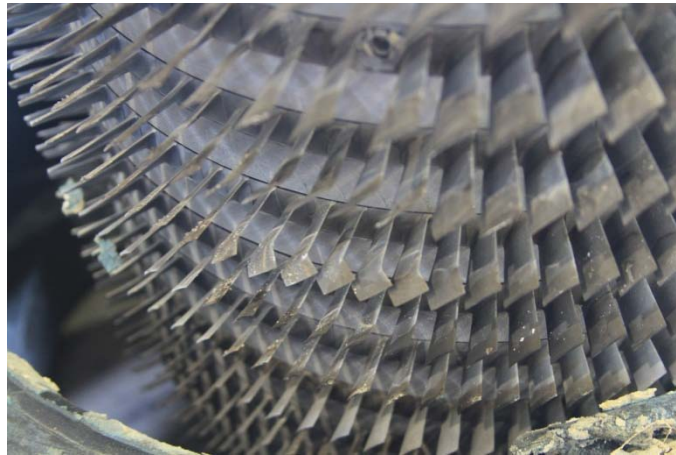
Figure 3. Engine #1 Compressor Blades

Most compressor blades (See Figure 3) had water stains and discoloration, most likely caused by sediments in the crash site water. Some of the compressor blades were damaged, but the physical evidence reveals the damage occurred on impact and was not causal to the mishap (Tab DD-8 to DD-10).

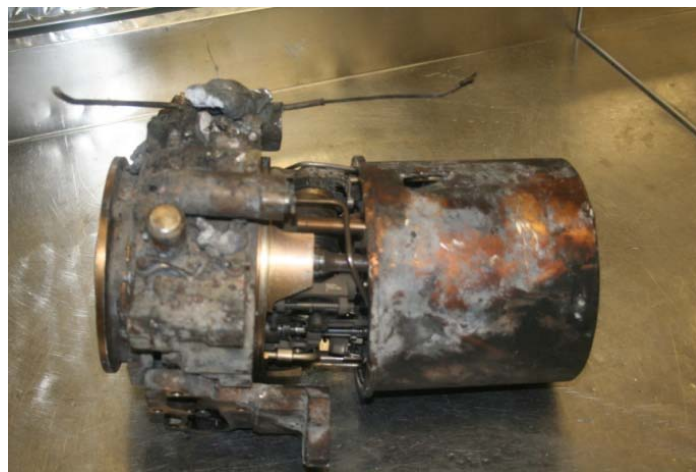
Figure 4. Engine #1 MFC

The accessory gear box fractured in multiple locations with only the Integrated Drive Generator still attached. The starter gear assembly was bent, but no torsional shear was indicated (Tab J-6). The Main Fuel Control (MFC) (See Figure 4) was taken to the fuel control overhaul facility at Fleet Reserve Center Southeast at Jacksonville Naval Air Station, Florida for disassembly and analysis. A analysis of the MFC depicts that there was a core speed of 20-21%, but this data neither conclusively supports nor disproves whether the engine was actually running (Tab DD-5, DD-11 and DD-19).

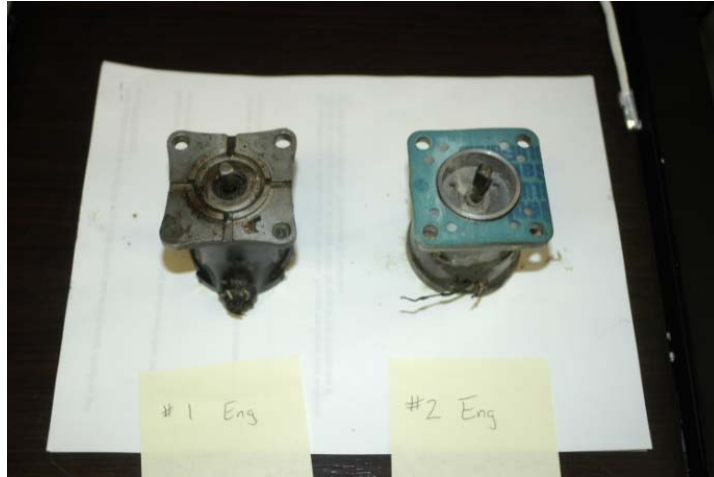
Figure 5. Tachometer Generators

The Tachometer Generator (See Figure 5) had impact damage to its case. However, the shaft was intact and it rotated freely (Tab DD-11).

The Tachometer Generator (See Figure 5) had impact damage to its case. However, the shaft was intact and rotated freely (Tab DD-18).

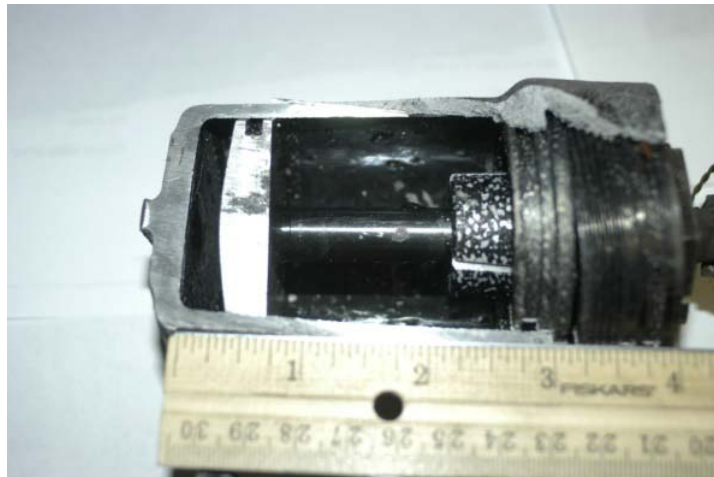
Figure 6. Engine #1 VG Actuator

One VG actuator was found for Engine #1. The TF-34 engineer disassembled the VG actuator (See Figure 6) and determined it to be closed at the time of impact, which implies that the engine core was turning at low or no RPM (Tab DD-12).

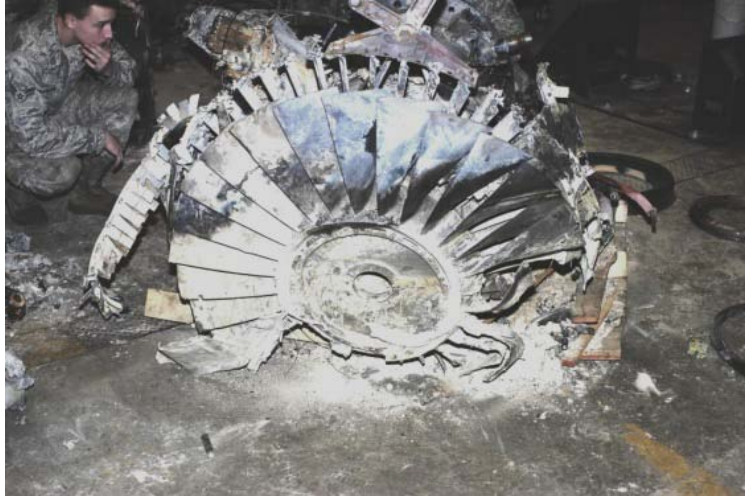
Figure 7. Engine #2

Engine #2 ( See Figure 7) suffered extensive damage in the crash, but was not exposed to temperatures as high as Engine #1. All iron components were oxidized. While some composite portions of the fan case were destroyed in the post-crash fire, some portions were intact. From behind the engine looking forward, the fan blades in the 5 to 7 O'clock positions were broken at the platform or below, while the fan blades in the 3 to 5 O'clock position had buckled. The front frame received significant damage; however, it was not melted (Tab DD-12 to DD-13).

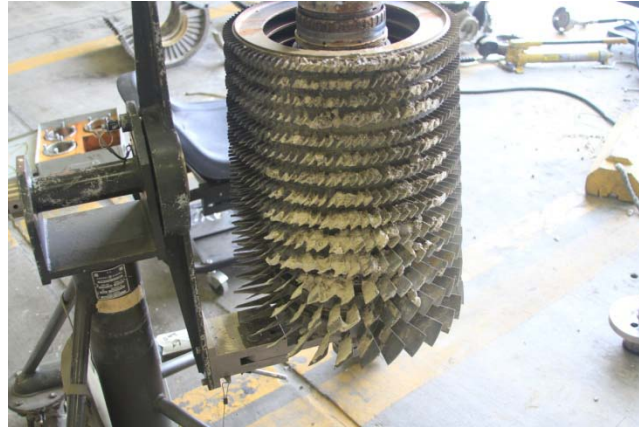
Figure 8. Engine #2 Compressor

Most compressor blades (See Figure 8) had stains due to mud and water, but the physical evidence shows no significant blade damage (Tab DD-16).

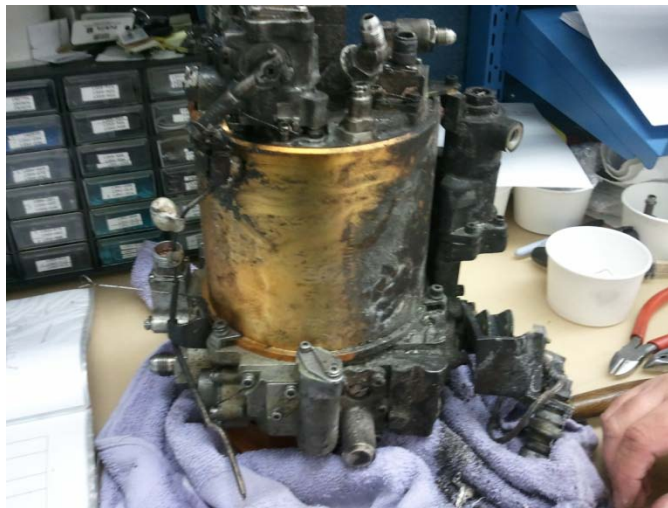
Figure 9. Engine #2 MFC

The starter gear assembly is bent but no torsional shear is noted. The MFC (See Figure 9) was taken to the fuel control overhaul facility at Fleet Reserve Center Southeast at Jacksonville Naval Air Station for disassembly and analysis. A analysis of the MFC depicts that there was a core speed of 36-37%, but this data neither conclusively supports nor disproves whether the engine was actually running (Tab DD-5, DD-16 and DD-19).

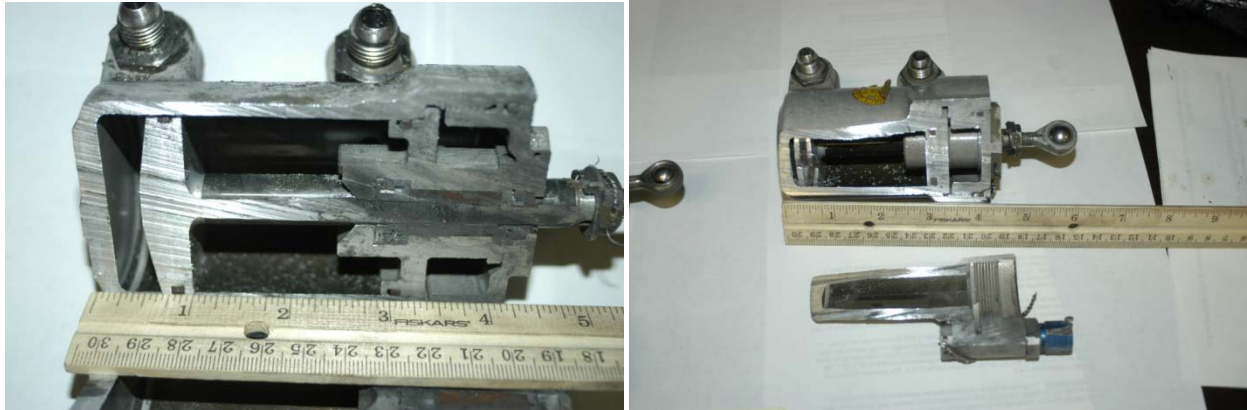
Figure 10. Engine #2: VG Actuator 1 (Left) and VG Actuator 2 (Right)

Both VG actuators were found for Engine #2. The TF-34 engineer disassembled the VG actuators (See Figure 10) and determined them both to be closed at the time of impact, which implies that the engine core was turning at low or no RPM (Tab DD-17).

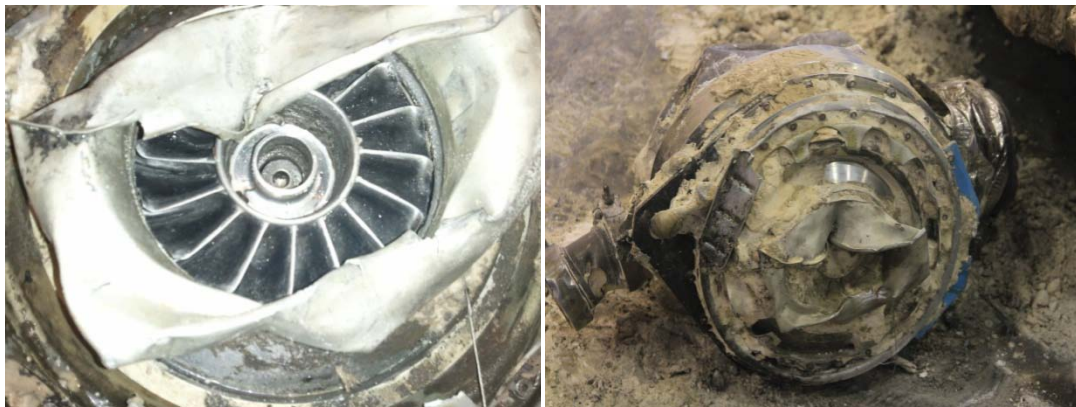
Figure 11. APU Turbine w/dirt removed (Left) and Remains of the APU (Right)

The APU (See Figure 11) was severely damaged by crash forces. The MP testified that the APU gauges indicated it was fully powered when turned on during the mishap flight. (Tab V-1.5 to V-1.6). In addition, an aerospace engineer from the Ogden Air Logistics Center reviewed the MP's testimony, photos of the mishap APU and the technical evaluations of the MA engines conducted during the Safety Investigation Board and the AIB. The aerospace engineer certified that the APU was fully functional at the time of the mishap (Tab DD-3).
