UNITED STATES AIR FORCE
AIRCRAFT ACCIDENT INVESTIGATION
BOARD REPORT

CV-22B, T/N 08-0037

LOCATION: Kandahar Air Base, Afghanistan

DATE OF ACCIDENT: 11 October 2011

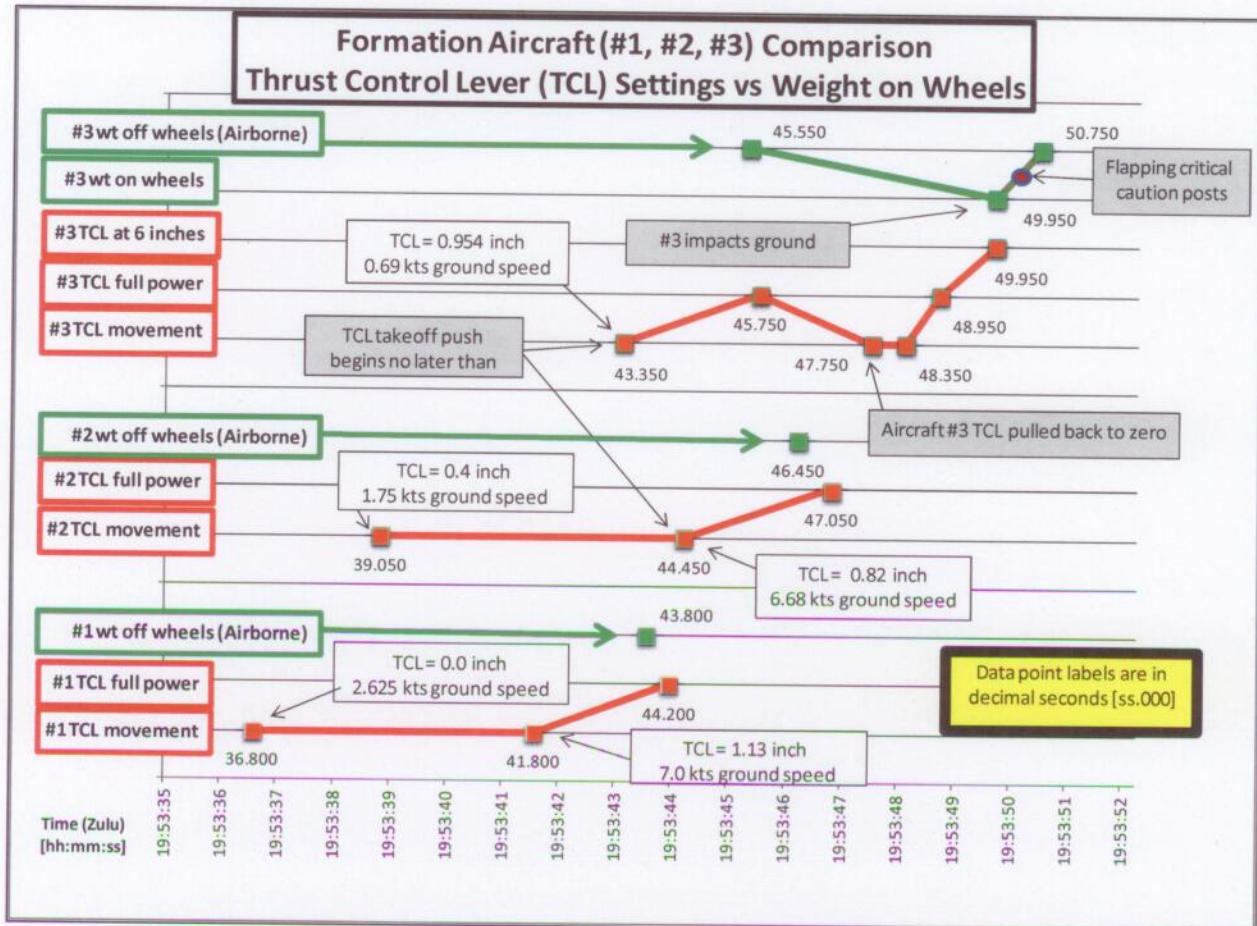
Figure 1 – Comparison of TCL and Weight on Wheel data of Mishap Formation

The below figure utilized comparison of Aircraft Maintenance Event Ground Station (AMEGS) TCL and weight on wheel data to graphically display the sequence of events during the mishap. A detailed description of this figure's data can be found in Tab EE (EE-24).
