UNITED STATES AIR FORCE  
**AIRCRAFT ACCIDENT INVESTIGATION**  
**BOARD REPORT**

**TARS, T/N 4220**  
**MARFA, TEXAS**

**DATE OF ACCIDENT: 14 FEBRUARY 2012**

**EXECUTIVE SUMMARY**  
**AIRCRAFT ACCIDENT INVESTIGATION**  
**TARS, T/N 4220, Marfa, Texas**  
**14 February 2012**

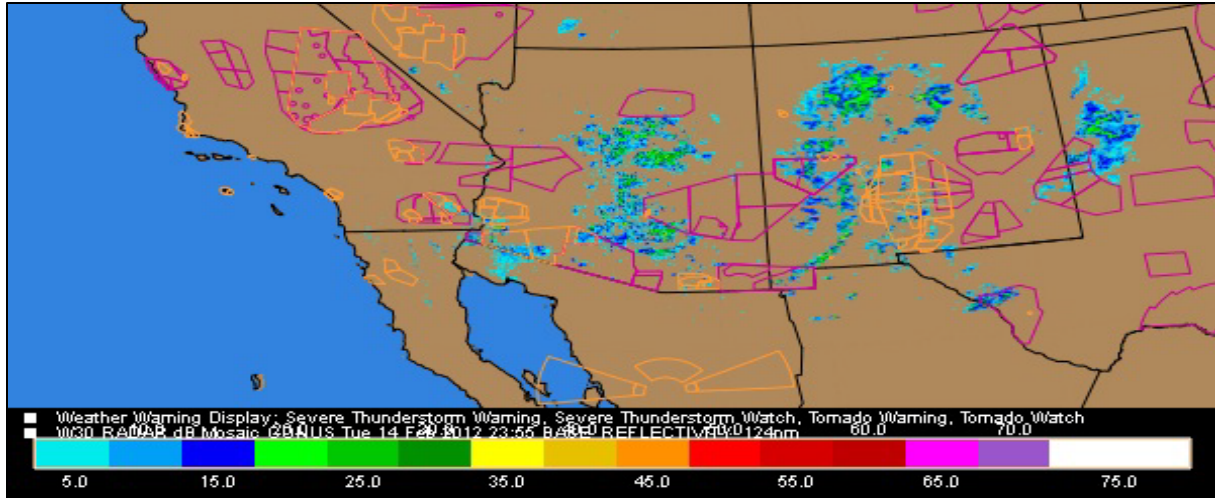
**Figure 7.8 NEXRAD Composite Reflectivity**

The Marfa TARS is equipped with a Doppler Radar. A Doppler Radar picture indicates approaching rain showers located to the northwest of Marfa TARS, moving southeast. (Tab W-76, Figure 7.1) Although none of the thunderstorm clouds reach the Marfa TARS, virga (rain that does not reach the ground) could be seen in the distance on video to the northwest (Tabs S-55, V-8.3)
