**UNITED STATES AIR FORCE
AIRCRAFT ACCIDENT INVESTIGATION
BOARD REPORT**

F-16CM, T/N 90-0771

**36TH FIGHTER SQUADRON
51ST FIGHTER WING
OSAN AIR BASE, REPUBLIC OF KOREA**

**LOCATION: HWACHON-RI, HWAYANG-MYEON, SEOICHEON,
CHUNGCHEONGNAM, REPUBLIC OF KOREA
DATE OF ACCIDENT: 21 MARCH 2012
BOARD PRESIDENT: LIEUTENANT COLONEL WILLIAM R. JONES**

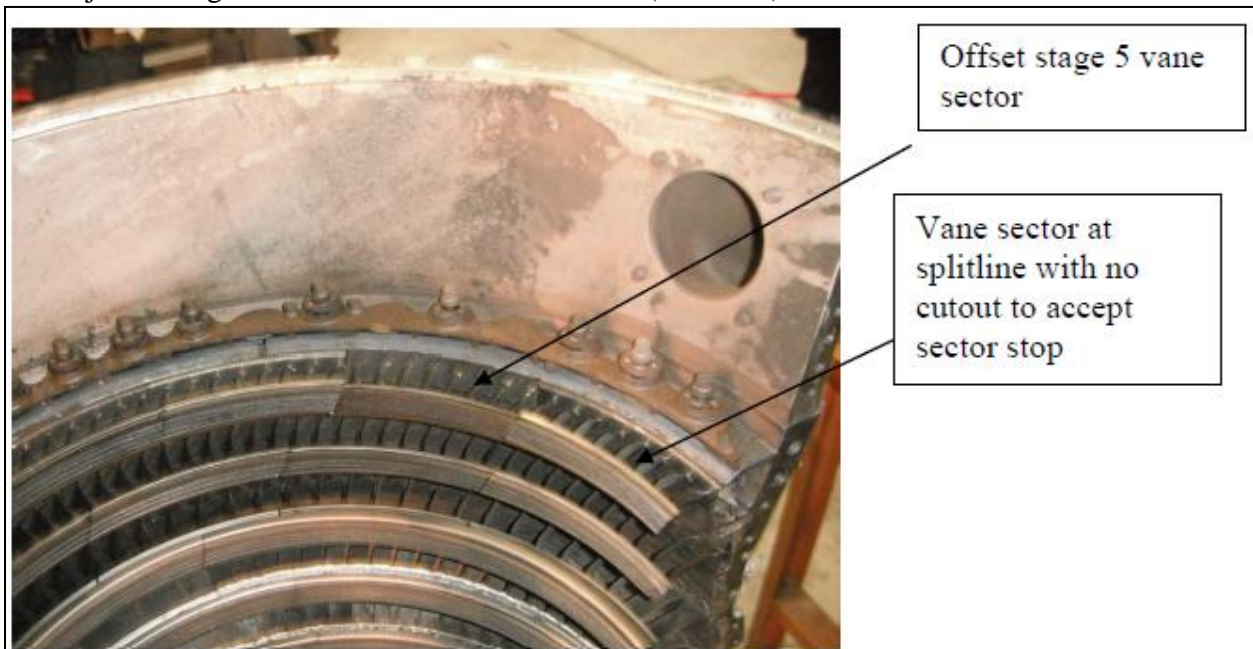
The lower and upper outer fan ducts were moderately damaged with buckling and holes due to the impact (Tab J-23). The exterior of the forward stator case assembly exhibited no signs of damage (Tab J-24). Stage 1 vane sectors had damage to the leading edge on several vanes with no trailing edge damage (Tab J-24). Stage 2 sector vanes had minor nicks on both the leading and trailing edges (Tab J-24). Stage three vanes showed heavy damage on the leading edges and minor damage on the trailing edges (Tab J-25). Stage 4 vane sectors exhibited much more damage on the trailing edges than the damage noted on the stages forward of stage 4 (Tab J-25). Uniform damage was identified in the form of large tears and nicks along the outer diameter of the stage 4 vane sectors (Tab J-25). One of the stage 5 vane sectors was found offset from the two adjacent stage 5 vane sectors as shown below (Tab J-25).

Forward case with two incorrectly installed stator vane sectors (Tab J-25)

The offset stage 5 vane sector was turned 180 degrees in the radial direction, that is to say it was found installed 180 degrees out from its designed position. The offset sector has a cutout to accept the anti-rotation stop whereas the vane sector installed at the 3 o'clock splitline did not have a cutout for this stop (Tab J-25). This indicates that not only was the vane sector installed 180 degrees out but the positions of these two stator vane sectors were incorrect.

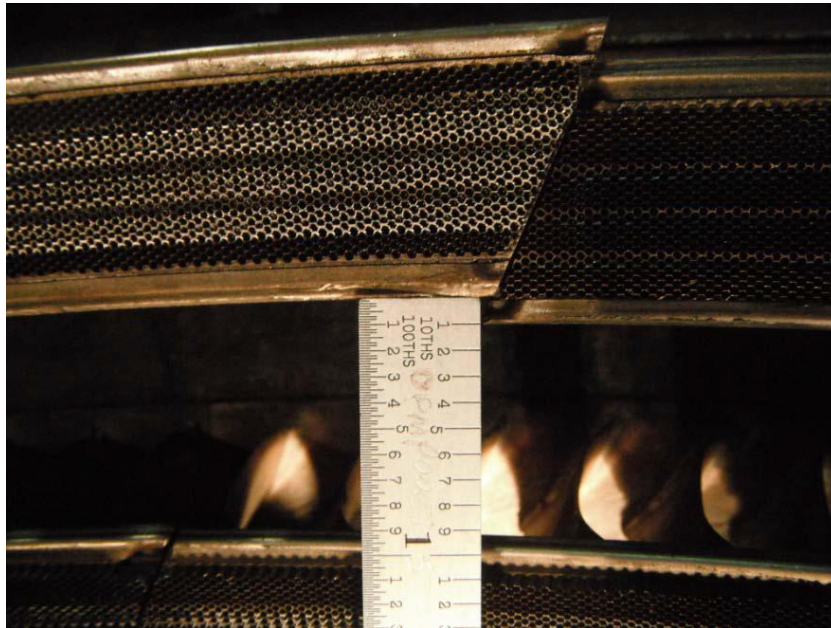
The incorrectly installed sector extended forward approximately 0.1 inch into the stage 5 compressor blade area as shown below (Tab J-25).

Offset vane sector extending forward 0.1 inch (Tab J-26)

All stage 5 vanes showed significant damage on both the leading and trailing edges (Tab J-26).

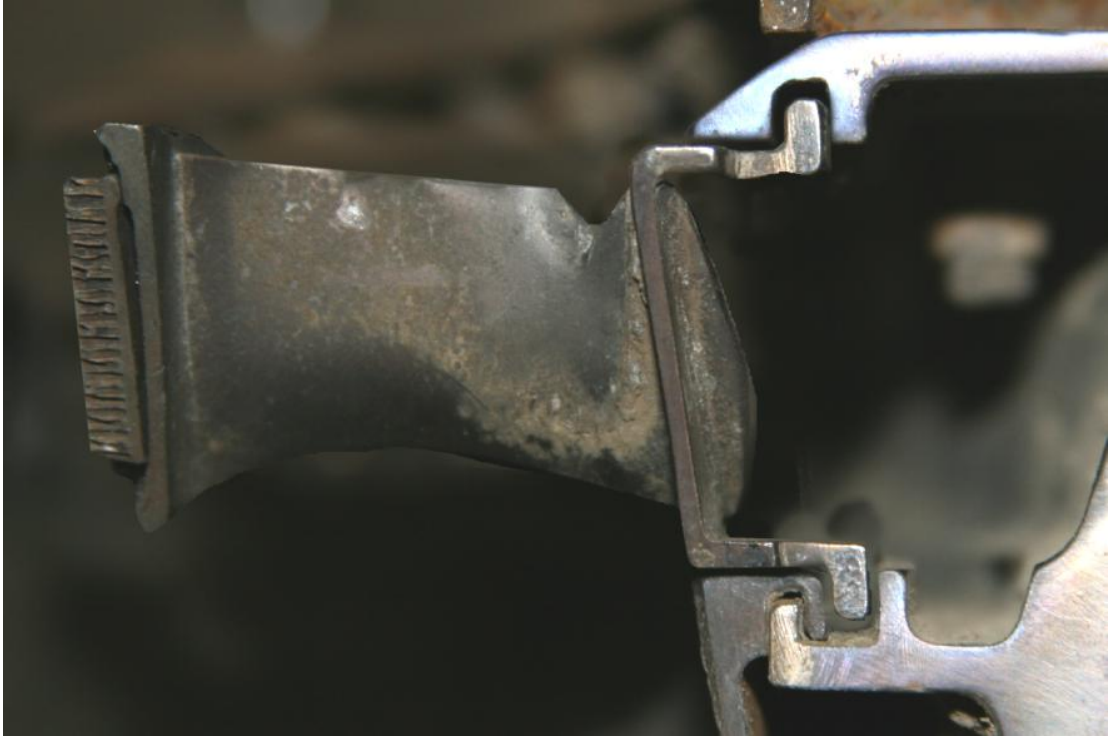
Correctly Installed Stator Vane Sector

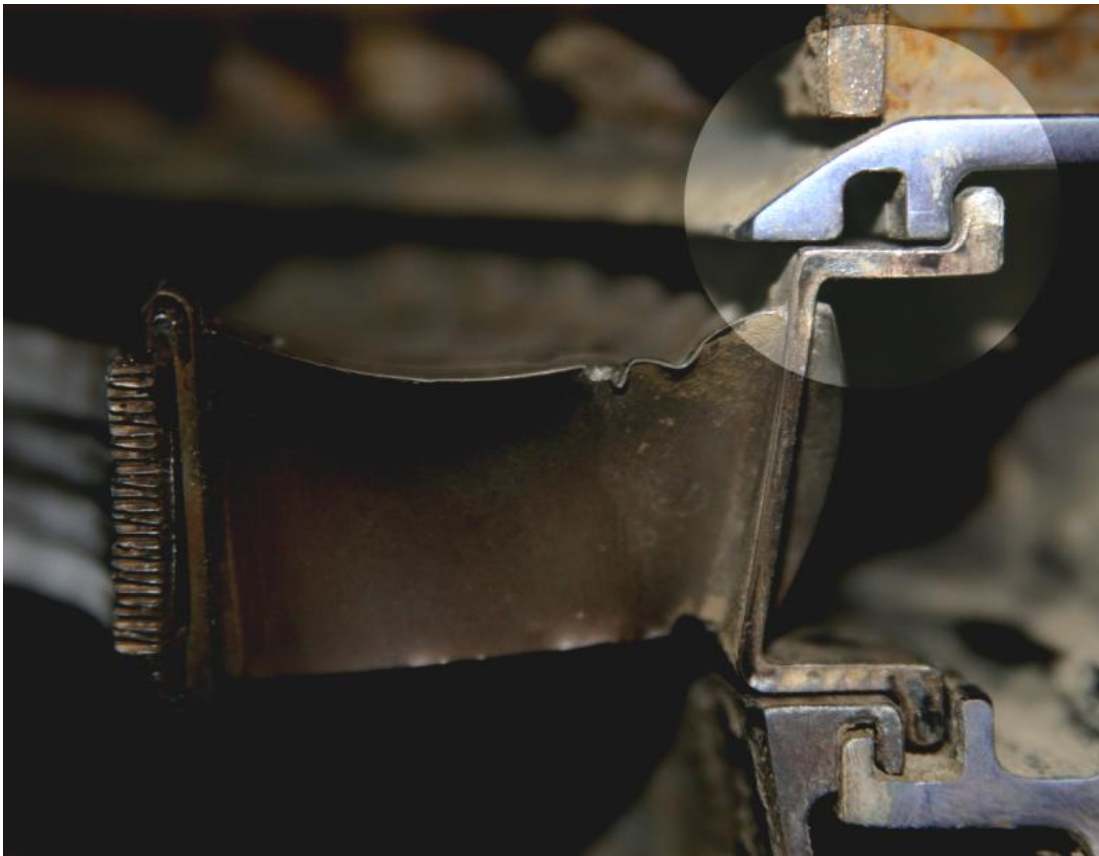
The aft compressor case showed severe damage on both leading and trailing edges (Tab J-26). For the compressor rotor, stages 1-4 were all intact with damage on the leading and trailing edges (Tab J-26). Stage 5 blades of the compressor rotor showed extreme damage and four stage 5 blades were liberated (Tab J-26). Metallurgical examination revealed that all four blades fractured in fatigue with features consistent with low-alternating stress, high-cycle fatigue (Tab J-46). Of the four liberated blades, two were liberated based on the vibrat~~ion~~pp-induced loading while the other two were liberated based on the subsequent stall (Tab J-46). The first two blades to liberate were shown to have a crack initiating from a small impact at the leading and trailing edges (Tab J-46). This is consistent with the bead damage that the ME was originally removed for and routed to JEIM for repair (Tab U-51). Inconsistent pressure within the compressor section resulting in pressure pulsing would be one of the effects of an improperly installed stator vane sector in stage 5 (Tab U-153).

Incorrectly Installed Stator Vane Sector

I find by clear and convincing evidence that the primary cause of the accident was an incorrectly installed stage 5 stator blade sector, brought about by an inadvertent operation and procedural error, which occurred during maintenance on the Mishap Engine. I further find by a preponderance of evidence that procedural guidance substantially contributed to the mishap by failing to instruct maintenance members with suitable detail in the manner in which the error could occur as well as failing to represent the magnitude of the risk associated with the error.
