UNITED STATES AIR FORCE
AIRCRAFT ACCIDENT INVESTIGATION
BOARD REPORT

F-15E, T/N 90-0235
391ST FIGHTER SQUADRON
366TH FIGHTER WING
MOUNTAIN HOME AIR FORCE BASE, IDAHO

LOCATION: SOUTHWEST ASIA
DATE OF ACCIDENT: 28 MARCH 2012
BOARD PRESIDENT: BRIGADIER GENERAL
CHARLES L. MOORE, JR.
Conducted in accordance with Air Force Instruction 51-503

EXECUTIVE SUMMARY
AIRCRAFT ACCIDENT INVESTIGATION
F-15E, T/N 90-0235, SOUTHWEST ASIA
28 MARCH 2012

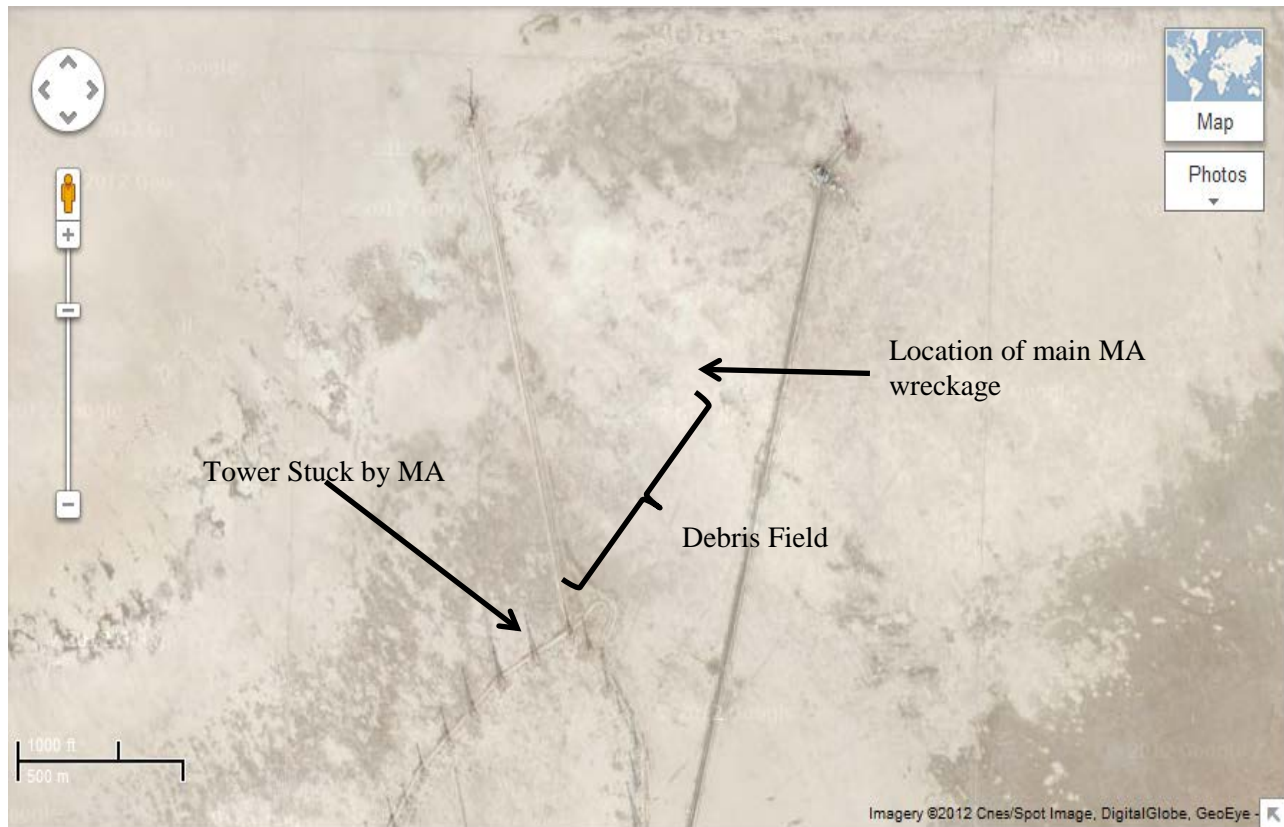
Figure 3. Mishap Site Location

The MA impacted the terrain at approximately 16:03:30Z about 18 NM west, southwest of the deployed location in Southwest Asia (Tabs H-2 and GG-8). The MA was in the same configuration at impact as it was prior to take-off (Tab GG-8). The MA struck a 377-foot tall radio tower and crashed approximately 0.5 NM northeast of the tower (Tab H-2). Based on the damage to the MA, it appears the right wing of the MA struck the radio tower (Tab J-3). The impacted radio tower was part of a large tower array just north of a major east-west running well-trafficked highway (Tab J-64).

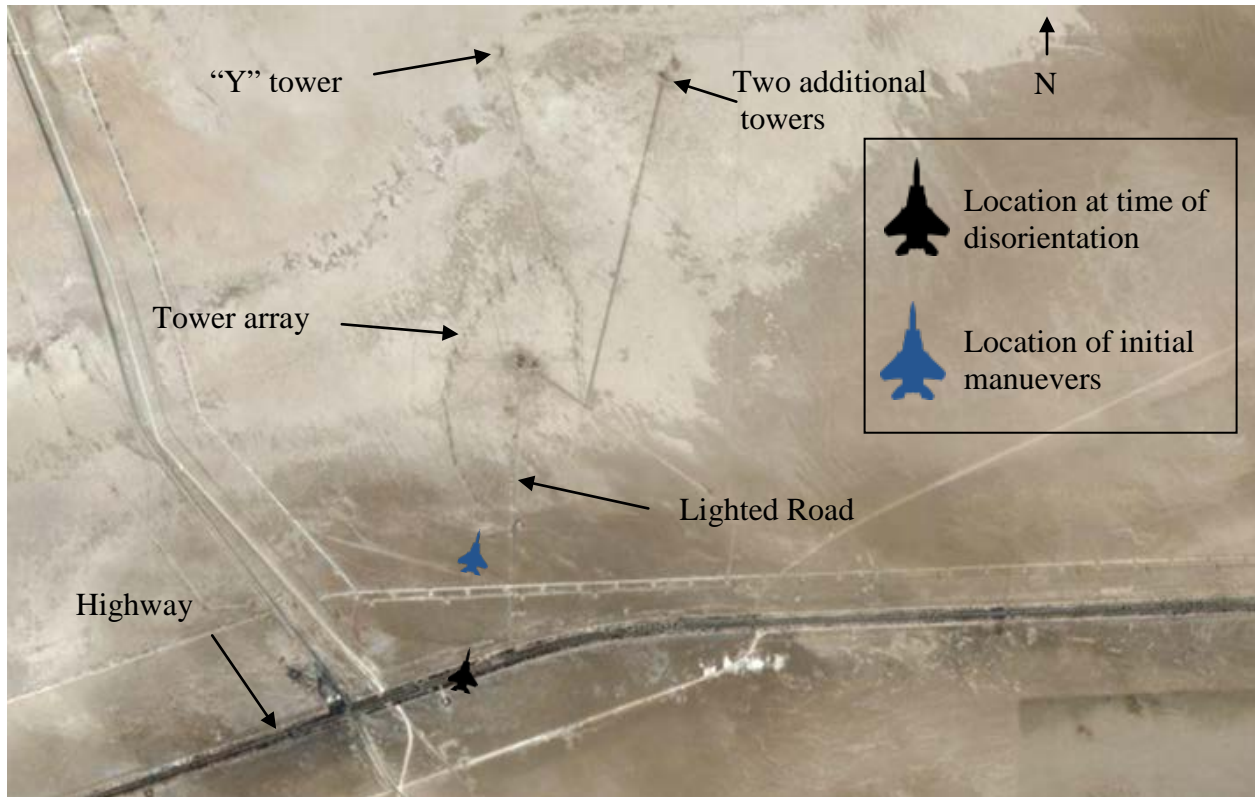
Figure 4. An aerial view of the mishap location

Witnesses described the night of the mishap as very dark with no discernable horizon. Additionally, the MP was briefed that the recovery arc would be dark with no cultural lighting. There were no discussions pertaining to highway lights or radio towers (Tab V-1.14 and V-3.9). The mishap occurred at an isolated radio tower array 18 NM west, southwest of the base (See Figure 4). This array forms a horseshoe shape and consists of 31 primary towers. These towers are of varying heights with the tallest being 377 feet in height (Tab Z-3). Each radio tower contains one or two closely spaced steady red lights at the top of the tower and two to four steady red lights at the midpoint (See Figure 5) (Tab EE-3 to EE-4). There is one distinct "Y" shaped tower 1,403.31 meters to the north of the main tower array (Tab Z-3). Directly east of this tower are two additional towers with buildings at their base. There are several buildings in the center of the tower array, which all have white security lights. A lighted road leads out of the horseshoe south towards a major east-west running well-trafficked highway (See Figure 4) (Tab EE-4 to EE-5).

Secondly, the MP may have perceived the tower lights located on left side of the array as a false horizon (Tab HH-3 to HH-5) (See Figure 4). The flickering lights of the highway would have entered the MP's peripheral vision at the same time the lights of the "Y" tower would have entered his focal vision. When the MP pushed the nose of the MA over in an attempt to orient himself to the "Y" tower's lights, the left line of tower lights would have also come into his focal view. The MP may have attempted to correct to this false horizon by placing the line of lights in the center of his vision and rolling left to situate the lights in a more traditional horizontal orientation.

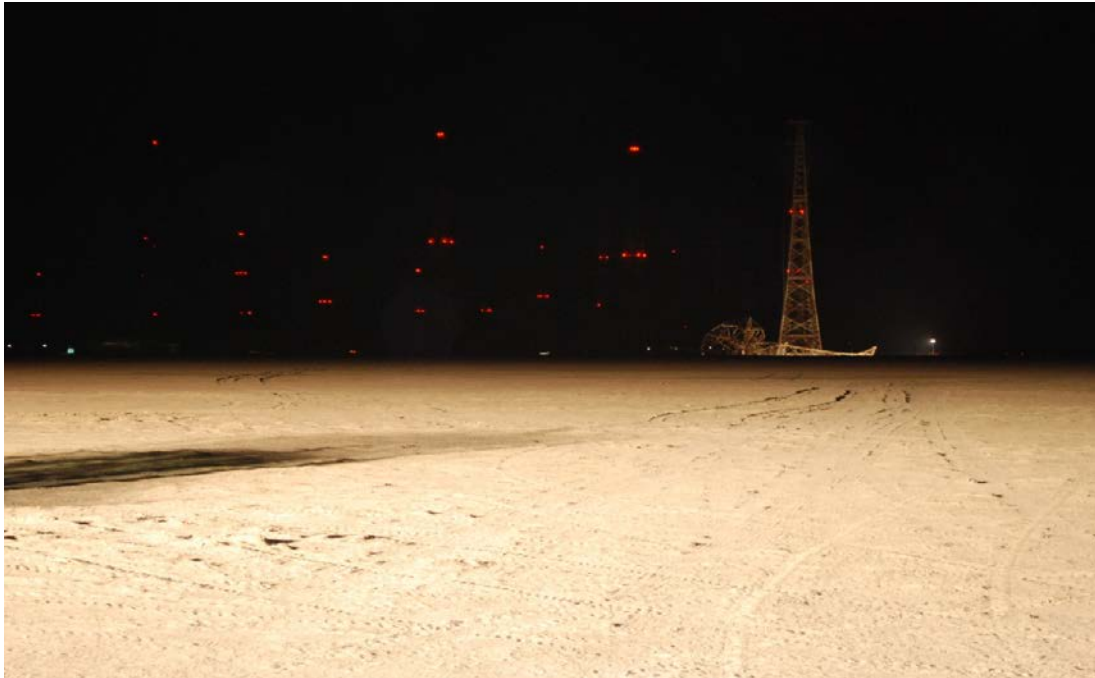
Figure 5. An image of tower lights at night with one to two red lights on top and two to four red lights midway up the tower (photographed on 5 April 2012)

First, the radio tower lights that came into the MP's focal view may have been perceived as the position lights of another aircraft (Tab HH-4). The MA was behind an aircraft on the recovery arc, which the MP had identified on the SIT(P). The expected location of the aircraft per the SIT(P) was left of the MA's midline just below the horizon (See Figure 8) (Tab GG-7). If the MP misinterpreted the two lights on top of the "Y" tower as that aircraft, then that image would have conflicted with what he expected because it appeared right of the MA's midline and 10 degrees low (See Figure 7). As a result, the MP incorrectly perceived the MA as inverted (See Figure 10).

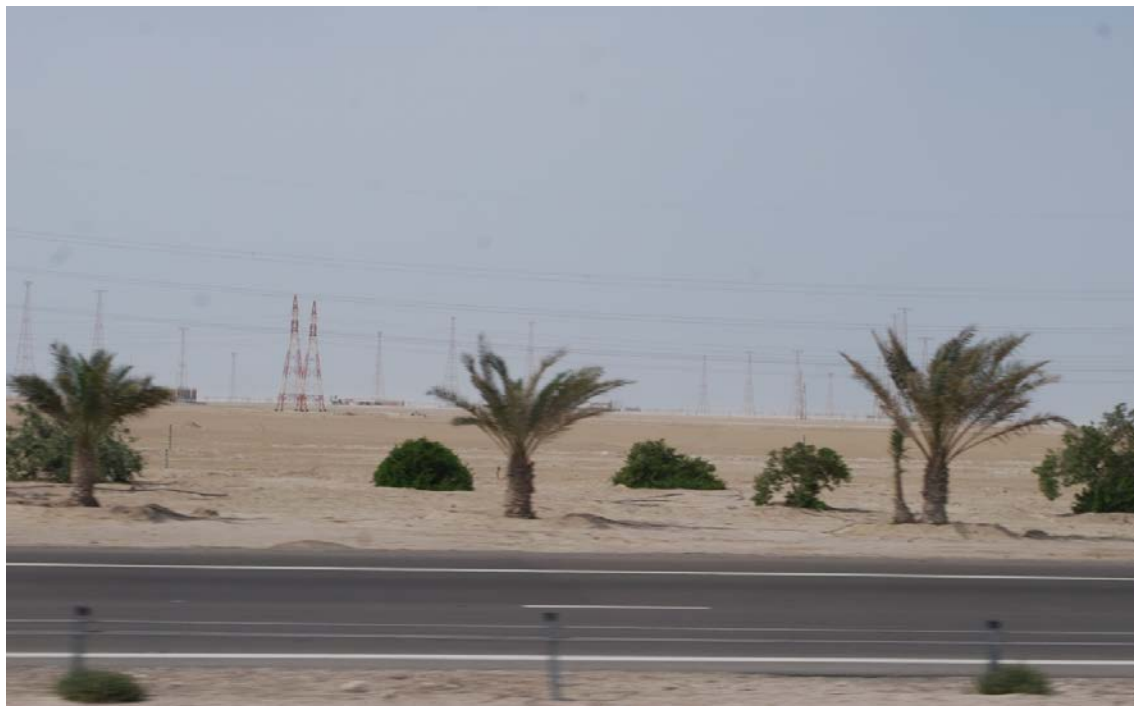
There is a heavily trafficked, lighted highway south of the radio tower array. There are palm trees planted at a set interval along the side of the highway, which causes a flickering image at night due to the headlights of passing vehicles (See Figure 6) (Tab V-6.10). In addition, many of the trucks commuting along this road have flashing yellow lights on the top of their freight (Tab R-5).

Figure 6. A view of the palm trees planted along the road. The radio tower array can be seen in the background.

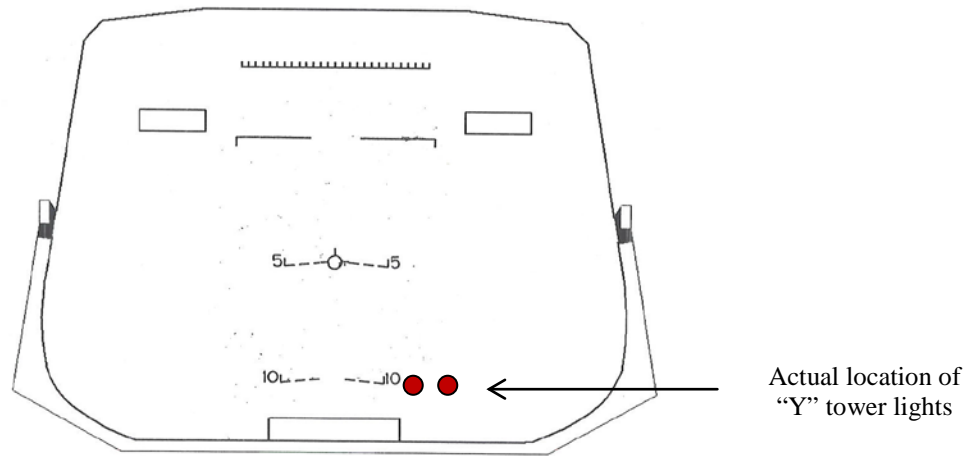
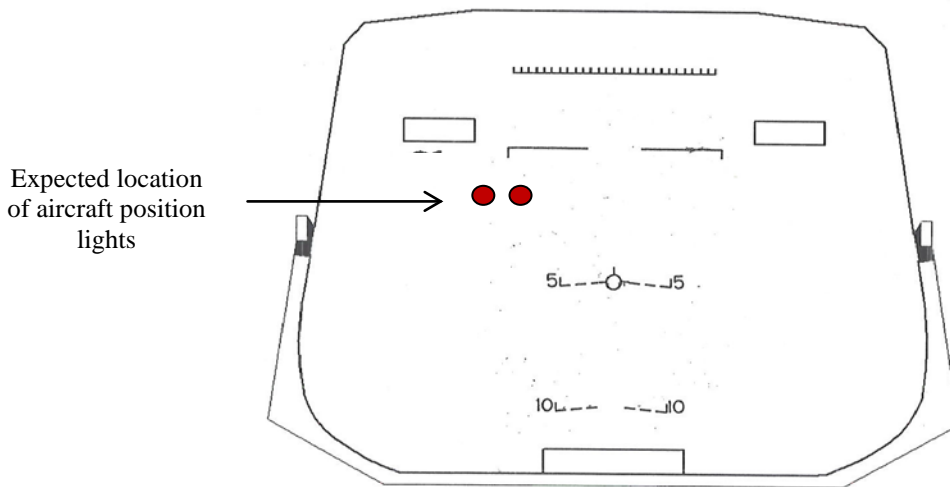
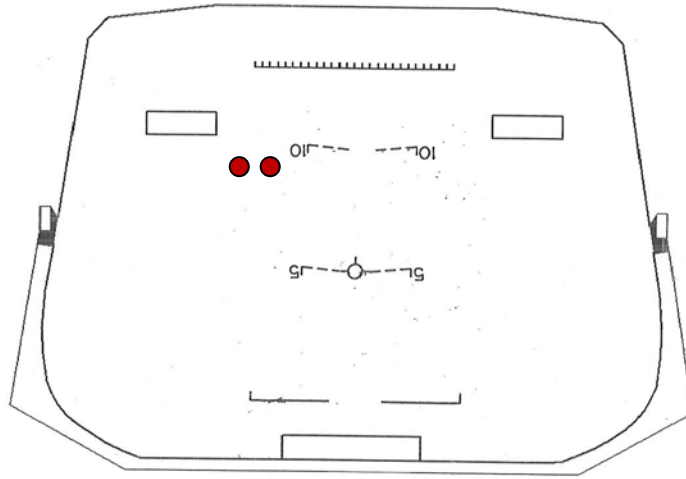
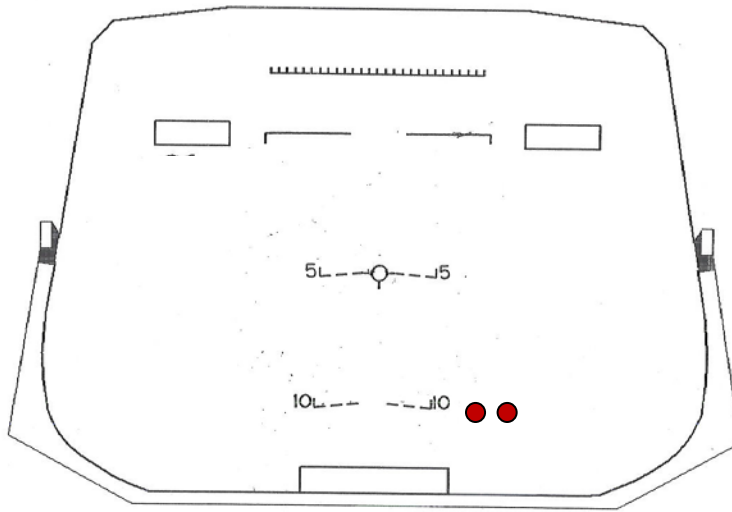
Figure 7. Actual representation of MA HUD

Figure 8. A representation of what the MP expected

Figure 9. A representation of the HUD if the MA was truly inverted

Figure 10. A representation of what the MP may have mistakenly perceived due to a visual illusion (inverted and five degrees nose low)

Based on what he was seeing on the SIT(P), the MP expected the aircraft in front of him to be to his left (Tab GG-7). A tower light misinterpreted as an aircraft would have appeared to be on the MP's right. This perceived inverted image of the expected scene, along with the peripheral lighting of the highway below, could have caused the MP to become disoriented (See Figures 7 to 10).

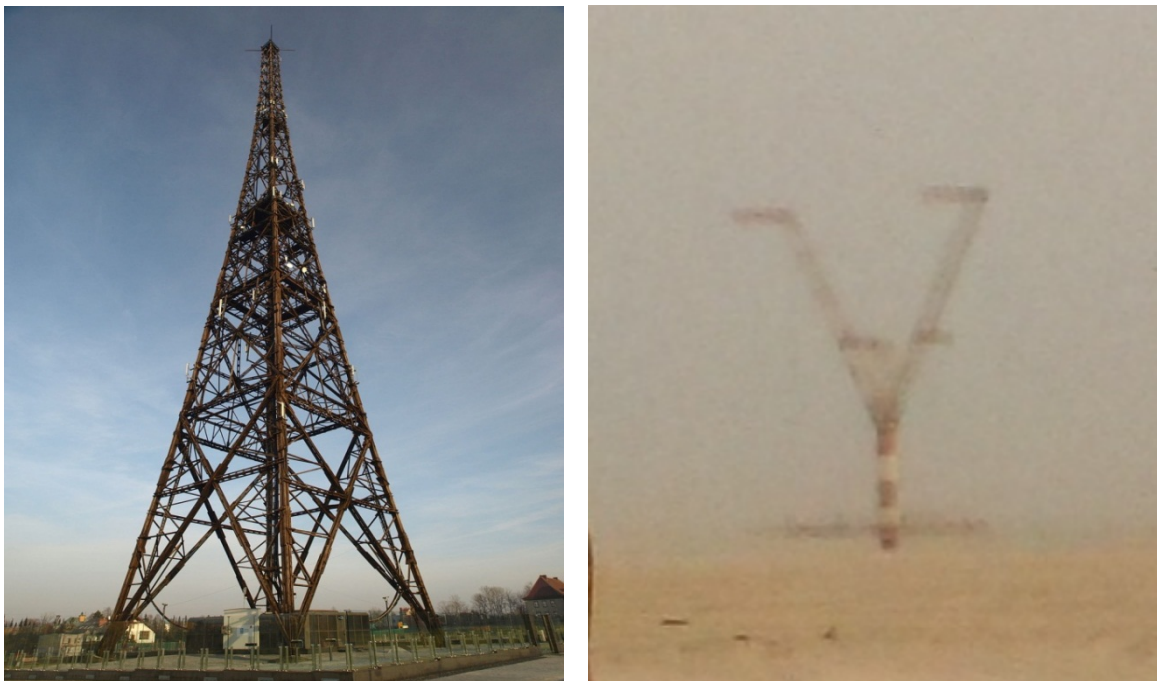
This would be due to the aforementioned highway lighting in his periphery and the atypical orientation of this isolated “Y” tower. This radio tower in the MP’s focal view would have been an unfamiliar shape, wide at the top and narrow at the bottom. A typical radio tower would be the opposite shape, with a wide base and a narrow top (Figure 11). Instead of realizing he was viewing an unusual “Y” shaped tower, the MP may have thought he was viewing a “typical” tower that appeared like a “Y” because he was inverted.

Figure 11. The left image shows a “typical” tower, wide at the bottom and narrow at the top. The right image shows the “Y” tower located north of the tower array.

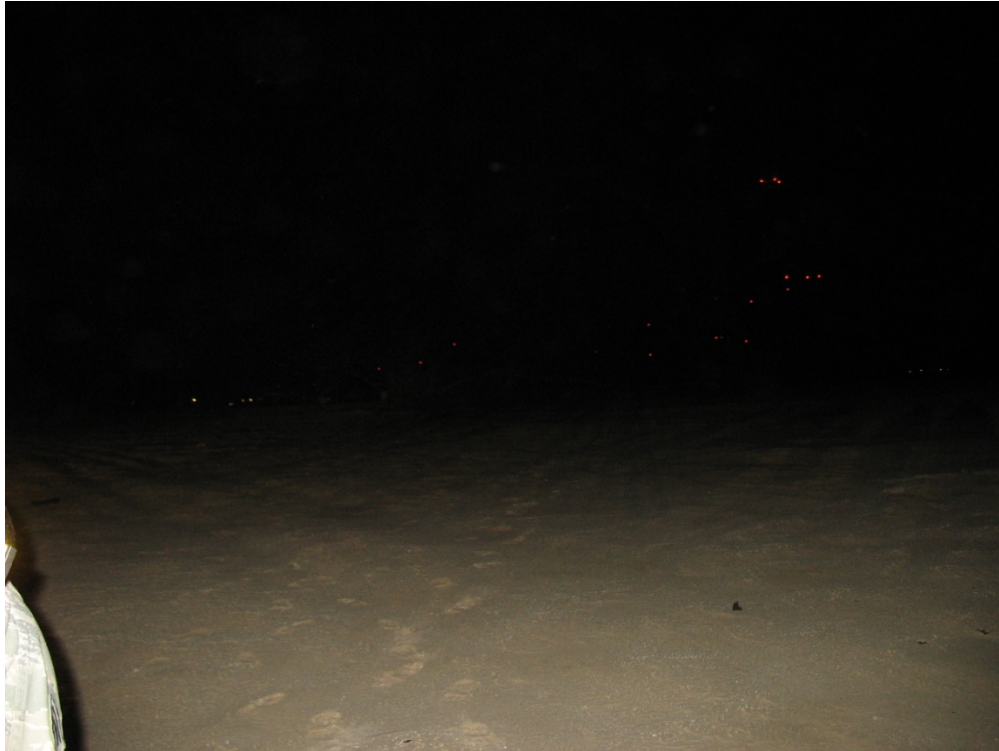
only point of reference for visual orientation. It is possible the MP based his false orientation solely on these lights due to the lack of reliable visual cues (e.g., horizon, city lights). It would have been difficult for the MP to maintain his attitude in this environment without an instrument crosscheck using the EADI or standby ADI.

Figure 12. Photograph of mishap location 28 March 2012. The foreground light was utilized by the recovery team and was not present at the time of the mishap.
