UNITED STATES AIR FORCE
AIRCRAFT ACCIDENT INVESTIGATION
BOARD REPORT

F-15E STRIKE EAGLE, T/N 90-0254
391st FIGHTER SQUADRON
366th FIGHTER WING
MOUNTAIN HOME AIR FORCE BASE, IDAHO

LOCATION: SOUTHWEST ASIA
DATE OF ACCIDENT: 3 MAY 2012
BOARD PRESIDENT: COLONEL HENRY L. CYR
CONDUCTED IAW AIR FORCE INSTRUCTION 51-503

F-15E STRIKE EAGLE, T/N 90-0254 SOUTHWEST ASIA 3 MAY 2012

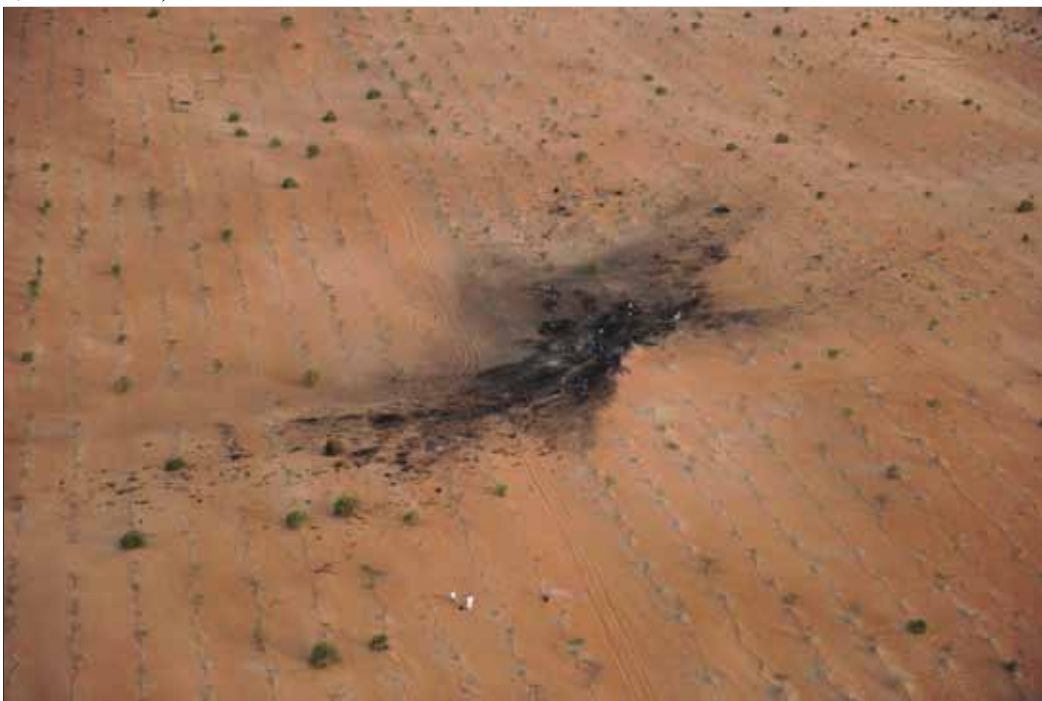
Upon impact, the aircraft created a scatter field measuring approximately 800 ft. by 1200 ft. (see fig. 3). The main wreckage consisted of a large crater with both engines still attached to the aircraft structure forward of the crater with both wings and left and right empennage sections nearby (see fig. 4). The forward and center fuselage sections were not identifiable at the wreckage site. The majority of the debris field was forward of the crater with small pieces of the wreckage surrounding the area in a radial pattern. Evidence of all flight control surfaces remained either installed or nearby to their respective airframe locations. (Tab J-45-53, H-105, J-88-110, J-225-276)

Fig. 3. Overview of Mishap Site (Tab S-4)

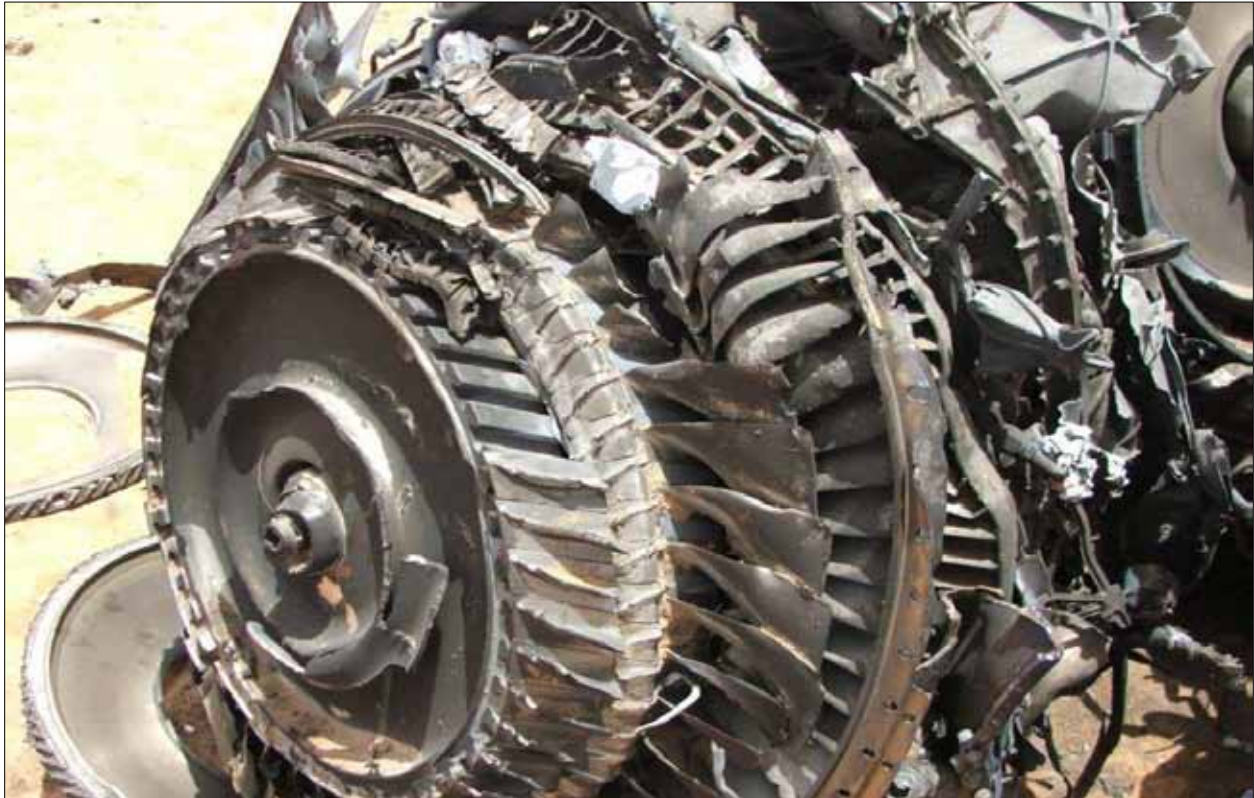
The number 2 engine (PW0E720172) showed evidence of a titanium fire in the compressor section. The engine was severed aft of the compressor split case, and evidence of the titanium fire was visible in the rear compressor section when reviewed at the mishap site. The engine was recovered and investigation focused on the Core Module and compressor section, and the hardware condition upstream of the compressor. (Tab J-88-110) The HPT and FDT were inspected internally using an Olympus iPlex borescope to establish the condition of these components. The IFM 2nd and 3rd stage blade disks remained with the rest of the engine (see fig. 5). There were numerous fan blades remaining in their respective positions in the 2nd and 3rd stage blade disks. (Tab J-88-110) Evidence from the IFM, HPT and FDT was used to determine the engine was wind milling at the time of impact. (Tab J-88-110)

Fig. 5. PW0E720172 Inlet Fan Module (Tab J-98)

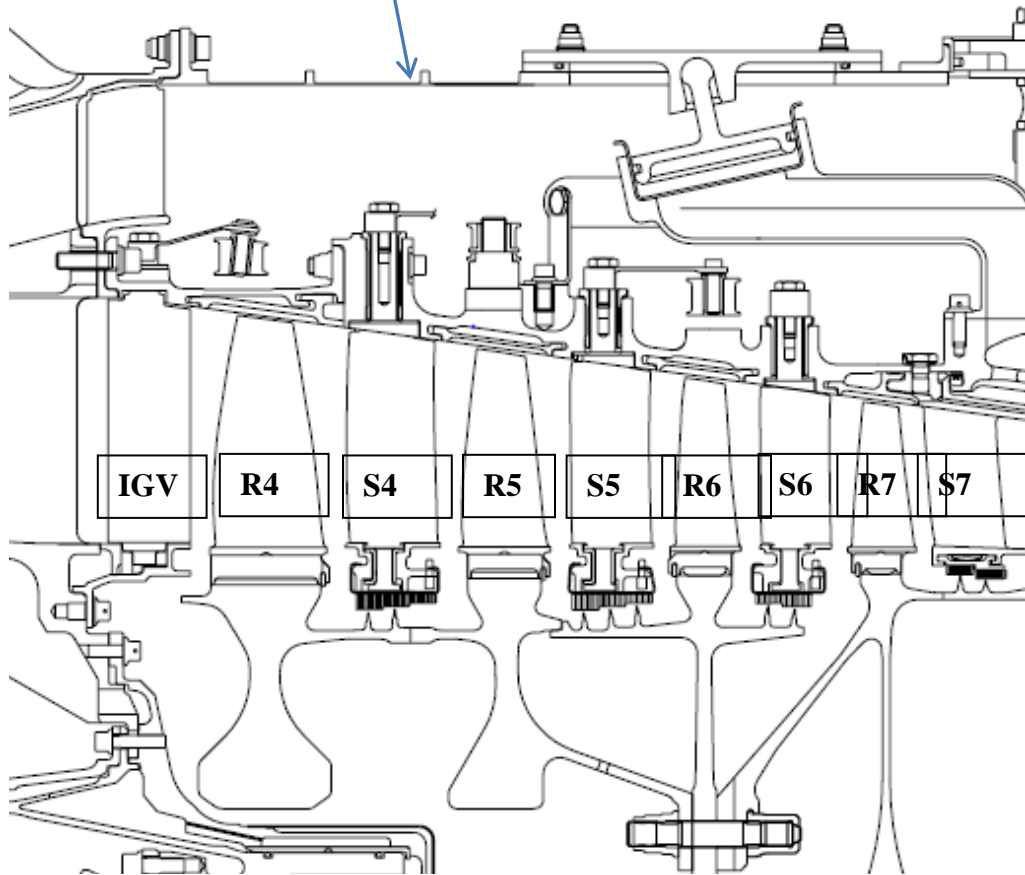
Post-mishap analysis localized the start of the titanium component fire to the 5th and 6th stages of the engine. Analysis was also able to determine the core of the mishap engine did not shift forward or rearward, eliminating one potential cause of the fire. The compressor case was removed for investigation. The 4th through 9th case was damaged by fire and impact. The case was severed by a titanium fire at both the 5th and 6th stage area, creating three separate pieces of the case. The 5th and 6th stage blade area was completely burned through for the entire circumference of the case, with the greatest damage at the 4 to 5 o'clock position, viewed aft looking forward. (Tab J-88-110) The 7th stage area was burned, but not through the case. The 8th through 13th stage area was not burned through, but had melted material covering the blade air seal abradable material. The abradable material in those locations did not display any blade tip rubbing other than what is normally seen in the compressor. When the radial location of the compressor is not maintained correctly during engine operation, (rotor/blade shift/imbalance or case displacement) the blades will contact the abradable material and create deep rubs; this was not evident in the mishap engine. (Tab J-88-110)

Fig. 6. Cross Section of the forward Portion of the High Pressure Compressor
