**UNITED STATES AIR FORCE**  
**AIRCRAFT ACCIDENT INVESTIGATION**  
**BOARD REPORT**

**M-28, T/N 08-0319**

**318th Special Operations Squadron  
27th Special Operations Wing  
Cannon Air Force Base, New Mexico**

**DATE OF ACCIDENT: 18 DECEMBER 2011**

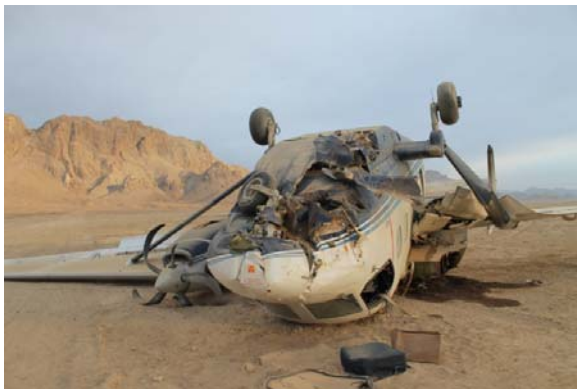
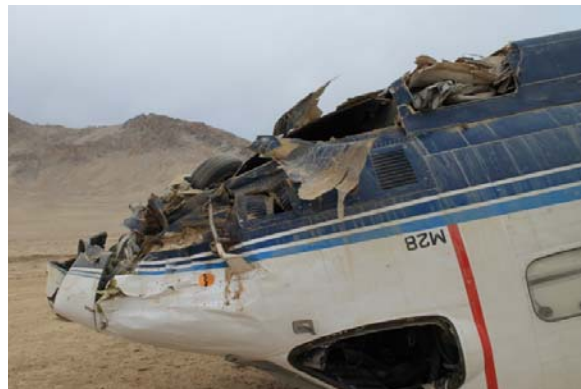
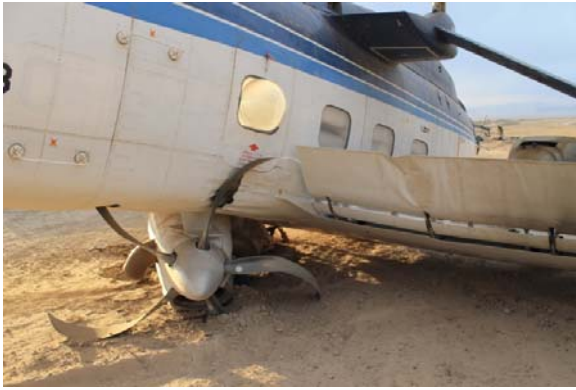
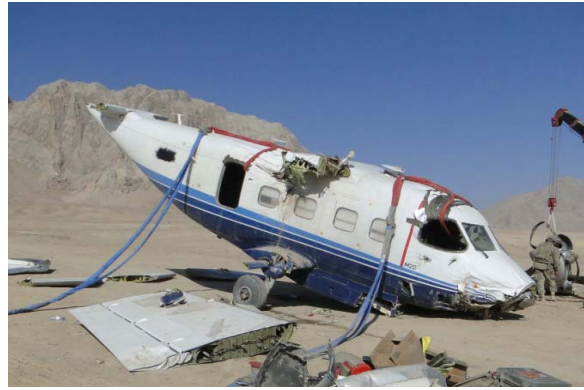
The MA fuselage received significant structural damage to the bottom forward section during the mishap. It also sustained damage to the top and sides of the fuselage during the mishap. It received additional damage during the process of being prepped for shipment which included moving the MA to a safer distance from the mishap landing zone, flipping it over to the upright position, and cutting away the wings, nacelles, and empennage.

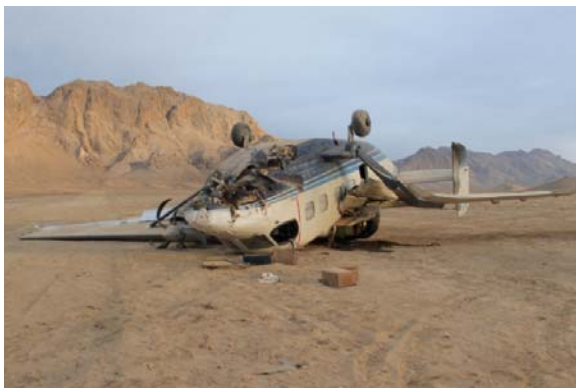
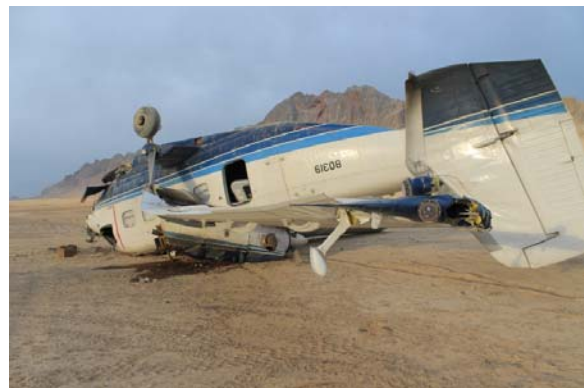
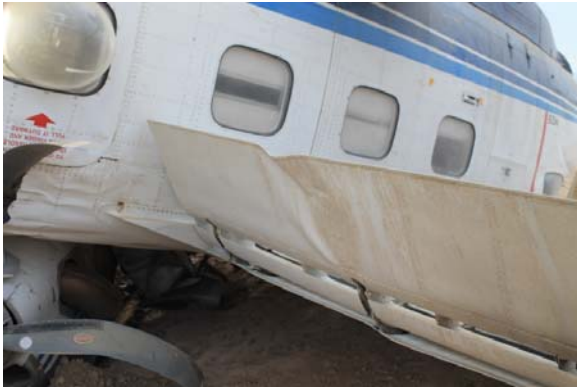
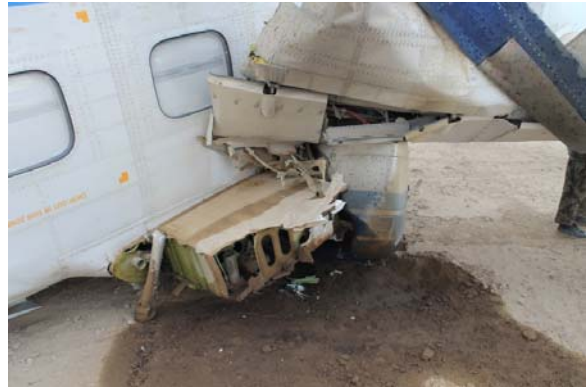
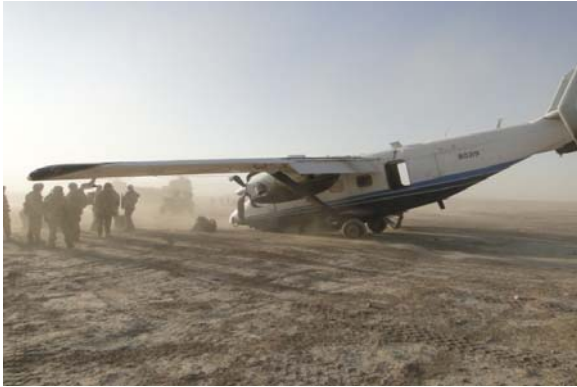
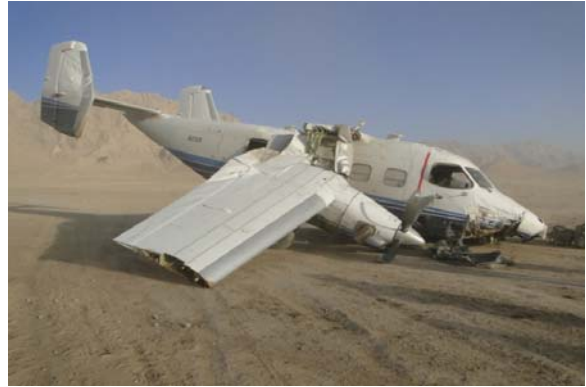
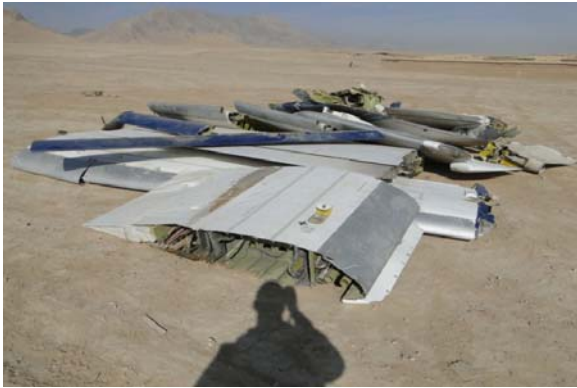
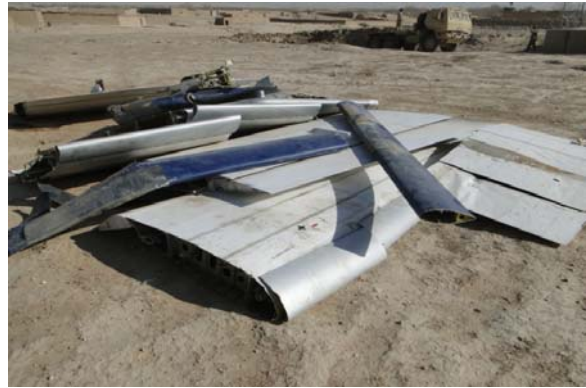
The right outboard wing and center wing sustained significant structural damage during the mishap. The left outboard wing sustained damage to its outer surface and flight control surfaces during the mishap. Additional damage was sustained during the process of prepping the aircraft for shipment. This included moving the MA to a safer distance from the mishap landing zone, flipping it over to the upright position, and cutting the wings away from the fuselage. It also included cutting the wings into smaller sections for shipment.

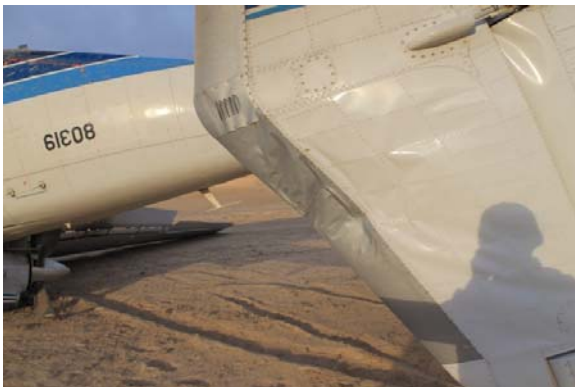
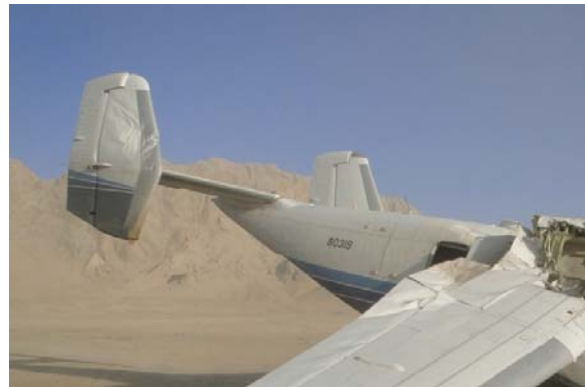
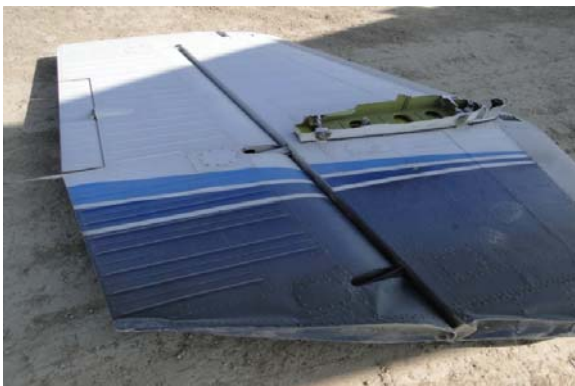
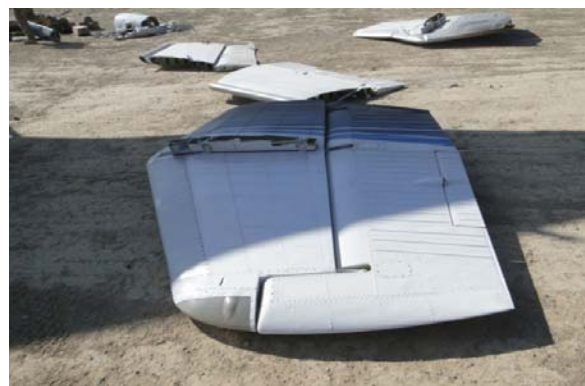
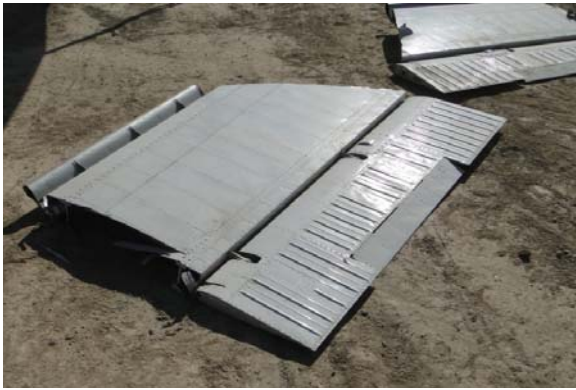
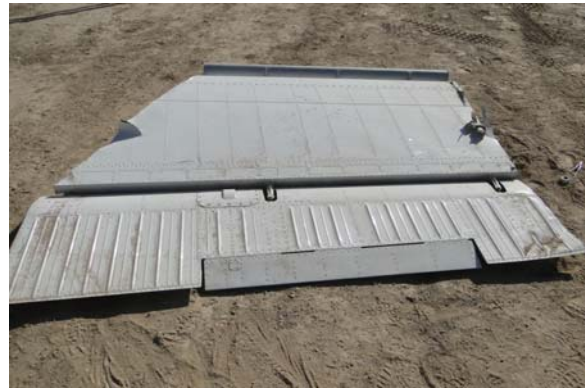
The empennage sustained damage to the vertical fins during the mishap. Additional damage was sustained during the process of prepping the aircraft for shipment. This included moving the MA to a safer distance from the mishap landing zone, flipping it over to the upright position, and cutting the empennage away from the fuselage. It also included cutting the empennage into smaller sections for shipment.

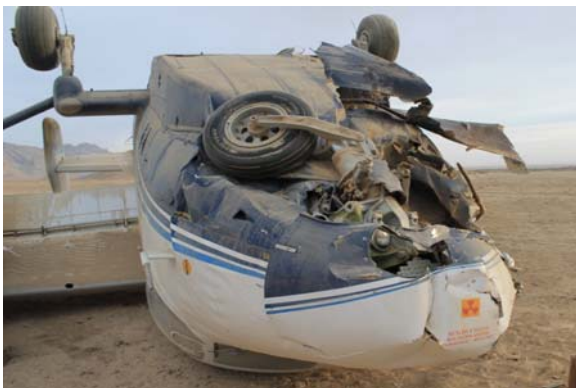
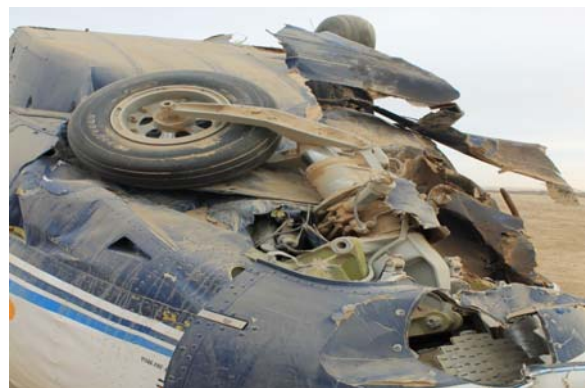
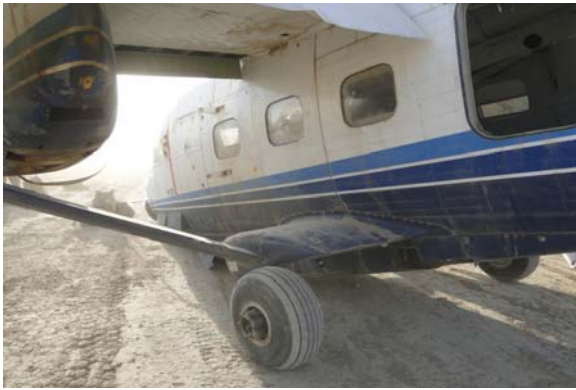
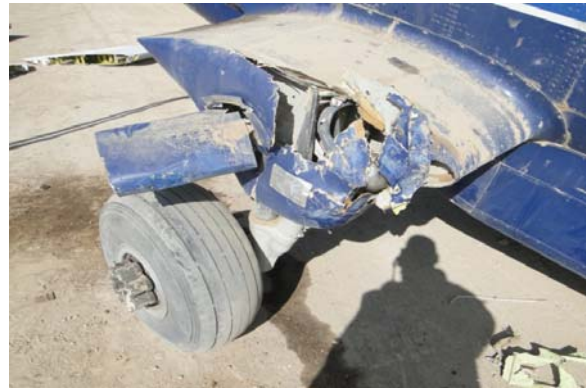
The nose wheel landing gear structural support collapsed during the mishap allowing the nose wheel landing gear to collapse into the bottom forward fuselage. The main landing gear fairings sustained damage when the outboard wing supports were cut away in preparation for shipment.

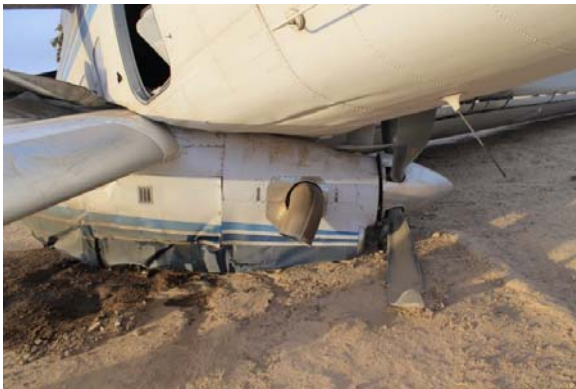
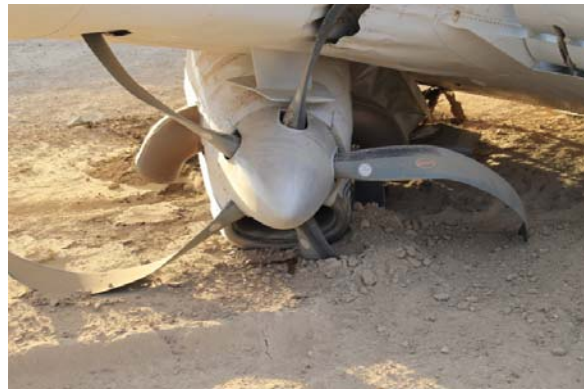
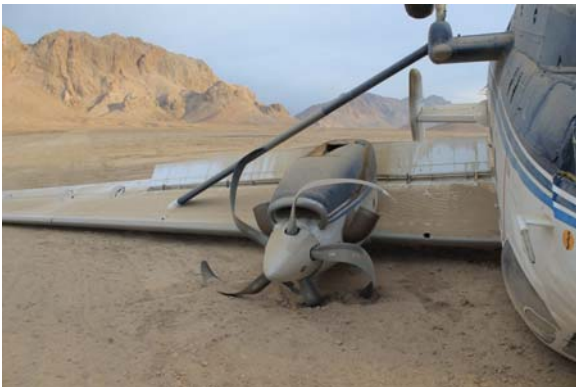
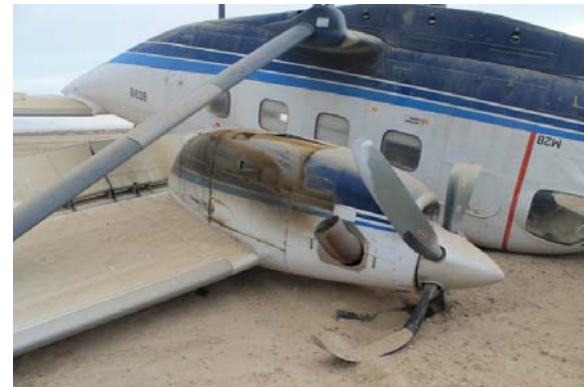
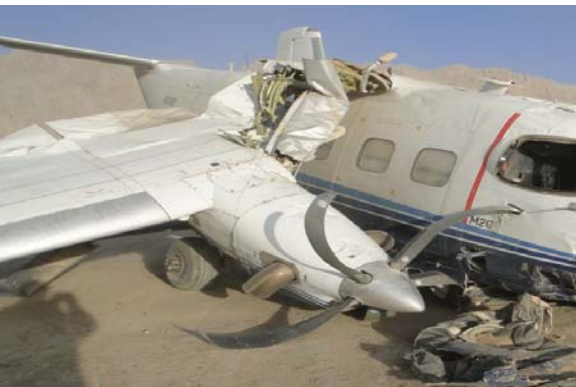
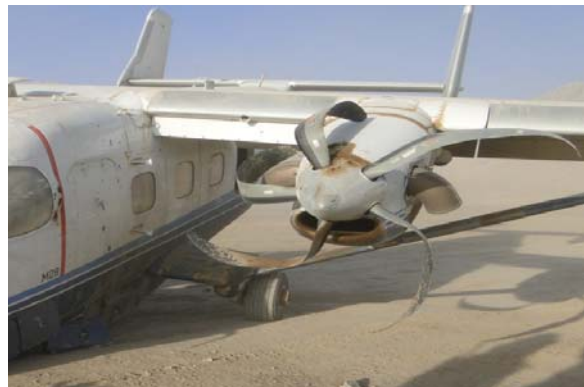
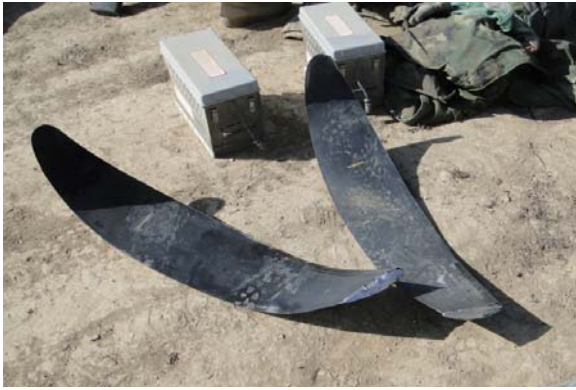
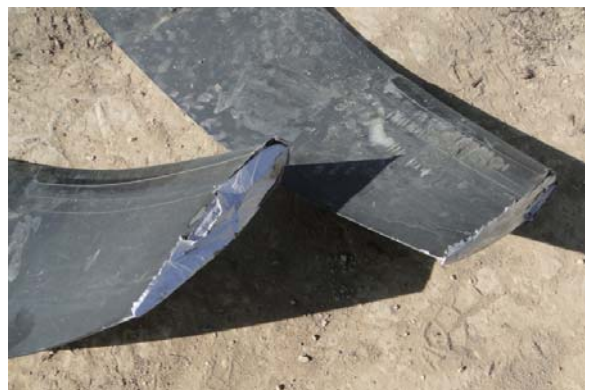
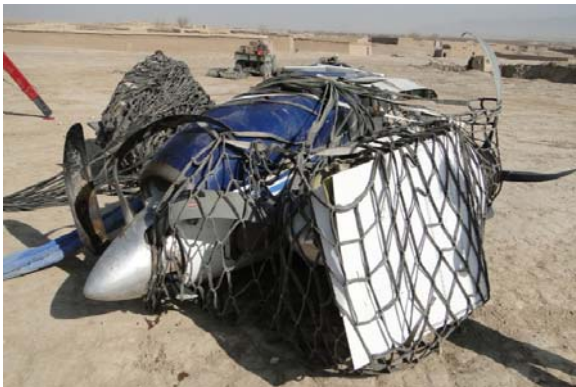
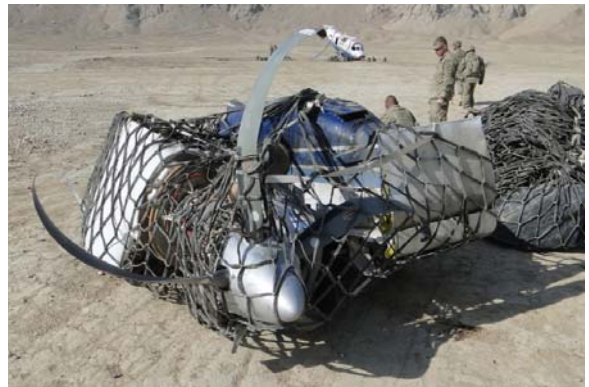
The right engine nacelle and both left and right propeller systems sustained damage during the mishap. Both the left and right engine nacelles and propeller systems sustained additional damage during the process of prepping the aircraft for shipment. This included moving the MA to a safer distance from the mishap landing zone, flipping it over to the upright position, and cutting the nacelles away from the wings. It also included cutting the individual propellers away from the propeller hubs.
