**UNITED STATES AIR FORCE**  
**AIRCRAFT ACCIDENT INVESTIGATION**  
**BOARD REPORT**

**F-16CM, T/N 88-0510**

**31ST FIGHTER WING  
AVIANO AIR BASE, ITALY**

**DATE OF ACCIDENT: 28 JANUARY 2013**

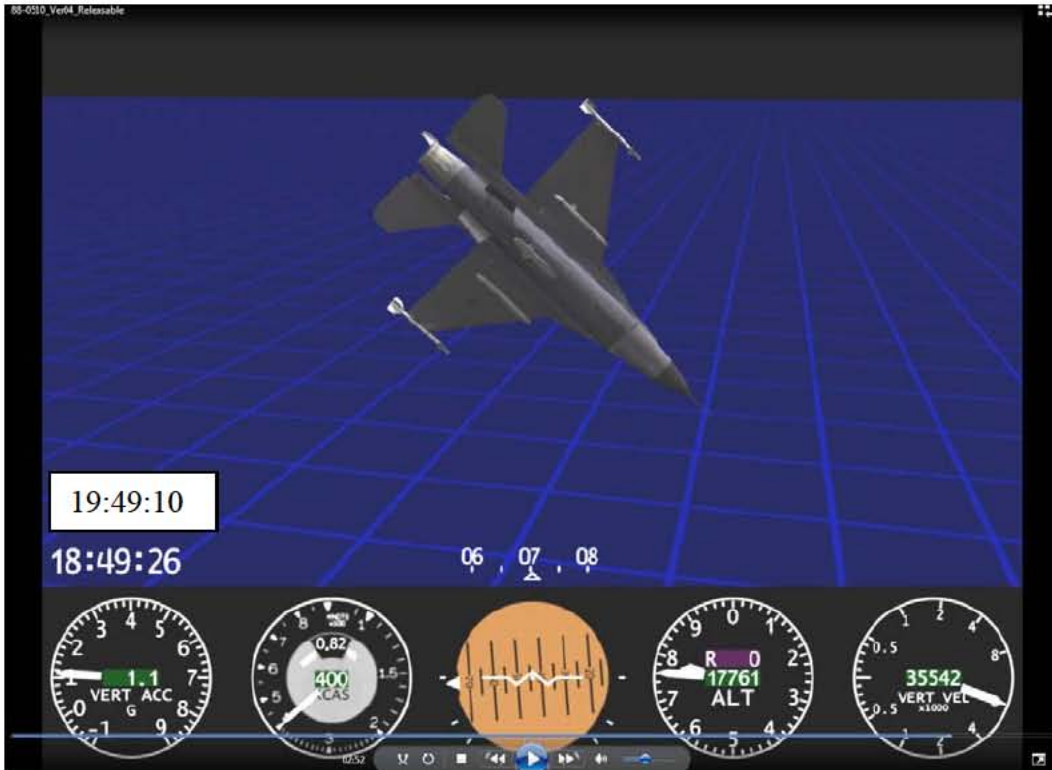
Figure 1 (Tab Z-4)

“Knock it off” procedures are used to direct aircraft or aircrew to stop engagements, scenarios and tactical maneuvering. “I’m spatial D” meant that the MP recognized that he was spatially disoriented. Spatial disorientation is a failure to correctly sense a position, motion, or attitude of the aircraft or of oneself within the fixed coordinate system provided by the surface of the earth and the gravitational vertical (Tab BB-32). Three seconds later at 19:49:16L, the MW directed the MP to transition to primary recovery instruments by communicating “Look at the round dials, disregard the HUD” (Tab N-17). The round dials are the primary attitude, altitude, and airspeed indicators used in unusual attitude recovery, and the HUD is the head-up display (Figure 2 and Tab BB-55).

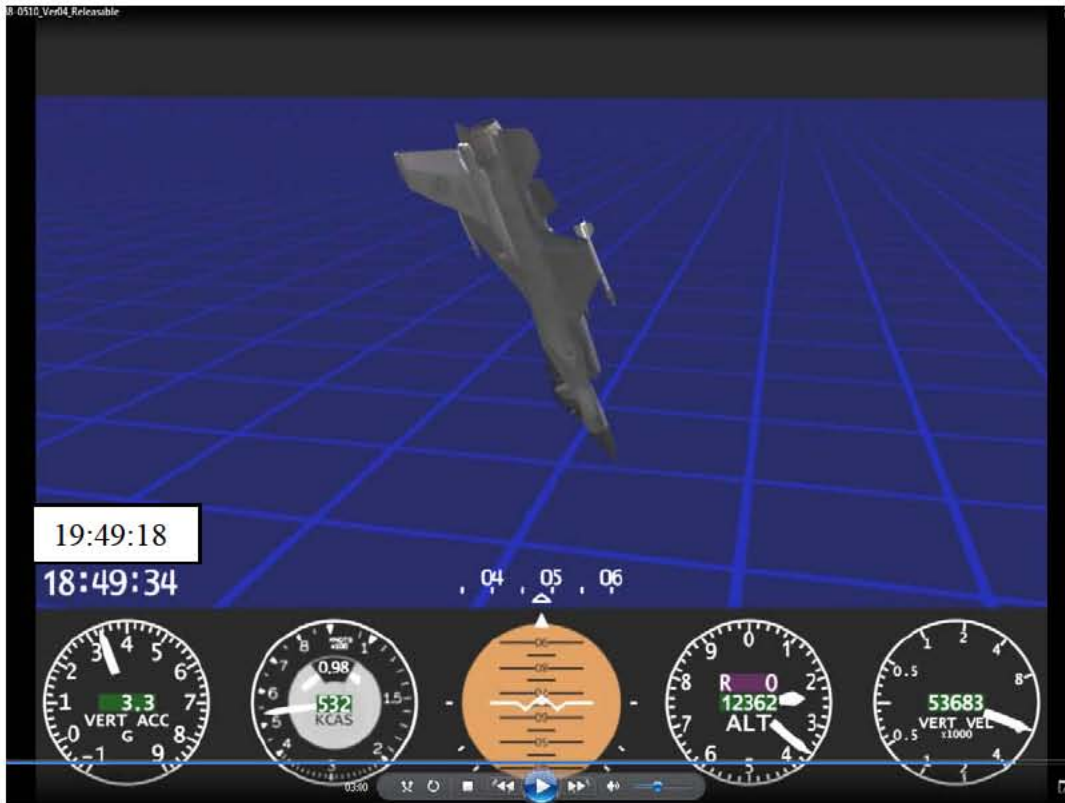
**Figure 3 (Tab Z-5)**

The MA initially continued with the same flight parameters. Then one second later, at 19:49:17L, the MP rolled the MA left, away from the horizon to approximately 180 degrees fully inverted, with the top of the canopy pointing directly towards the ground, and pulled to 70 degrees nose low, towards the water. The MA airspeed increased to 535 knots, as the MA passed through 12,000 feet of altitude. One second later, at 19:49:18L (Figure 3), the MP initiated a rapid roll to the right, attempting to establish wings level flight.

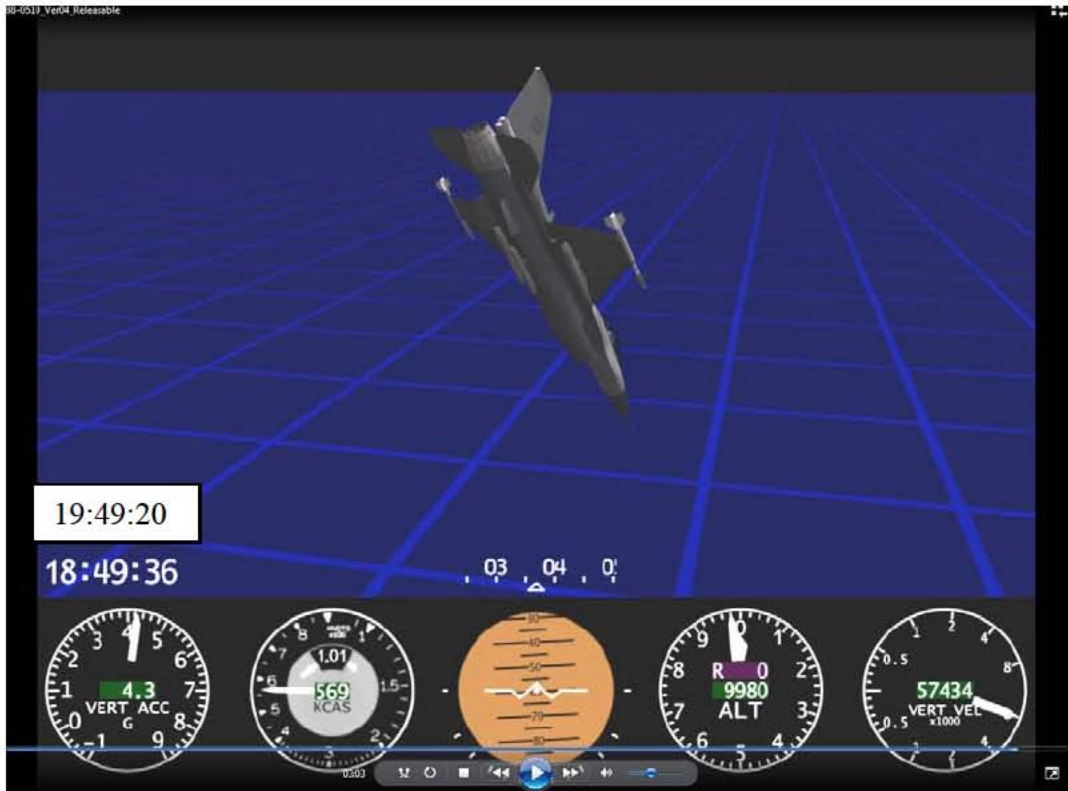
Figure 4 (Tab Z-5)

By 19:49:20L (Figure 4), at 10,000 feet, with a descent rate of 57,500 feet per minute, the MP established the MA at 55 degrees nose low in approximately upright wings level flight. At the same time, the MA's gravitational force loading increased from 2.0 Gs to a maximum recorded 8.6 Gs as the MA nose started to come up towards the horizon from 55 degrees nose low (Tab DD-9).

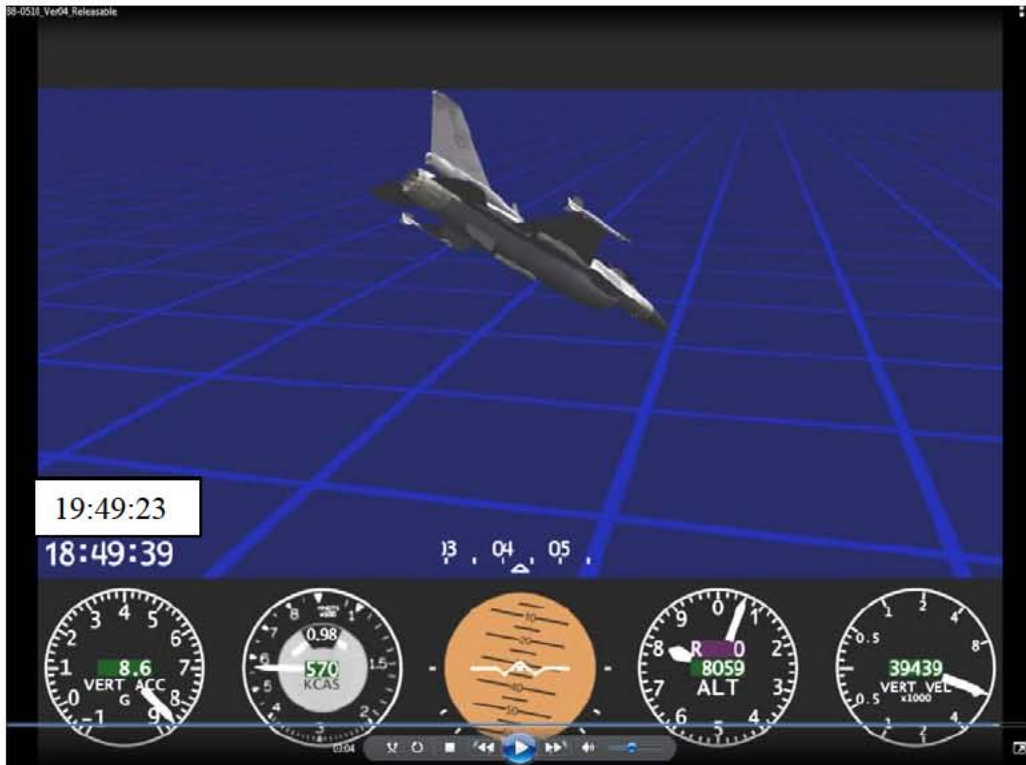
Figure 5 (Tab Z-6)

At 19:49:23L (Figure 5), the MW queried the MP: “1 status your round dials?” with no response from the MP (Tab N-17). This question implies the MW was trying to determine if the MP had transitioned his scan to the primary attitude instrument. At this time, the MA was at 25 degrees nose low, 15 degrees left bank, 568 knots, 8.6 Gs, while passing through 7,900 feet with a descent rate of 37,300 feet per minute (Tab DD-9).

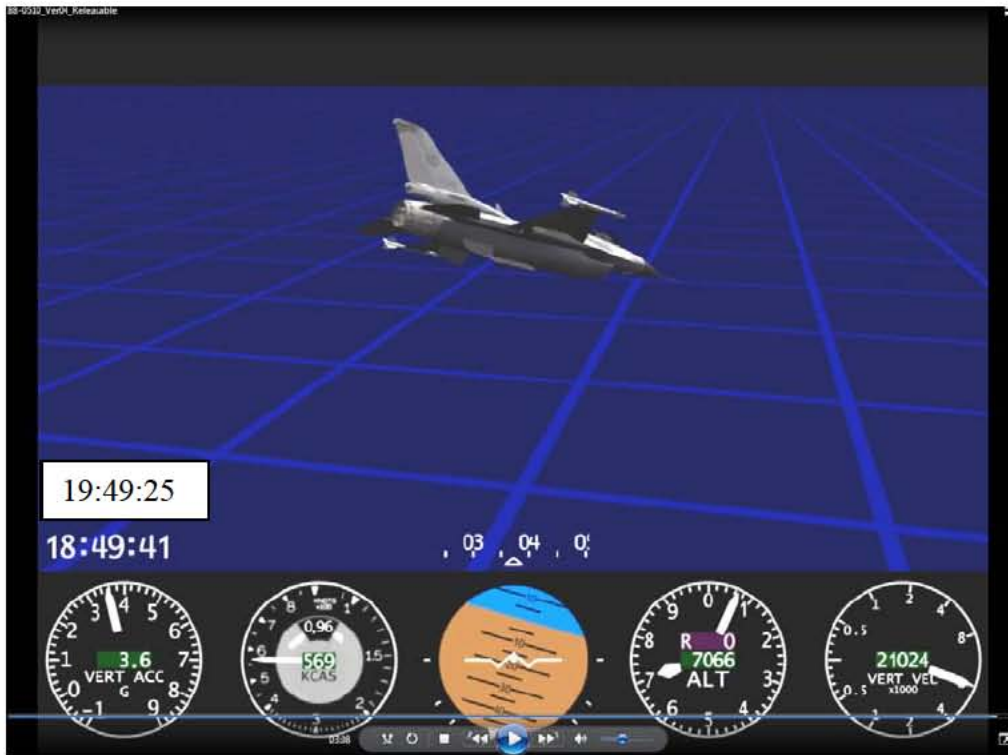
**Figure 6 (Tab Z-6)**

At 19:49:24L, the G forces on the MA started to decrease rapidly, indicating the MP was no longer pulling back on the control stick. The MP then initiated the ejection sequence. At 19:49:25L (Figure 6), the seat data recorder stopped receiving input from the MA, indicating the seat had begun to depart the MA.

The MA parameters at the time of the ejection were a heading of 037 degrees, 7,066 feet altitude, 569 knots (.96 Mach), dive angle of 16 degrees nose low, and 18 degrees left bank and with a 21,024 feet per minute rate of descent (Tab DD-9). The ejection occurred at approximately N 44 17.786 E 12 35.239 (Tab S-2).

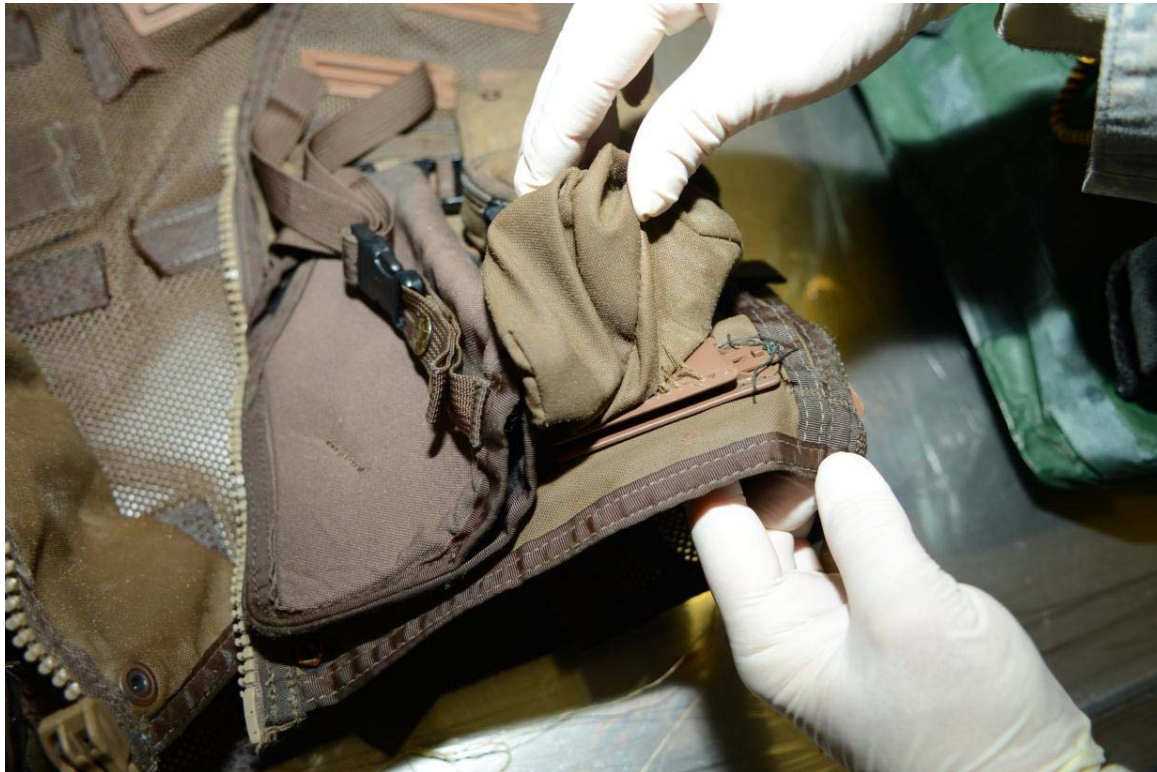
**Figure 9**

The MP's survival vest sustained minor damage during the ejection. Stitching on three of the pocket rails were broken, but the pockets were still fully attached on the vest (Tab Z-2). There is no evidence to suggest the MP attempted to access or utilize the survival radio (Tab Z-2).

**Broken stitches on MP's survival vest pockets (Tab Z-2)**

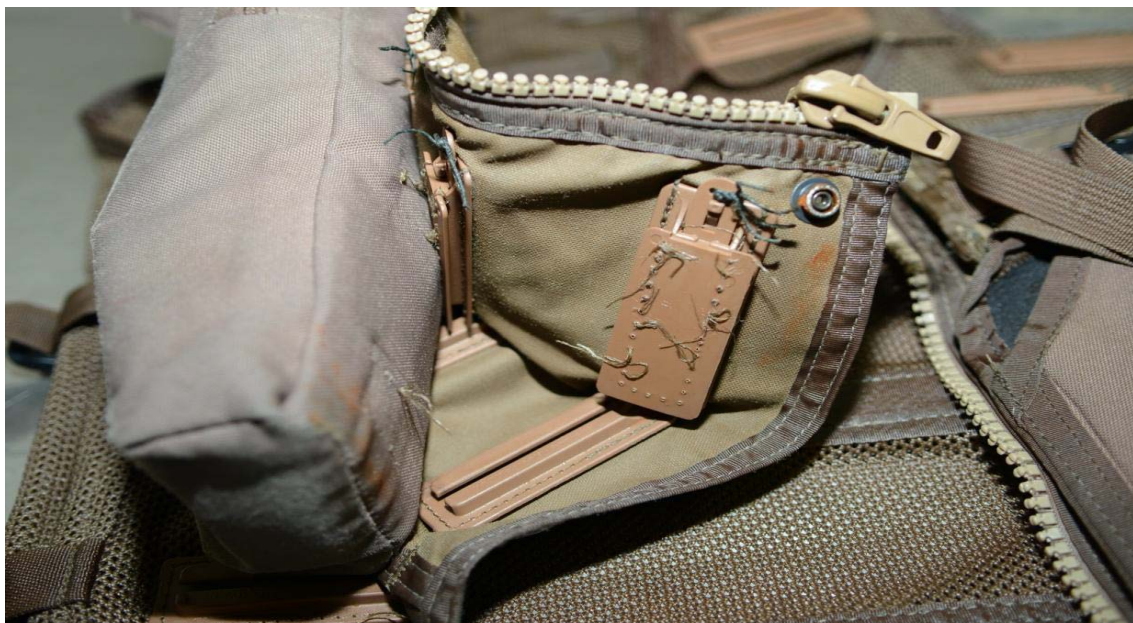
**Figure 10**

**Broken stitches on MP's survival vest pockets (Tab Z-2)**

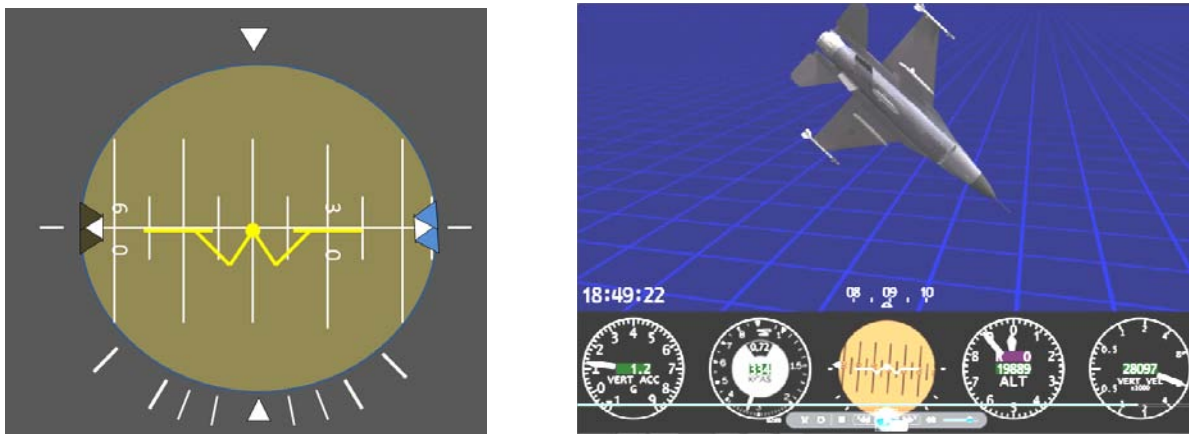
Figure 12 depicts the appearance of the main ADI seven seconds prior to the MP declaring that he was spatially disoriented (Tab DD-8 and N-17). The MP would have seen a brown field with no blue horizon when prompted by the MW to refer to the round dials (Tab N-17). Evidence shows that the MP aligned the aircraft with the horizon bar but incorrectly interpreted which way was up (Tab DD-9). Transition from NVGs to the round dials once the MA attitude was greater than 25 degrees below the horizon left the MP with fewer cues as to which direction to turn for the most efficient recovery and may explain why the MP initially turned in the wrong direction.

**Figure 12. MA at 19:49:06L – 40 degrees nose low and 90 degrees left bank.**  
 (The depictions on the right list times that are 59 minutes and 44 seconds in error from the actual mishap time sequence (Tab DD-5).)

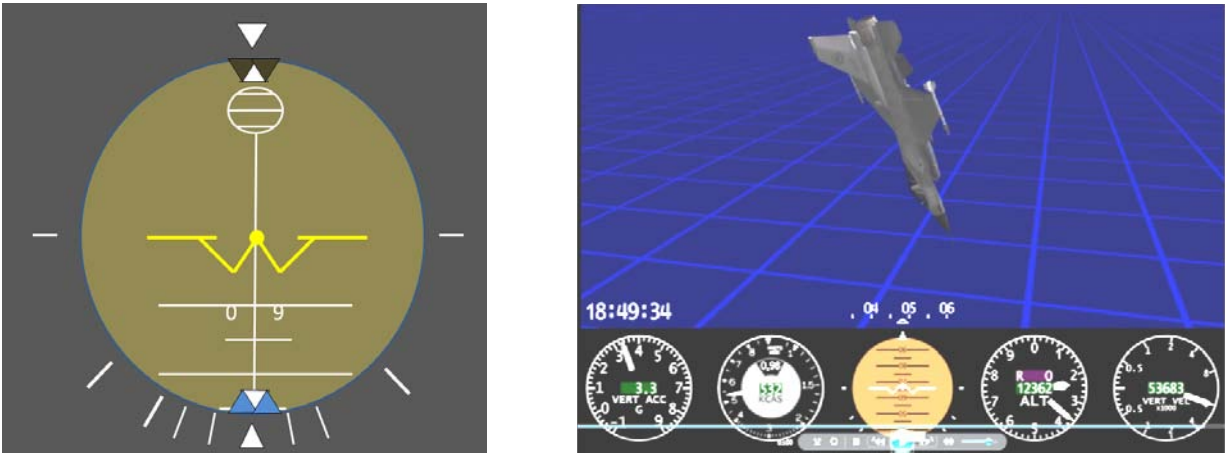
Once the MP reached 70 degrees nose low, a round ball appeared in the ADI indicating a straight down pointing at the earth direction referred to in Figure 13. The MP reoriented the MA to the correct horizon within one second of the time that the “earth” ball would have come into view in the ADI (Tab DD-9).

**Figure 13. MA at 19:49:18L – 70 degrees nose low and 180 degrees bank.**  
 (The depictions on the right list times that are 59 minutes and 44 seconds in error from the actual mishap time sequence (Tab DD-5).)

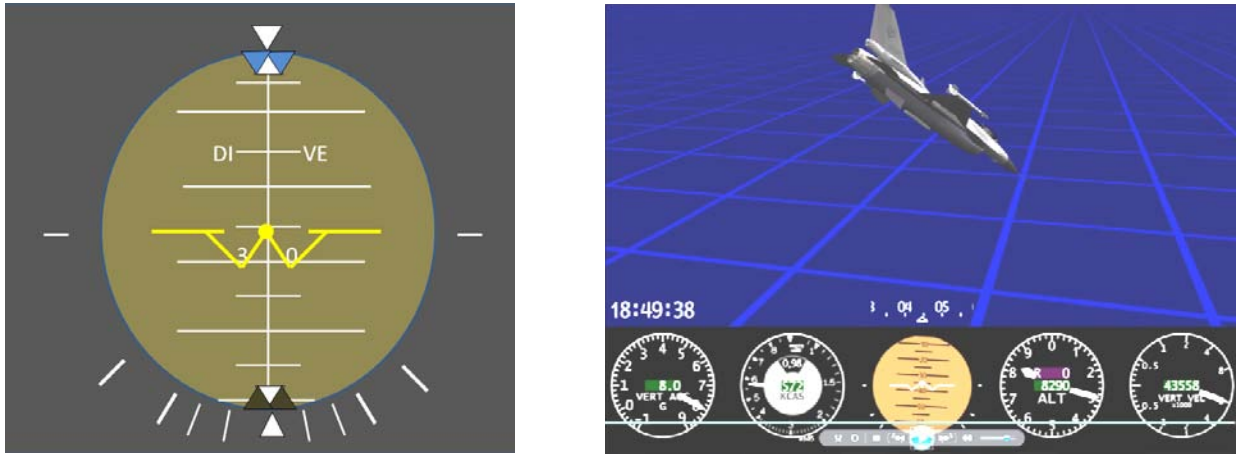
The ejection seat left the MA at 19:49:25L as the MA approached 16 degrees nose low at just over 7,000 feet and 569 knots (Tab DD-9). At the time of ejection, the MA was essentially recovered from its unusual attitude and the MA flew for an additional four miles before impacting the water (Tabs DD-9 and S-3). Human response time-lag reasonably approaches one second or longer. Response lag is the delay between perceiving the need for an action and being able to execute the action. (see, *Fundamentals of Aerospace Medicine, 4th Edition*, Jeffrey R. Davis, Robert Johnson, Jan Stepanek, Jennifer A. Fogarty Lippincott, Williams & Wilkins, Philadelphia, 2008, p. 364). Flight data also shows a decrease in demanded G forces one second prior to ejection indicating the MP had likely let go of the controls. Therefore it is likely that the MP initiated ejection at 19:49:23L at which time the MA was 25 degrees nose low, 7,900 feet

and 568 knots (Tab DD-9). This attitude is depicted in Figure 14 below. Note the lack of blue horizon.

**Figure 14. MA at 19:49:22L – 25 degrees nose low and wings level (3 seconds prior to ejection). (The depictions on the right list times that are 59 minutes and 44 seconds in error from the actual mishap time sequence (Tab DD-5 ).)**
