**EXECUTIVE SUMMARY
AIRCRAFT ACCIDENT INVESTIGATION**

**F-16C, T/N 87-0314, and F-16C, T/N 86-0357
WARNING AREA 386
1 AUGUST 2013**

**SUMMARY OF FACTS AND STATEMENT OF OPINION
F-16C, T/N 87-0314, AND F-16C, T/N 86-0357
1 AUGUST 2013**

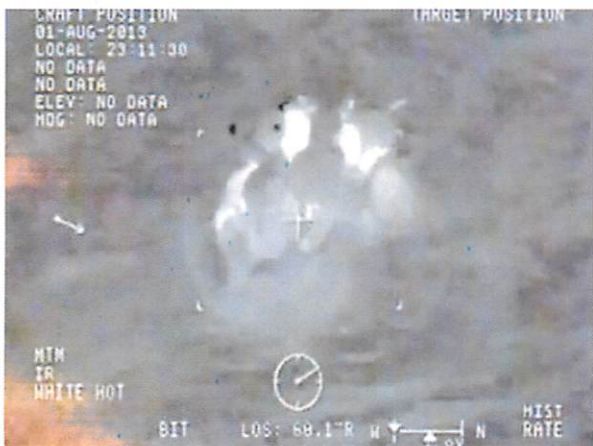
Infrared photo from HH-60 during recovery.

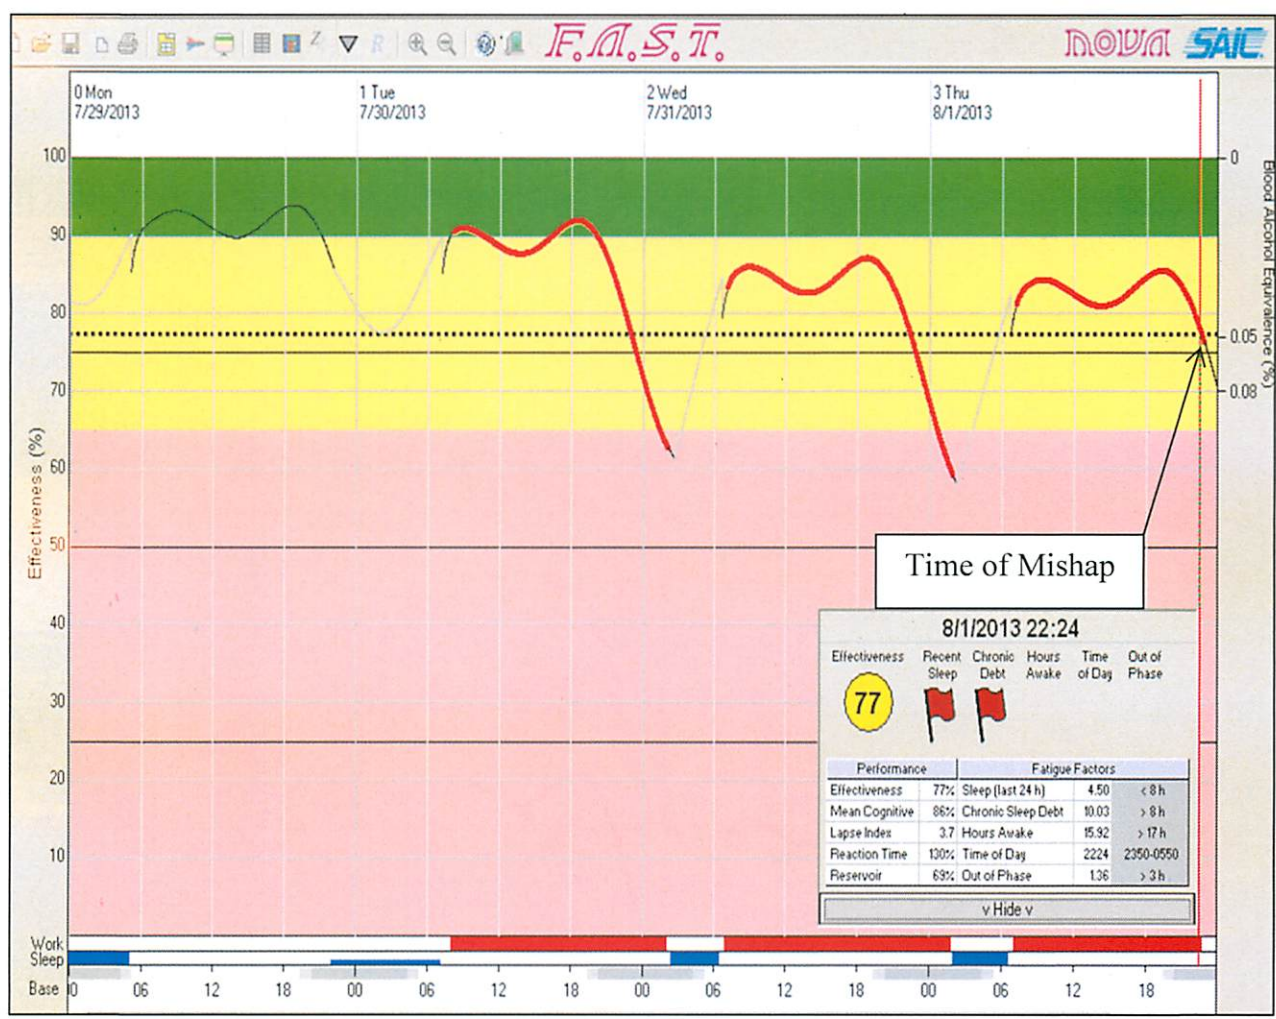
The MP1 slept 4.5 hours the night preceding the mishap (Tabs V-5.10 through 5.11, V-8.1 through V-8.5). In addition, the MP1 had been awake for a continuous period of 15.92 hours before the mishap (Tab V-8.5). Given his inadequate sleep the evening before the mishap, and his overly long military and civilian duty day, the MP1 had 10.03 less hours of sleep than he should have had to be properly rested (Tabs V-5.10 through 5.11, V-8.1 through V-8.5, BB-11). His inadequate rest history is a direct result of the MP1's attendance during the day at his civilian job while flying nights with his unit (Tabs V-8.1 through V-8.5, DD-7).

Figure 11-1: The MP1's FAST calculated cognitive performance at time of mishap= 77%

The MP1 had 4.5 hours of sleep the day of the mishap and 4 hours the previous day. Further, the MP1 had been awake for a continuous period of 15.92 hours before the mishap. The MP1's attendance each morning at his civilian job while flying nights with his unit resulted in his inadequate rest and subsequent fatigue.
