UNITED STATES AIR FORCE
AIRCRAFT ACCIDENT INVESTIGATION
BOARD REPORT

B-1B, Tail Number 85-0091
34TH BOMB SQUADRON
28TH BOMB WING
ELLSWORTH AIR FORCE BASE

LOCATION: BROADUS, MONTANA
DATE OF ACCIDENT: 19 AUGUST 2013
BOARD PRESIDENT: COLONEL BRIAN A. HUMPHREY
CONDUCTED IN ACCORDANCE WITH AIR FORCE INSTRUCTION 51-503

SUMMARY OF FACTS AND STATEMENT OF OPINION
B-1B, Tail Number 85-0091
19 AUGUST 2013

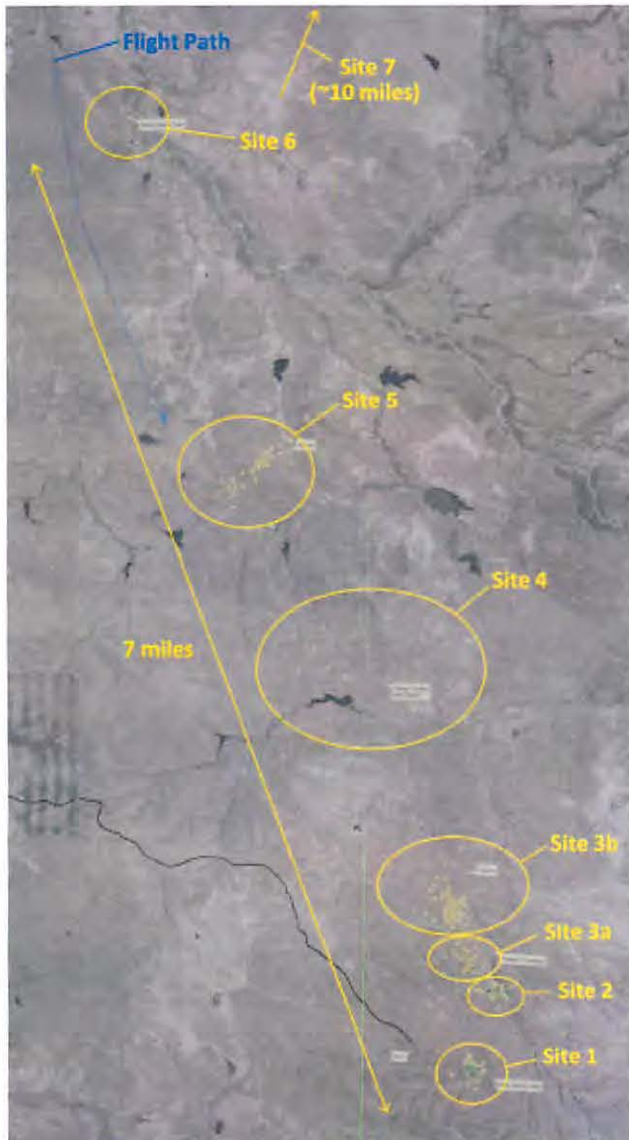
The MA impacted the ground at approximately 0916L (Tabs J-67 and FF-7). Debris from the MA spread over a 17-mile area of privately owned, grass-covered pastureland within the MOA, approximately 24 miles east of Broadus, MT (Tab J-53 and J-71). Distinct groups of MA parts were found along a path generally headed in a northwesterly direction, which eventually changed to a southeasterly direction (Tab J-71 to J-72). The debris spanned Site 1 to Site 7 in Figure 1 (Tab J-54). The forward portion of the MA separated and impacted approximately 1.5 miles from the main crash site (see Figure 1) (Tabs H-7, J-54, and J-72).

Figure 1. Crash Sites (Tab J-53 to J-64).

Figure 1 details the location of debris from the MA. Upon impact at Site 1, the main portion of the MA disintegrated, resulting in the immediate release of the remaining fuel and other combustibles (Tabs J-61 to J-64, J-72, and Z-3 to Z-13). Burning at the north end of Site 1, where the wings and main carry-through box impacted, was more intense than at the south end (Tab J-72). The fires self-extinguished because of the remote location of the crash site (Tab J-72).

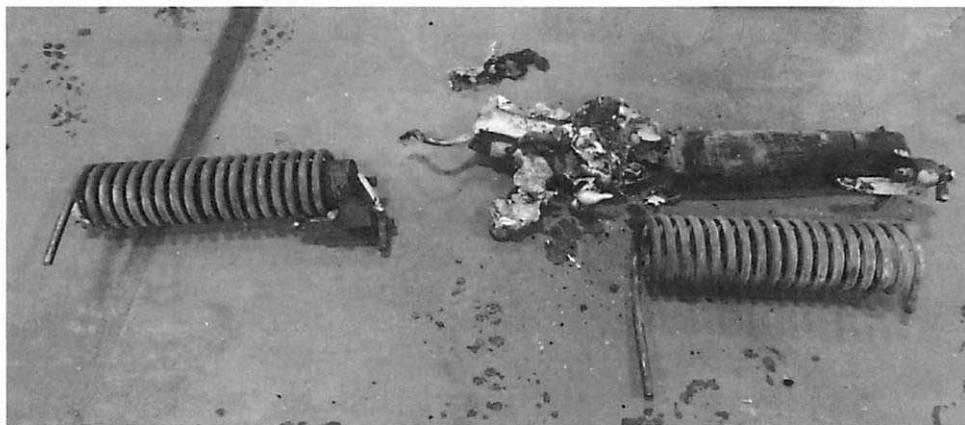
The left forward and aft mandrel spring assemblies from the MA were severely damaged (see Photograph 1) (Tab GG-3 to GG-5).

Photograph 1. Recovered Left Mandrel Spring Assemblies (Tabs GG- 3 to GG-5 and Z-22).

I considered whether the left underwing fold down baffle may have detached due to the failure of the forward mandrel spring assembly, as a possible substantially contributing factor but could not so conclude. The fold down baffle attaches to the underwing fairing at four points. Mandrel spring assemblies (forward and aft) form two of the attachment points, providing the pressure necessary to push the fold down baffle into place as the wings sweep. A forward and an aft mandrel spring assembly recovered at the crash site are consistent in form and fit with those found in the left overwing fairing cavity. Both assemblies showed evidence of structural overload, along with significant damage from exposure to fire. Of note, the forward mandrel spring assembly was missing the spring component, the interior tube was gouged and crushed, and the sheared forward mounting plate was co-mingled with a mass of melted aluminum. Thus, the cause and timing of the detachment of the left fold down baffle remains unknown.

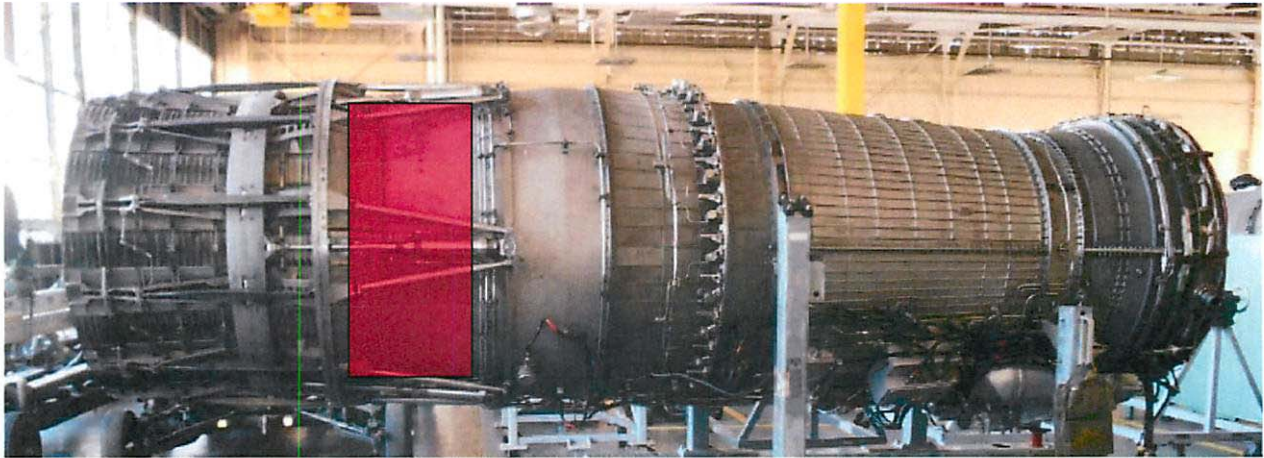
None of the engines from the MA exhibited any evidence of in-flight mechanical or thermal non-containment (Tab J-11 and J-31). In addition, there was no evidence of uncommanded, non-recoverable engine shutdown during flight (Tab J-31). The fire damage found between Engine 1 and Engine 2 is consistent with an in-flight fire, originating *external* to the engines (Tab J-31). All other engine damage is consistent with ground impact and post-impact fire (Tab J-31). The location of the fire external to Engine 1 is marked in Figure 3.

Figure 3. Location of Apparent In-flight Fire Outside of Engine 1 Highlighted in Red on Sample Engine (Tab J-32).

Although the Engine 1 and Engine 2 warning lights came on during flight, analysis of the engines revealed that the fire was external to the engines and not a result of engine failure (Tabs J-31, J-67, V-1.7 to V-1.8, V-1.12, V-3.8 to V-3.9, and V-4.10 to V-4.11).

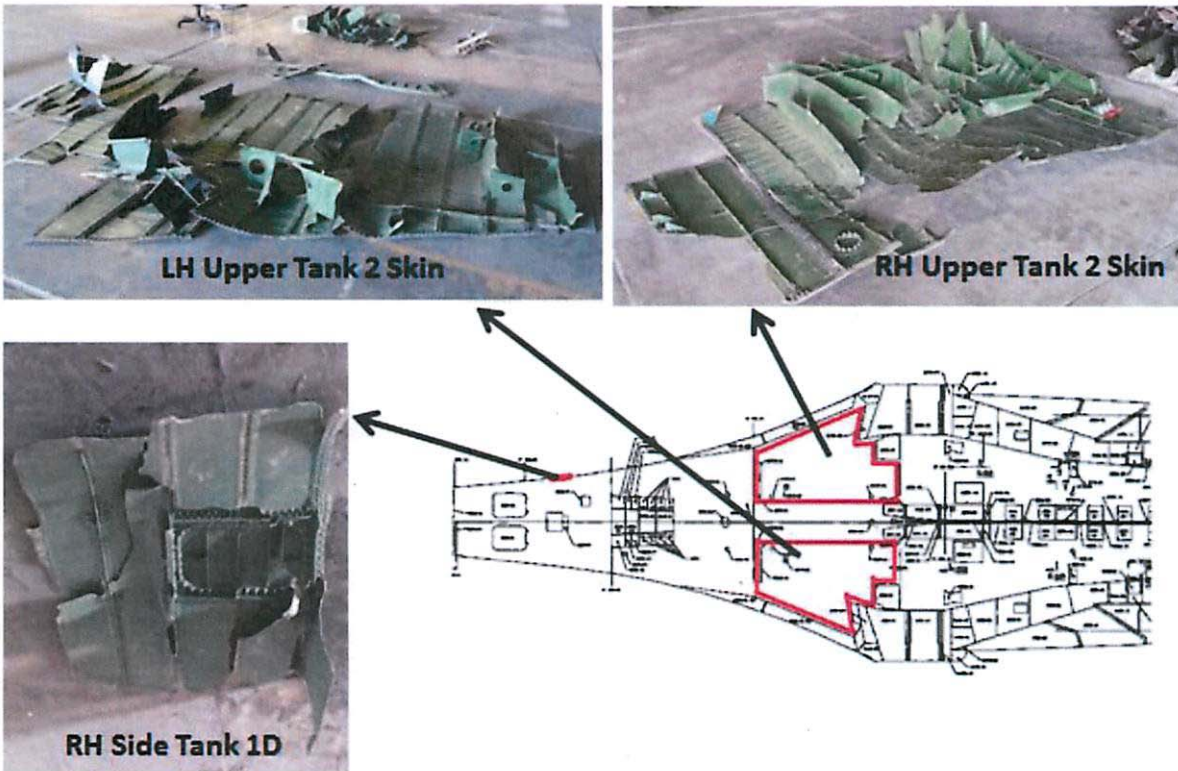
The ruptured upper skin of Tank 2A, Tank 2B, and Tank 1D found at Site 5 (see Figure 4) indicate an in-flight overpressure condition in the fuel vent system (Tab J-80). Over 90 pieces of Tank 2A and Tank 2B were recovered at Site 5 (J-76). Site 5 is located just under 4.5 miles from the main impact site and approximately 12.5 miles from Site 7 where the left overwing fairing was located (Tab J-54). There was no evidence of ground fire at Site 5, and all of the recovered pieces were relatively clean, lacking any evidence of being involved in a typical hydrocarbon-fed in-flight fire (Tab J-56).

Figure 4. Debris from Tops of Tank 2A and Tank 2B (Tab J-57).

The MC heard a second explosion immediately prior to loss of electrical power, and approximately 1.5 minutes after the first explosion (Tab V-1.8 to V-1.9, V-2.7, V-3.9, V-3.13, and V-4.11). Given the type and condition of debris located at Site 5 and the distance between debris from Site 7 and Site 5, this second explosion was likely from an overpressure condition in Tank 1D, Tank 2A, and Tank 2B (Tab J-80).

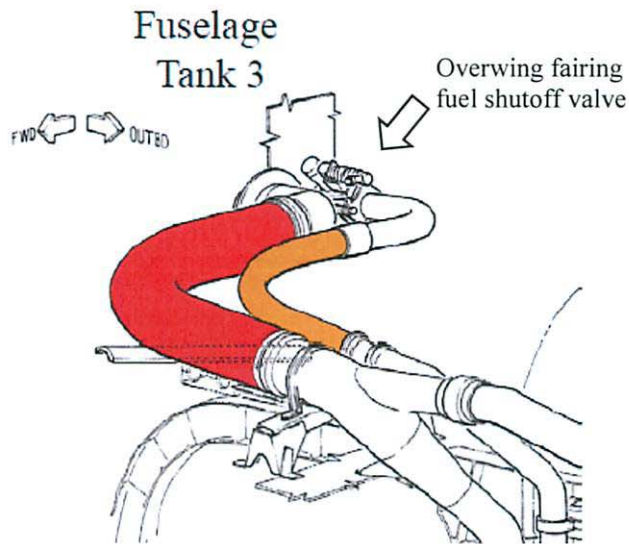
Diagram 3. Two-Inch Fuel Cooling Loop Line (Orange) and 4.5-Inch Main Fuel Line (Red) (Tab J-113).

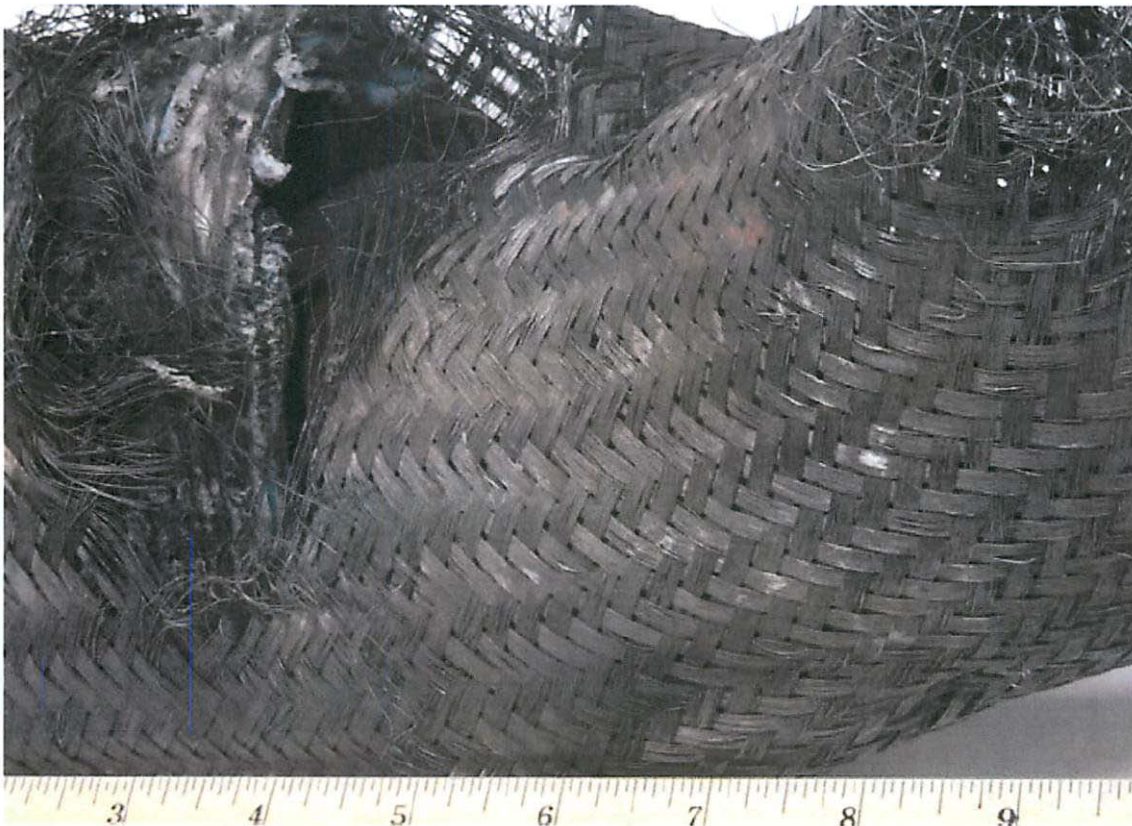
The 4.5-inch main fuel line from the MA's left overwing fairing was recovered from the crash site and exhibited extensive damage (Tab J-108 to J-110). Specifically, the line had a v-shaped cut to the top half of the fuel line (Tab J-108 to J-110 and J-122). Analysis suggests the v-shaped cut resulted from impact from an external object (Tab J-109).

The 2-inch fuel cooling loop line and 4.5-inch main fuel line (see Diagram 3) from the left wing root bay were submitted to the Air Force Research Laboratory at Wright-Patterson AFB, OH, for analysis (Tab J-107). The 2-inch fuel cooling loop line showed evidence of line collapse due to thermal exposure (Tab J-107 to J-108, J-113, and J-115). The 4.5-inch main fuel line showed multiple fractures and melting of the inner layers of the line, likely due to thermal exposure (Tab J-108 to J-109). In addition, the 4.5-inch main fuel line had a v-shaped cut (see Photograph 2) through the exterior braiding and into the inner layers of the line (Tab J-109).

This type of damage suggests the 4.5-inch main fuel line had been cut by impact with an external object (Tab J-109).

Photograph 2. Damage to 4.5-Inch Main Fuel Line (Tab J-122).
