**UNITED STATES AIR FORCE**  
**AIRCRAFT ACCIDENT INVESTIGATION**  
**BOARD REPORT**

**B-52H, T/N 61-0014**

**OKLAHOMA CITY – AIR LOGISTICS COMPLEX  
AIR FORCE SUSTAINMENT CENTER  
TINKER AIR FORCE BASE, OKLAHOMA**

**DATE OF ACCIDENT: 1 NOVEMBER 2012**

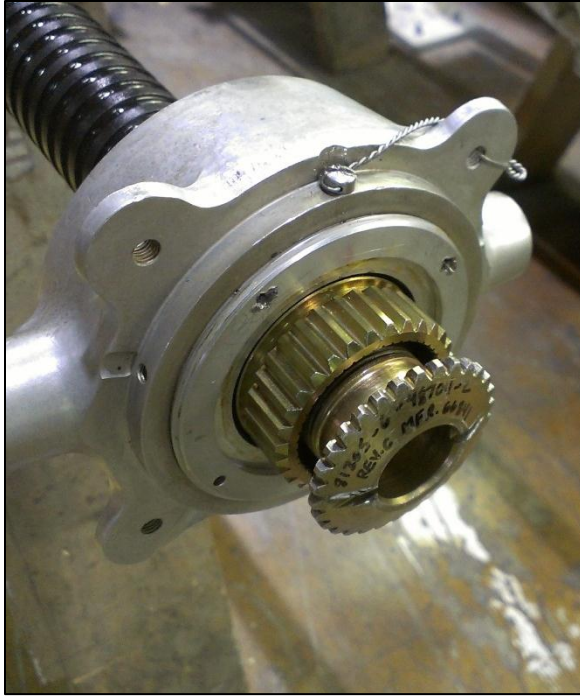
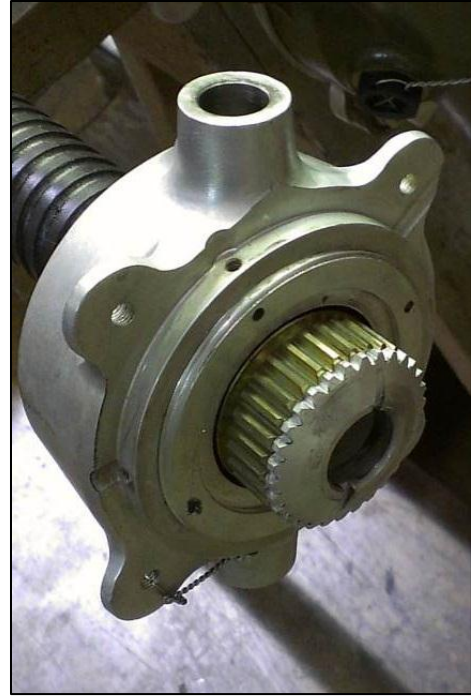
**Figure 8. B-52 Flap Drivescrew Retainer Plug Installation**

The retainer plugs were not present in the #4 and #5 flap drivescrew assemblies. (Tab J-13 to J-14) Post-flight disassembly and visual inspection of the #4 and #5 trunnions, splined adapters and adapter tubes showed no signs of a retainer plug. Inspections of these retained parts also showed no damage consistent with a broken retainer plug. (Tab J-17 to J-18) Further, the lack of damage to the inside threads of the recovered drivescrew confirmed the retainer plugs were not present in the #4 and #5 flap drivescrew assemblies. (Tabs Z-25 and DD-7) Their absence left the drivescrew assembly unable to resist the drag loads experienced during flap retraction. (Tab J-13, J-14, J-17, J-18)

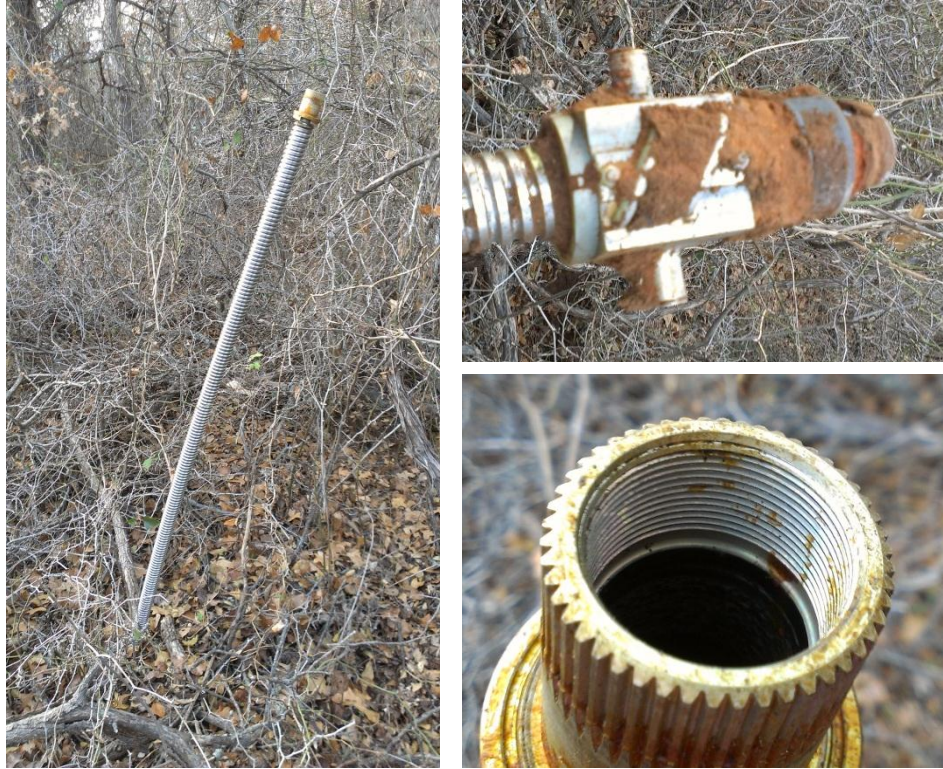
**Figure 12. Recovered Drivescrew**

The AIB visited the impact sites of the flaps. On 15 December 2012, the AIB discovered the #5 flap drivescrew near the flap impact points, with the aft end stuck in the ground, as shown in Figure 12. (Tab Z-23 to Z-25) The AIB determined this drivescrew was the #5 drivescrew based on a comparison of a serial number (#136) stamped on the drivescrew nut with the serial number recorded on the Serviceable Tag (DD Form 1574) that was in the aircraft maintenance records. (Tab Z-26) A B-52 SPO engineer inspected the recovered #5 drivescrew. (Tab DD-7)

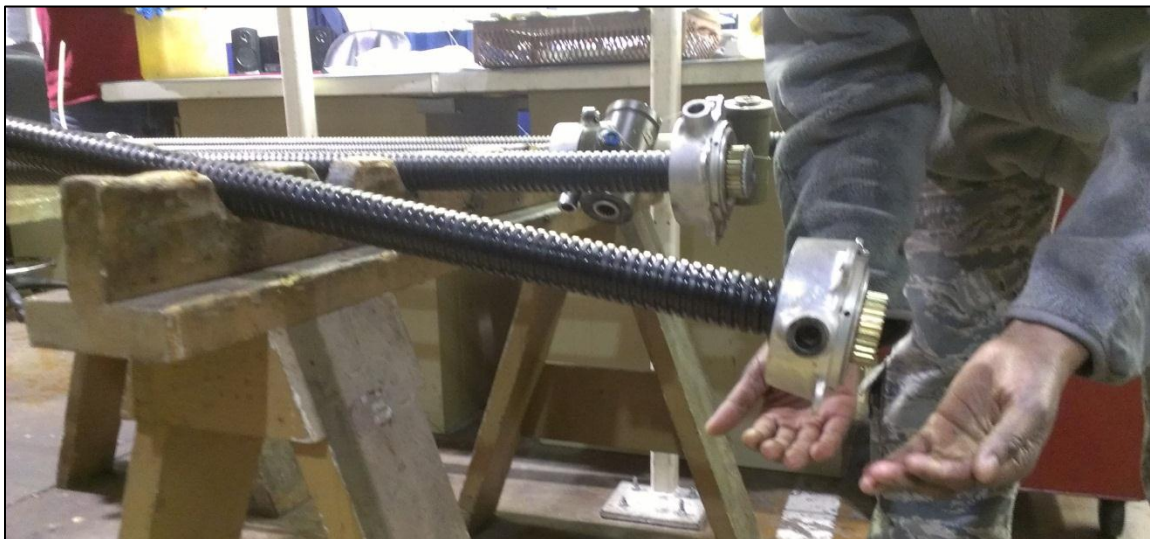
**Figure 13. Drivescrew Held at Incline with Retainer Plug Missing**

Cursory testing of this condition in the 552 CMMXS Wheel and Gearbox Shop area indicated could be held at an incline of approximately 20-30 degrees before this would happen. (Figure 13) The photo below shows a drivescrew assembly, with the retainer plug not installed, being held at such an angle, without the trunnion and splined adapter sliding off. (Tab Z-10) The exact angle required would likely depend on several factors such as part tolerances, grease consistency, and vibration. However, if the drivescrew assembly was kept horizontal, or if the gearbox end of the assembly was held higher than the drivescrew end, the assembly would likely remain together and the missing retainer plug would not be detected.

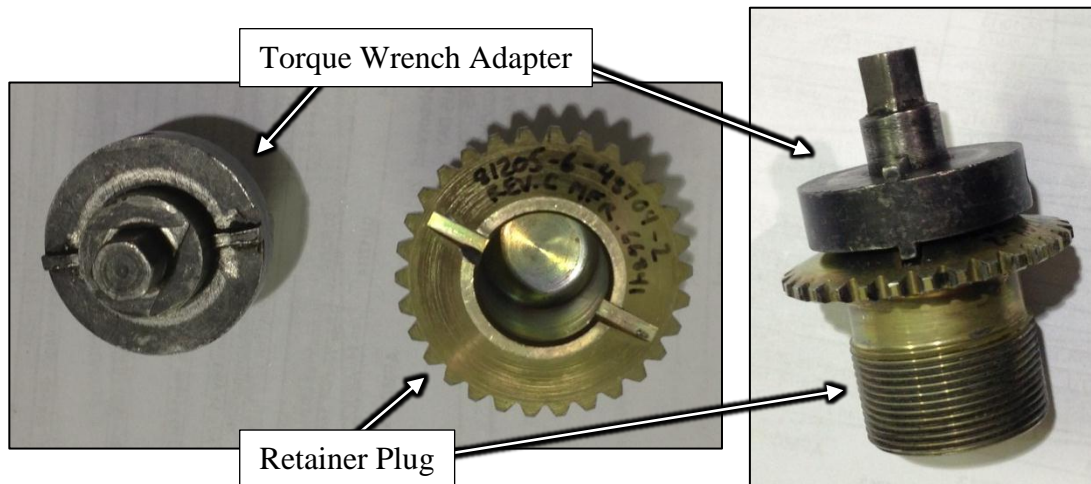
**Figure 14. Retainer Plug and Torque Wrench Adapter**

552 CMMXS Wheel and Gearbox Shop consistently deviated from the reassembly procedures detailed in T.O. 16G-2-21-3, specifically step “r” on page 2-10. Step “r” required the mechanic to torque the plug to “between 450 to 500 pound inches with wrench, Part No. F52141-500.” (Tab BB-31) The process required a specialized adapter for the torque wrench; however, the adapter had been missing for years. (Tabs V.7.6 to V-7.7, V-7.14, and Z-77 to Z-78) Instead, the mechanics involved in the reassembly over at least the past six years installed the plug to “finger tight,” before using a chisel and hammer to torque it “slightly tighter.” (Tab V-5.11, V-7.6) Although the mechanics incorrectly installed the retainer plug, its anti-rotation provisions would have prevented the retainer plug from falling out, so there is no evidence that this deviation contributed to this mishap.
