**UNITED STATES AIR FORCE**  
**AIRCRAFT ACCIDENT INVESTIGATION**  
**BOARD REPORT**

**MQ-9 REAPER, T/N 09-4066**  
**138TH ATTACK SQUADRON**  
**174TH ATTACK WING**  
**HANCOCK FIELD AIR NATIONAL GUARD BASE**

**LOCATION: LAKE ONTARIO, NEW YORK**  
**DATE OF ACCIDENT: 12 NOVEMBER 2013**  
**BOARD PRESIDENT: COLONEL DANA A. HESSHEIMER**  
**CONDUCTED IAW AIR FORCE INSTRUCTION 51-503**

**SUMMARY OF FACTS AND STATEMENT OF OPINION  
MQ-9 REAPER, T/N 09-4066  
12 NOVEMBER 2013**

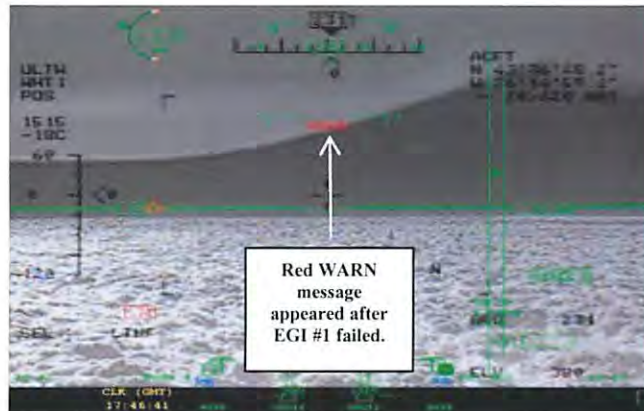
Figure 1. MCE GCS HUD (Tab AA-3)

At 12:46:25L, the MA's EGI unit #1 failed and began sending erroneous telemetry data (i.e., pitch, roll, yaw, latitude, longitude) to flight computer assembly (FCA) #1 (Tab DD-5). The EGI units provide aircraft position data by receiving signals from navigation satellites (Tab BB-50). An FCA is a single board computer capable of controlling the aircraft and receiving sensor data (Tab BB-42). Two seconds after EGI unit #1 failed, a number of warnings and cautions appeared on the head down displays (HDDs) for both members of the MCE (Tabs V-4.6, DD-5). The red "WARN" head up display (HUD) message was also present (See Figure 1) (Tab AA-3). Additionally, the artificial horizon line turned from green to red on the LRE GCS HUD (See Figure 2) (Tab AA-4).

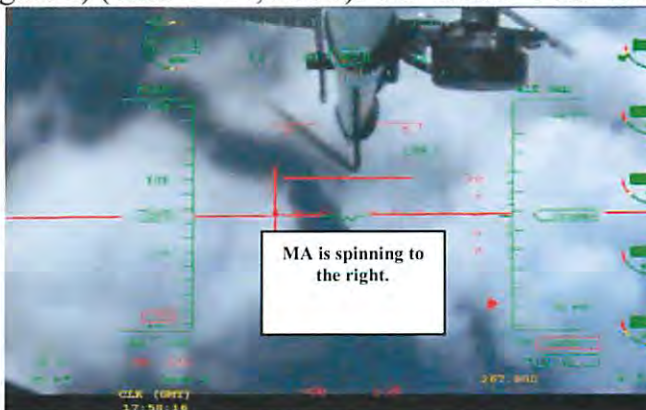
Figure 3. LRE HUD Snapshot of Spin (Tab AA-5)

P1 called Ops Sup who informed the MC that the MA had gone lost link (Tab V-5.7, V-6.6). The MC entered the LRE GCS and began to run the Gaining Handover Checklist at approximately 12:54L (Tabs V-7.8, AA-7). At 12:58:14L, EGI unit #3 failed and began sending erroneous telemetry data to FCA #3 (Tab DD-6). No additional cautions or warnings were generated (Tab DD-6). At 12:58:30L, IAW the Gaining Handover Checklist, MP enabled the GDT transmitter and gained control of the MA (Tabs V-5.9, AA-24). Approximately one to two seconds later, the MA began a pre-programmed autopilot command turn to the right (Tabs V-7.3, AA-8). It continued to turn to the right until completely inverted (Tab AA-8). Then it entered a right-hand spin (See Figure 3) (Tabs V-7.4, AA-8). MP stated "I can't recover it" (Tab AA-8).

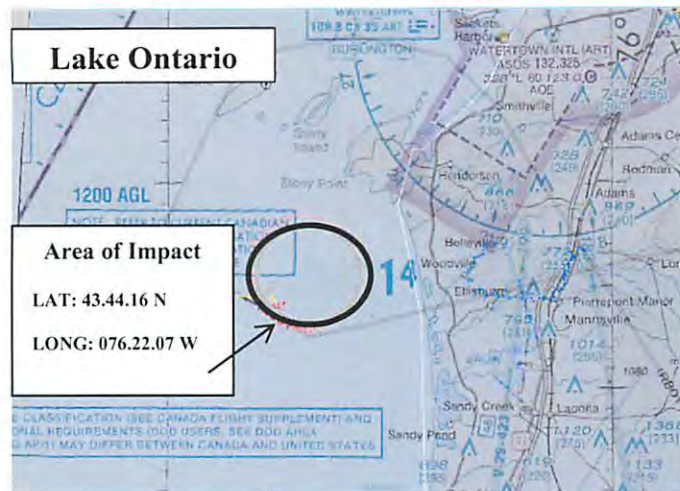
Figure 5. Last Known Position of MA, Lake Ontario (Tab DD-22)

The MA impacted Lake Ontario at approximately 13:01L (Tab AA-8). The point of impact was latitude 43.44.16 North (N), longitude 076.22.07 West (W), approximately 35 nm to the southwest of Wheeler-Sack AAF (See Figure 5) (Tabs AA-8, DD-22). The MA was completely inverted and spinning at the time of impact (Tab AA-8). It was destroyed upon impact, and the majority of its parts was not recovered (Tabs Q-6, AA-8).

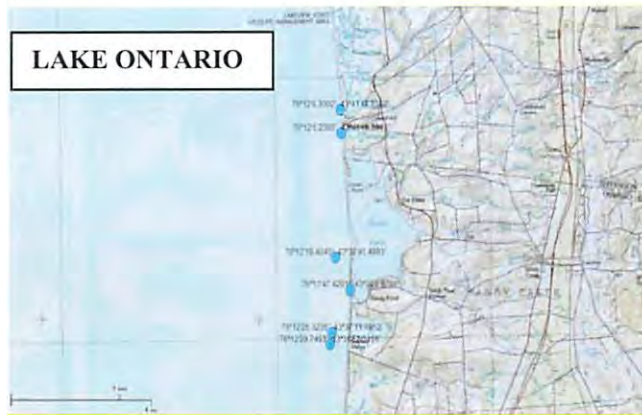
Figure 6. Debris Locations (Tab S-4)

The majority of the MA, including the EGI units onboard the MA at the time of the mishap, was not recovered from Lake Ontario (Tab AA-8). Approximately three days after the mishap, a few components (miscellaneous composite fuselage and control surface pieces) washed ashore (See Figure 7) (Tabs Z-3, AA-8). Figure 6 details the locations where these components were recovered (Tab S-4). There is no evidence to suggest the recovered parts contributed to the mishap.

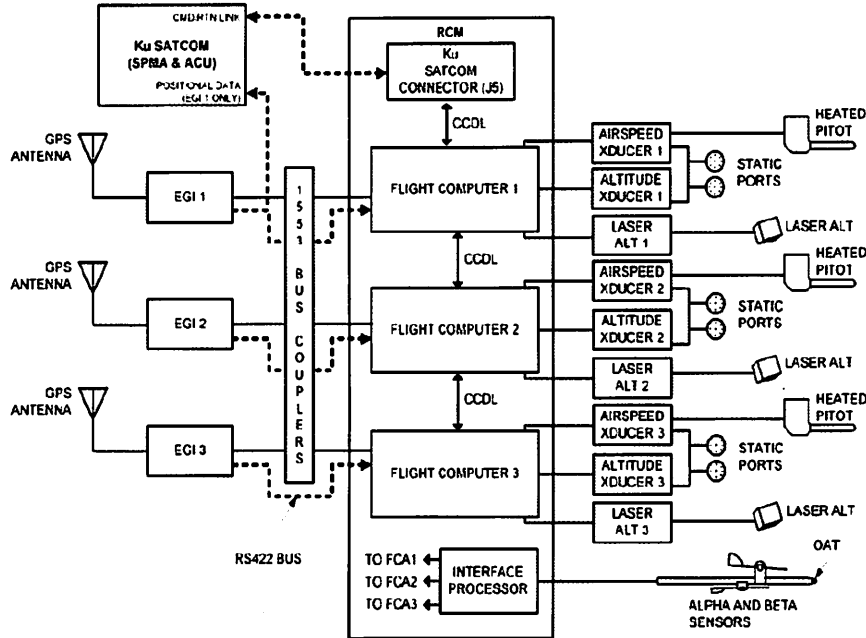
Figure 8. MQ-9 Attitude, Air Data, and Navigation System (Tab BB-44)

The three EGI units onboard the MA were manufactured by Honeywell Aerospace (Tab U-8). The EGI units provide aircraft level platform data for the attitude data system (Tab BB-44). Each EGI unit has accelerometers and a gyro that sense linear accelerations (i.e., speeding-up) and angular rates (rolling or turning) in relation to the three perpendicular axes (yaw, pitch, and roll) of the aircraft (Tab BB-44). Each EGI unit transmits its attitude data to its assigned FCA via a 1553 bus (Tab BB-44). An FCA is a single board computer capable of independently controlling the aircraft and receiving sensor data (Tab BB-42). Each of the flight computers receives attitude data from its paired EGI unit (Tab B-44). The 1553 bus is the primary information handler between the flight computers and the triple EGI units (See Figure 8) (Tab BB-44).

The redundant control module (RCM) is the heart of the aircraft’s digital control system, and the autopilot is an integral part of the RCM (Tab BB-28, BB-42). One of the functions of the RCM is to control the MA’s autopilot command generation and distribution (Tab BB-42). In essence, the RCM takes attitude data from the EGI units and sends control commands to the components or autopilot system (Tab BB-42, BB-58). Put simply, the RCM is the brain of the MQ-9 aircraft digital control system, generating valid data using the EGI units to give autopilot control commands (Tab AA-25). If an individual EGI malfunctions, an FCA can use EGI data from another FCA to provide input to the RCM (Tab BB-44). In theory, in the case of two EGI unit failures, the RCM should select “good” or valid quality data from another sensor, which prevents the use of invalid data from EGI units to generate autopilot commands (Tabs AA-25, BB-42). In the case of the MA, after the MA’s EGI unit #1 failed, the RCM continued to provide valid output using the remaining functioning EGI units #2 and #3 (Tab AA-25). When EGI #3 failed, the RCM should have stopped the selection process and selected data from the remaining functioning EGI unit #2 (Tab AA-25). However, the RCM did not use EGI #2’s input, instead, it

set all autopilot values to 0. The MA was unable to determine its attitude because of the invalid input to the control system from the RCM.
