**UNITED STATES AIR FORCE**  
**AIRCRAFT ACCIDENT INVESTIGATION**  
**BOARD REPORT**

**HH-60G, TAIL NUMBER 88-26109**  
**56TH RESCUE SQUADRON**  
**48TH FIGHTER WING**  
**ROYAL AIR FORCE LAKENHEATH**

**LOCATION: CLEY NEXT THE SEA, NORFOLK,**  
**UNITED KINGDOM**

**DATE OF ACCIDENT: 7 JANUARY 2014**

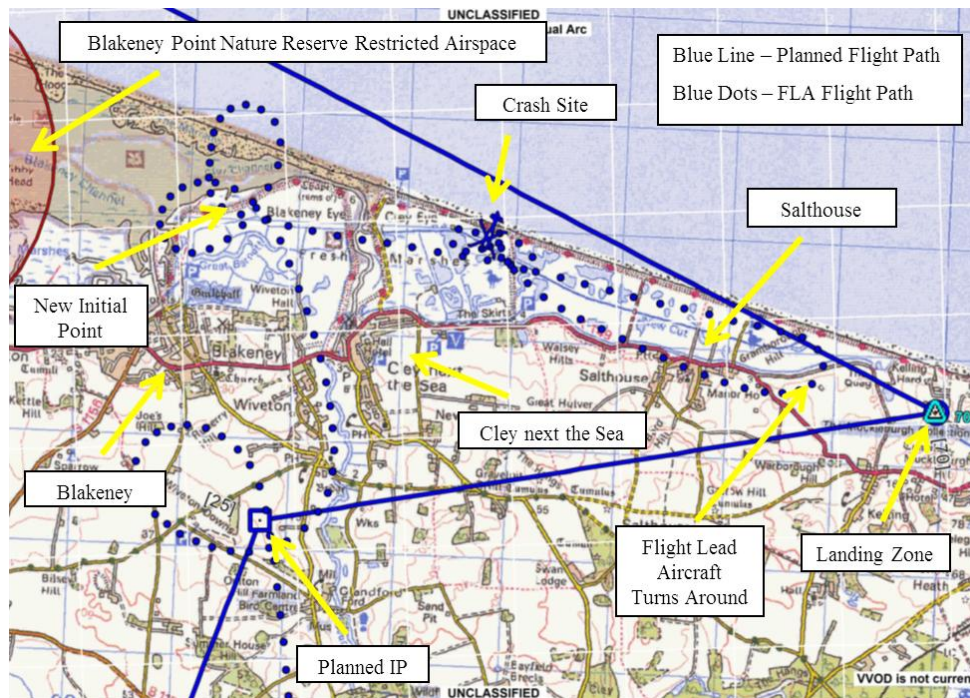
**Figure 2: Flight Path of the Flight Lead Aircraft (Tab S-16).**

The MF conducted simulated threat countermeasures en route to the IP (Tab S-15). Threat countermeasures are training maneuvers designed to train crews to react to various threats while in flight (Tab V-1.10). An IP is a pre-planned point where a helicopter formation enters a circular pattern, known as an orbit, where the crew conducts threat analysis, verifies the status of a downed pilot, and completes other mission-related tasks prior to picking up the downed pilot (Tab BB-132). The MF completed the simulated threat countermeasures without incident (Tab R-5 and R-30).

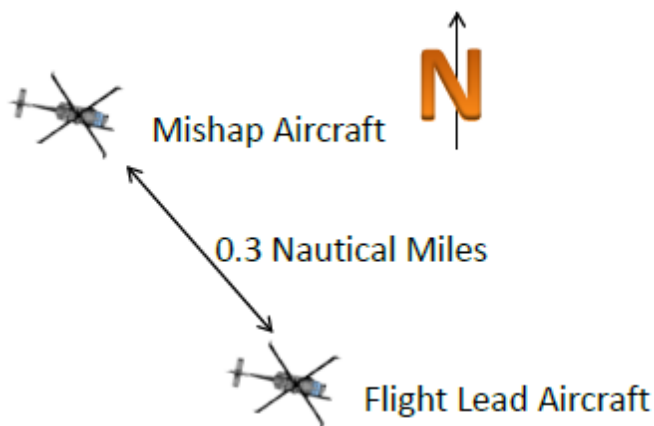
**Figure 3: Relative Position of the Mishap Formation after Departure from the Initial Point (Tab V-3.11).**

At some point during the MF's approach to the LZ, a flock of birds took flight from Cley Marshes. The sound of the approaching MF likely startled the geese (Tab V-13.2 to V-13.3). The geese took approximately one minute to reach 110 feet AGL—the altitude of the MA (Tabs V-13.3 and EE-6).

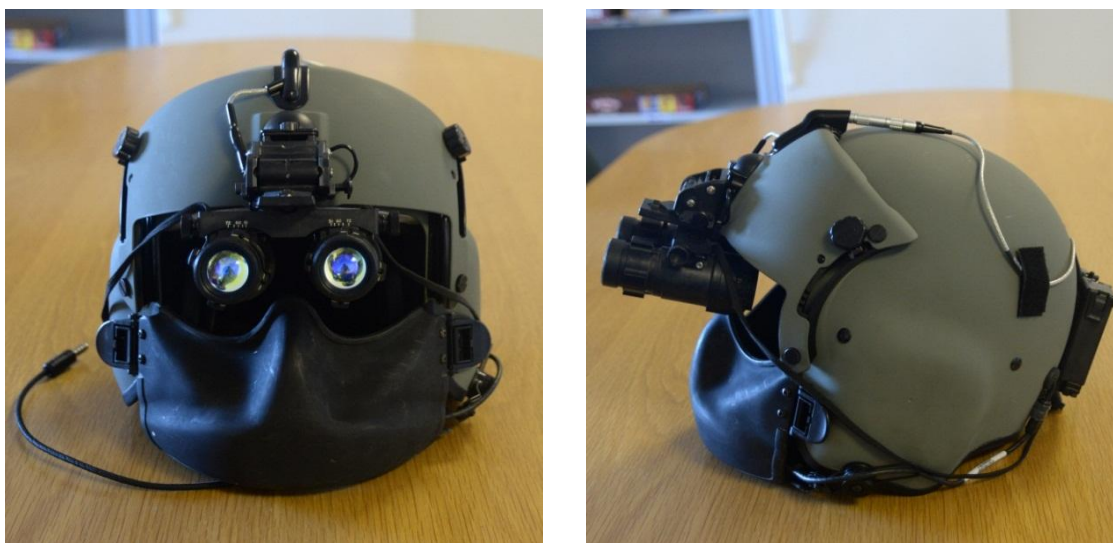
**Figure 4: ANVIS-4949 Night Vision Goggles Mounted to HGU-56/P Helmet (Front and Side Views) (BB-292).**

All four of the MC's NVGs were destroyed in the mishap (Tabs R-131, R-140 to R-141, V-1.17, V-1.21, V-4.15, V-4.18, and V-5.10).

Although the field of view seen through the NVGs worn by the FLC and MC may have limited the ability to sense motion from the geese, I did not find sufficient evidence to conclude the NVGs caused or substantially contributed to the mishap.

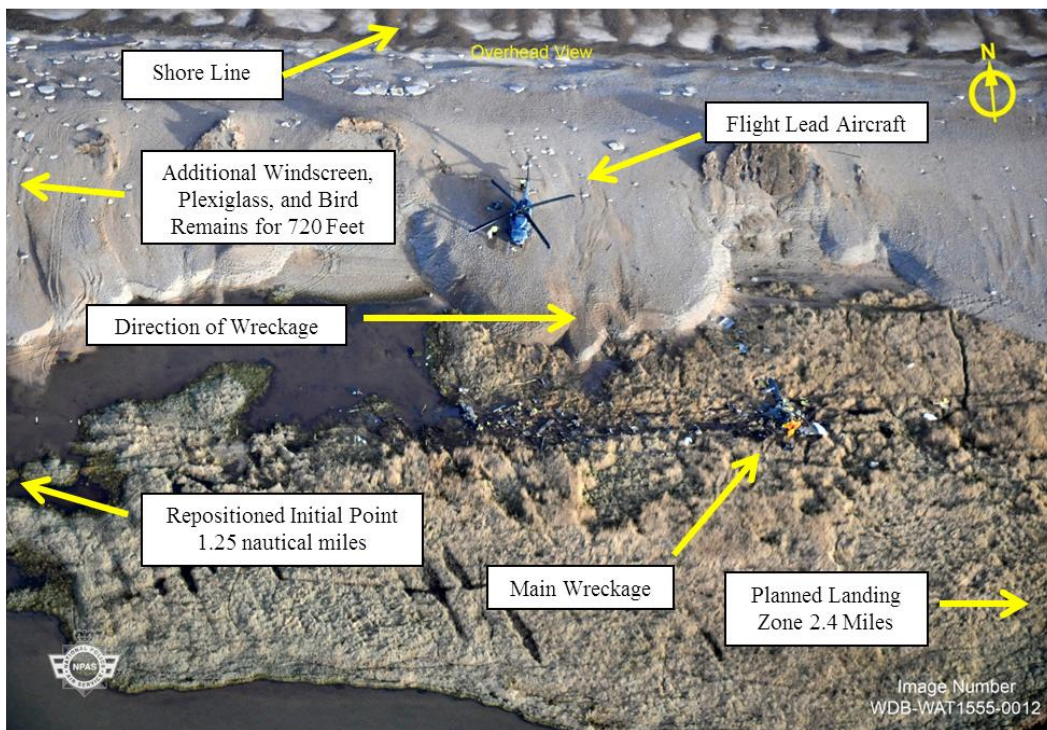
**Figure 5: Crash Site (Tab S-12).**

Almost immediately after the MA impacted the ground, FLAG announced to the FLC that the MA was no longer visible (Tab V-3.27). FLFE confirmed the MA could not be seen on his side of the aircraft (Tab V-3.27). The FLC immediately stopped all training, attempted to contact the MC by radio, and climbed to a safe altitude (Tab V-3.27). When the MC did not respond, the FLC circled back to Cley Marshes where FLAG noticed a small fire (Tab V-3.27).

The FLC acted as the initial emergency responders, circling back to search for the MA at approximately 1806L. The FLC spotted the MA on the ground and landed north of the crash site, approximately 3 minutes and 30 seconds after the crash (which is the time it took for the FLA to circle back to the mishap site) (see Figure 5 below) (Tabs S-16, V-4.17 and EE-4 to EE-5). FLFE and FLAG exited the FLA and began searching for survivors. FLP followed soon thereafter (Tab V-5.9 and V-5.10). FLCP began coordinating with RAF Lakenheath over the radio for emergency support at approximately 1809L (Tab V-3.27). The three crewmembers from FLA quickly found all four members of the MC and determined there were no survivors (Tab V-5.9 and V-5.10). FLC determined the tide would not affect the immediate area of the

crash site and left the MC in place for investigators (Tab R-7). The investigators covered the bodies in white sheets (Tab V-4.18 and JJ-17).

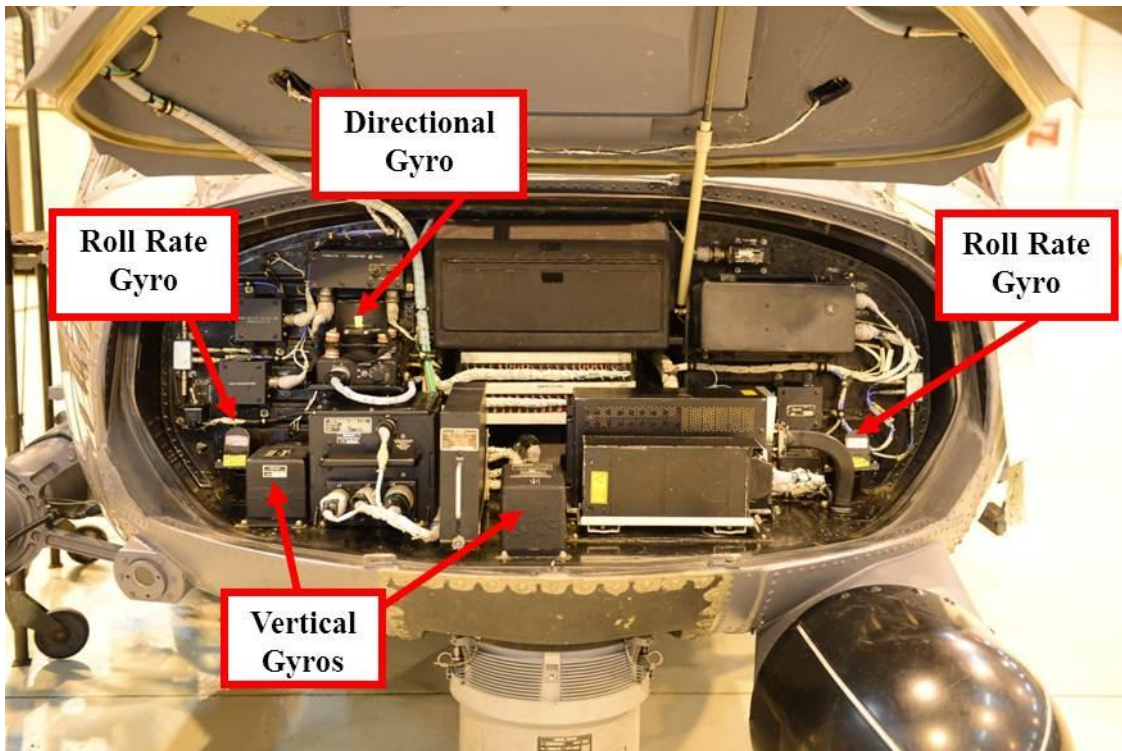
**Figure 8: Nose Compartment Avionics.**

At least one goose struck the nose of the MA, disabling the Trim and Flight Path Stabilization (FPS) systems—two key components of the Automatic Flight Control System (AFCS) (Tab EE-7). The AFCS helps improve aircraft performance by assisting the pilot with aircraft control. It has five subsystems. The Trim and FPS systems provide control positioning and force gradient functions, as well as basic autopilot functions when the FPS is engaged. The force gradient functions cause increasing resistance on the cyclic stick (which controls aircraft pitch and roll) the further the cyclic stick is moved from center (Tab BB-222). Because the impact from the geese rendered MP and MCP unconscious and disabled the Trim and FPS, the cyclic stick was free to move randomly (Tabs V-17.12 to V-17.13 and BB-220). The free-floating cyclic stick fell to the left, inducing a rapid left roll (Tab V-17.17 and V-17.18). Once the MA passed 50 degrees angle of bank, the MA began a descent and continued rolling (Tab BB-133). Simulator testing showed that the MA could not recover once it passed 50 degrees at 110 feet AGL (Tab EE-9 and EE-10). The MA continued to roll and descend (Tab EE-7).

The Trim system permits the pilot or copilot to fly the helicopter with light control force (Tab BB-224). When the Trim is engaged, the pitch, roll, and yaw systems are activated to keep the cyclic and tail rotor controls in a fixed position (Tab BB-224). The pilot can override the Trim system by making any control input, but it requires more pressure to be applied to the controls than it would without the Trim system engaged (Tab BB-238 and BB-240). Once pressure is released, the controls return to their previously trimmed positions unless the Trim system is taken offline or repositioned (Tab BB-224). If the Trim and FPS systems are offline, the cyclic can free-float and induce a rapid, un-commanded roll (Tabs MM-10 to MM-12 and V-17.20 to V-17.21). No pre-existing anomalies were noted in the Flight Control Systems (Tab J-16). No problems were noted with the AFCS system before the mishap (Tab J-16).

A certified Air Force Developmental Test Pilot (AFDTP) conducted a thorough ground test of the AFCS and focused particularly on the Trim and FPS systems. The tests verified the impact force from a bird strike to the front of the HH-60G could damage critical components, resulting in the Trim and FPS systems being disabled and taken offline.
