UNITED STATES AIR FORCE
ABBREVIATED AIRCRAFT ACCIDENT
INVESTIGATION BOARD REPORT

MQ-1B, T/N 07-3213
432D WING
CREECH AIR FORCE BASE, NEVADA

DATE OF ACCIDENT: 26 APRIL 2014

ABBREVIATED AIRCRAFT ACCIDENT INVESTIGATION MQ-1B, T/N 07-3213 JALALABAD AIRFIELD, AFGHANISTAN 26 APRIL 2014

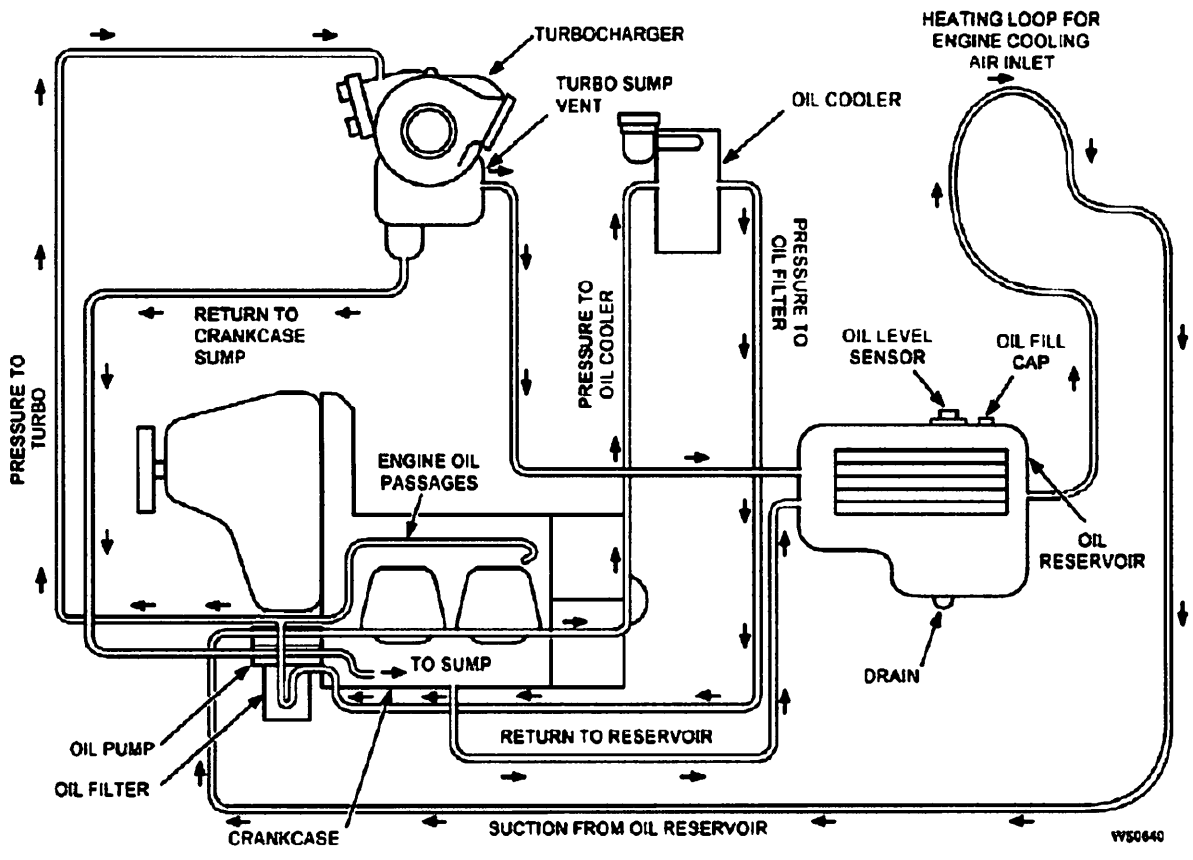
Figure 1. (Tab BB-6)

The MA's engine was manufactured by Rotax (Tab D-130). The MQ-1B engine oil system uses a dry sump, forced lubrication system to provide oil to all internal engine components (Tab BB-4). The oil system houses a 9-quart oil reservoir for the engine (Tab BB-4). The main oil pump draws engine oil from the oil reservoir, pressurizes the oil, and sends it through a line to the oil cooler (Tab BB-4). The oil is forced through the cooler and sent back down to the oil filter mounted to the side of the oil pump assembly (Tab BB-4). Pressurized oil is forced through the oil filter, through the oil pump assembly and distributed to the engine (Tab BB-4). In addition,

oil from the filter is fed through a separate line from the main pump assembly to the shaft bearings of the turbocharger (Tab BB-4 through BB-5). (See Figures 1 and 2).
