UNITED STATES AIR FORCE
AIRCRAFT ACCIDENT INVESTIGATION
BOARD REPORT

RC-135V, T/N 64-14848

LOCATION: OFFUTT AIR FORCE BASE, NEBRASKA

DATE OF ACCIDENT: 30 APRIL 2015

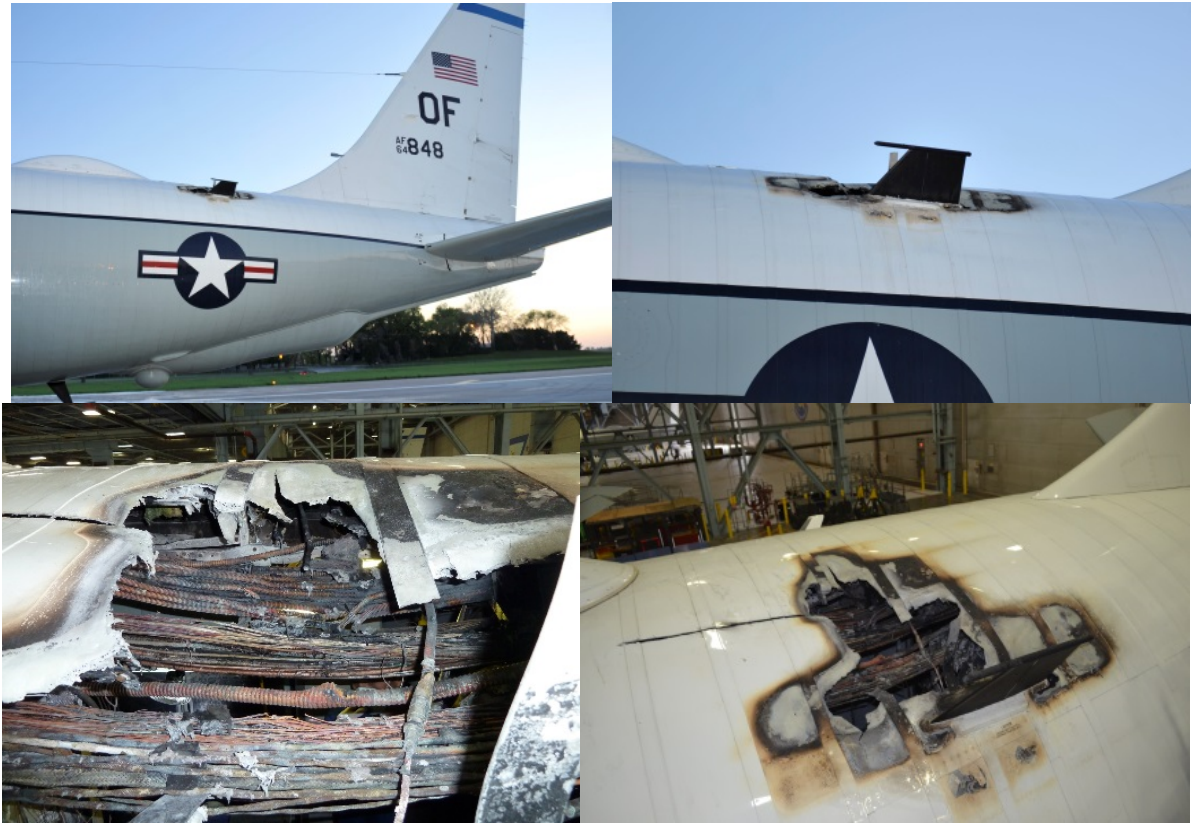
Figure 1. Damage to Fuselage (Tabs S-1.11, Z-1.4, Z-1.5, Z-1.7)

Damage to the MA was photographed immediately following the mishap (Tabs S-1.1 through S-1.5). The aircraft sustained substantial structural damage, including fire damage to several vertical and lengthwise structural components to the fuselage known as frames and stringers.

The fire also burned a sizable hole through the aircraft skin (Tabs S-1.11, Z-1.4, Z-1.5, Z-1.7).

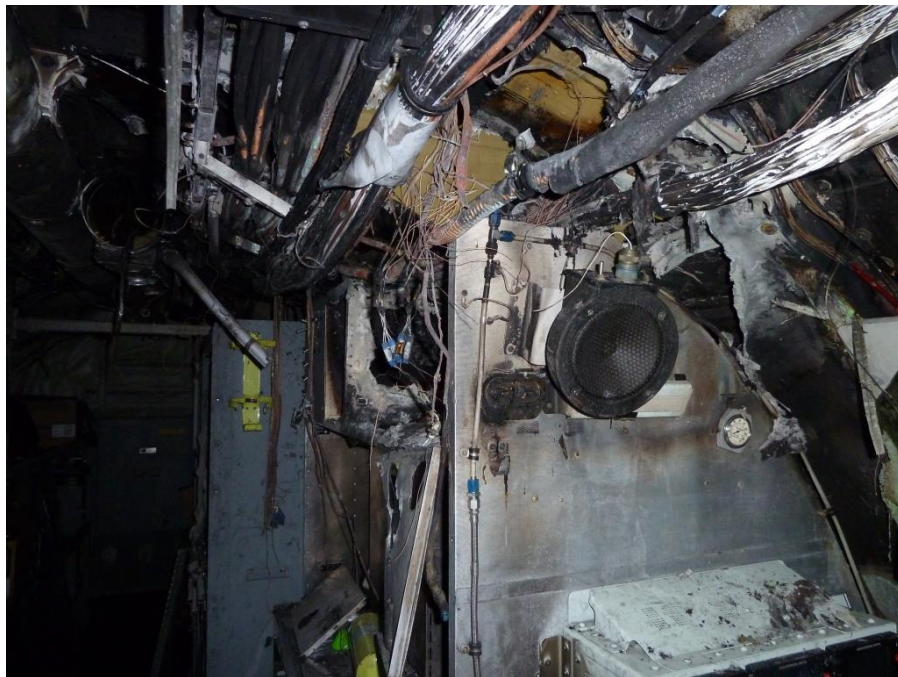
Figure 3. Galley Area of T/N 64-14848 (Tab S-1.9)

The mishap rendered a number of aircraft systems inoperable (Tab S-1.9). The MA sustained substantial damage to the oxygen system and electrical input to the rudder power control unit. An antenna located at the site of the hole in the fuselage was also damaged (Tabs S-1.2, S-1.9 through S-1.11). Portions of the crew rest area in the rear compartment and the entire aircraft galley were severely damaged (Tab S-1.3). See Figures 2 and 3. Additionally, the fire caused substantial damage to a number of aircraft mission systems (Tabs S-1.3, S-1.11).

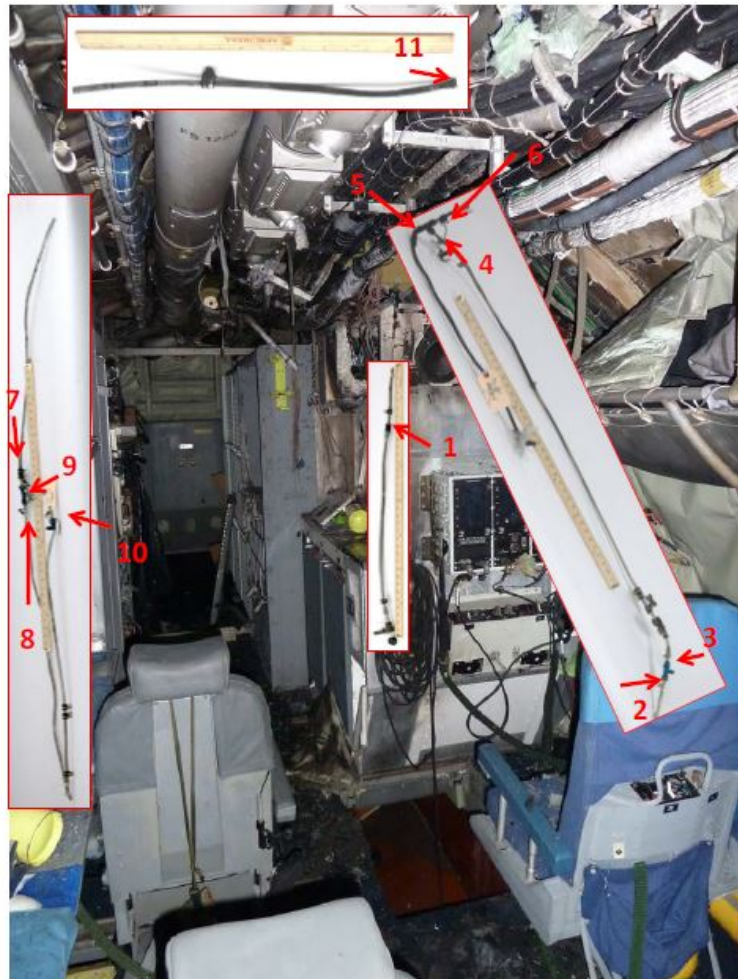
Figure 4. Oxygen System Tubing (Tab J-26).

Figure 4 shows components of the oxygen system superimposed on an image of the MA. Figure 4 also has a numbering system for the junctions (also called joints or fittings) that will be used for reference in this report (Tab J-26). Prior to the mishap, Junction #5 was connected to Junction #11 via flex hose (Tab J-31).

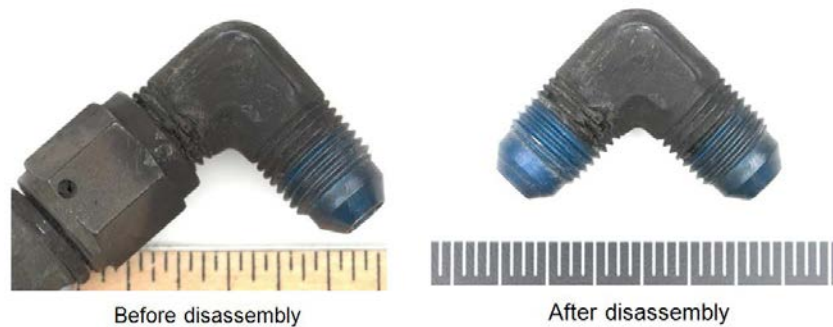
Figure 6. Elbow Fitting (Tab J-29).

revealed there was no B-nut on the other side of Junction #11 (Tab J-8). A fragment of the missing B-nut was discovered in the debris (Tab J-8). Analysis of the fragment indicated that the B-nut had melted (Tabs J-8, J-29). There was no evidence that the B-nut had forcibly passed over either the sleeve or the flared end of the corresponding tube (Tab J-8).

Figure 6 shows the male threaded end of the elbow fitting where the B-nut at Junction #11 should have been located (on the right side of the elbow) (Tab J-29). Upon disassembly of the fitting, difference in colors of the threads between the protected side (left) of the elbow fitting and the missing B-nut side (right) indicate that the left side was exposed to some combustion products (such as soot), but not as much as the missing B-nut side (Tab J-29).

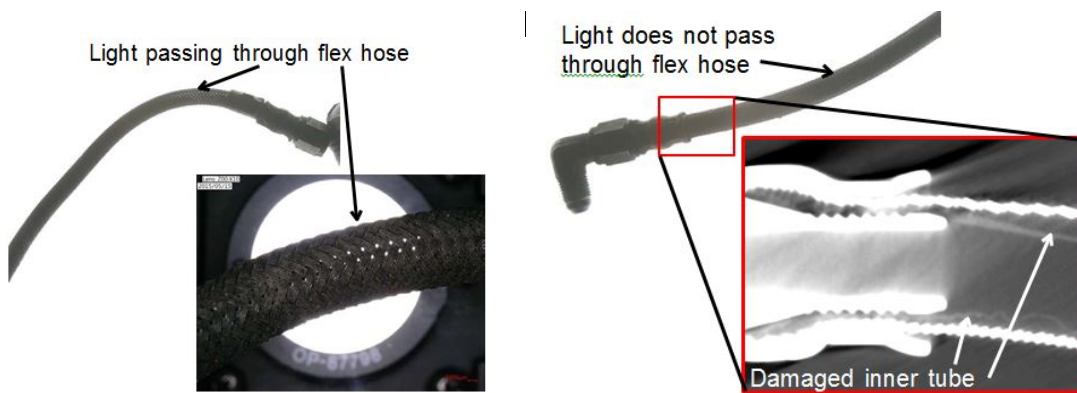
Figure 7. Flex Hose Between Junction #5 (Left) and Junction #11 (Right) (Tab J-31).

Further examination of the tubing system showed the inner liner of the flex hose between Junction #11 and Junction #5 was destroyed (Tab J-8). See Figure 7. Light passing through the flex hose indicates the inner tubing is completely destroyed near Junction #5 (Tab J-31). Images of the flex hose near Junction #11 shows rumpling deformation on the inner tube, indicating exposure to heat (Tab J-31).

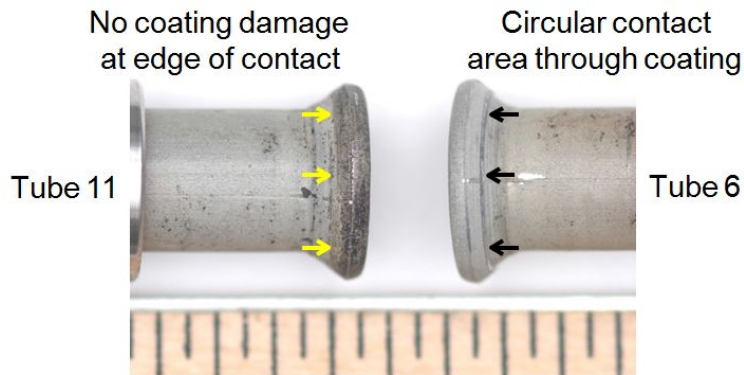
Figure 8. Flared Tube Ends (Tab J-35).

Examination of the flared ends of the tubes for each fitting indicated they all had a circular contact impression from the sleeve, through the tube coating to the base metal, except the flare at Junction #11 (also referred to as Tube #11) (Tabs J-10, J-35). See Figure 8. While the torque value at Junction #11 could not be measured due to the melted B-nut, the lack of a contact scar on Tube #11 indicates it had the lowest torque value of all the fittings examined (Tabs J-10, J-12, J-

35).

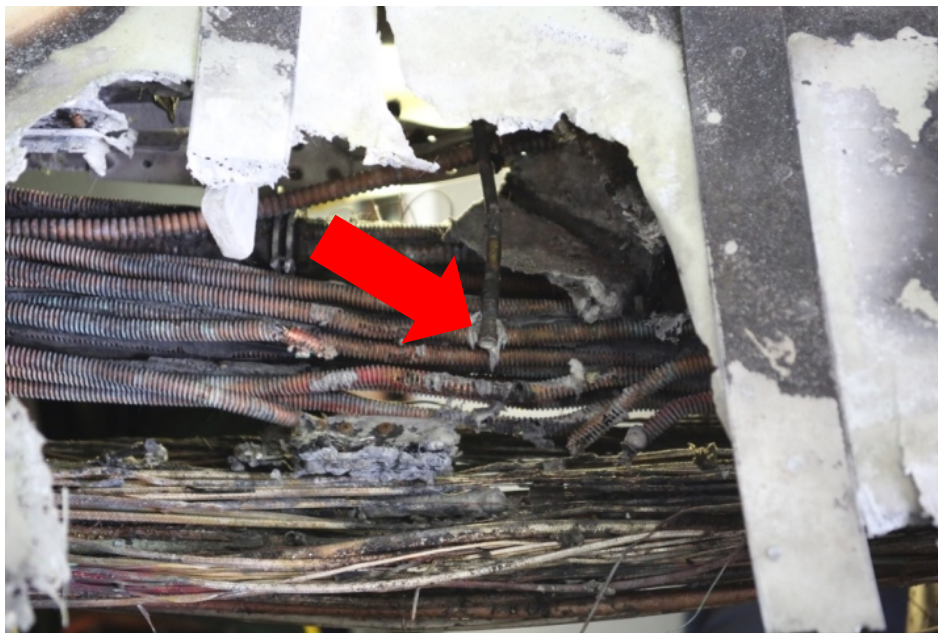
Figure 11. Location of Tube #11 Prior to Removal (Tabs J-26, S-1.9, Z-1.1 through 1.3).

Additionally, the sleeve located at Junction #11 had significant pitting (i.e, tiny holes or “pits”) on one side (Tab J-10). The pitting on this sleeve indicates the damage was directional, since it was present on one side and not the other (Tab J-10). Pitting was also found more frequently on one side of the corresponding Tube #11, just past the area the sleeve covered (Tabs J-10, J-38). No pitting damage was found beneath the sleeve (Tab J-10). The damaged B-nut fragment also had localized melting, which is consistent with damage on one side of the tube, starting at the shoulder of the B-nut (Tab J-11). Physical evidence indicates the area of high heat was localized, causing damage predominantly to one side of the sleeve and Tube #11 (Tabs J-11, J-35). The location of Tube #11 prior to removal from the MA is shown in Figure 9 (Tabs J-26, S-1.9, Z-1.1 through 1.3).

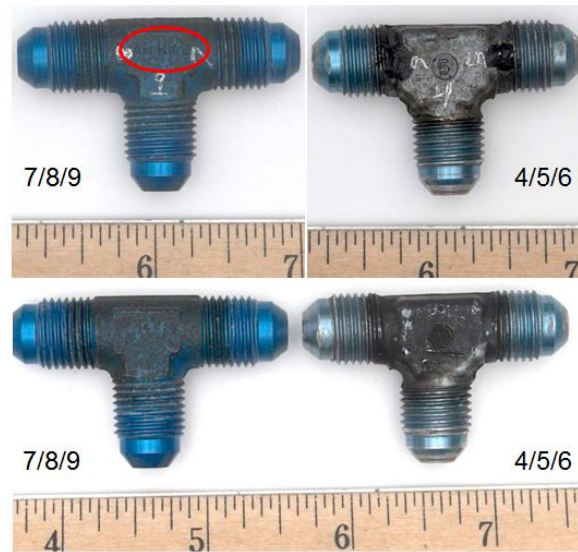
AFRL/RXSA also determined that the T-shaped fitting connecting Junctions #4, #5 and #6 (4/5/6 fitting) lacked required letter markings and appeared to have a parting line and a rough surface (Tab J-10). See Figure 10. Parting lines and rough surfaces are both typical of a casting, whereas a machined or forged part is required by the specifications (Tab J-10). The 4/5/6 fitting also showed uneven wear patterns, nicks, gouges, and large areas of exposed metal which would also be cause for rejection of the fitting (Tab J-10). AFRL/RXSA determined that fittings similar to the 4/5/6 fitting were last manufactured in 2003 (Tabs J-10, J-34).

Figure 10. T-Shaped Fittings. Red circle indicates a correct marking (Tab J-34).
