UNITED STATES AIR FORCE
AIRCRAFT ACCIDENT INVESTIGATION
BOARD REPORT

F-16C, T/N 89-2019, and F-16C, T/N 89-2034

**125TH FIGHTER SQUADRON
138TH FIGHTER WING
TULSA AIR NATIONAL GUARD BASE, OKLAHOMA**

**LOCATION: MOLINE, KANSAS
DATE OF ACCIDENT: 20 OCTOBER 2014**

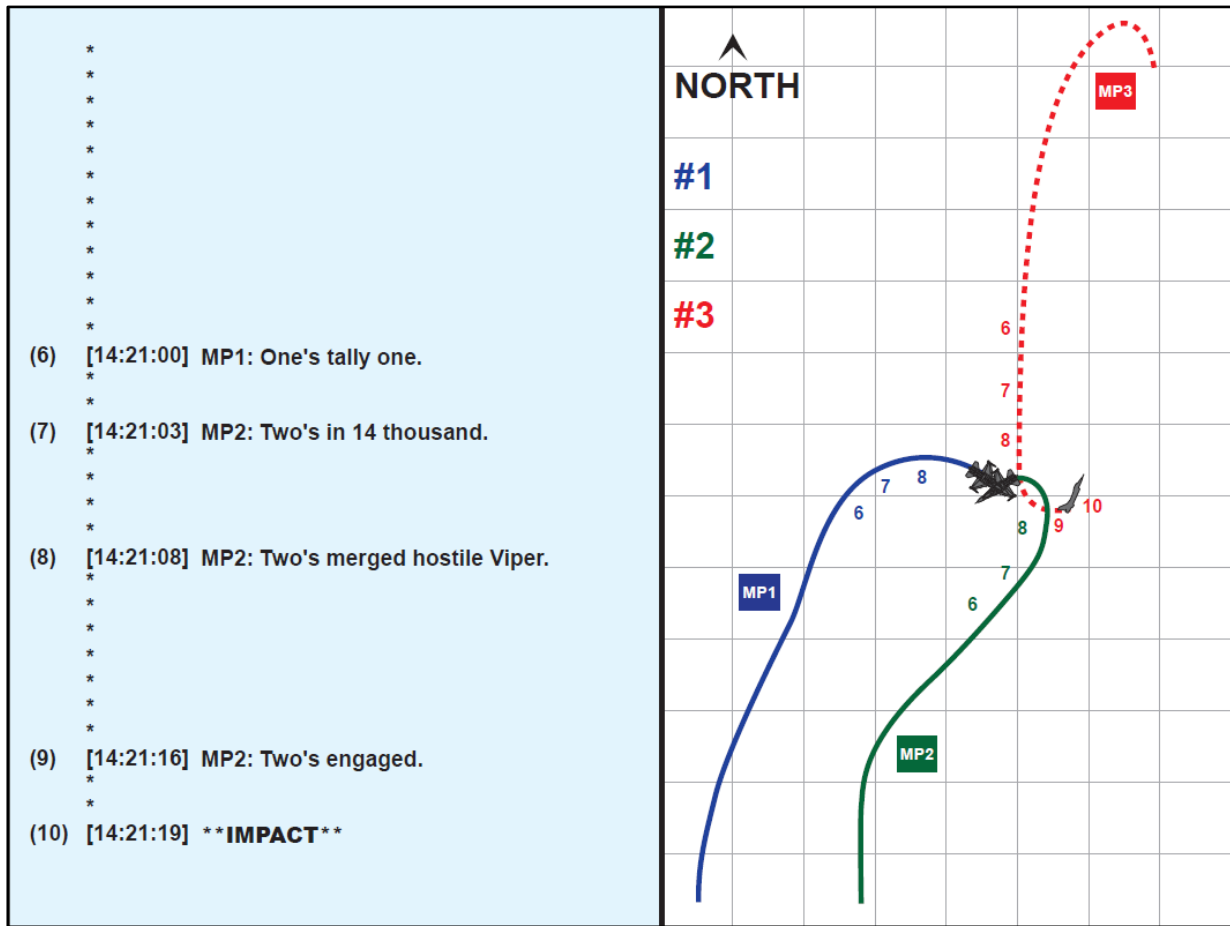
Figure 2: Mishap Engagement Illustration Second Half

The ME rejoined and continued south for twenty-one seconds (Tabs N-4 and V-1.5). They hooked right, back to the north in their cap while they assessed fuel state (Tabs N-4 and V-1.5). The second engagement began at 14:20:17, when MP1 picked up radar histories and directed MP2 to target that group (Tabs N-4 and V-1.5). The adversary was 15-20 NM off their nose, which was shorter than planned (Tabs N-3, J-4 and V-4.5). MP2 called targeted at 14:20:26 (Tab N-4, and V-7). MP1 then directed MP2 to bracket right to the east (Tab N-4). The mishap element (ME) maneuvered in an offensive manner in order to identify, and if hostile, attack the adversary (Tab V-1.5). MP2 called that he was targeted by the adversary and defended to the northeast (Tabs N-4 and V-1.5). At this point, MP2 was the most defensive fighter (Tabs N-4, V-1.5). MP1 could have given MP2 the EF role by calling "2 PRESS" at any point from now until MP2 merged (as in opposite traffic on a two lane highway) with MP3; however, he did not initiate a role exchange (Tab V-2.9). MP1 acknowledged that he should have initiated a role exchange to give the engaged fighter responsibilities to MP2 since he was clearly the most defensive fighter in accordance with AFTTP 3-3, but did not initiate this role swap (Tab V-2.9). MP2 did not defend effectively enough to defeat MP3's radar, so MP3 continued to attack MP2 as per the briefing (Tabs V-4.3 and V-4.4). At 14:21:00 MP1 called "1's TALLY ONE" to indicate that he is in sight of the adversary, but unable to make a declaration of hostile intent (Tab N-4). MP1 turned into the adversary to be in a position to take a shot if MP2 identifies the adversary as hostile (Tab DD-9). MP2 called "TWO's IN 14 THOUSAND" at an altitude of 14,600 feet at 14:21:03, three seconds after his "TALLY" call (Tab N-4, DD-9). During an interview with MP2, he stated this call was made to inform MP1 that MP2 was maneuvering into the fight; however, MP2 subsequently acknowledged this was an incorrect and mistimed call. The correct term would have been "greasing in" (Tab V-3.18 through V-3.19). At this point,

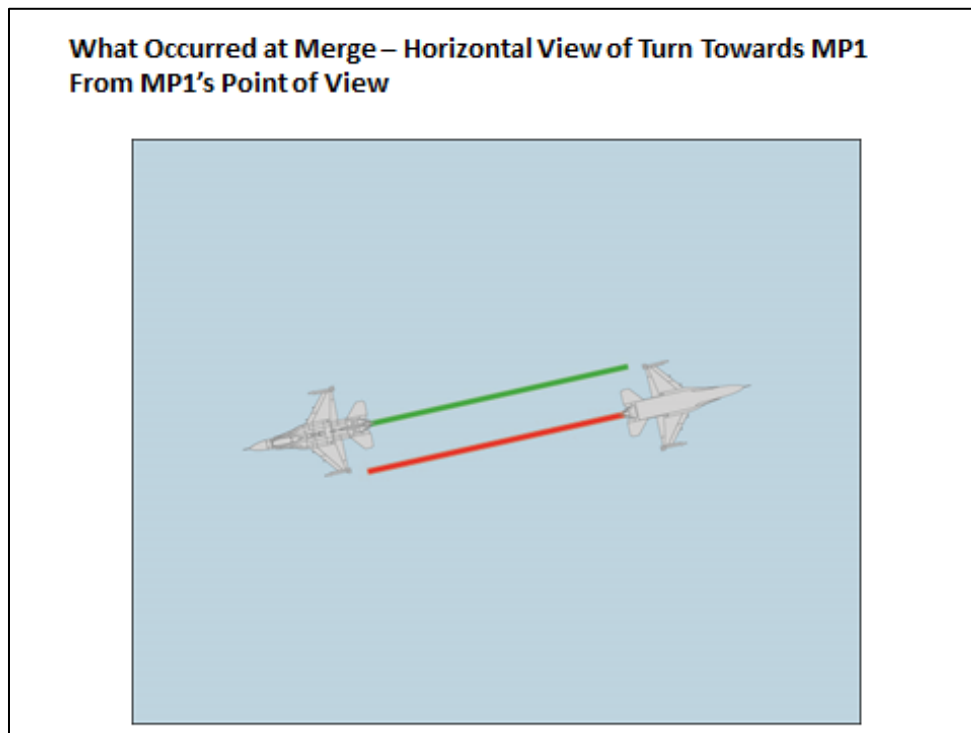
Figure 5: Horizontal View of MP1 #2

MP2 did not call “blind” during the engagement and focused exclusively on MP3 following his “2’S IN 14 THOUSAND” call (Tabs BB-8, N-4, V-3.24). MP2 never saw MP1 prior to the collision and described the impact as passing through jet wash (Tab V-3.5). After impact, MP3 initiated a “knock-it-off” call several times to end the fight (Tabs N-4 and N-5). While recovering his aircraft, MP2 saw MP1’s aircraft trailing white smoke and appeared as though it was skidding across the ground with a high angle of attack (Tab DD-9, V-3.5). At 14:21:32, MP2 realizing MA1 had departed controlled flight, called “BAILOUT, BAILOUT, BAILOUT” in an effort to convince or direct MP1 to eject from the aircraft (Tab N-5).

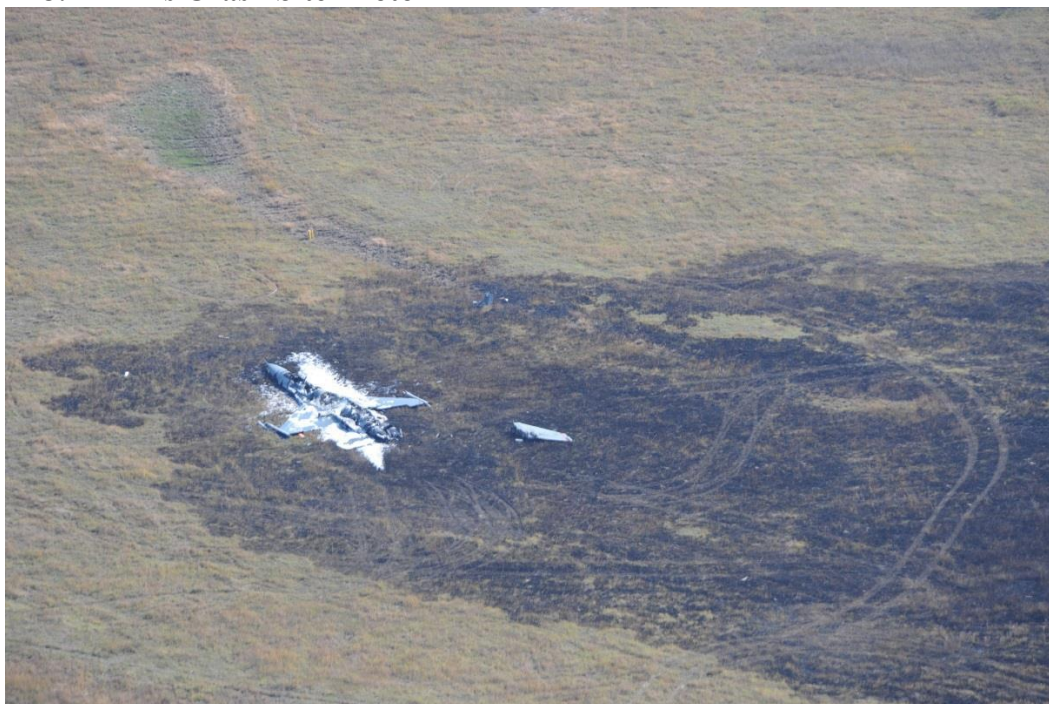
FIGURE 8: MA1's Crash Site Photo

MP1's crash site was located in southeastern Kansas, approximately three miles north of the town of Moline, approximately 76 NM, 335 degrees True of Tulsa ANGB, OK (Tab J-4). The crash site was grassy and relatively flat (Tab J-4). The aircraft hit the ground on a heading of approximately 060 degrees True with essentially no forward velocity as indicated by a witness mark under the pitot probe (Tab J-4).

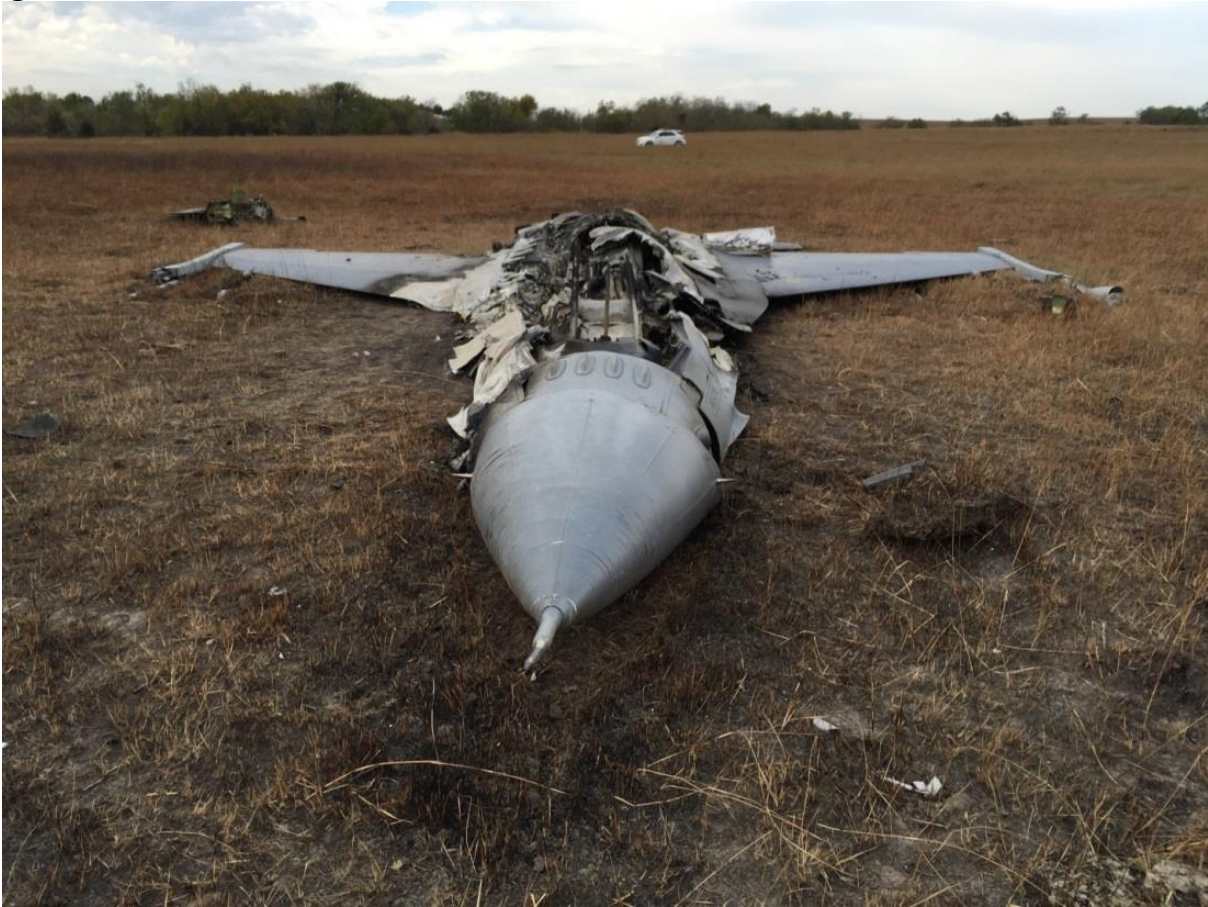
Figure 10: MA1's Crash Site Photo #3

The lower portion of the fuselage was crushed due to ground impact and the entire fuselage was further damaged due to post impact fire (Tab J-5).

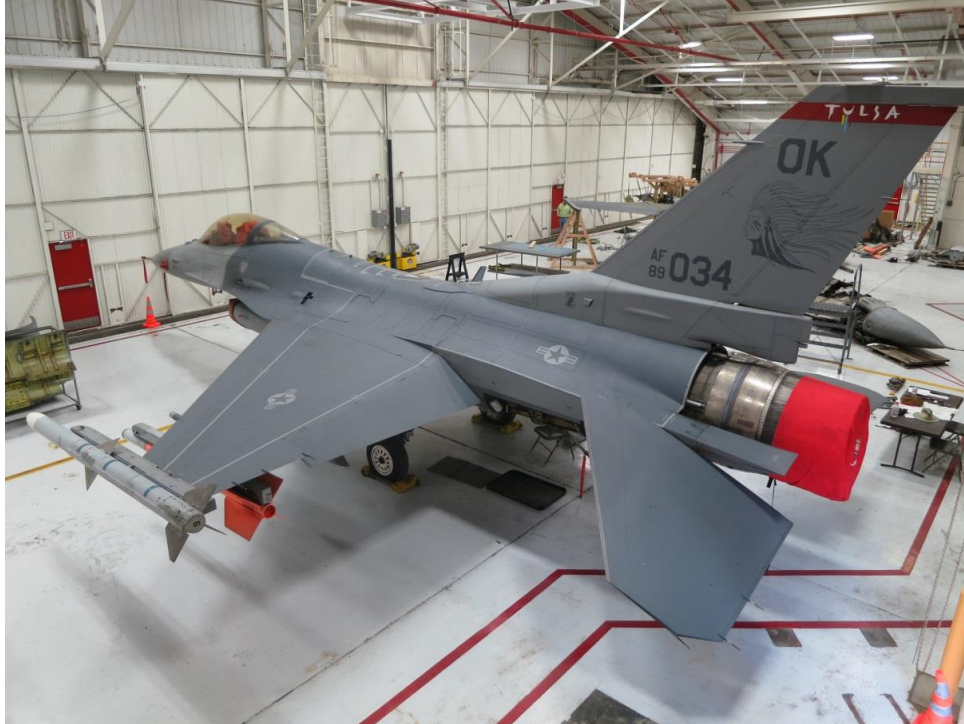
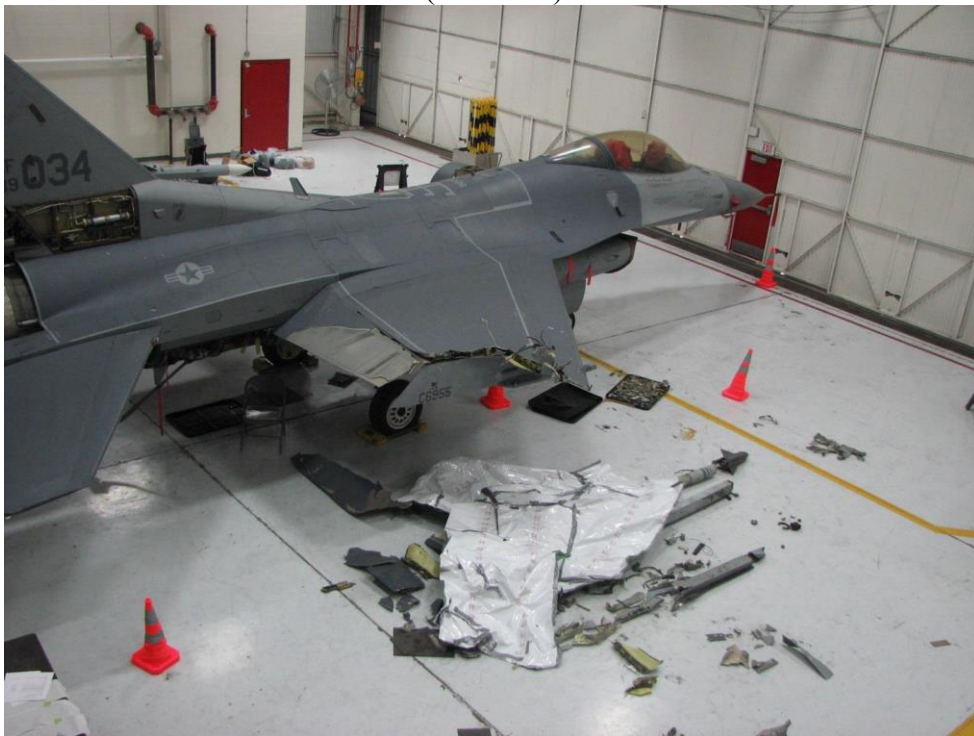
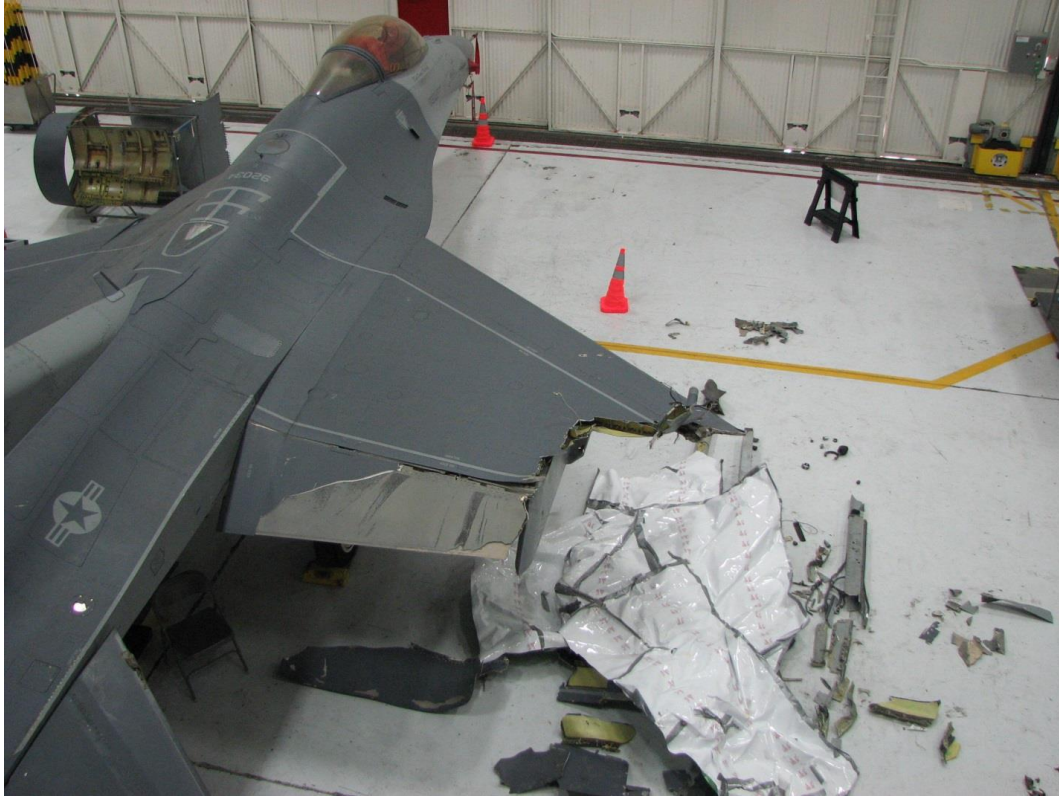
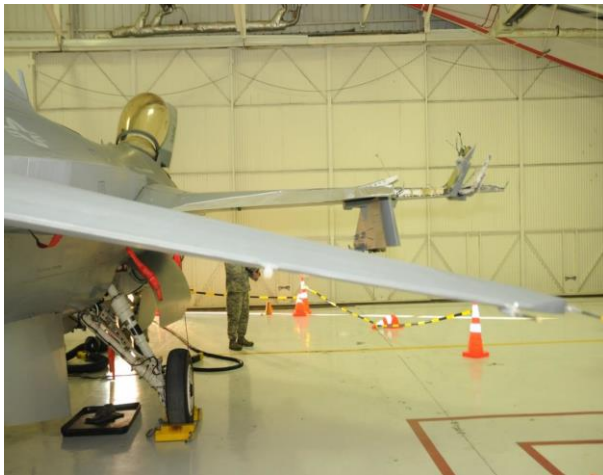
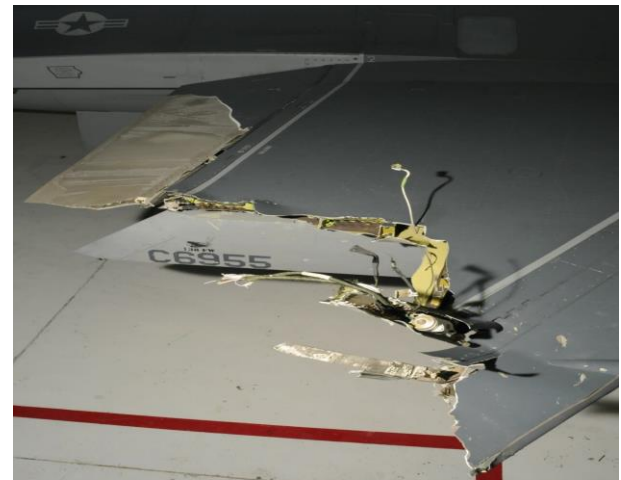
Figure 9: MA2 Post-Mishap

MP2’s right wing was severed outside of Station 7, about five feet from the end of the wing (Tab J-6). He joined with another F-16C, call sign Loco 3, another aircraft that was not part of the MF (Tabs N-7 and V-3.37). They performed a controllability check over an unpopulated area before making the decision to return to Tulsa ANGB (Tabs N-8, V- 3.38 through V-3.40 and V-5.3). It was determined during the controllability check that MA2 was controllable at approach and landing speeds, even though part of the right flaperon was missing (Tabs V-3.39 and V-5.3). MP2 landed safely without further incident out of a visual straight-in approach (Tab V- 5.3).

MA2 was flown back to Tulsa ANGB with nearly five feet of the right wing missing (Tabs V-3.39 through V-3.40 and V-5.3). Many pieces of the missing wing material were recovered in the debris field near Moline Kansas (Tab S-16).
