UNITED STATES AIR FORCE
AIRCRAFT ACCIDENT INVESTIGATION
BOARD REPORT

F-16CM, T/N 91-0375

DATE OF ACCIDENT: 1 DECEMBER 2014

SUMMARY OF FACTS AND STATEMENT OF OPINION
F-16CM, T/N 91-0375
1 DECEMBER 2014

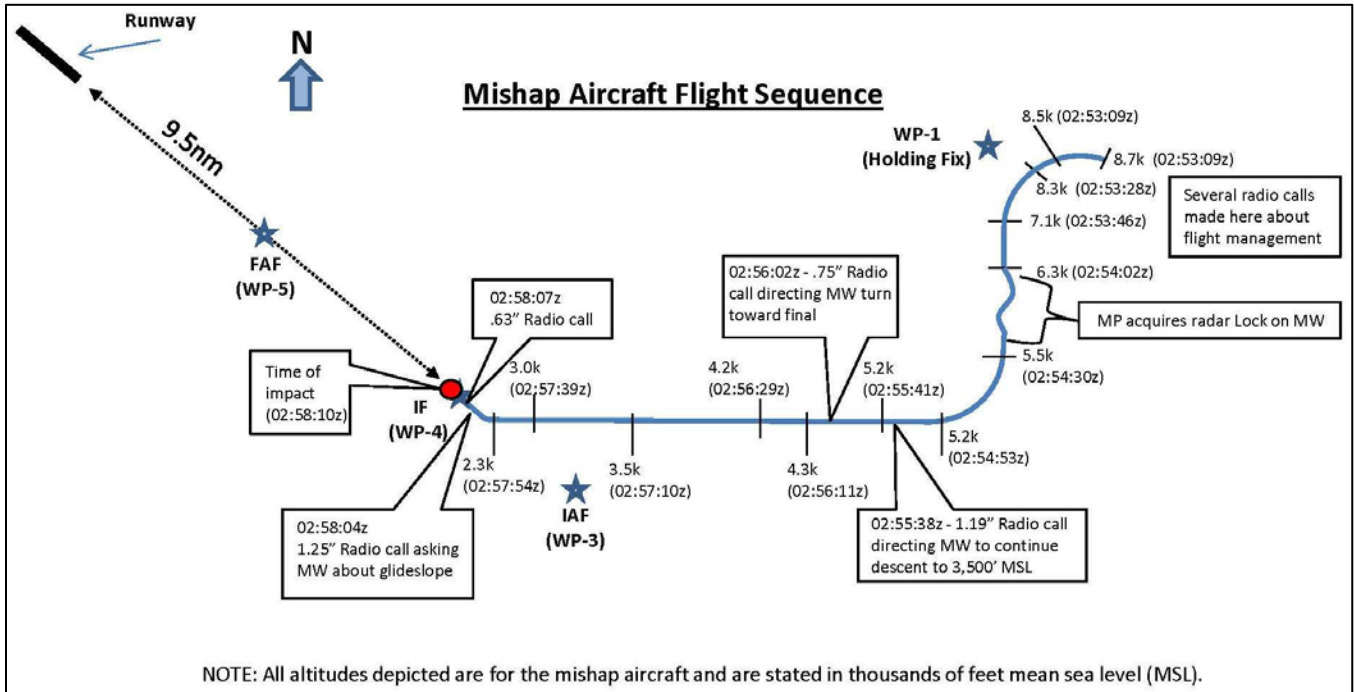
Figure 1. Visual Representation of last 5 minutes, 1 second of MA's flight (Tab Z-3)

At 02:57:39Z the MP passed through 3,000’ MSL while still heading west with the throttle set near idle and a descent rate of approximately 2,700 feet per minute (FPM) (Tab L-2). During the last 32 seconds of flight, from 3000’ MSL to impact, the MA maintained a continuous descent (Tab L-2). At 02:57:54Z, 16 seconds from impact, descending through 2,300’ MSL, the MP turned approximately 40 degrees to intercept final approach course, using up to 42 degrees of bank (Tab L-2). Near the end of this turn, 6 seconds prior to impact, the MP called the MW on the radio to ask if he was receiving the ILS glideslope (Tabs L-2, R-6, S-22). During the last second of flight, the MP initiated a 4G level pull away from the ground. However, this action was executed too late to avoid impact with the ground (Tabs L-2, S-22).

The MA impacted the ground at 02:58:10Z with landing gear extended and lined up on the approach course, 9.5 nm short of the end of the landing runway (Tabs M-7, S-3, AA-13). At last recorded data, 0.5 seconds prior to impact, the MA's flight parameters were: 1,760' MSL, zero degrees pitch, 2,220 fpm vertical velocity down, 216 kts calibrated airspeed, engine revolutions per minute (RPM) at 83%; and 4G's, with 4,300 pounds of fuel remaining, (Tab L-2). Weather reported at the airfield at the time of impact was 12 kilometers (km) visibility, winds variable at 3 kts, skies clear, and illumination of 2.68 mlx, extremely dark (Tabs F-8, W-3).

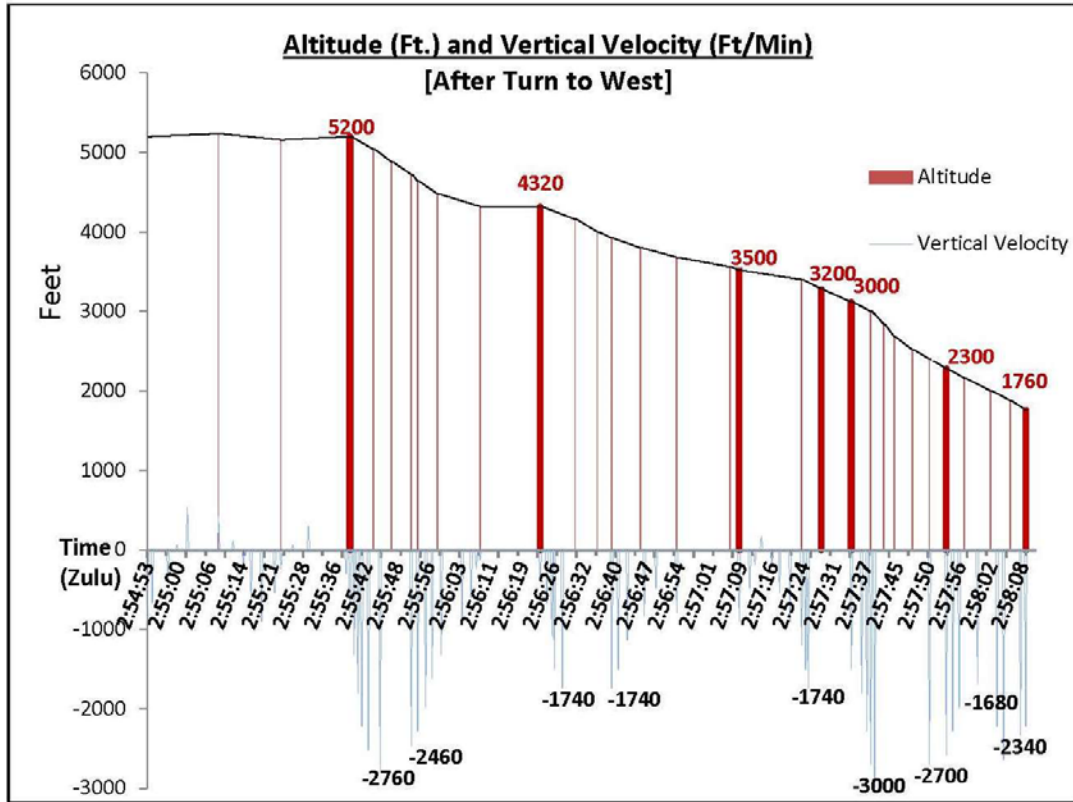
Since the vestibular system registers accelerations, it would stop providing inputs once a relatively steady descent was reached (Tab AA-40, AA-43 through AA-44). Any attempt to decrease or arrest the steady descent would cause the body to sense a pitch up/climb (Tab AA-43 through AA-44). If the pilot does not monitor attitude, altitude, and VVI during this critical time, the vestibular illusion can cause him to put the aircraft back into a descent (Tab AA-44). This vestibular illusion is also known as the "elevator illusion" referencing the common circumstance of a long elevator descent with no visual references (Tab AA-38, AA-43).

Figure 2 displays a variety of MA flight parameters over time. Figure 2-1 charts altitude and vertical velocity. Figure 2-2 charts airspeed and throttle position (from the lowest power setting of "idle" to the highest power setting without afterburner of "military," or "MIL"). According to the flight path data, the MA passed through 3,100' MSL in a steady 1,500 fpm descent (Tabs L-2, S-22). The MP then pushed the stick forward and increased his descent angle (Tabs L-2, S-22). Pursuant to AFMAN 11-217, V1, page 160, had the MA been at 3500' MSL, then the MP's flight control inputs would have been the correct actions to descend to 3,000' MSL, however, the MA was already in an unrecognized descent (Tab BB-31). Given the MP's unperceived 1,500 fpm descent rate from the ongoing elevator illusion, his flight control inputs further increased the actual descent rate to between 2000-3000 fpm (Tabs L-2, S-22). At 2,300' MSL (160' above ground level (AGL)) and sinking at 3,000 fpm, the MP turned to the right, and increased power in a 1.3G turn to the final approach course (Tabs L-2, S-22). Without a thorough instrument visual scan, this additional G Force would stimulate the MP's vestibular system to register another false pitch up sensation exacerbating the elevator illusion and reinforcing the decision to continue the descent (Tab AA-42 through AA-44).
