UNITED STATES AIR FORCE
AIRCRAFT ACCIDENT INVESTIGATION
BOARD REPORT

F-16CM, T/N 88-0518

**421ST FIGHTER SQUADRON
388TH FIGHTER WING
HILL AIR FORCE BASE, UTAH**

OF ACCIDENT: 29 MARCH 2016

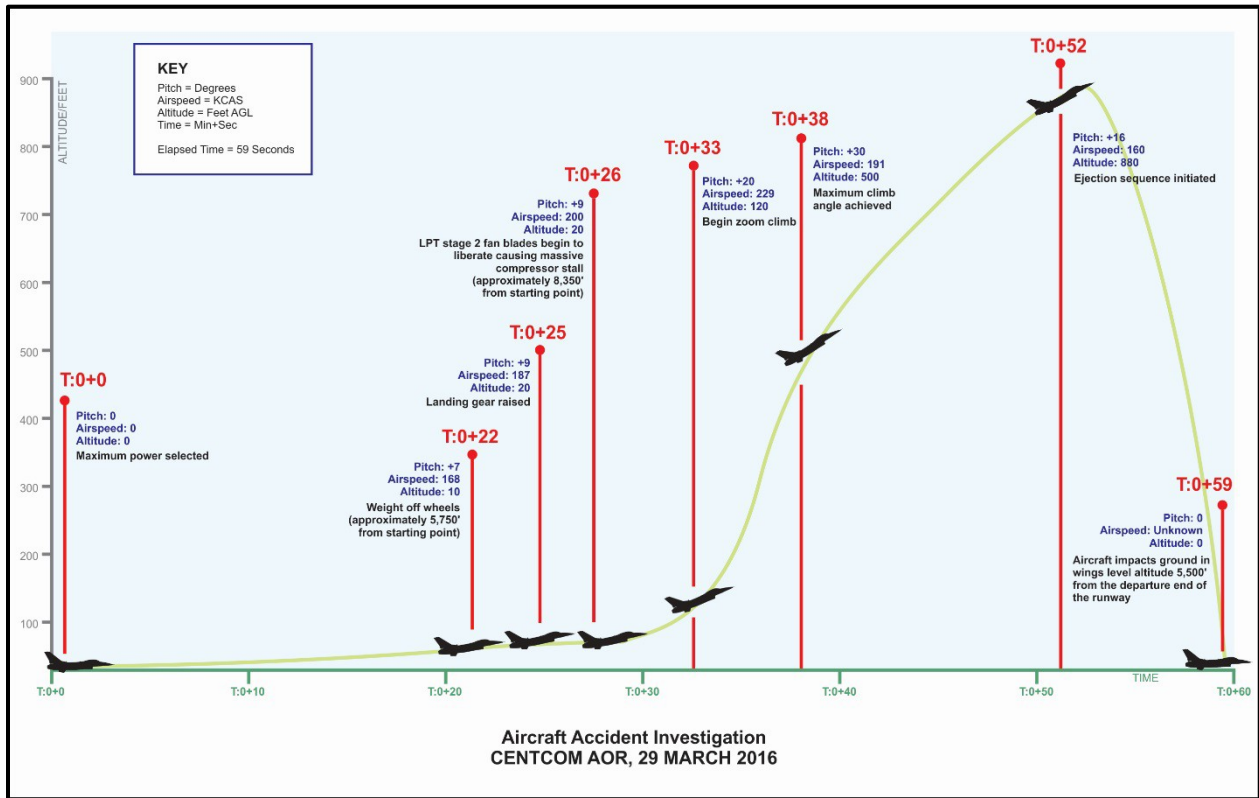
Diagram 1. CENTCOM F-16 Mishap Flight Path (Tab Z-2)

During take-off roll, the MA had good thrust and the MP found the ME to be working properly with all engine instruments indicating normal readings (Tab V-1.5). The MA accelerated at a normal rate, and the MP rotated the aircraft approximately 17.5 seconds after selecting maximum power (max afterburner (AB)) (Tab J-8). The MA lifted off four seconds later, and the MP retracted the landing gear 2.5 seconds thereafter (Tab J-8). Approximately 1.7 seconds after the MP moved the landing gear handle to the up position, while the landing gear was still in transit, the MP saw a giant explosion with white sparks shooting out the front of the MA, heard some loud grinding and two big thumps, and felt significant vibrations (Tabs J-8 to J-9, V-1.15, and V-3.1). At that point, the MA was 20' Above Ground Level (AGL) at 200 Knots Calibrated Airspeed (KCAS) and the MP initiated a climb maneuver (Tab J-9). The climb resulted in an altitude of 880' AGL with the airspeed decreasing below 170 KCAS (Tab J-9). Twenty-six seconds after the initial malfunction, the MP initiated the ejection sequence (Tab J-9). The throttle was in max AB; however, the ME was operating at a significantly degraded thrust level and impacted the ground less than eight seconds later at a nearly wings-level attitude (Tab J-5).

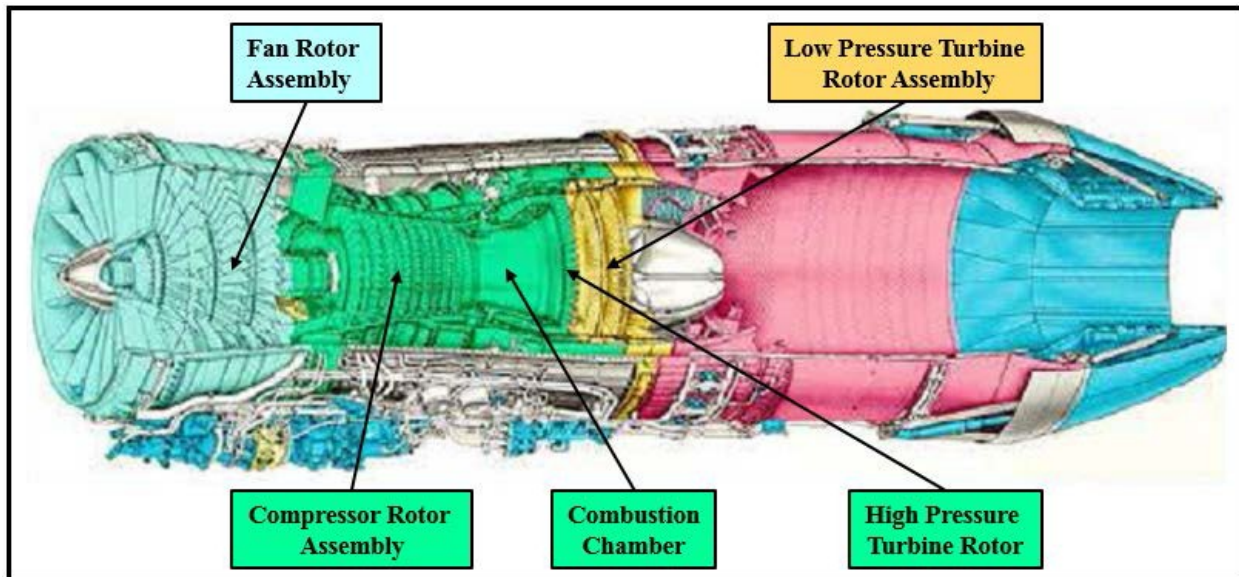
Figure 5. F110-100C Engine Cross-Section Overview (Tab Z-3)

Immediately after takeoff and with the landing gear in transit, at least one blade of the Stage 2 Low Pressure Turbine (LPT) Rotor Assembly liberated and went on to damage all 94 blades of the Stage 2 LPT (Tabs J-36, S-38 to S-40, and V-1.5). This damage resulted in an imbalance within the ME that created significant vibrations and loud grinding noises audible to the MP (Tab V-1.5).

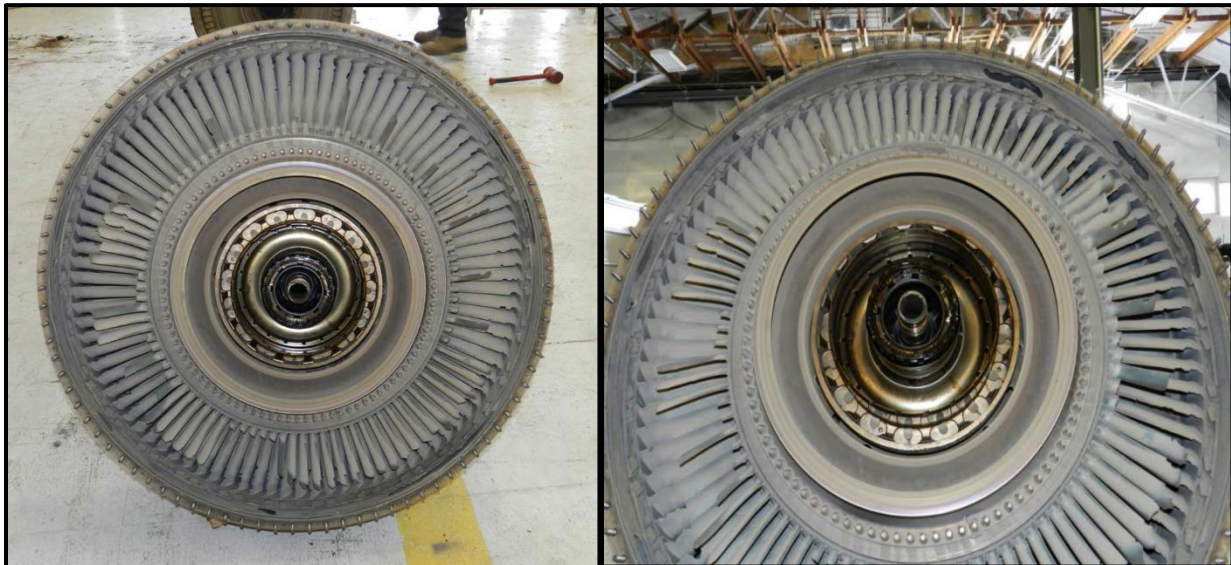
Figure 1. Stage 2 LPT Damage (Tab S-38)

The liberation of a Stage 2 LPT blade resulted in significant Stage 2 LPT Assembly damage (Figures 1-3) (Tab S-38 to S-40). This led to an immediate rollback to the Fan Rotor Assembly RPM that eventually caused the ME to experience a compressor stall (Tab J-9 and J-10). A metallurgical investigation performed by General Electric (GE) showed all 94 Stage 2 LPT blades fractured due to “overstress” (Tab J-44). A scanning electron microscope examination of nine blades showed no evidence of “creep” (stretching) or “over-temperature” (Tab J-45). The GE metallurgical report showed no evidence of a pre-existing condition in the Stage 2 LPT (Tab J-44). The damage to the Stage 2 LPT Assembly was so drastic it created an imbalance within the engine components, which led to eccentric rotational damage to other major ME components (Tab J-33).

Figure 2. Stage 2 LPT Damage (Tab S-39)

Tinker Engineering (TE) assisted in the teardown and inspection of the ME at Hill AFB (Tab J-23). The ME was recovered from the crash site mostly intact with evidence of significant damage consistent with low-speed shallow-angle ground impact (Tab J-24). The three main engine component sections (Fan, High Pressure Compressor, and Low Pressure Compressor) exhibited damage patterns to suggest that the engine was operating in a significantly degraded state at the time of impact (Tab J-42 and Tab S-36 to S-40). TE also discovered damage in the Low and High Pressure Compressor sections that occurred while the engine was operating prior to ground impact (Tab J-31 to J-33). TE specifically identified extensive wear damage to the High Pressure Turbine blades caused by eccentric rotation (Tab J-31) and damaged blades in the Stage 2 LPT consistent with blade liberation while the MA was still airborne (Tab J-33).

The GE analysis concluded that all 94 Stage 2 LPT blades were fractured with features consistent with overstress (Tab J-44). Further analysis indicated that there was no evidence of creep or over-temperature and the blade structures and composition were consistent with proper material standards (Tab J-44). For further details, see paragraph 6.a(2).

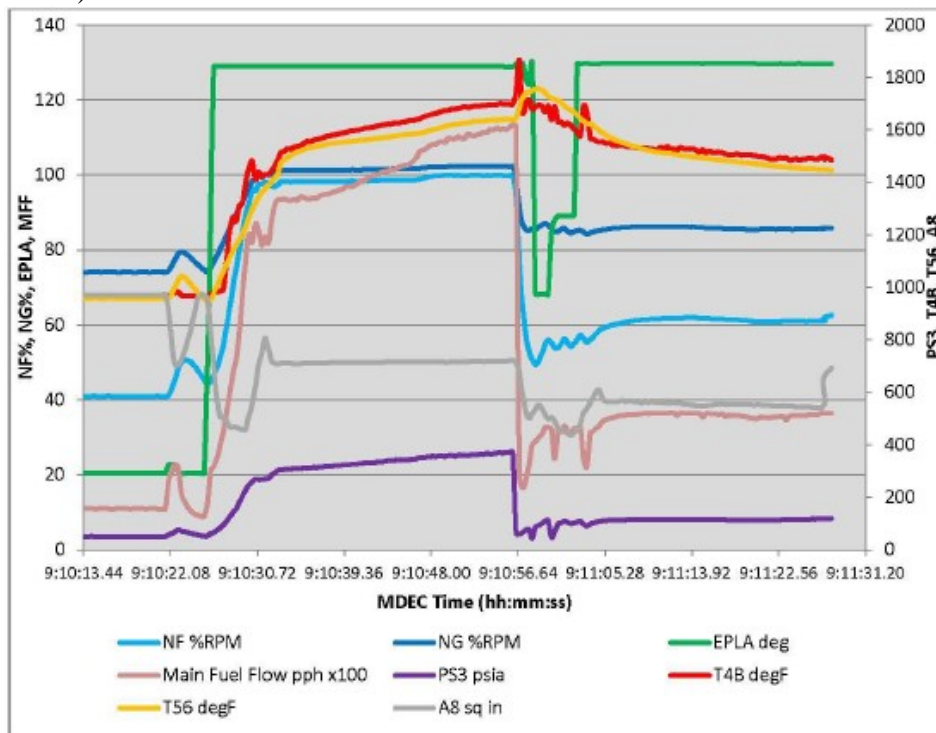
Figure 4. MDEC Recorded Engine Parameters (Tab J-41)

Engineering analysis of the CSFDR indicates the engine experienced uncommanded RPM rollback, followed by an immediate rise in ME temperatures, and a near simultaneous compressor stall of the ME fan and core sections (Tab J-9 and J-11). The ME RPMs never again exceeded 61% (Fan RPM) and 85.5% (Core RPM), respectively (Figure 4) (Tab J-9 and J-41). Data gathered from the CSFDR also revealed the ME continued to operate at a low power condition until ground impact (Tab J-42).

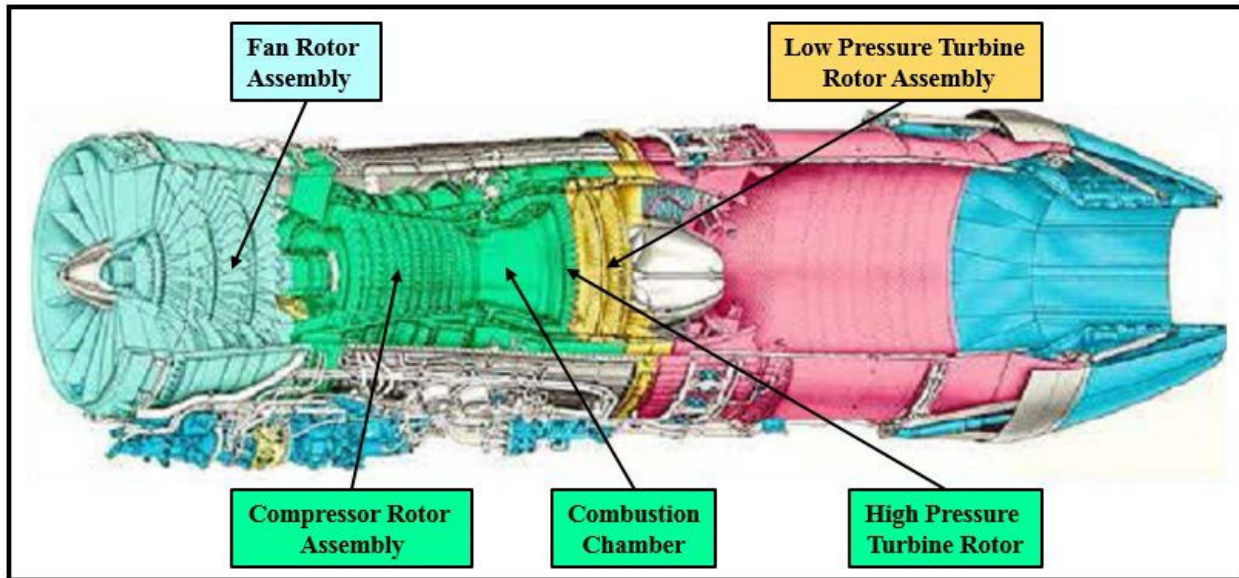
Figure 5. F110-100C Engine Cross-Section Overview

Post-flight analysis of flight data recorders and wreckage revealed the following information that explains the reduced ME performance; please see Figure 5. Immediately after takeoff and with

the landing gear in transit, at least one blade of the Stage 2 Low Pressure Turbine (LPT) Rotor Assembly liberated, which went on to damage all 94 blades of the Stage 2 LPT. This damage resulted in an imbalance within the ME that created significant vibrations and loud grinding noises audible to the MP.

The immediate effect of the LPT damage was an interruption in airflow that caused a compressor stall, as evidenced by numerous loud thumps and engine rollback. The more lasting effect of the LPT damage was a resulting drop in the Fan Rotor Assembly Revolutions per Minute (RPM) that hindered the Compressor Rotor Assembly from providing the necessary airflow to the Combustion Chamber to create adequate thrust. Identifying that there existed significant mechanical problems, the MA's Digital Electronic Control (DEC) transitioned the ME to a Hybrid mode of operation, which is where fuel flow scheduling and metering was controlled by the Main Engine Control (MEC) system. The MP predominately left the MA's throttle in the max AB position, except for a short cycling of the throttle to attempt to clear the stall. The extent of the damage caused the MEC to operate the Front Rotor Assembly at 61% RPM and limited the Core Rotor Assembly at 85.5% RPM. The ultimate result was insufficient thrust to maintain adequate airspeed or altitude for continued safe flight, and left the MP with only one reasonable decision—to eject.
