UNITED STATES AIR FORCE
ABBREVIATED AIRCRAFT
ACCIDENT INVESTIGATION
BOARD REPORT

MQ-1B, T/N 07-3198

15TH ATTACK SQUADRON
432D WING
CREECH AIR FORCE BASE, NEVADA

DATE OF ACCIDENT: 8 MARCH 2016

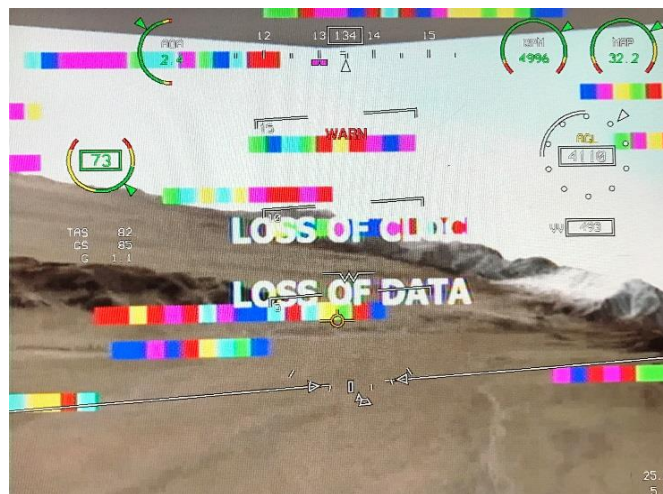
Figure 1. Lost Datalink Indicator: Main Screen (Tab Z-5)

view what the MRPA is actually doing via the main displays on the multifunction workstation (MFW) within the GCS (Tab V-5.1). At this point, both the command and the return datalink had been lost (Tab V-3.1 and V-4.1). The MMCE could not control or see what the MRPA was doing (Tab V-4.1). If the MMCE loses only the return datalink, the MRPA could still be commanded (good command datalink) without the MMCE being able to monitor what the MRPA was doing due to the lost return datalink (Tab V-5.1). The two separate emergency checklists the MMCE discussed executing were the PSO1 rack lock-up and the lost datalink checklists (Tabs V-3.1 and BB-18 to BB-25). The MP and MSO wanted to start with the PSO1 rack lock-up emergency procedure, believing regaining control of the MRPA was the most critical emergency (Tab V-3.1). However,
