UNITED STATES AIR FORCE
AIRCRAFT ACCIDENT INVESTIGATION
BOARD REPORT

U-28A, T/N 0724

**318th Special Operations Squadron
27th Special Operations Wing
Cannon Air Force Base, New Mexico**

DATE OF ACCIDENT: 14 March 2017

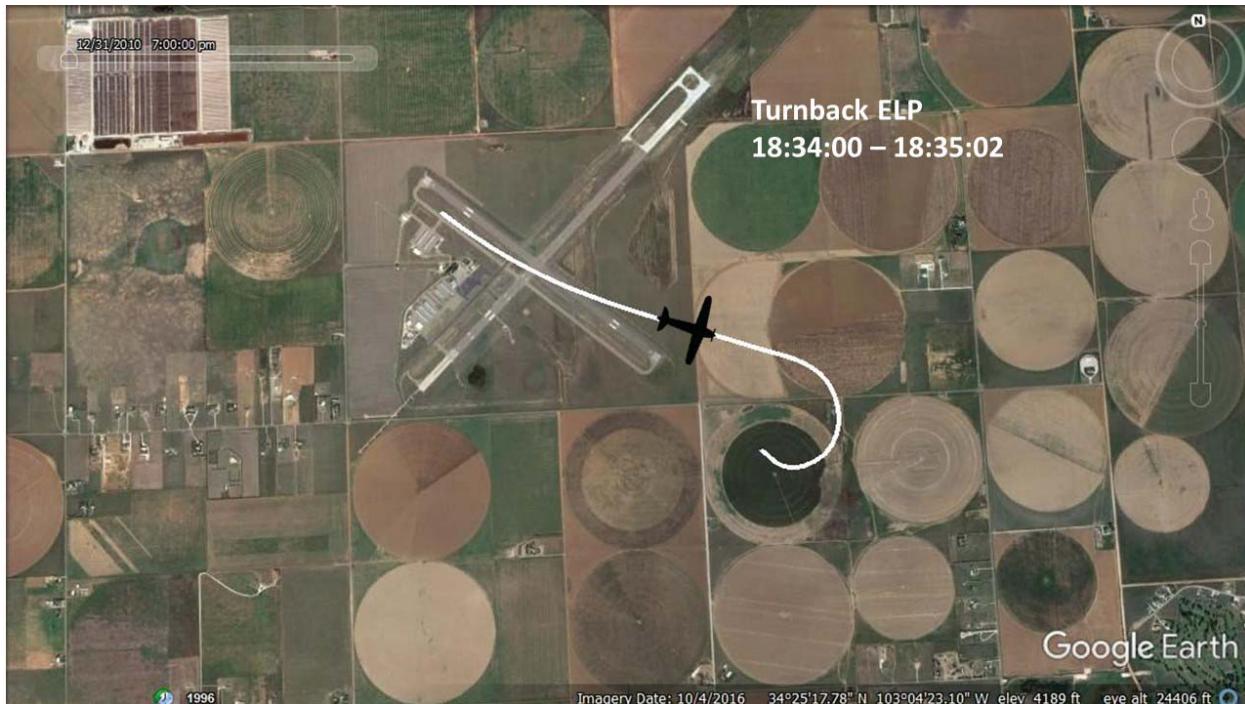
Figure E –Practice Turnback ELP (Tabs J-173, Z-7, and BB-43)

After their low approach to R12 at 1834:00L, the MC set-up for a practice turnback ELP to runway 30 (R30) by climbing-out to the southeast (Figure E). (Tabs J-173, Z-6, and BB-43)

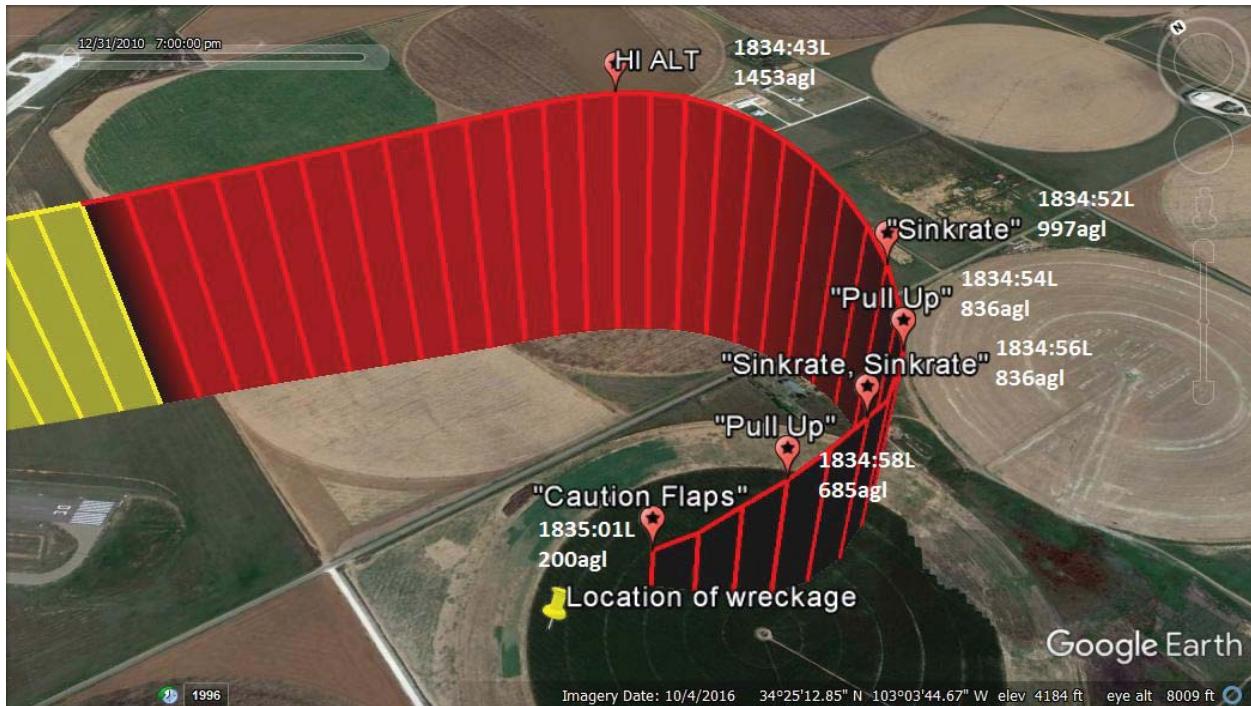
Figure F – Practice Turnback ELP with EGPWS Alerts, Altitude and Time Stamps (Tabs J-173, Z-8, and BB-43)

DE 25 initiated their practice turnback ELP maneuver at 1834:43L from approximately 1,450 feet above ground level (AGL) and 100 knots indicated airspeed (KIAS), with 0° flaps and a descending right hand turn toward R30. (Tabs J-139 to J-140, J-173, Z-8, Z-14, and BB-43) Six seconds into the maneuver, at 1834:49L, the MA was 110 KIAS, descending at -3,000 feet per minute vertical velocity (VVI), and 35° of right bank. (Tabs J-173, Z-9, Z-14, and BB-43) At 1834:52L, altitude and descent rate were approximately 1,000 AGL and -5,000 VVI respectively, which caused the MA's Enhanced Ground Proximity Warning System (EGPWS) to emit an aural "sinkrate" alert. (Tabs J-173, Z-9, Z-14, and BB-43) At 1834:54L, the EGPWS issued an aural "pull up" alert. (Tabs J-173, Z-8, Z-14, and BB-43) At this point, the MA was approximately 800 AGL, 124 KIAS, -5,200 VVI and 50° of right bank (Figures F and G). (Tabs J-173, Z-8 to Z-9, Z-14, and BB-43)

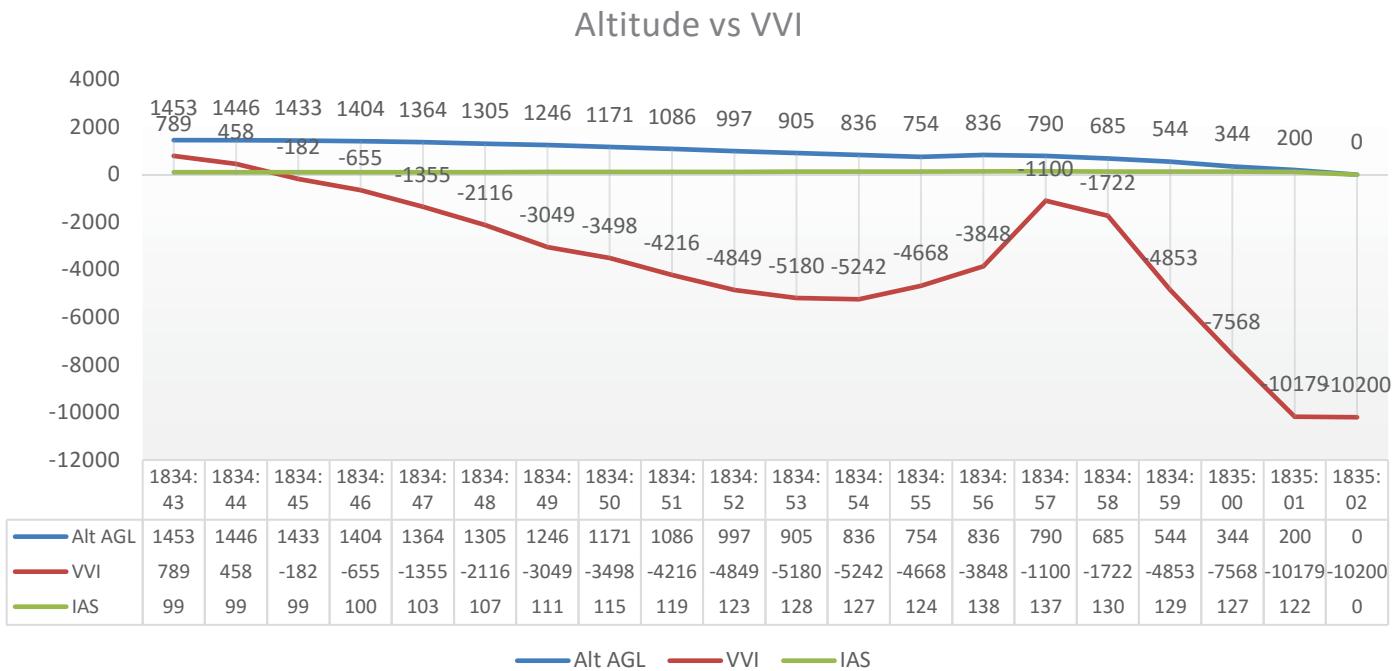
Figure G: Altitude vs VVI and Airspeed (Tabs J-173, Z-9, and BB-43)

Coincident with the EGPWS aural “pull-up” alert, the MA VVI momentarily eased and AGL altitude increased, indicating the MC attempted to arrest their nose-down attitude and descent rate. (Figure G) (Tabs J-219, Z-8 to Z-9, Z-14, and BB-43) The MA performed a hard pull up at low altitude from an extreme nose-down angle. (Tabs R-10 to R-11, R-42, Z-9, Z-11, and BB-43) Following this initial reaction by the MC, the MA again increased descent rate and bank angle. (Tabs J-173, Z-8 to Z-9, and BB-43)

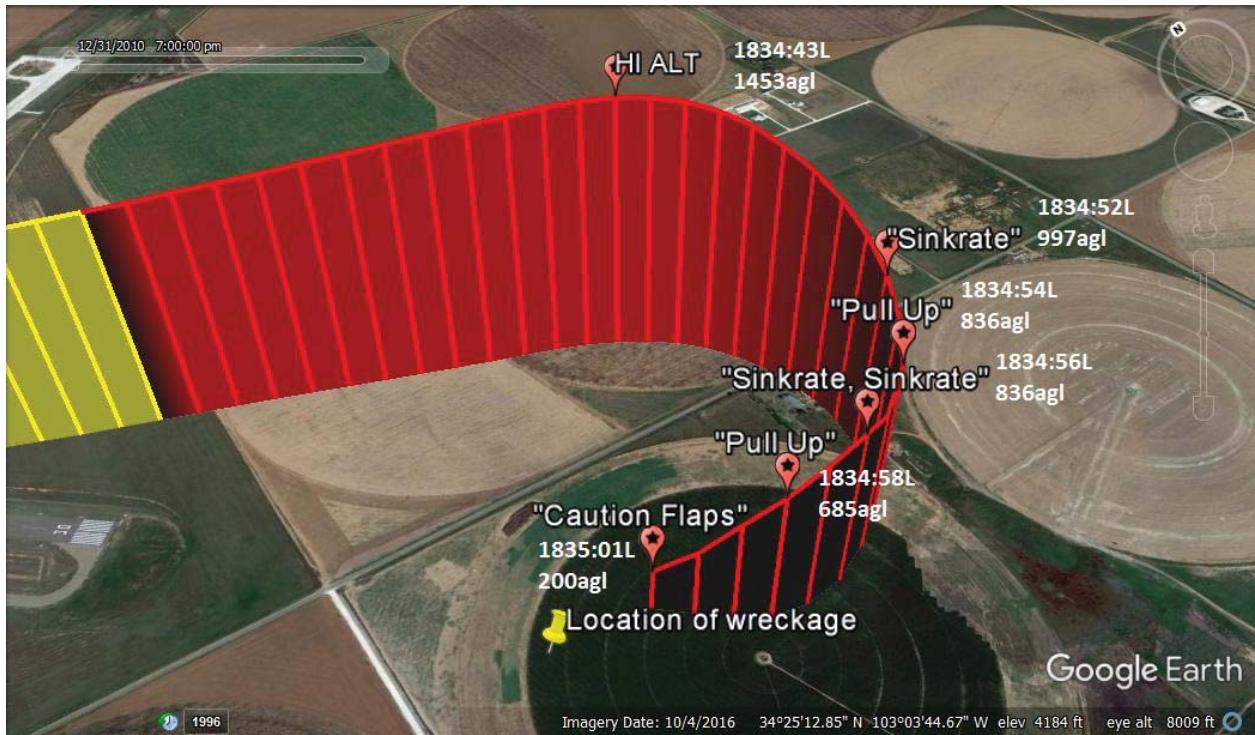
Figure F: Practice Turnback ELP with EGPWS Alerts, Altitude and Time Stamps (Tabs J-173, J-219, Z-8, and BB-43)

The MC received EGPWS aural alerts “sinkrate, sinkrate” at 1834:56L and “pull up” at 1834:58L. (Tabs J-219, Z-8, Z-14 and BB-43) From 1834:58L through impact, the MA descent rate increased while indicated airspeed decreased, indicative of a stall. (Tabs R-5, Z-8 to Z-9, Z-14, BB-13, and BB-43) Subsequent power increases and flight control inputs did not enable the aircraft to recover from the stall within remaining altitude. (Tab R-11) The MC added power approximately 3.5 seconds prior to impact. (Tabs R-10 to R-11, R-35, Z-11, BB-43). At 1834:59 the MA reached a maximum bank angle of 60°. (Tabs J-173, Z-8, Z-14, and BB-43) At 1835:01 the descent rate was -10,179 VVI and the MC received an aural EGPWS “caution flaps” alert. (Tabs J-219, Z-7 to Z-9, Z-14, and BB-43) The MA impacted the ground at approximately 1835:02L in excess of -10,000 VVI and less than 120 KIAS with a 13° nose-high, 7° left-wing low attitude. (Tabs H-4, Z-8 to Z-10, and BB-43).

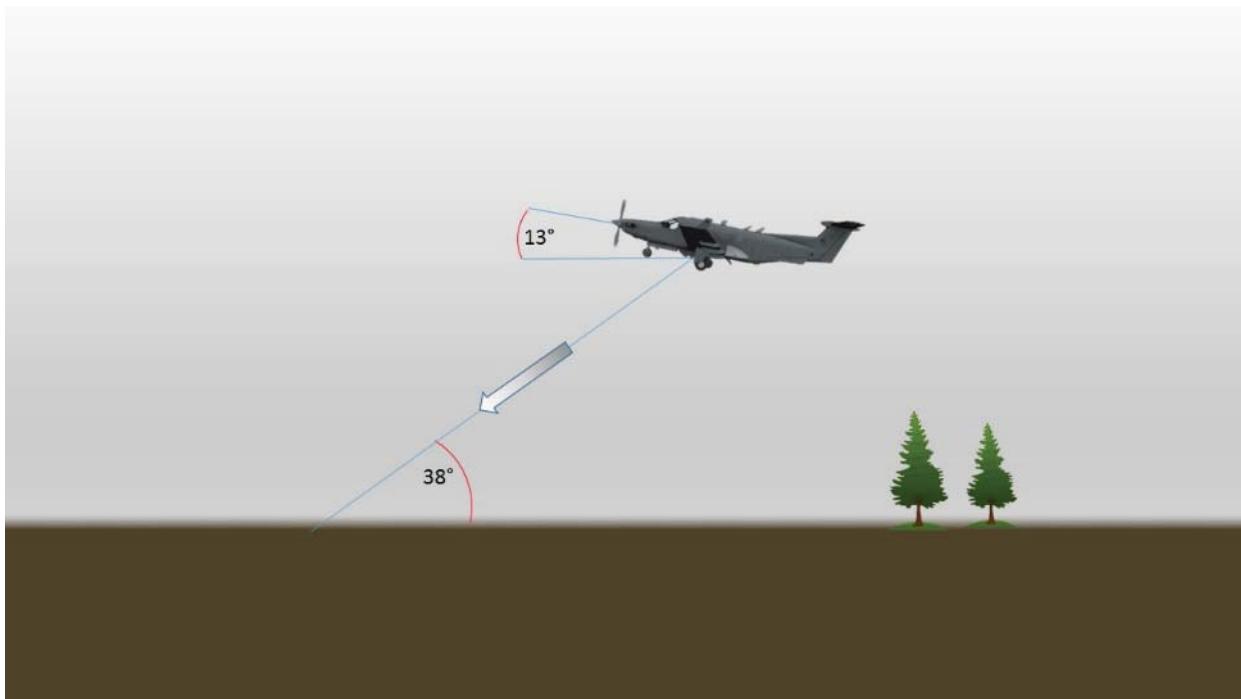
Figure H – Attitude and Angle of Approach at Impact (Tabs H-4, Z-11, BB-43)

The MA impacted the ground at approximately 1835:02L, 3 hours and 23 minutes into the sortie, in a freshly tilled field 0.34 nautical miles southeast of the end of R30. (Tabs H-3 to H-4, P-2, S-8, Z-8 and BB-43) At impact the MA was configured with gear down and 0° flaps. (Tabs J-139 to J-140, J-154 to J-161, R-34, Z-11, and BB-43) The MA attitude was 13° nose-high and 7° left-wing low. (Tabs H-4, Z-11, and BB-43) The MA impacted at a 38° angle of approach (Figure H). (Tabs H-14, Z-11, and BB-43)

The MA contacted the ground with the aft section of the tail first and then pitched down, striking the ground with the main section of the fuselage, which bounced and rolled once before coming to a stop. (Tab H-3 to H-4) During the impact sequence, the gear, wings, engine and propeller separated from the aircraft. (Tab H-4) The tail section was torn from the aircraft but remained connected by flight control cables and electrical wire bundles. (Tab H-4) The tail section did not roll with the fuselage. (Tab H-4)
