UNITED STATES AIR FORCE
AIRCRAFT ACCIDENT INVESTIGATION
BOARD REPORT

F-16C T/N 87-0306
121ST FIGHTER SQUADRON
113TH WING
JOINT BASE ANDREWS, MARYLAND

LOCATION: CLINTON, MD
DATE OF ACCIDENT: 5 APRIL 2017
BOARD PRESIDENT: COLONEL DAVID V. COCHRAN
Conducted IAW Air Force Instruction 51-503

SUMMARY OF FACTS AND STATEMENT OF OPINION
F-16C, T/N 87-0306
5 APRIL 2017

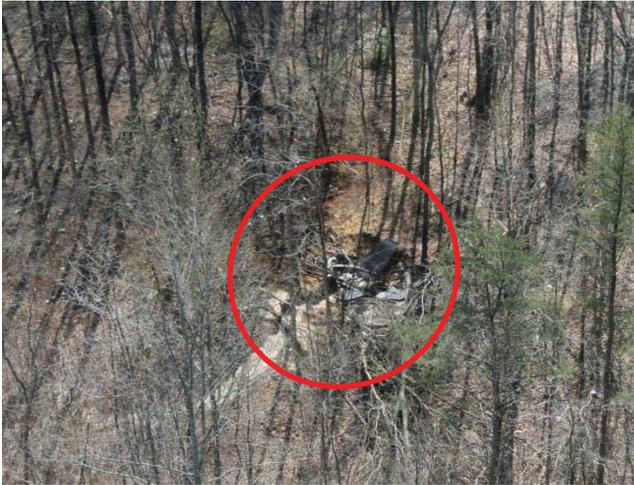
Figure 1 – Aerial view of crash site (Tab S-2)

The MA was destroyed on impact (Tab J-34). Due to the steep impact angle, the radome, cockpit, and forward fuselage sections of the aircraft folded beneath the engine and aft fuselage (Tab J-35). The right wing was in two pieces and the left wing was mostly intact (Tab J-5). The aft fuselage, vertical tail, left horizontal stabilizer and the engine (Figure 5) were in one piece (Tab J-5).

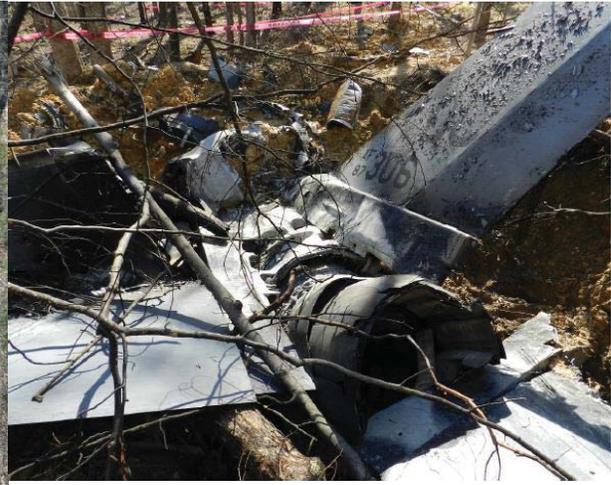
Figure 2 – Ground level view of MA crater site (Tab S-2)

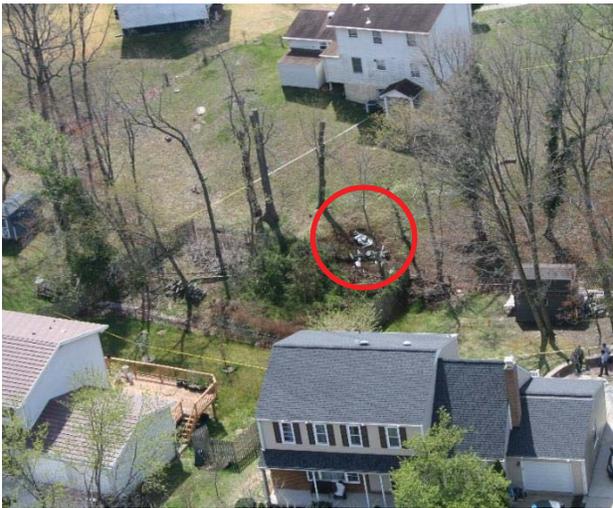
The MP jettisoned both external wing fuel tanks, which landed approximately one half-mile south of National Harbor; one landed in a residential area between two houses (Figure 3), and the other landed in a wooded area (Figure 4) (Tabs N-3, Z-3, Z-6, and Z-14).

Figure 3 – Wing external fuel tank impact site 1 (Tab Z-6)

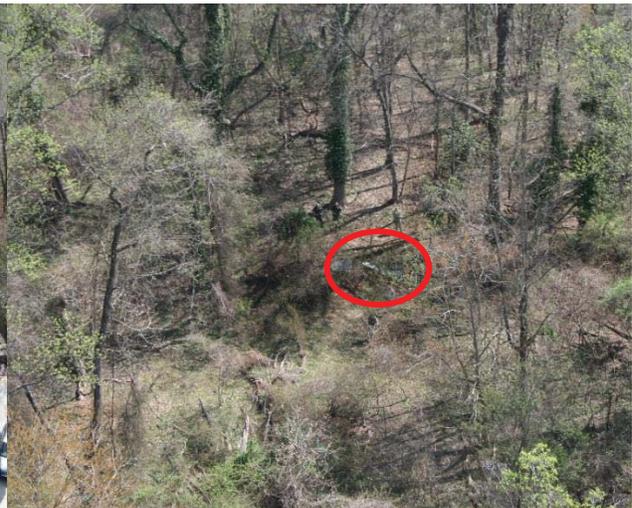
Figure 4 – Wing external fuel tank impact site 2 (Tab Z-14)

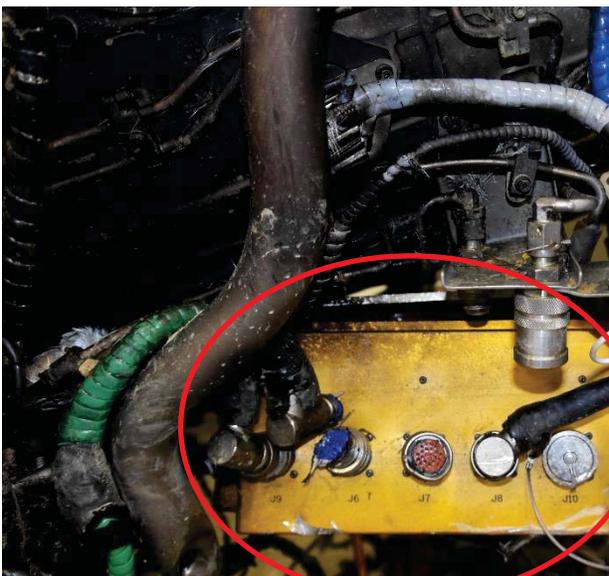
Figure 6: MDEC (Tab J-8)

The engine remained relatively intact with exception of the front frame, which sheared off along with most of the struts (Tab J-7). The controls and accessories were still attached to the gearbox, with the exception of the hydraulic pump (Tab J-8). The fuel boost pump and augments fuel pump were badly damaged and sheared from the gearbox, but remained attached to the engine via tubing (Tab J-8). The MDEC also remained attached to the lower fan duct with one mount bolt and tubing holding it in place (Tab J-8). The MEC and main fuel pump remained mounted to the gearbox housing with the v-band clamp still secured (Tab J-8). The MDEC, MEC, and main fuel pump had relatively minor structural damage, as seen in Figure 6 and Figure 7 (Tab J-8).

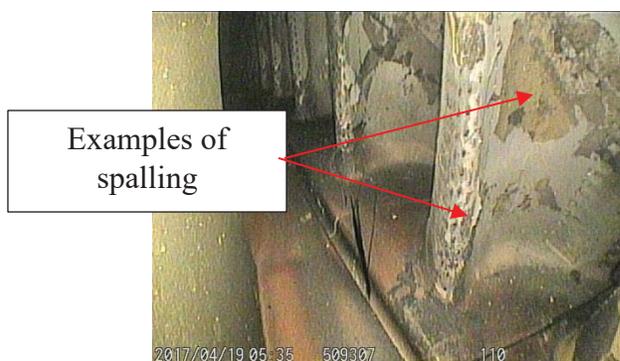
The low pressure turbine (LPT) rotor was unable to be removed (Tab J-15). Therefore, the condition of the combustor, high-pressure turbine (HPT) nozzles, HPT blades, LPT nozzles (Stage 1 and leading edge of Stage 2), and LPT Stage 1 blades could only be documented by borescope (Tab J-15). The combustor discharge nozzle case was structurally intact with no evidence of external/internal penetration or burn through (Tab J-15). The combustor liners showed evidence of thermal distress, exhibited by visual burn marks and thermal barrier coating spallation (Tab J-15). This condition was relatively consistent throughout the entire combustion chamber (Tab J-15). The HPT nozzles were all intact with no signs of significant damage (Tab J-16). No evidence of excessive cracking, spalling, or deterioration was noted (Tab J-16). All HPT blades were present and intact; however, they exhibited extensive deterioration, especially near the blade tips (Tab J-17). Severe spalling of the aluminide coating was observed on all surfaces of the blades, as seen on Figure 8 (Tab J-17).

Figure 8: HPT Blades Leading Edge and Platform (Tab J-17)

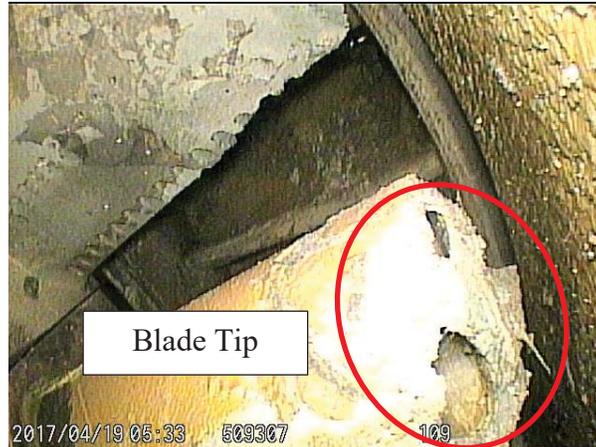
Deterioration of the tips extended radially inward past the blade tip caps, exposing the hollow interior of the blade (Figure 9) (Tab J-18 to J-19).

Figure 9: HPT Blade Tips (Tab J-19)

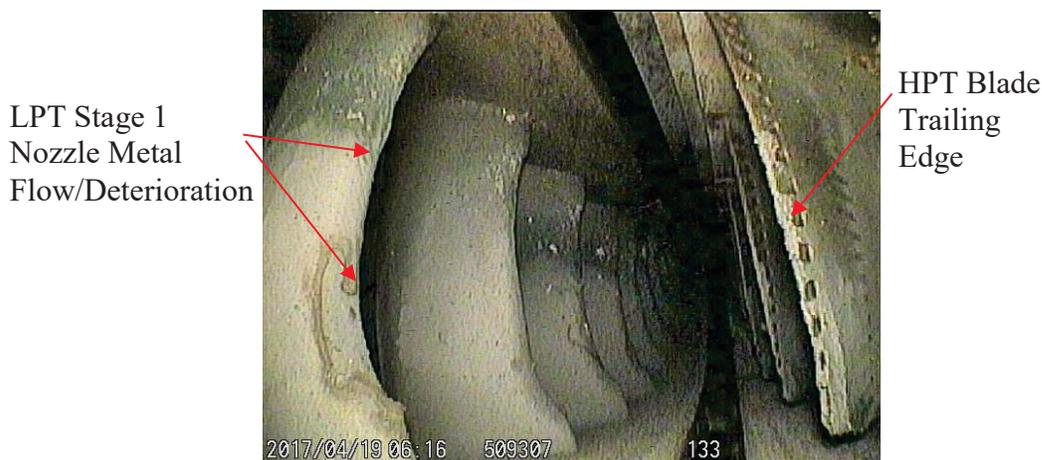
LPT Stage 1 nozzle segments were all intact with significant damage noted (Tab J-19). The vanes exhibited signs of deterioration and metal splatter from upstream hardware (Tab J-19). There was also evidence of metal flow on the leading edge of the nozzle vanes as shown in Figure 10 (Tab J-19 to J-20). The trailing edges showed severe deterioration, spalling, and metal splatter (Tab J-19). All damage on the LPT Stage 1 is indicative of an over temperature condition (Tab J-19).

Figure 10: LPT Stage 1 Nozzle Leading Edge deterioration (Tab J-20)

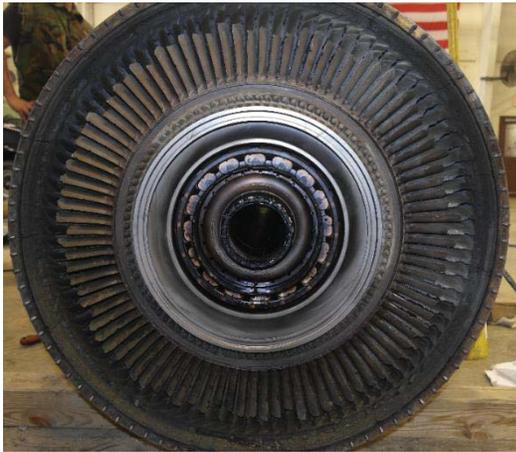
nozzle, the LPT Stage 2 Nozzle showed evidence of severe heat distress with missing coating and erosion seen on all surfaces (Tab J-21). All of the LPT Stage 2 blades, as shown in Figures 11 and 12, were missing approximately one-half to one-third of the blade from the blade midpoint, radially outboard to the blade tip (Tab J-22 to J-23). Metal splatter and coating loss was also observed (Tab J-22). The Stage 2 nozzle shrouds also showed evidence of severe rubbing (Tab J-22).

Figure 11: LPT Stage 2 Blades (Tab J-22)

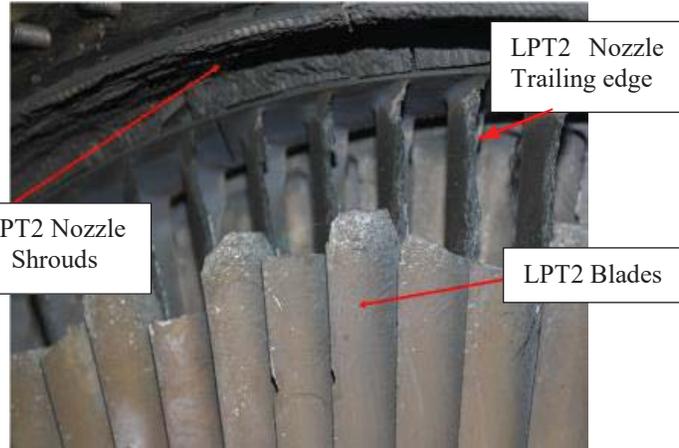
Figure 12: LPT Stage 2 Blade Distress (Tab J-23)

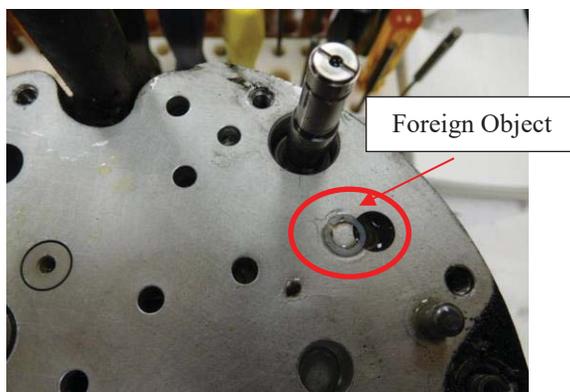
Upon removal of the manifold plate gaskoseal, a backing ring was found between the gaskoseal and the pilot valve plate (Figure 13) (Tab J-83 to J-84). The backing ring appeared to be of a Teflon or nylon material, and not included on the parts list for this MEC (Tab J-83). The backing ring was noted to be .015-inch thick and 5/16-inch in diameter (Tab J-83).

Figure 13: Foreign Object backing ring (Tab J-84)

The backing ring was found in a position that could have prevented full internal sealing of the gaskoseal against the manifold plate (Tab J-83). Additionally, Viton seals are more prone to loss of sealing in extremely cold temperatures, and as a result, fluorosilicone is utilized in the MEC (Tab FF-12). However, there is no evidence to suggest that the backing ring or the Viton seals were a factor in the mishap.

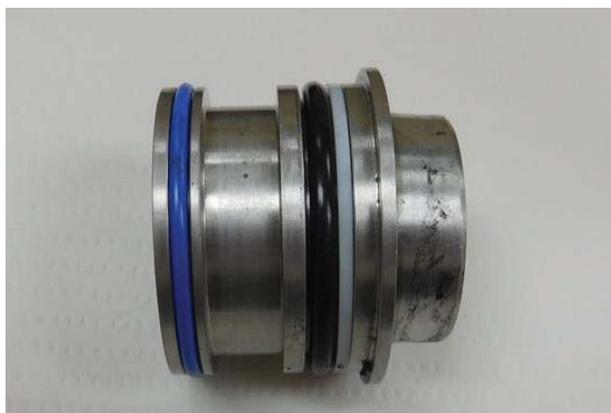
The pressuring valve transfer tube was found to contain a Viton seal rather than a fluorosilicone seal as specified in tech data (Figure 14) (Tab J-86).

Figure 14: Pressurizing valve transfer tube – Black ring is Viton (Tab J-86)

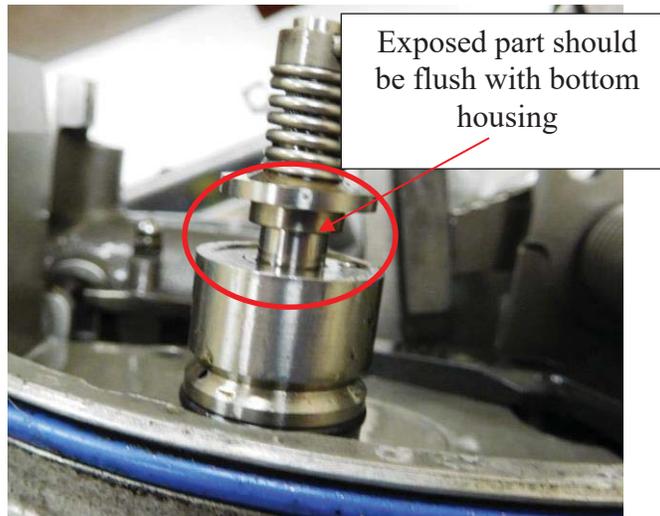
The differential pressure (ΔP) pilot valve was removed and it was observed that the 600-degree spiral retaining ring, which normally secures the internal bushing and anti-rotation pin, was missing (Tab J-84). The anti-rotation pin was also missing (Tab J-84). The bushing was displaced aft approximately 0.300 inch and was noted to be contacting the dashpot of the ΔP valve and the dashpot was entirely outside the valve sleeve (Figure 15) (Tab J-84 to J-85). The contact between the bushing and the dashpot was such that score marks were clearly visible on the forward end of the dashpot and aft end of the bushing (Figure 16) (Tab J-85). Figure 17 shows exemplars of the missing parts (Tab FF-14).

Figure 15: ΔP Pilot valve dashpot extended aft (up in photo) and contacted by the ΔP bushing (Tab J-85)

The missing 600-degree spiral retaining ring and anti-rotation pin allowed the internal bushing to migrate aft and contact the dashpot of the ΔP valve (see Figure 15) (Tab J-84 to J-85). The dashpot was entirely outside of the valve sleeve and exposed to case reference pressure versus metered fuel pressure (Tab J-84). Due to pressure fluctuations, the ΔP valve could not achieve a null state and pressure was ported to the bypass valve driving it toward the closed position, resulting in uncontrolled (high) fuel flow to the engine (Tab FF-11 to FF-12). The uncontrolled high fuel flow

resulted in the engine T4B over temperature, NF overspeed and ultimately uncontrolled engine operation (Tabs J-47 and FF-12 to FF-13). The fuel valve housing was taken to the real-time x-ray facility and checked for the missing spiral retaining ring and anti-rotation pin (Tab J-86). The retaining ring and pin were not detected within the housing during this check (Tab J-86).

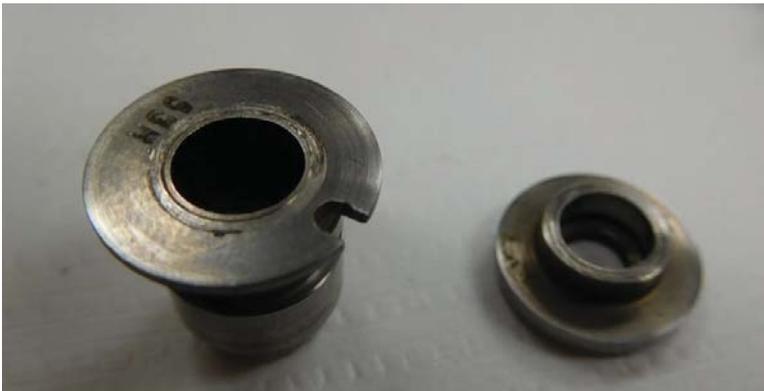
Figure 16: Bushing removed (left) Dashpot (right) – note relative score marks and spiral ring witness on bushing circumference (Tab J-85)

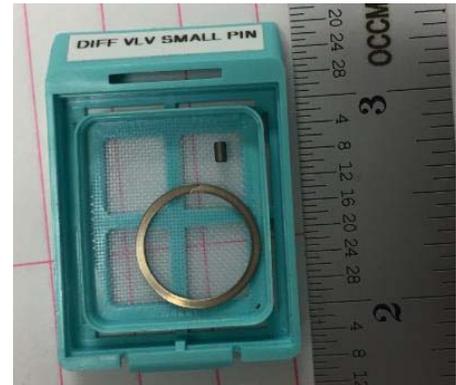
Figure 17: Exemplar photo of missing retaining ring and anti-rotation pin (Tab FF-14)
