UNITED STATES AIR FORCE
AIRCRAFT ACCIDENT INVESTIGATION
BOARD REPORT

F-35A, T/N 12-5052

LOCATION: MOUNTAIN HOME AIR FORCE BASE,
IDAHO

DATE OF ACCIDENT: 23 SEPTEMBER 2016

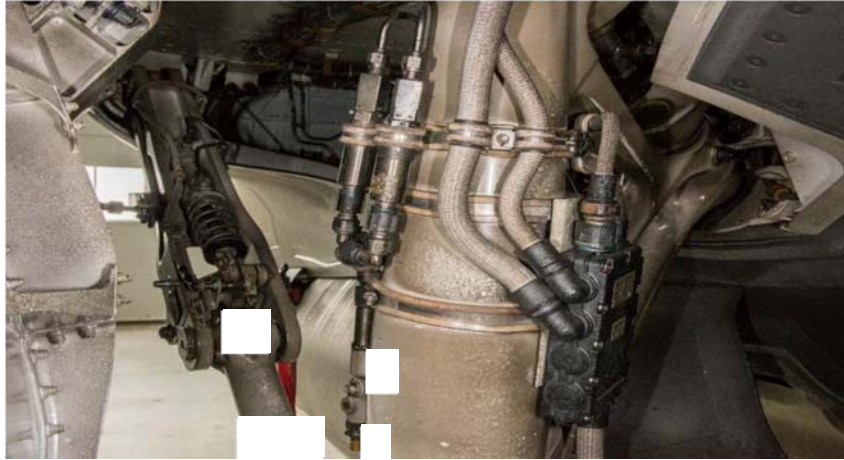
Fig 1. Left Side Landing Gear (Tab Z-11)

The F-35A landing gear wheel wells are equipped with optical fire detectors. Crash Survivable Memory Unit (CSMU) (sometimes referred to as the “black box”) data analysis indicated the main landing gear optical fire detectors were the first to detect a fire 47 seconds after the engine switch was set to RUN (Tab DD-8 and DD-9). The main landing gear fire detectors indicated fire was present for 20 seconds (Tab DD-9). The fire caused damage to multiple landing gear surfaces, surrounding areas and components in the left and right main landing gear wheel wells (Tab P-3 thru P-5) (See Figs-1, 2).

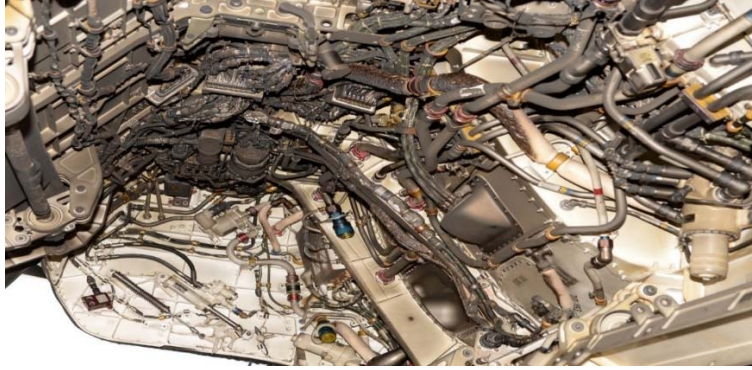
Fig 3. Right Side Weapon Bay (Tab S-6)

The F-35A aircraft weapon bays are located on the underneath portion of the aircraft on both the right and left side. The bays house various components and cables which allow aircraft systems to operate. The weapon bays have both inner and outer doors which close when commanded. Typically, the weapon bay doors remain open for ground procedures, to include engine start sequence, and are then closed after engine start. During the mishap, the open doors allowed the fire to enter both weapon bays causing damage to aircraft surfaces, panels, multiple system components, and multiple system wiring cables (Tab P-3 thru P-5) (See Figs-3, 4).

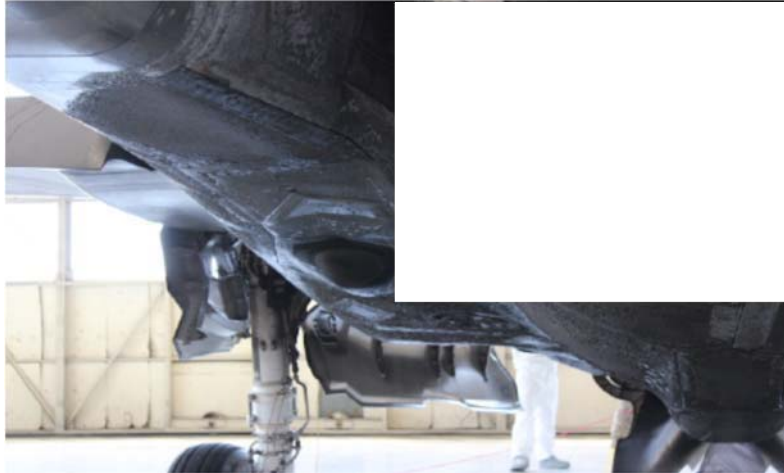
Fig 5. Lower Left Section of Mishap Aircraft (Tab S-4)

Many outer surfaces of the aircraft on the aft two thirds of the MA's center fuselage section exhibited varying degrees of fire damage. The majority of the damage occurred on the aircraft's aft most surfaces, mainly along the center portion of the jet, including the top, sides, and underneath portions of the aircraft. However, minor damage was noted on some surfaces even forward of the cockpit (Tab P-3 thru P-5) (See Figs-5, 6, 7).

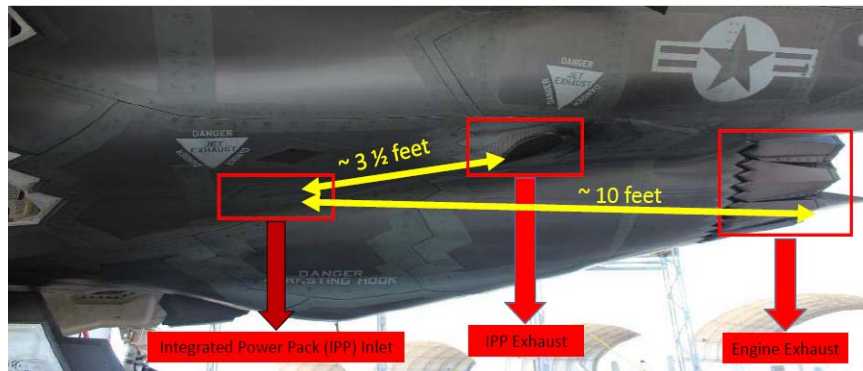
Fig 8. IPP Inlet and Exhaust Reference (Tab Z-9)

The MA IPP started and performed normally up through the beginning of aircraft engine start on the day of the incident. However, the IPP inlet temperature rose 24 seconds after the initiation of aircraft engine start (Tab DD-20) (See Fig-9). The only sources of hot gas in the vicinity were the IPP exhaust and the engine exhaust from the MA (See Fig-8).

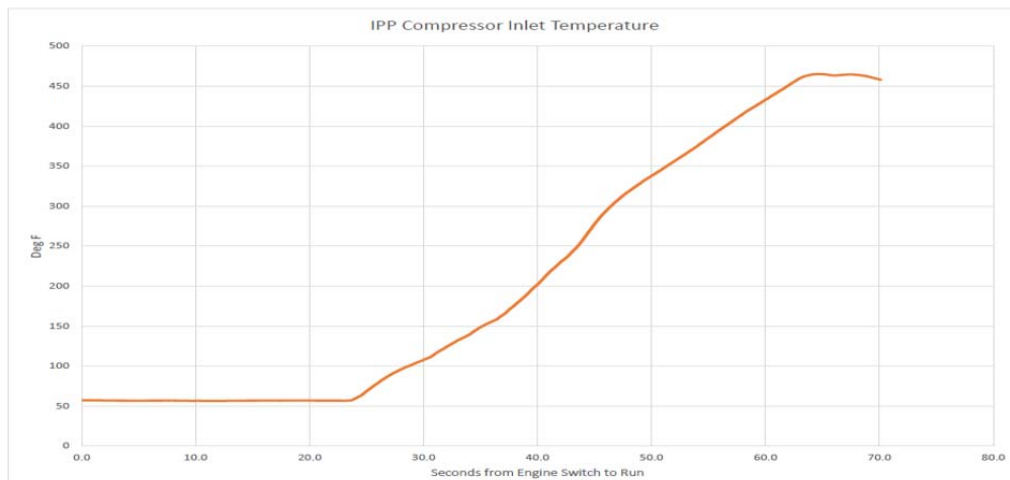
Fig 9. IPP Compressor Inlet Temperature (Tab Z-19)

In response to the increased IPP inlet temperature, the PTMS began taking actions IAW the hot-gas ingestion logic. Power to the ICCs and ES/G was reduced (See Fig-10). Increased fuel was added to the IPP motor which contributed to increasing EGT (See Fig-11). These actions continued for 17 seconds, until the threshold for an IPP EGT over-temp was reached (Tab DD-20). The PTMS commanded the IPP to shut down two seconds later (Tab DD-20 and DD-21). The IPP and PTMS performed as designed (Tab DD-21). (See Figs-9, 10, 11).

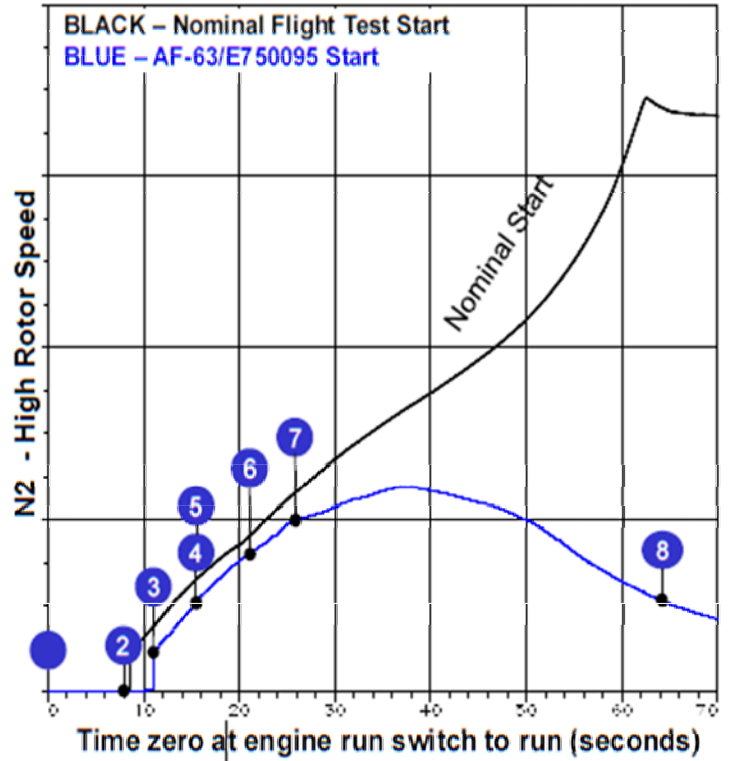
Fig 13. Significant Events During Engine Start (Tab EE-7)

Analysis performed by P&W showed the MA engine's start was normal until just after combustion began (Tab EE-7) (See Fig-13). Approximately 24 seconds after start initiation, acceleration of the MA engine began to slow because power to the ES/G decreased due to increased IPP inlet temperature (See Figs-10, 13). Approximately nine seconds later (33 seconds after start initiation), increased fuel was added to the engine because of the slowed acceleration (See Fig-14). At approximately 39 seconds after start initiation, the ICCs stopped providing power to the ES/G (See Fig-10). At this time, the aircraft engine rotation was powered by combustion alone, which was insufficient to support engine acceleration, resulting in engine speed deceleration (See Fig-13). Increasing fuel flow to the aircraft engine continued until approximately 62 seconds after engine start initiation (See Fig-14). All systems operated as designed (Tab EE-12).

- 1 Engine run switch from off to run
- 2 N2 rotation
- 3 N2 sensor in-range
- 4 Fuel on
- 5 Ignitor on
- 6 Typical Light-off
- 7 N2 accelerating but roll off indicative of reduction in airframe supplied torque
- 8 Fuel flow shutoff by FADEC

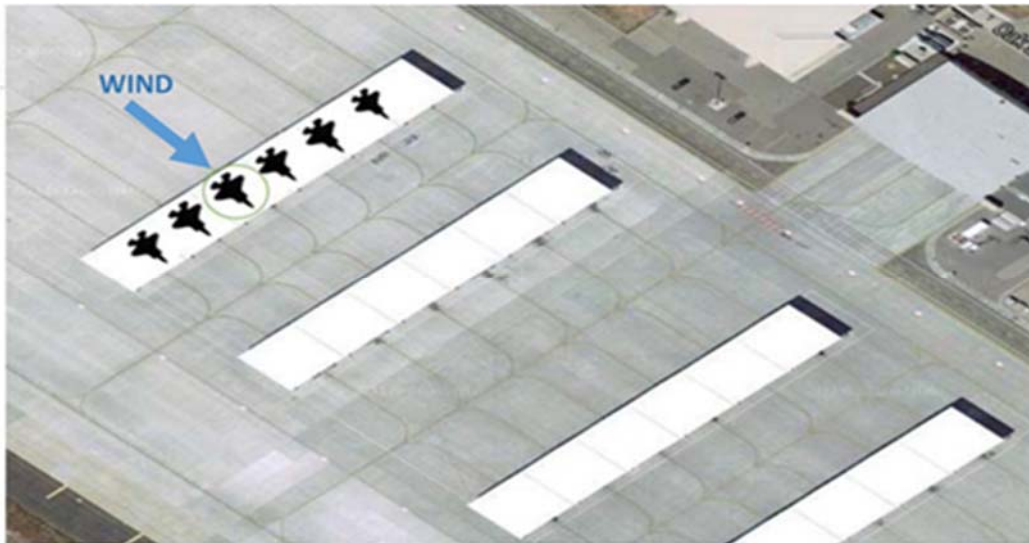
Fig 15. POSITION OF MA WITH RELATIVE WIND (Tab Z-25)

A wind sensor on the airfield recorded winds of 300 degrees at 34 knots at 0850L, and 290 degrees at 29 knots gusting to 37 knots at 0853L (Tab F-3). The MA engine start was initiated at approximately 0852L. The MA was parked facing a 120 degree heading. Therefore a direct tailwind of 30 knots or greater was present during engine start (See Fig-15).

The mishap was caused by a tailwind blowing hot air from either the MA IPP exhaust or MA engine exhaust into the IPP inlet. The hot air entering the IPP inlet started a sequence of events ultimately ending in an uncontained engine fire.
