**UNITED STATES AIR FORCE  
AIRCRAFT ACCIDENT INVESTIGATION  
BOARD REPORT**

**KC-10A, T/N 83-0080  
9TH AIR REFUELING SQUADRON  
60TH AIR MOBILITY WING  
TRAVIS AIR FORCE BASE, CALIFORNIA**

**LOCATION: NEAR MOUNTAIN HOME AFB, IDAHO  
DATE OF ACCIDENT: 1 NOVEMBER 2016  
BOARD PRESIDENT: COL PERRY M. LONG III  
Conducted IAW Air Force Instruction 51-503**

## Class A Mishap, Near Mountain Home AFB, ID

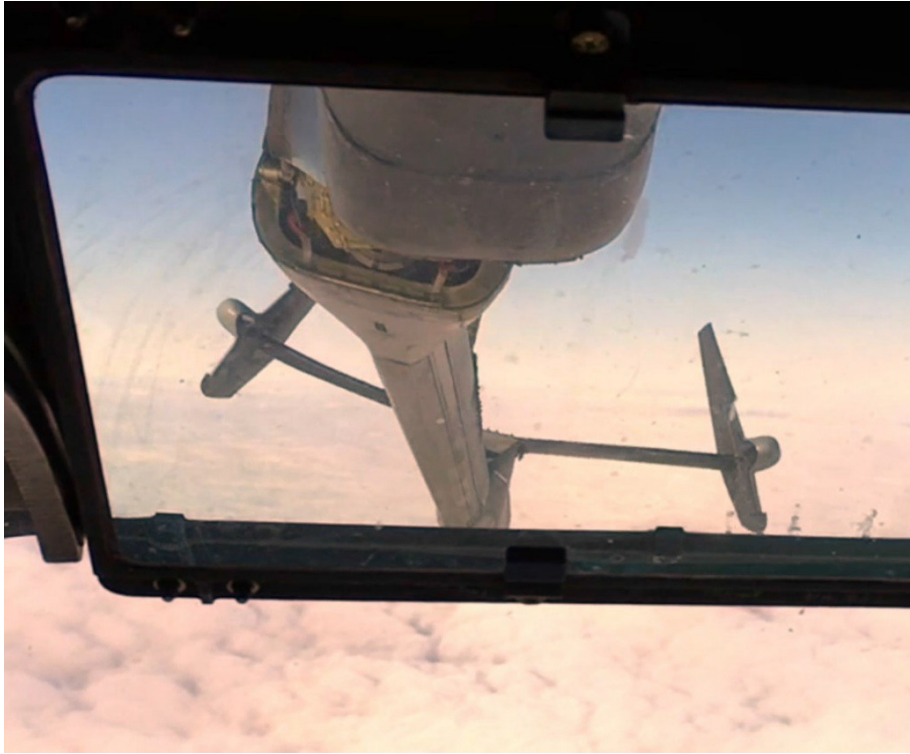
**Figure 4.1 (Tab Z-3)**

At 0846L/1646Z, the MB stated, “[i]t’s getting crazy again...I don’t know...honestly what’s holding it on right now. But it’s just trailing behind us.” and then says “[t]his boom is completely detached, it’s still connected some way but it’s, everything is ruined” (Figure 4.1) (Tabs N-14 to N-15, and Z-3). The MP decided to slow the aircraft to attempt to alleviate aerodynamic pressure on the boom (Tab N-15).

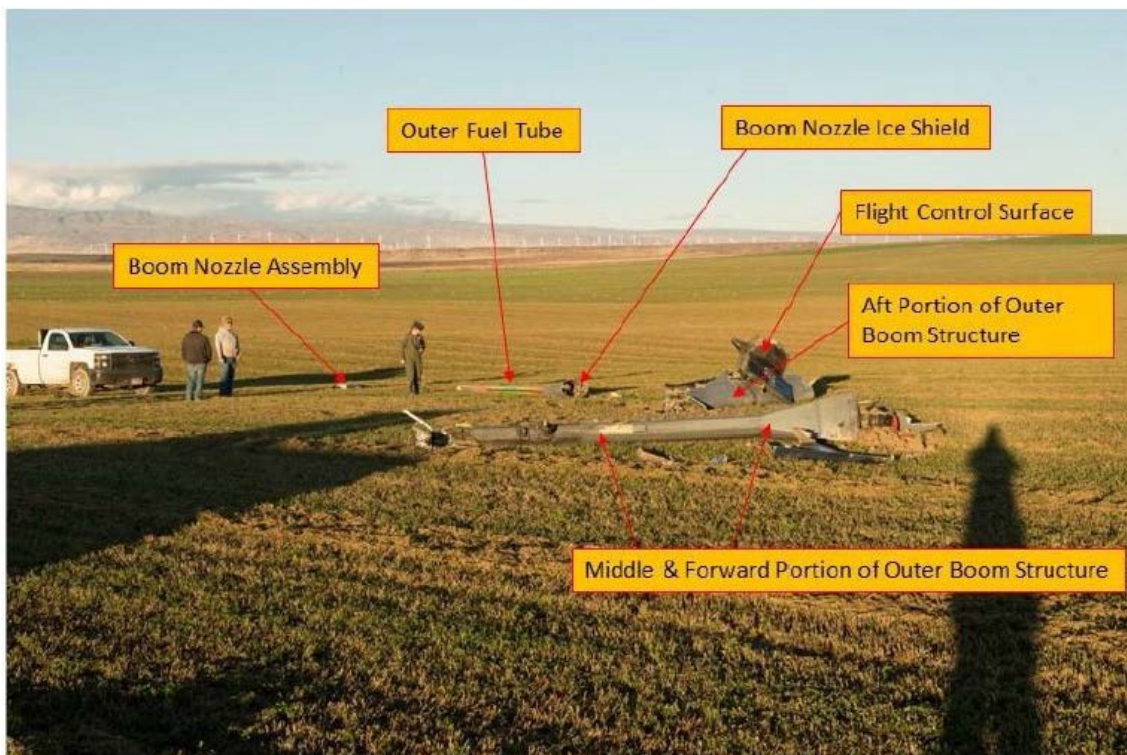
Figure 6.7 (Tab S-3)

- Complete fractures of the gimbal housing assembly, yoke retainer and support fittings were found obliterated due to mechanical damage from impact and were therefore of little use for analysis (Tabs J-212, S-3, and S-4).

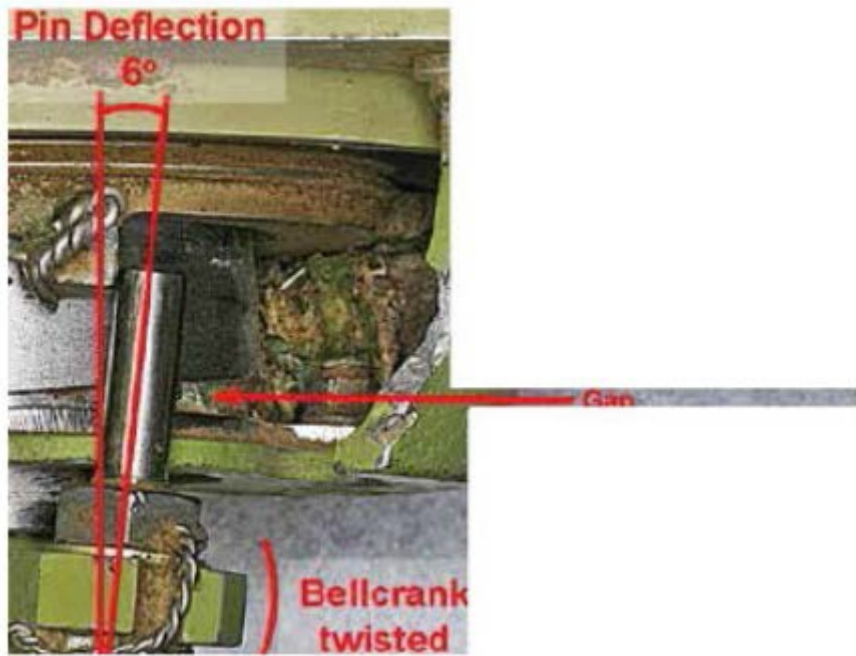
Figure 6.8 (Tab J-223)

- The bellcrank arm was twisted and the DRVT housing end cap was damaged, which resulted in a deflection of the indicator pin approximately 6 degrees to the left (Figure 6.8) (Tab J-211 and J-223).

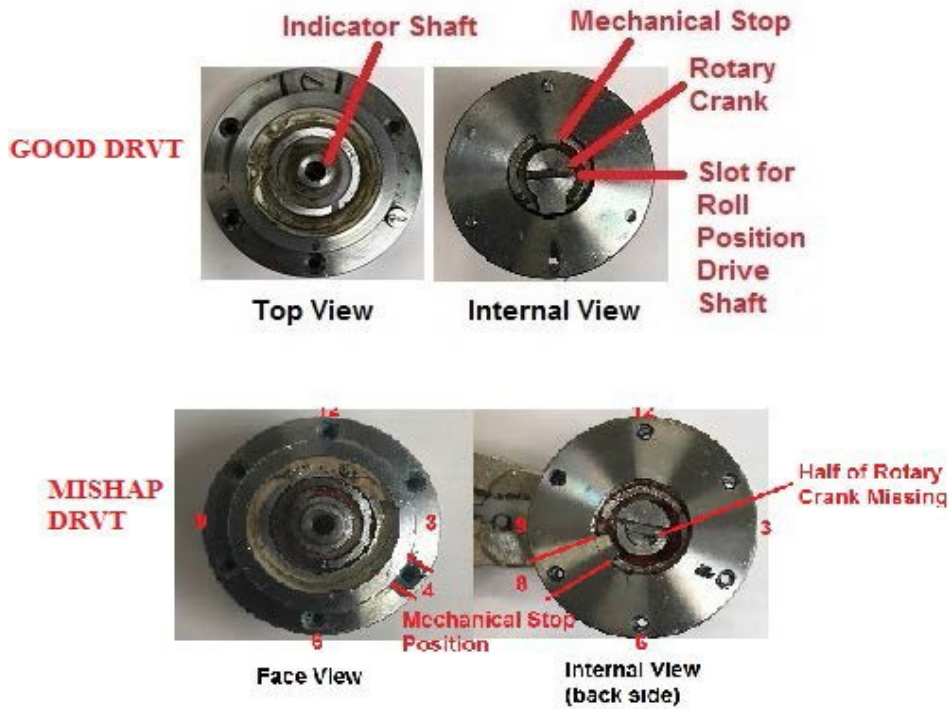
Figure 6.9 (Tabs EE-13, EE-14)

- The DRVT rotary bearing assembly was oriented 120° clockwise placing the internal mechanical stop in the 4 o'clock position looking from the face view or 8 o'clock position (240°) if viewing from internal view when removed (Figure 6.9) (Tab EE-13).
- The misalignment was out of design specifications, and was found to have put the mechanical stop in the normal range of motion of the rotary crank (Figure 6.9) (Tab EE-14).
- The rotary crank sheared and the rotary crank mechanical stop was damaged (Tab EE-15).
- With the rotary crank sheared, DRVT rotary drive shaft cannot fully engage the rotary crank (Figure 6.11) (Tab EE-15).

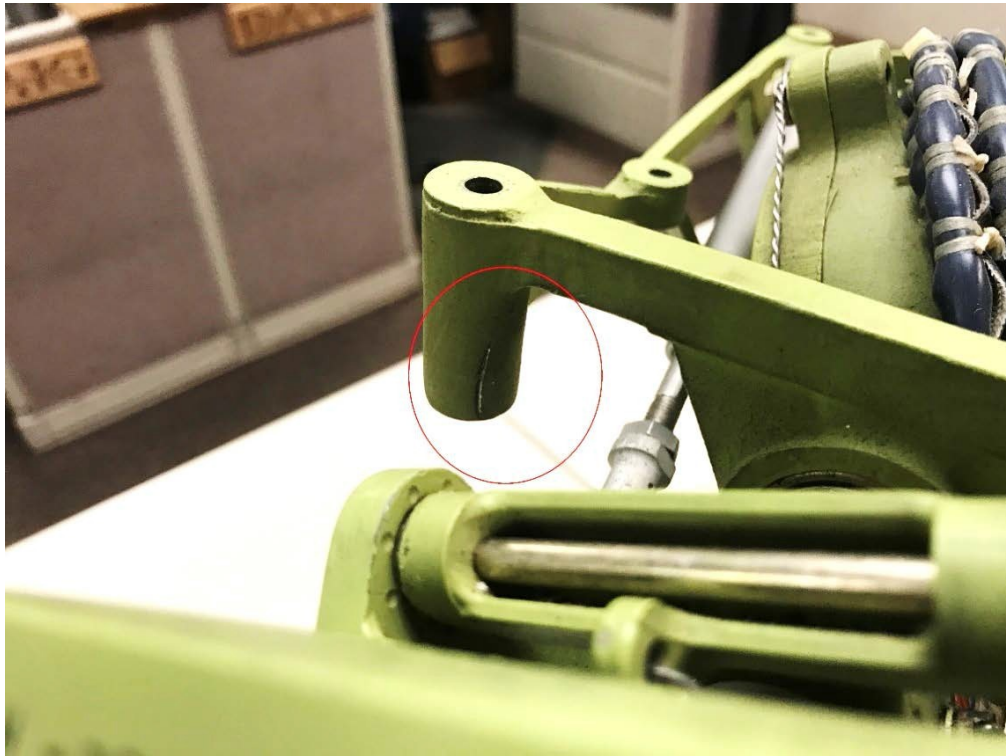
**Figure 6.12 (Tab Z-22)**

- Initial inspection of the BCA revealed that the red wire to the roll feedback motor was disconnected (Tabs J-193, and EE-20).
- The crank assembly binds the support frame when the elevation motor is engaged (Figure 6.12) (Tabs J-190, EE-20, Z-22).
- All four pitch and roll LVDTs failed the voltage bench test (Tabs J-194, EE-20, EE-21).
