UNITED STATES AIR FORCE
AIRCRAFT ACCIDENT INVESTIGATION
BOARD REPORT

F-16CM, T/N 92-3883

13TH FIGHTER SQUADRON
35TH FIGHTER WING
MISAWA AIR BASE, JAPAN

DATE OF ACCIDENT: 20 FEBRUARY 2018

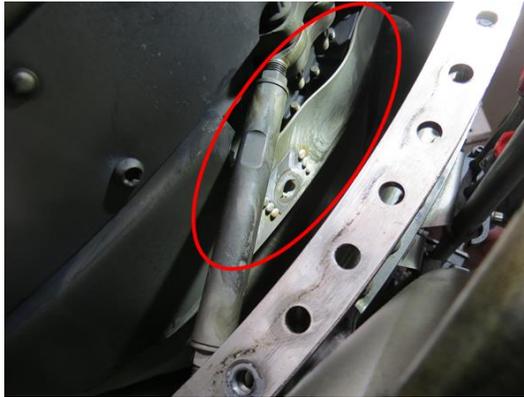
Figure 5 from the ME shows a fractured fairing segment at the 4:30 position. (Tab CC-75) This fairing segment was missing one of its bolt heads and had lifted away from its normal position. (Tab CC-75) **Figure 6** shows another larger section of the fairing segment that fractured and lifted into the cooling air flowpath. (Tab CC-75)

Figure 5: Turbine frame forward fairing with missing bolt at 4:30 position (Tab CC-75)

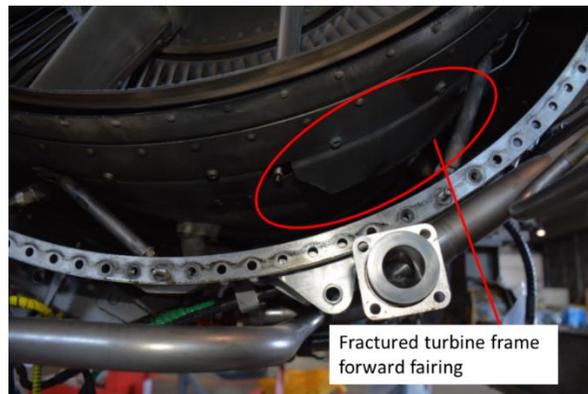
Figure 6: Turbine frame forward fairing damage at 5:30 position (Tab CC-75)

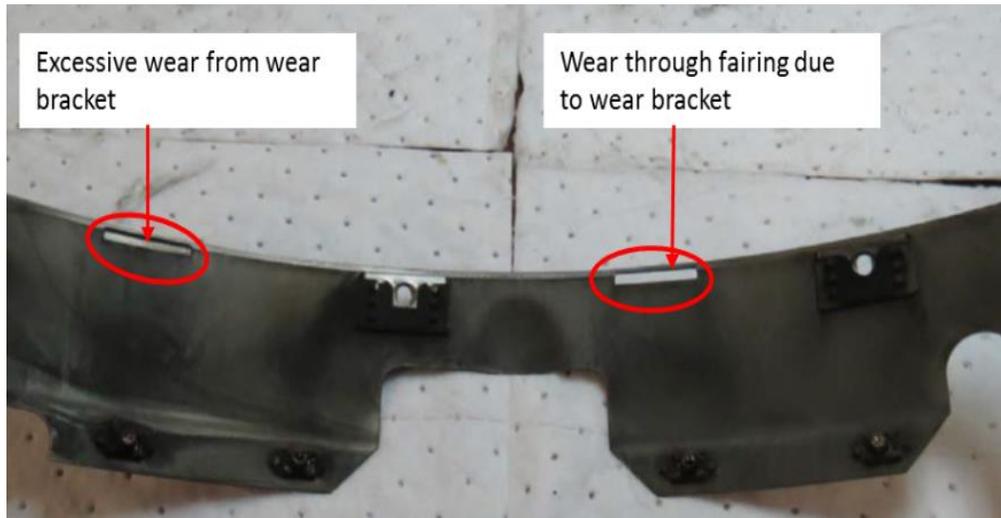
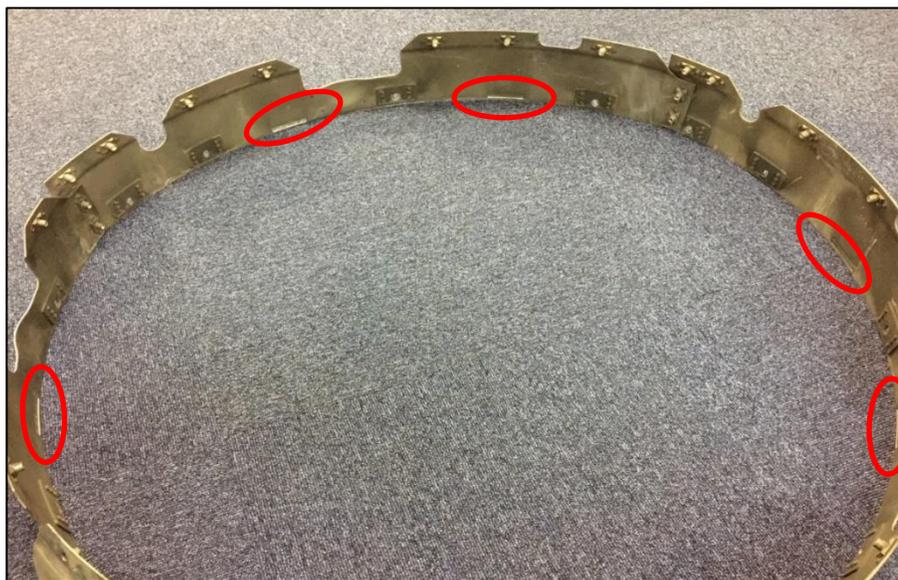
Removal of the forward fairing from the ME revealed wear from the updated mounting brackets that were installed underneath the turbine frame fairing. (Tab CC-75) In several locations, these

brackets had worn completely through the fairing. (Tab CC-76) **Figures 7 and 8** show these wear areas on the fairing segments. (Tab CC-76)

Figure 7: Turbine frame fairing wear marks (Tab CC-76)

Figure 8: Turbine frame fairing wear marks (Tab Z-13)

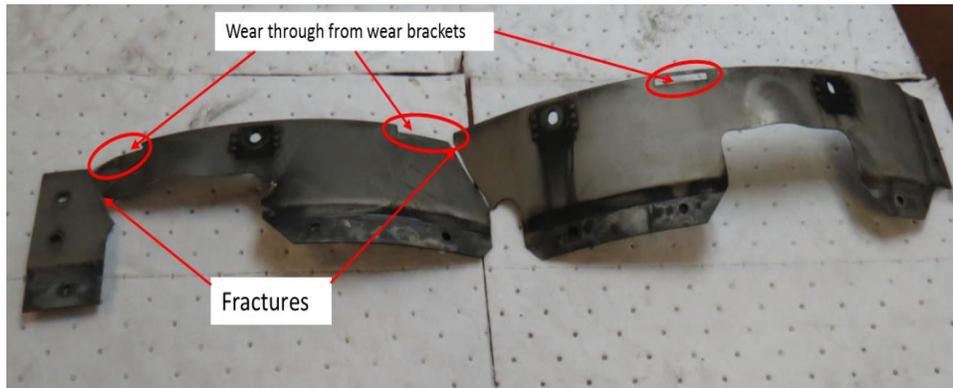
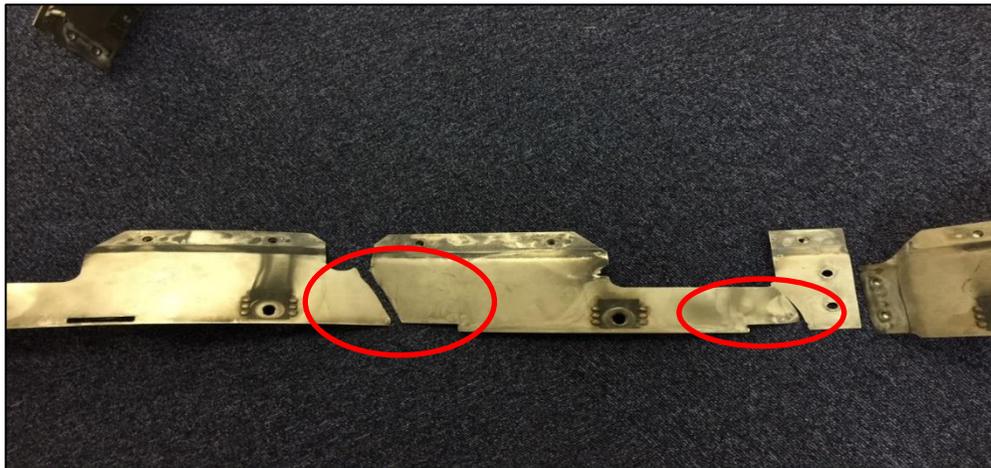
Figures 9 and 10 show the fracturing that occurred as a result of the excessive wear on the fairing segments. (Tab CC-76) **Figure 9** is a fairing segment that fractured in two locations. (Tab CC-76)

Both fractures emanate from areas where the wear brackets had worn completely through the fairings. (Tab CC-76)

Figure 9: Fractures emanating from bracket wear (Tab CC-76)

Figure 10: Fractures emanating from bracket wear (Tab Z-9)

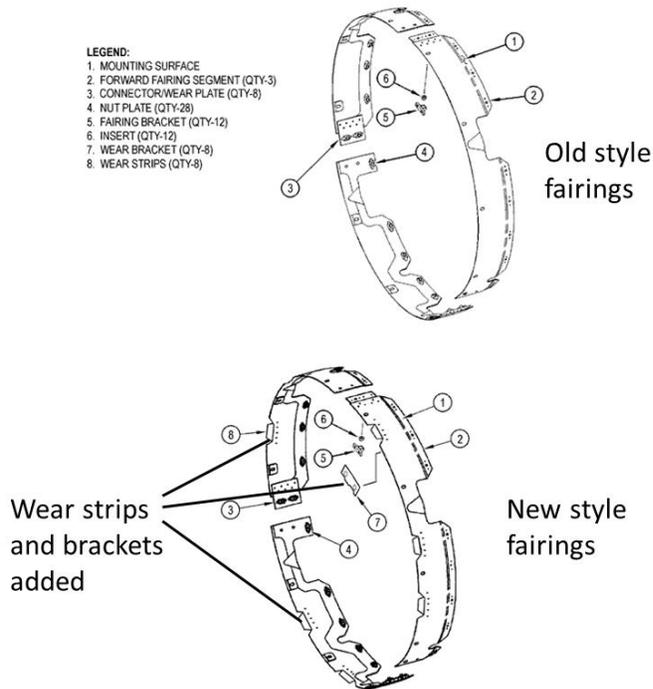
Figure 11: Fairing design change (Tab CC-79)

The absence of the wear strips on the obsolete fairing created a material mismatch between the relatively soft titanium fairing and the hardened composite material wear brackets. (Tab CC-71) This exacerbated the wear on the fairing and, in many areas, caused a complete wear-through at these contact points. (Tab CC-79)

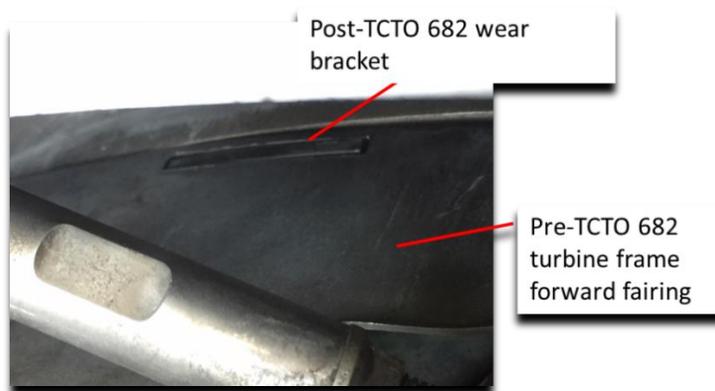
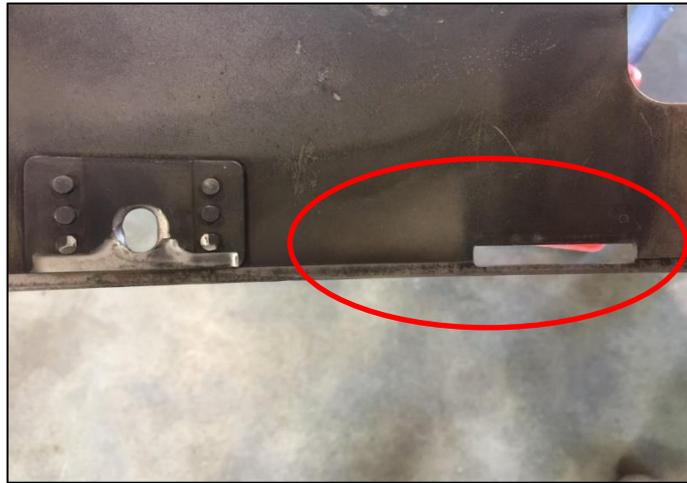
Figure 12 and 13 show one of the wear brackets worn completely through the obsolete fairing on the ME. (Tab CC-79)

Figure 12: Forward fairing wear bracket worn through fairing (Tab CC-79)

Figure 13: Forward fairing wear bracket worn through fairing (Tab Z-8)

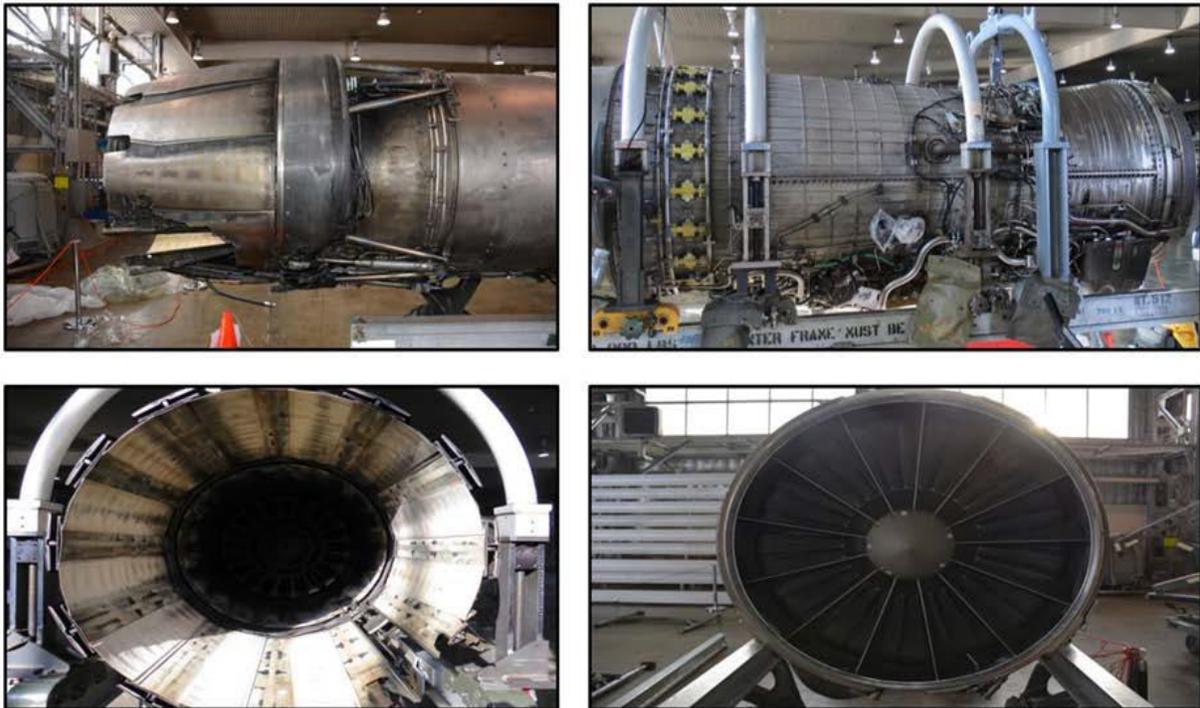
Figure 14 shows the external view and fire damage on the ME. (Tab CC-73) The only visible damage from the mishap is on the back right-hand side of the engine. (Tab CC-73)

Figure 14: External view of Engine 538133 (Tab CC-65)

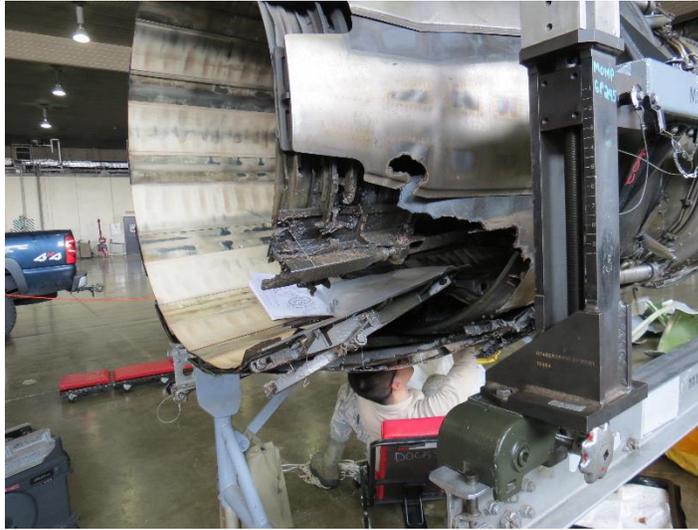
The engine's exhaust nozzle suffered extensive fire damage as shown in **Figure 15**. (Tab CC-73) The damage occurred from about the 3:00 to 6:00 position. (Tab CC-73)

Figure 15: Exhaust nozzle burn damage from 3:00 to 6:00 (Tab CC-73)

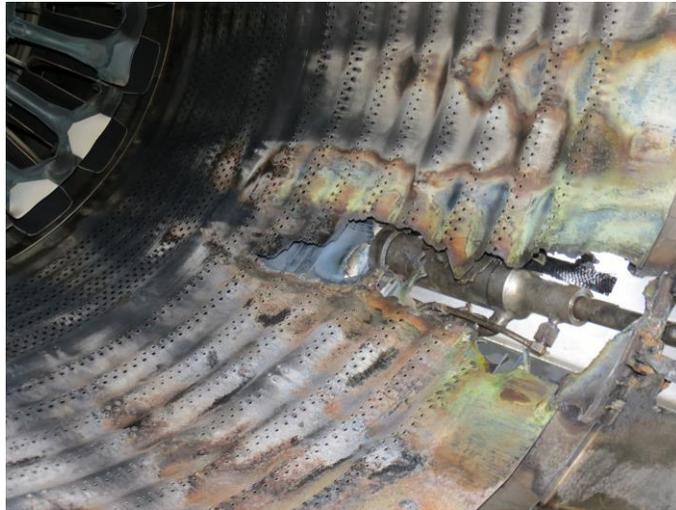
Figure 16 shows a close-up view inside the exhaust nozzle assembly. (Tab CC-74) The exhaust duct liner and the exhaust duct were burned completely through at the 4:30 position as a result of the fire. (Tab CC-74) In normal engine operation, a film of cooling air exists between the exhaust nozzle duct and the exhaust nozzle liner. (Tab CC-74) This air lowers the metal temperature of the exhaust duct liner during engine operation. (Tab CC-74) Without proper cooling air, the liner cannot withstand the temperatures of the hot engine gases from the exhaust. (Tab CC-74)

Figure 16: Burn-through on exhaust duct liner and duct at 4:30 (Tab CC-74)

The fire also caused the A8 actuator supply line at the 4:30 position to rupture and leak hydraulic oil. (Tab CC-74) The A8 actuators control the diameter of the nozzle during normal flight operations. (Tab CC-74) Decreasing the diameter of the nozzle allows the engine to produce thrust. (Tab CC-74) With the A8 actuators' hydraulic line ruptured, the MP was unable to decrease the diameter of the nozzle, creating a noticeable decrease in engine thrust. (Tab CC-74)

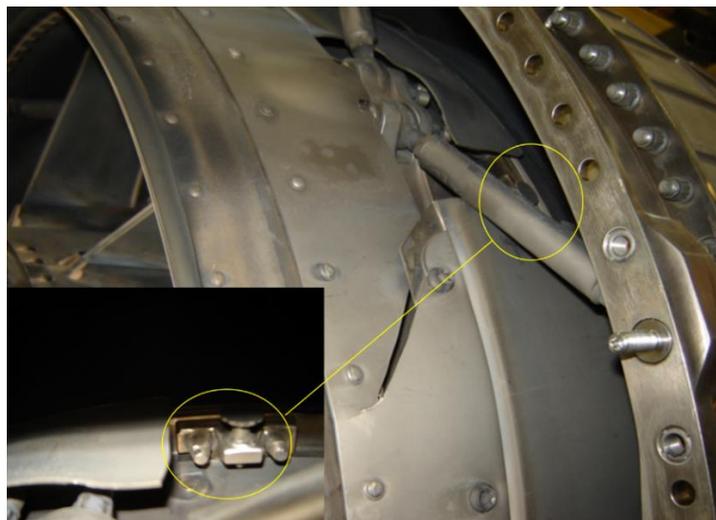
The primary TCTO at issue here, TCTO-682, was driven by the fact that during the early to mid-2000 timeframe, both the U.S. Air Force and foreign military operators of the F110129 engine began experiencing excessive wear, cracking and, in a few cases, failure of the turbine frame forward fairing. (Tab CC-69) Most of these fairings were found to be wearing on the front end where they would become thin, crack, and sometimes fail. (Tab CC-77) **Figures 18 and 19** show a previous fairing failure that occurred in 2009. (Tab CC-77) Note the similarities between **Figure 16** from this mishap and the 2009 fairing failure. (Tab CC-77)

Figure 17: Fairing failure in 2009 event (Tab CC-77)

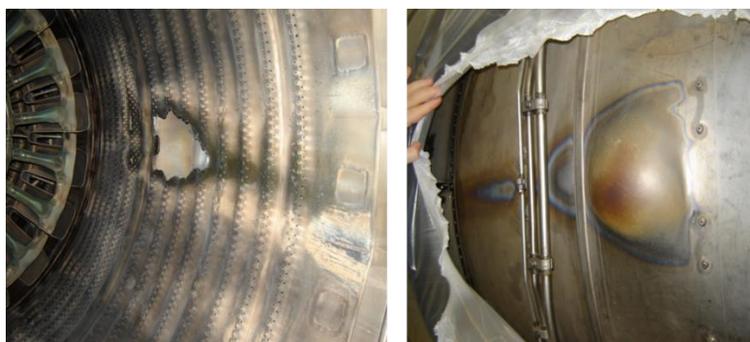
Figure 18: Exhaust duct liner and duct heat distress from event in 2009 (Tab CC-77)

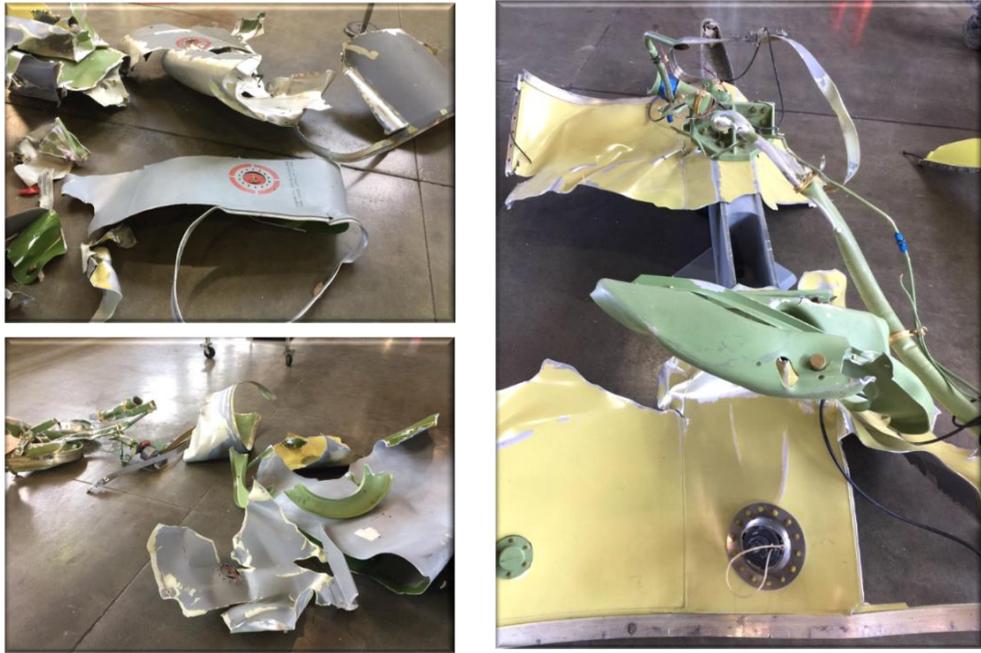
Figure 20 shows portions of the fuel tanks recovered during salvage operations. Overall, 99.9% of the fuel tank material was collected from Lake Ogawara, totaling 895.75 pounds. (Tab U-4) All response and recovery operations concluded on 16 March 2018.

Figure 20: F-16CM External Fuel Tanks-recovered material from Lake Ogawara
