UNITED STATES AIR FORCE
AIRCRAFT ACCIDENT INVESTIGATION
BOARD REPORT

F-16C, T/N 93-0531 and F-16C, T/N 92-3899

DATE OF ACCIDENT: 7 JUNE 2016

**United States Air Force Accident Investigation Board Report
F-16C (2x) Mishap, Louisville, GA**

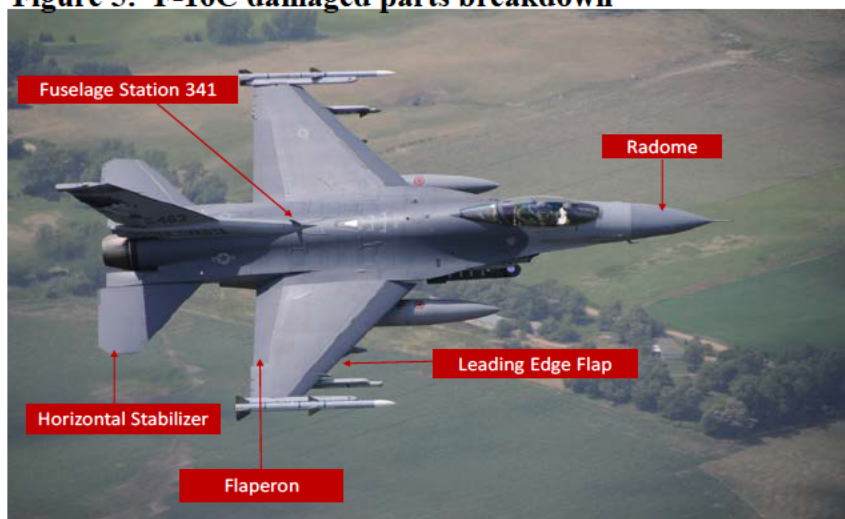
Figure 5: F-16C damaged parts breakdown

MA1 received damage during the midair collision to its right leading edge flap, the right outboard wing, the outboard flaperon, and the right horizontal stabilizer (Tab J-37). MA1 upon impact broke into two sections near the Fuselage Station 341 just forward of the installed engine (Tab J-7). Post impact analysis deemed MA1 a total loss (Tabs J-5 and P-4).

MA2 received damage during the midair collision to its right leading edge flap and the right inboard wing (Tab J-11 to J-12). MA2 sustained damage to all flight control surfaces detaching them from the fuselage upon ground impact (Tab J-9). There was evidence of post-impact fire at
