UNITED STATES AIR FORCE
AIRCRAFT ACCIDENT INVESTIGATION
BOARD REPORT

RQ-4B, T/N 07-2029

LOCATION: NEAR LONE PINE, CALIFORNIA

DATE OF ACCIDENT: 21 JUNE 2017

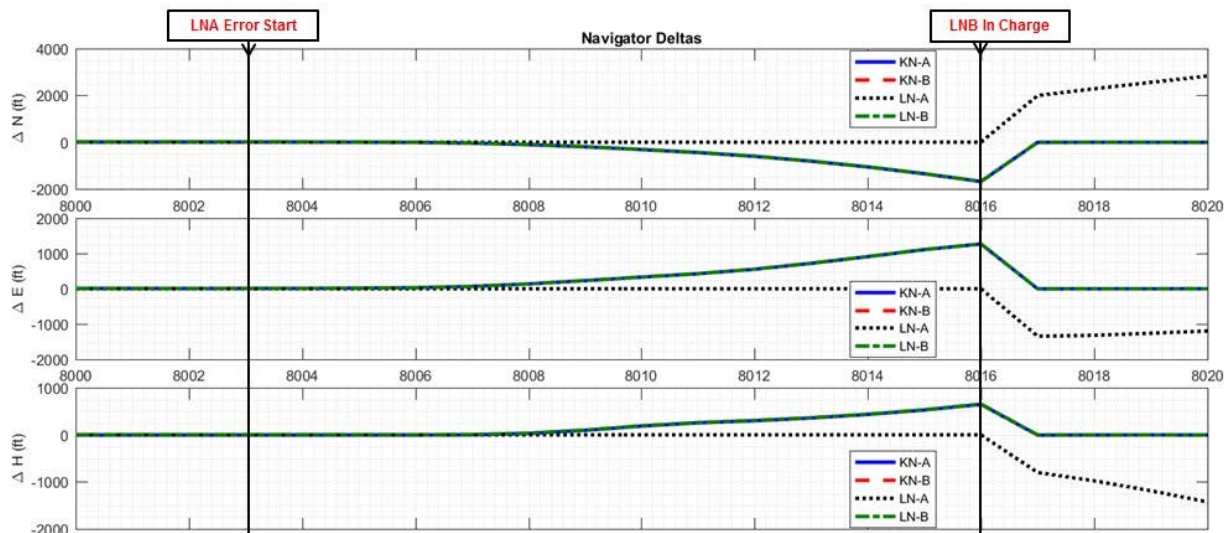
Table 2 (Tab DD-35)

Data recovered indicated how all four navigators were performing during the mishap sortie (Tab DD-32 and DD-35). Three navigators were operating normally (Tab DD-32 and DD-35). Because KNA and KNB were disabled at the time of the mishap, LNA was the "in-charge" navigator (Tab DD-18). LNA provided erroneous data, deviating from the other navigators (Tab DD-32 and DD-35). The RQ-4 is designed to detect erroneous data within the navigational

system (Tabs V-13.6, V-15.4, and DD-16 to DD-18). During the mishap sortie, the MRPA's navigation system did not detect LNA's erroneous data (Tab DD-32). Post-mishap analysis and testing of LNA, and same-type devices, were unable to determine the root cause of LNA's erroneous navigational data (Tab DD-40 to DD-41).
