UNITED STATES AIR FORCE
AIRCRAFT ACCIDENT INVESTIGATION
BOARD REPORT

A-10C, T/N 79-0204, AND A-10C, T/N 78-0657

LOCATION: NEVADA TEST AND TRAINING RANGE 65C

DATE OF ACCIDENT: 6 SEPTEMBER 2017

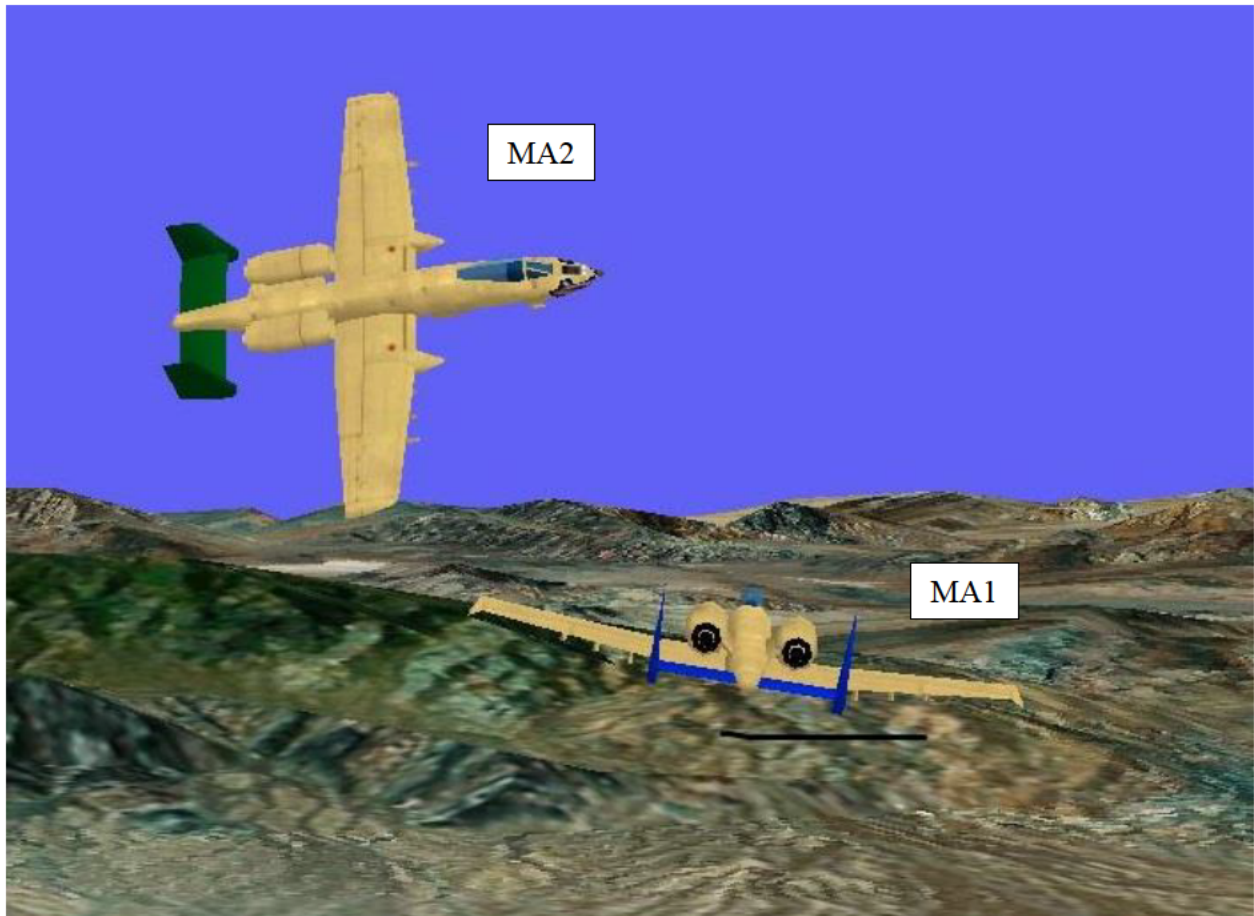
At 19:44:09L, MA1 (heading 200 degrees in a 10-degree right bank) and MA2 (heading 300 degrees in a 60-degree right bank) collided at approximately 11,400 ft MSL (Tab FF-4 to FF-5).

Figure 1. MF simulation (viewed from the north) 0.2 seconds prior to collision (Tab Z-2)

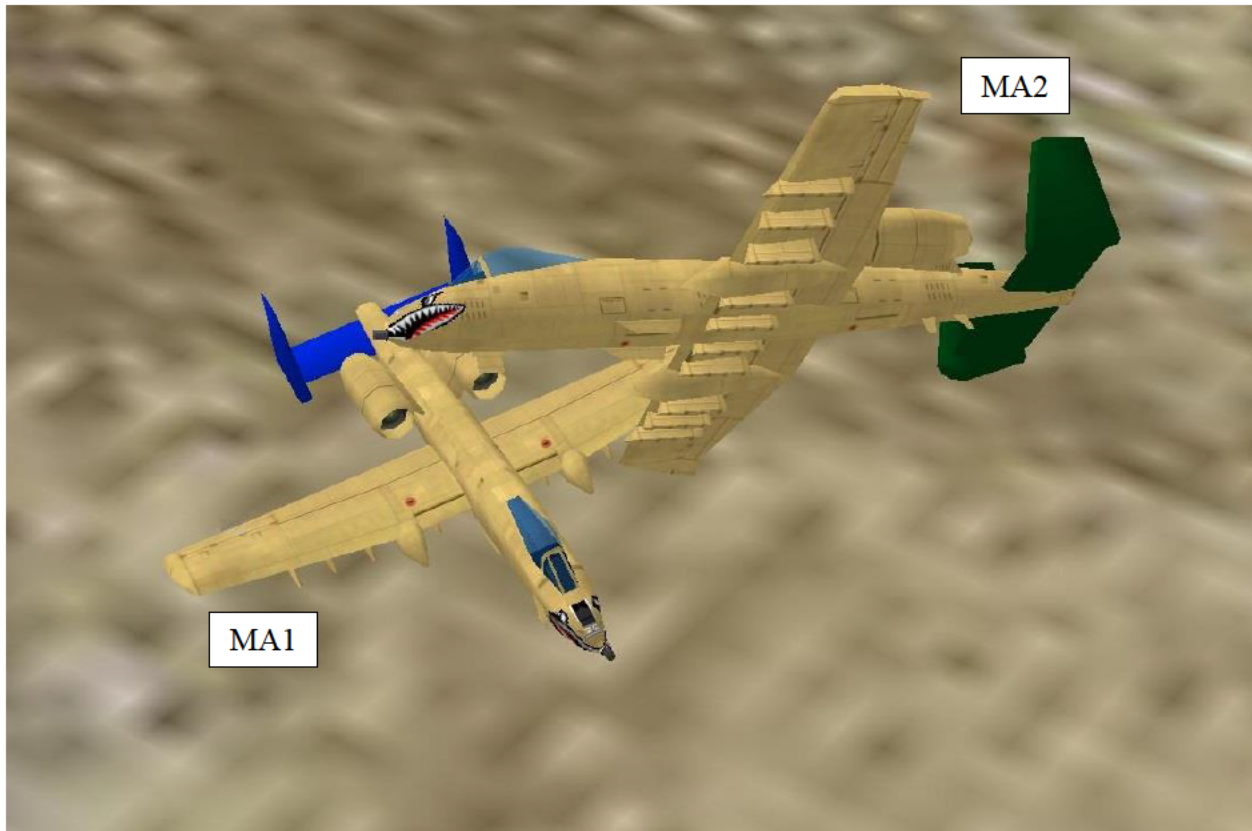
Figure 2. MF simulation (viewed from above) 0.1 seconds prior to collision (Tab Z-2)

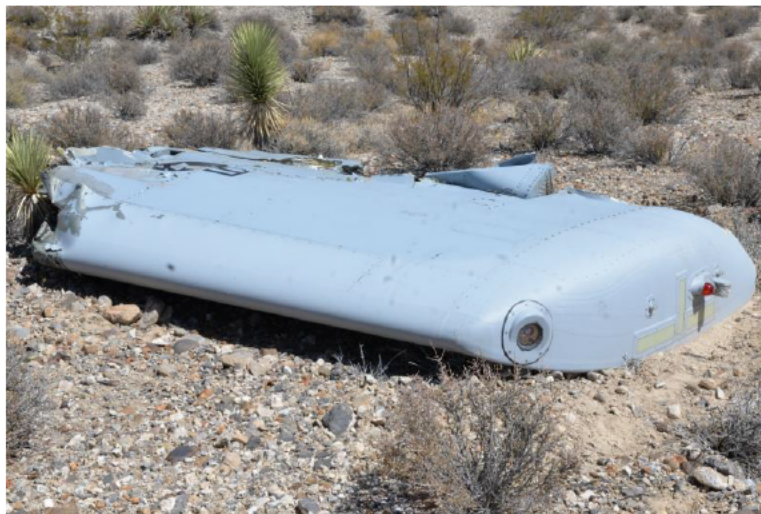
The midair collision caused the outermost 10 feet of the left wing as well as the left engine and the left vertical stabilizer to separate from MA1 (Tabs S-14, S-16, S-18, U-3, and Z-3). Additionally, the outermost five feet of the right wing was separated from MA2 during the midair collision (Tabs U-3 and Z-3).

Figure 3. MA1 left wing separated in collision (Tabs S-14 and U-3)

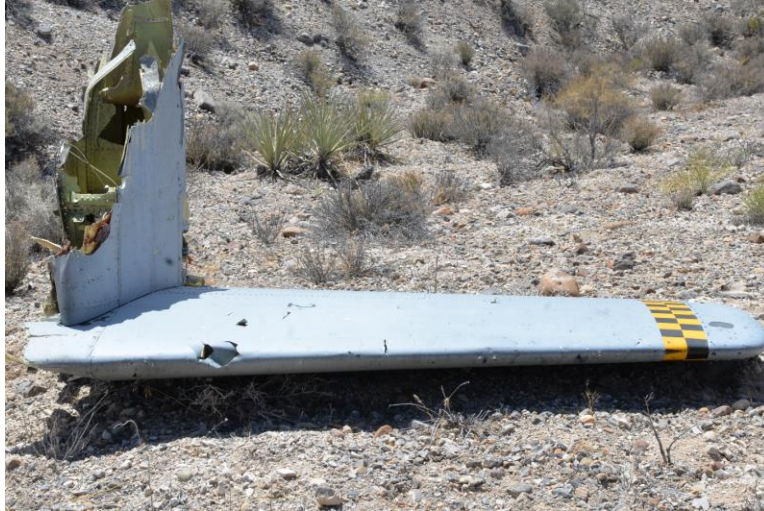
Figure 4. MA1 left vertical stabilizer separated in collision (Tabs S-16 and U-3)

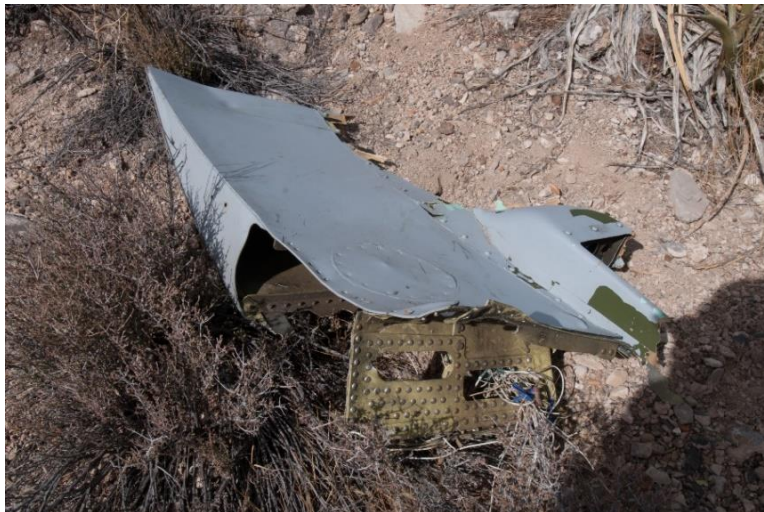
Figure 5. MA2 right wingtip separated in collision (Tab Z-3)

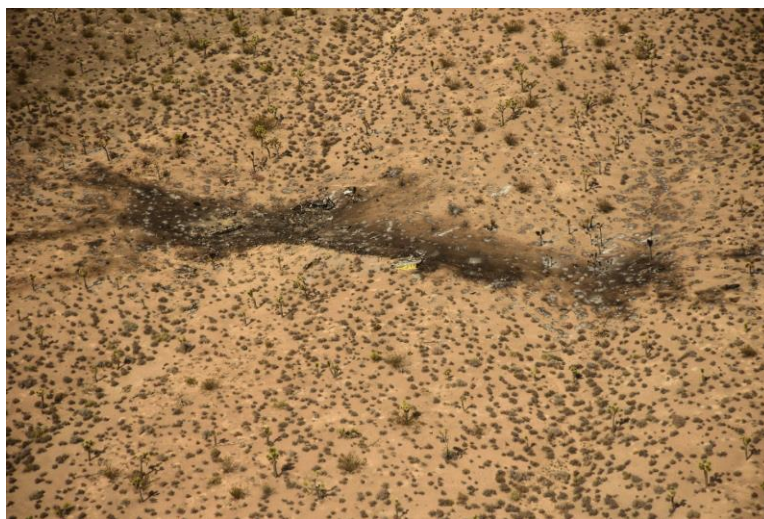
MA1 crashed into the ground 1 mile southwest of the midair collision location depicted in Figures 6 and 7 (Tabs S-8, S-23, Z-3, and FF-5). Based upon an inspection of the crash site, MA1 crashed in a left-wing-low orientation (Tab S-8 to S-12). At the time of the crash, MA1 was carrying training munitions (Tab P-4 to P-5).

Figure 7. MA1 crash site (looking north) (Tabs S-8 and Z-3)

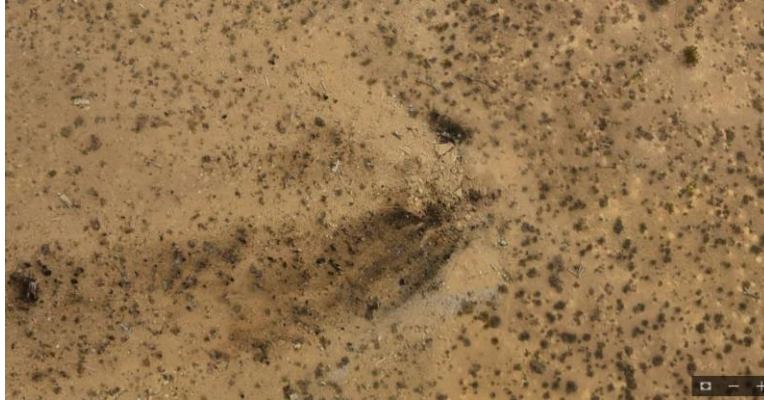
MA2 crashed shortly after MA1, 1.7 miles northwest of the midair collision location and 2.5 miles from the MA1 crash site as depicted in Figures 6, 8, and 9 (Tabs S-3 to S-7, S-23, V-2.20, Z-3, and FF-4). Based upon an inspection of the crash site and witness testimony, MA2 crashed while northbound in an 80 - 90 degree, nose-low orientation (Tabs S-3 to S-7, S-23, and V-2.20). At the time of the crash, MA2 was carrying training munitions (Tab P-6 to P-7).

Figure 8. MA2 crash site (looking southwest) (Tabs S-3 and Z-3)

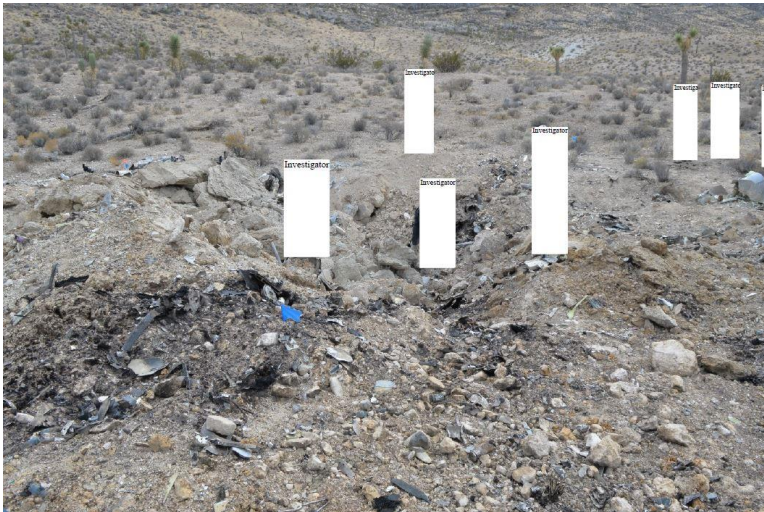
Figure 9. MA2 crash site (looking south) (Tab S-4 and Z-3)
