UNITED STATES AIR FORCE
AIRCRAFT ACCIDENT INVESTIGATION
BOARD REPORT

F-16C, T/N 00-0219

**LOCATION: NEAR BAGRAM
AIRFIELD, AFGHANISTAN**

DATE OF ACCIDENT: 3 APRIL 2013

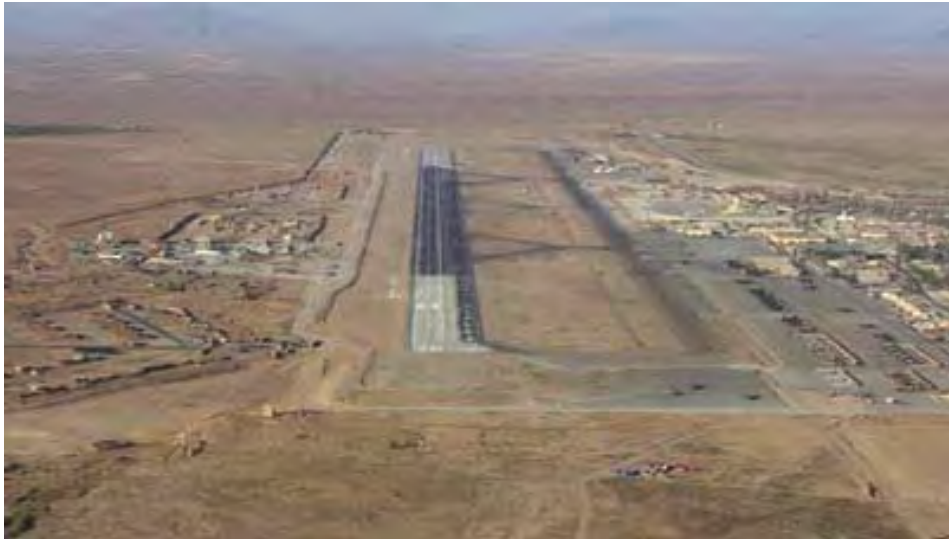
The MP and MW spent the first five months of their deployment flying out of KAF. The area around KAF had very little elevated terrain (Tab V-1.4 to V-1.6). Four days before the MF, the MP’s squadron moved to BAF, which has high terrain (Tab AA-3). The MF was only the MP’s second sortie flown out of BAF (Tab V-1.9 and V-1.19). As the MP flew 40 night approaches into KAF, and only one prior night approach into BAF, it is possible he reverted to a mental model of flat terrain (Tab G-12 to G-15).

Figure 2: KAF (minimal terrain) (Tab Z-3)

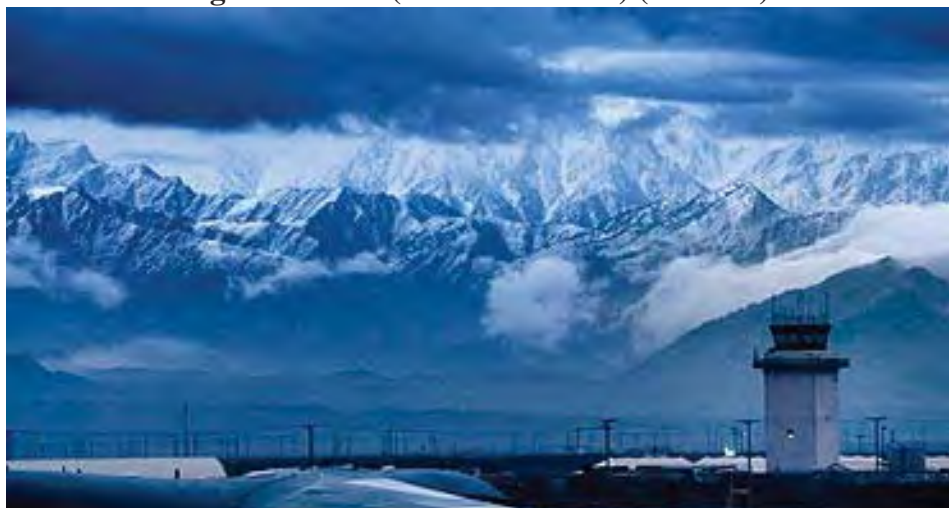
Figure 3: BAF (mountainous terrain) (Tab Z-5)
