UNITED STATES AIR FORCE
AIRCRAFT ACCIDENT INVESTIGATION
BOARD REPORT

MQ-1B, T/N 00-3068

LOCATION: Creech Air Force Base, Nevada

DATE OF ACCIDENT: 28 April 2009

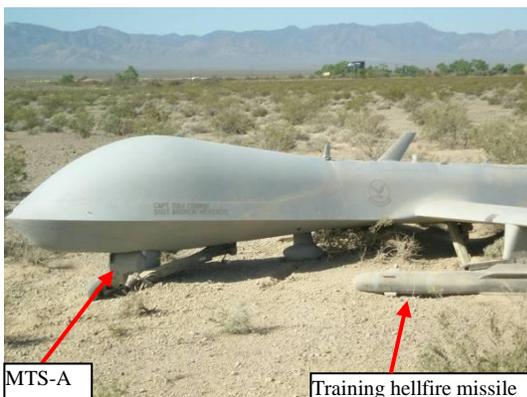
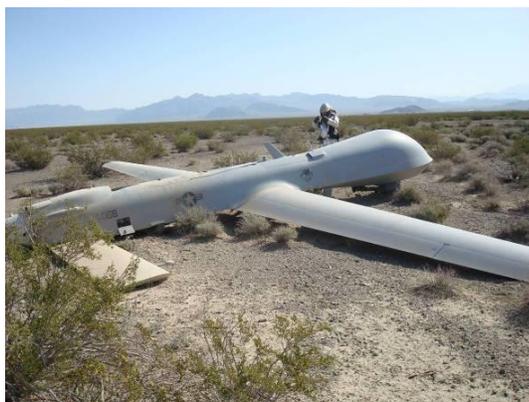
The MRPA's structure and engine were damaged as a result of the mishap. (Tab S-7)

Aircraft structural damage includes: left and right wing; left and right tail; vertical stabilizer; left and right MLG; NLG; left and right fillet; engine cowling; numerous mounts and attachments; bulkheads 5, 6, 7, and 10; aft fuel door; and upper and lower fuselage skin damage. (Tab P-4) The \$1.2 million MTS-A sustained minimal damage, and has been deemed repairable. (Tab S-7, S-10, S-18) The training hellfire missile was damaged when it became dislodged from the rail. (Tab S-10) Repair cost will exceed replacement cost.

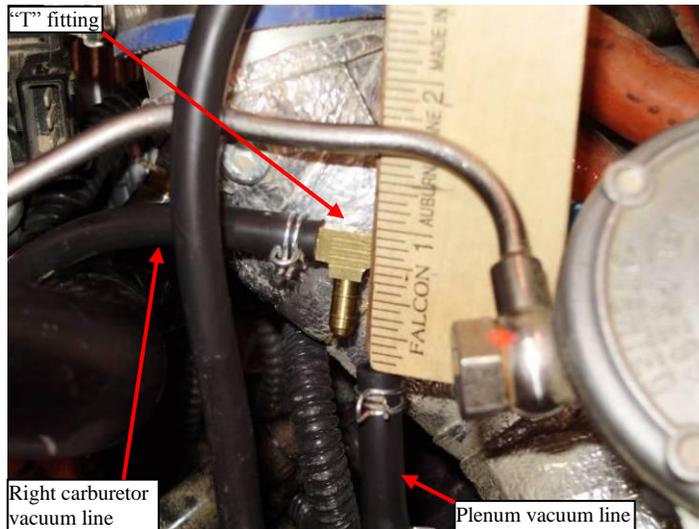
A thorough inspection of the engine after the mishap revealed that the MAP reference vacuum line disconnected from plenum chamber at a “T” fitting. There was approximately one half inch between the end of the vacuum line connected to the plenum and the “T” fitting.

The MAP reference vacuum line allows the carburetor to more precisely meter the amount of fuel entering the carburetor venturi to account for variations in air pressure at different altitudes. On the MQ-1B Predator manifold pressure is produced by a turbocharger driven by engine exhaust metered by a wastegate. As MAP increases the air entering the carburetor becomes denser allowing more fuel to be metered into the venturi resulting in increased engine power. If the vacuum line opens, i.e. becomes disconnected, the pressure sensed by the carburetors become that of the ambient (from the surrounding environment) atmosphere. If the MAP is higher than the ambient pressure, the amount of fuel metered into the venturi will decrease. This will lean the air fuel mixture entering the engine cylinders, which will lead to engine oscillations and decrease power.

The “T” fitting that connects the MAP reference vacuum line is situated such that the foot connects to a rubber vacuum line attached to the engine plenum and the arms connect to rubber vacuum lines for the left and right carburetors. The vacuum lines from the “T” fitting to the carburetors were cut to a length to allow for no slack, and as such they were under tension. This is to avoid rubbing and chafing. The section of vacuum line from the plenum to “T” fitting was installed IAW Air Force technical orders, but it was cut to a length that required pulling the “T” fitting one half inch toward the plenum to connect the vacuum line to the “T” fitting. This placed additional tension on the carburetor vacuum lines.
