**SUBJECT: Accident Investigation Board Report: F-16CM, T/N 89-2108, 421 FS,
388 FW, Hill AFB, UT, 22 June 2009**

AIRCRAFT ACCIDENT INVESTIGATION

**F-16CM, T/N 89-2108
UTAH TEST AND TRAINING RANGE
22 JUNE 2009**

SUMMARY OF FACTS AND STATEMENT OF OPINION
F-16CM, T/N 89-2108
22 JUNE 2009

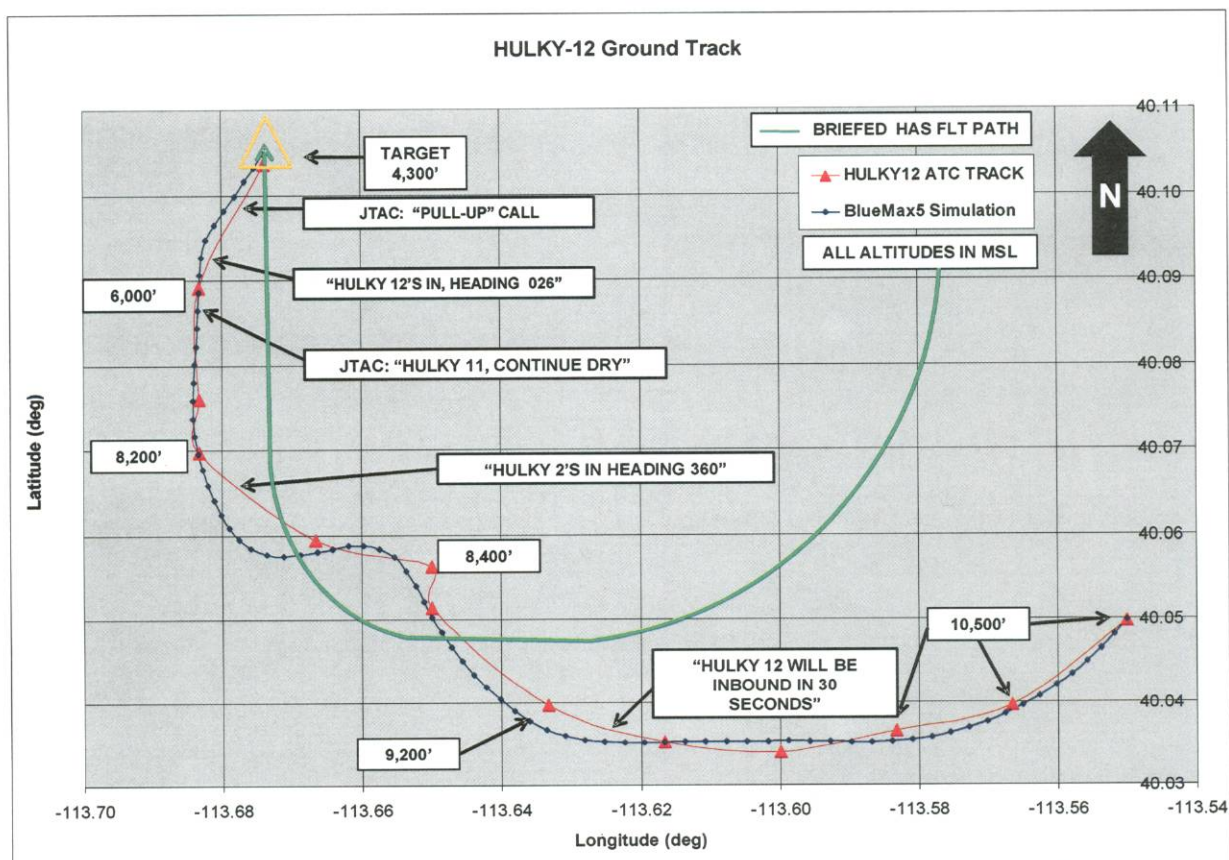
After visual acquisition and confirmation of the target, at 22:26:29L, 50 seconds prior to impact, the MA was 6,200 feet AGL, still within the briefed parameters to execute the briefed HAS attack (Tabs M-9 through M-12, N-3 through N-4, V-1.11 through V-1.12). At 22:26:50L, the MP declared he would be "inbound in 30 seconds," establishing his intent to roll-in for his attack in approximately 30 seconds (Figure 1) (Tab N-4).

Figure 1: HULKY12's radar-recorded and animation-derived flight paths, with associated altitudes and radio transmissions, compared to his briefed HAS flight path (Tabs M-10 through M-11, N-4, CC-14).

At this time, the MP's aircraft was positioned further from the target than briefed (Tabs M-9 through M-11, V-1.11 through V-1.12). Prior to rolling-in, the MP turned toward the target and descended slightly (Tabs M-10 through M-11, CC-9 through CC-10). He then turned away from the target momentarily before executing an almost level turn to the north, and at 22:27:07L the MP called "Hulky 2's in, heading 360" from an altitude of approximately 8,300 feet MSL (4,000 feet AGL) (Tabs M-10 through M-11, N-4). At that point, the MP commenced another shallow descent, setting himself up to commence his HAS attack more than 2,000 feet lower than the briefed minimum altitude (1,800 feet below the minimum stated on his attack card) (Figure 2) (Tabs M-10 through M-11, CC-15).

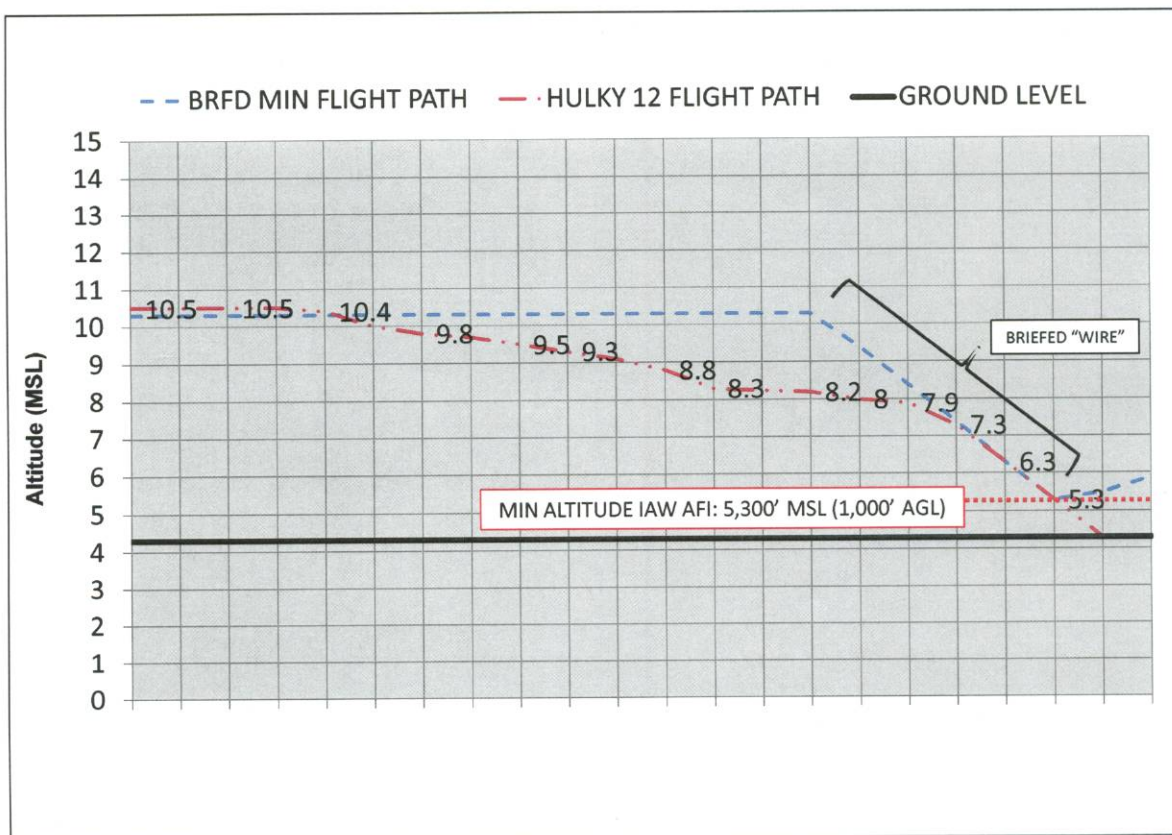
Figure 2: The MP's altitude during his HAS pass compared to the briefed minimum altitude for a HAS pass (Tabs M-10 through M-11, V-1.11 through V-1.13, CC-9 through CC-10).

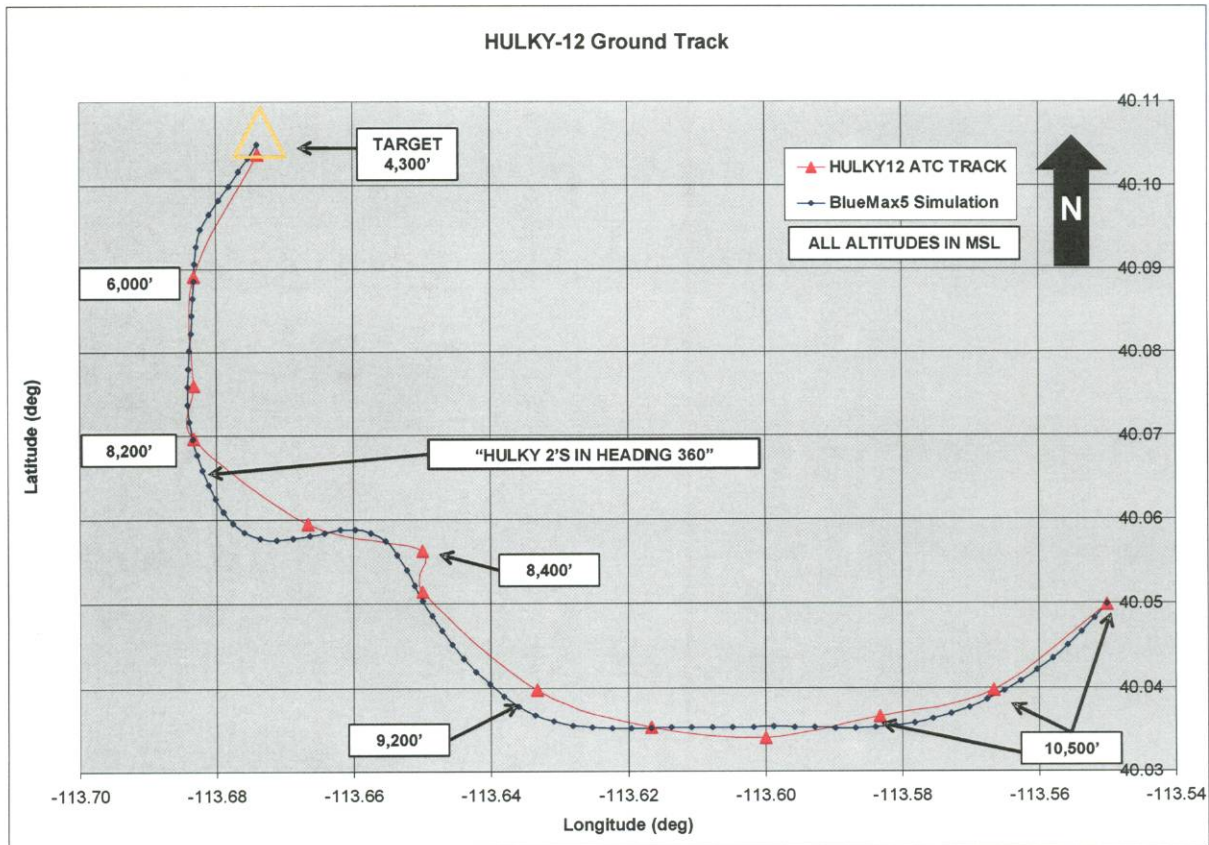
The MS was the first time the MP had attempted a HAS event using an IR marker to identify the target (Tab V-1.7). During the HAS pattern, the MP made several radio calls with the MFL confirming that he had visually acquired the IR marker and that it was on the correct target (Tab N-4). Analysis of the MFL's Link16 recording, along with position and altitude data from Clover radar control then showed the MP descending prior to roll-in for his HAS attack. The MP subsequently performed several maneuvers to correct his pattern position, during which he continued to descend (Figure 3) (Tab M-4 through M-11). At the time of the MP's call "Hulky 2's in heading 360," he was approximately 4,000 feet AGL, 2,000 feet lower than the briefed minimum altitude (Tabs M-14, N-4, V-1.13). When he made this turn, the MP delayed lowering his nose to the target (Tab M-4 through M-11). These maneuvers, combined with the MA's diminishing altitude, could suggest that the MP was channelized on visually establishing the correct angular trajectory through his NVGs to the exclusion of cross checking his altitude indications throughout the mishap sequence.

Figure 3: The MP's ATC and animation derived flight path (Tabs M-10 through M-11, CC-14).

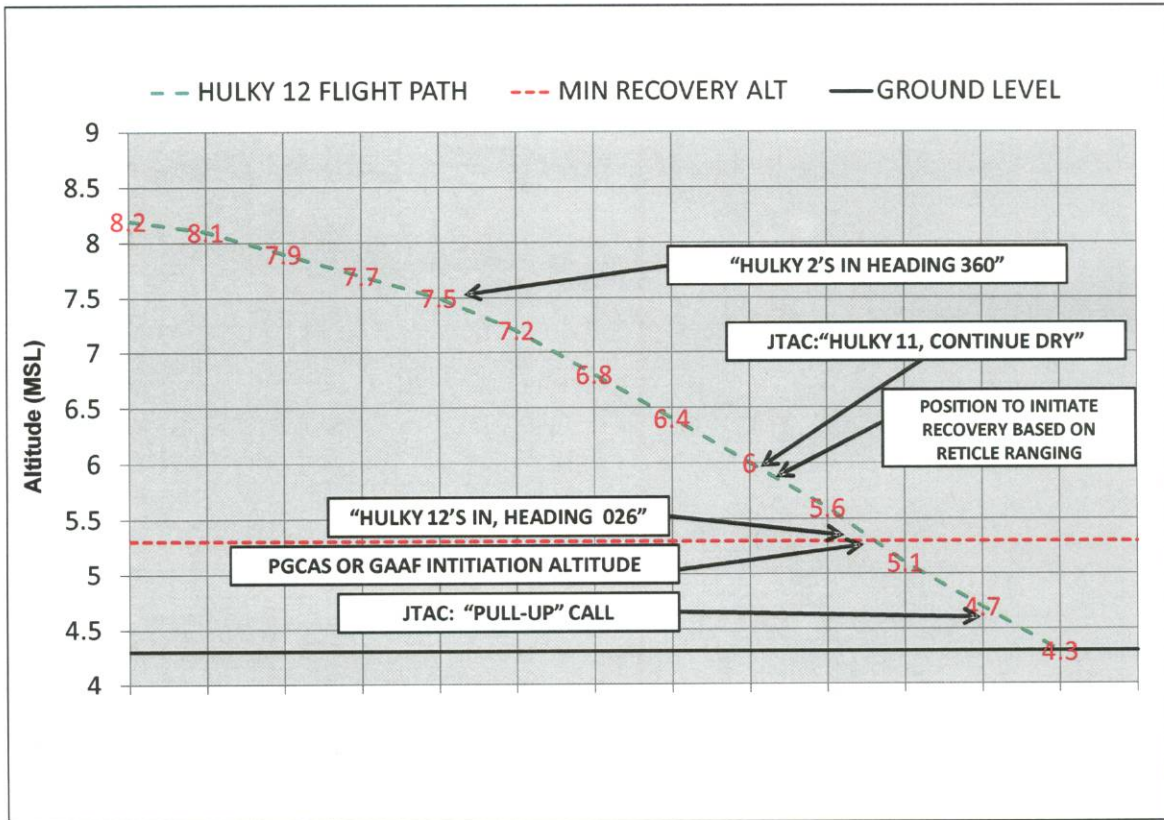
Given the MP's trajectory and the mechanization of F-16 low-altitude warning systems, it is highly likely the MP received a repeating auditory warning of "PULL UP, PULL UP" from the PGCAS along with a continuously displayed large, flashing "X" visual cue in the HUD by at least 900 feet AGL and 3 seconds prior to impact (Figure 4). In strafe mode, this is designed to allow the pilot a delay of 1 second to recognize the warning and 1 second to initiate a 5G recovery to remain above 50 feet AGL. If the PGCAS is turned off or not functioning, the MP would have received a repeating "PULL UP, PULL UP" warning and a continuous HUD "X" from the ground avoidance advisory function (GAAF), also by 900 feet AGL (Tab J-11 through J-15). During multiple simulations of the MS, pilots of various experience levels were consistently able to process these warnings, perform an instrument cross-check to confirm altitude and slant range, and initiate a recovery in time to avoid impacting the ground, with all pilots recovering by at least 450 feet AGL. A timely response to either of these warning systems

would have allowed sufficient time to recover the aircraft prior to ground impact (Tab CC-9 through CC-10). The lack of attempted recovery is consistent with channelized attention making it unlikely the MP mentally processed the warnings.

Figure 4: Hulky 12's altitude with associated radio transmissions and aircraft warnings (Tabs J-11 through J-15, M-10 through M-11, N-3 through N-4, CC-9 through CC-10).

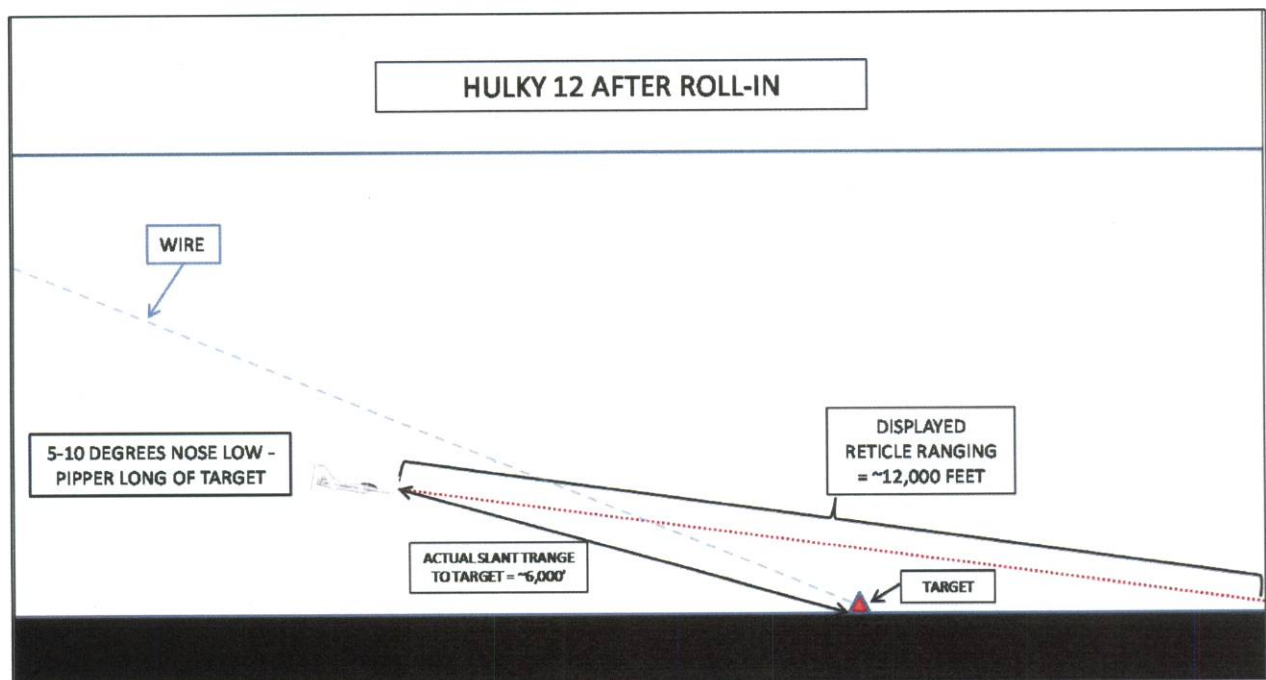
During the entire mishap sequence, the MP continued the pattern without correcting his altitude, despite being substantially lower than his briefed minimum altitude (Tabs M-14 through M-15, V-1.13). The communication from the MP gave no indication that he was aware of his diminished altitude and compressed range (Tab N-3 through N-4). If the MP had flown the HAS as briefed, he would have rolled in using a 120 degree bank turn and placed the aiming reference, or "pipper," 20 to 30 degrees below the horizon near the target (Tab V-1.11 through V-1.13). This would have put the MA on the briefed "wire." Once on the "wire" with the pipper near the target, the MP was trained to use reticle ranging (the range generated by the aircraft system measuring the line-of-sight distance through the pipper) as his primary cue for his distance to the target (Tab V-1.12). Had the MP been on the briefed "wire" at roll-in, the first reticle range he would see would have been at least 12,000 feet (Figure 5) (Tab CC-9 through CC-10).

Figure 5. Hulky12 after roll-in in relation to the briefed "wire" and the associated reticle ranging (Tab CC-9 through CC-10).

On the MS, the MP was initially below the briefed 20 to 30 degree "wire" and delayed lowering the MA's nose until reaching the "wire" (Tab M-4 through M-11). Under these conditions, since the MA was pointed long of the target, simulations indicated the reticle would probably still have displayed a range of over 12,000 feet, when the actual distance was less than 6,000 feet (Tab CC-9 through CC-10). This misleading reticle range could have corresponded to the

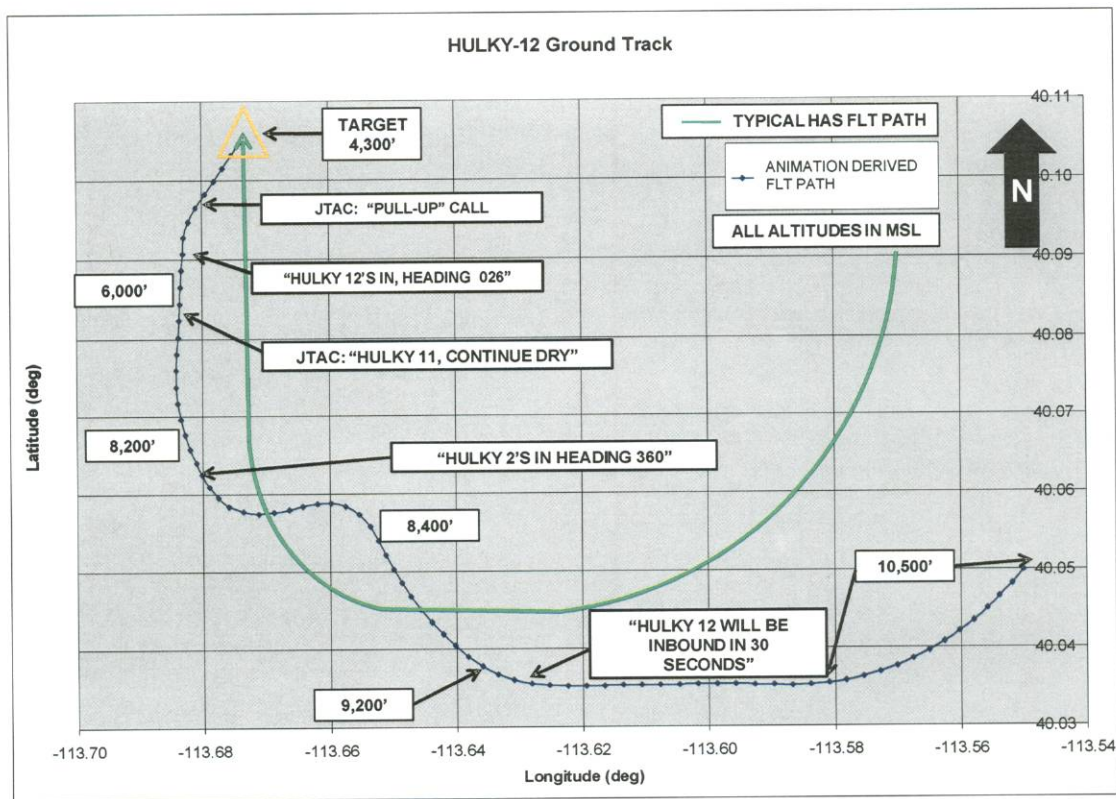
Figure 1: Ground Track Depiction

Figures 1 and 2 depict the MP's HAS pattern geometry, in two dimensions, relative to the geometry of a pattern the MP would be expected to fly, based upon the mishap flight briefing, the MP's training, historical evidence of MP technique, and his pre-mission discussion with the MFL.

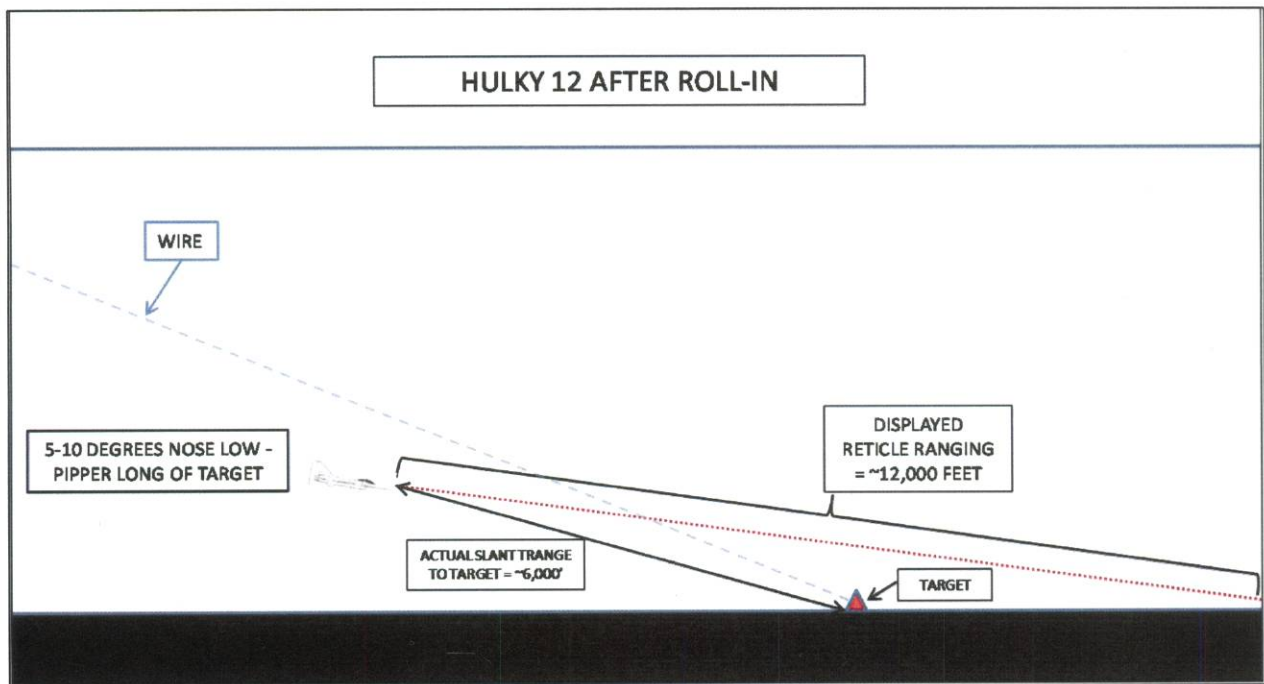
Figure 3

During the entire mishap sequence, the fact that the MP continued the pattern without correcting his diminishing altitude indicates he perceived himself to be at or above a minimum safe roll-in altitude. If the MP had flown this HAS attack as briefed, he would have rolled in using a 120 degree bank turn, placing the aiming reference (pipper) near the target, 20 to 30 degrees below the horizon. This would put the MA on what's referred to as the "wire." Once on the "wire" with the pipper near the target, the MP was trained to use reticle ranging (the range generated by the aircraft system measuring the line-of-sight distance through the pipper) as his primary cue for how close he was to the target. Had the MP been at the briefed altitude and position at roll-in, the first reticle range he would see would have been at least 12,000 feet (Figure 3).

On the MS, the MP was much lower than expected, below the briefed 20 to 30 degree “wire.” Assuming the MP thought he was at or above 6,000 feet AGL, it would now appear to him as if he were too far from the target laterally for that altitude, so he continued flying toward the target nearly level and delayed lowering the MA’s nose until reaching the “wire.” Since the nose of the aircraft was not pointed directly down at the target during this time, it is highly likely the reticle ranging was misleading, indicating 12,000 feet or more--the range he **expected** to see, vice his actual range, which at this point (5 to 7 seconds prior to impact) was less than 6,000 feet.
