UNITED STATES AIR FORCE
AIRCRAFT ACCIDENT INVESTIGATION
BOARD REPORT

CV-22B OSPREY, T/N 06-0031

DATE OF ACCIDENT: 9 APRIL 2010 (L)

SUMMARY OF FACTS AND STATEMENT OF OPINION
CV-22B, T/N 06-0031 ACCIDENT
9 April 2010 (L)

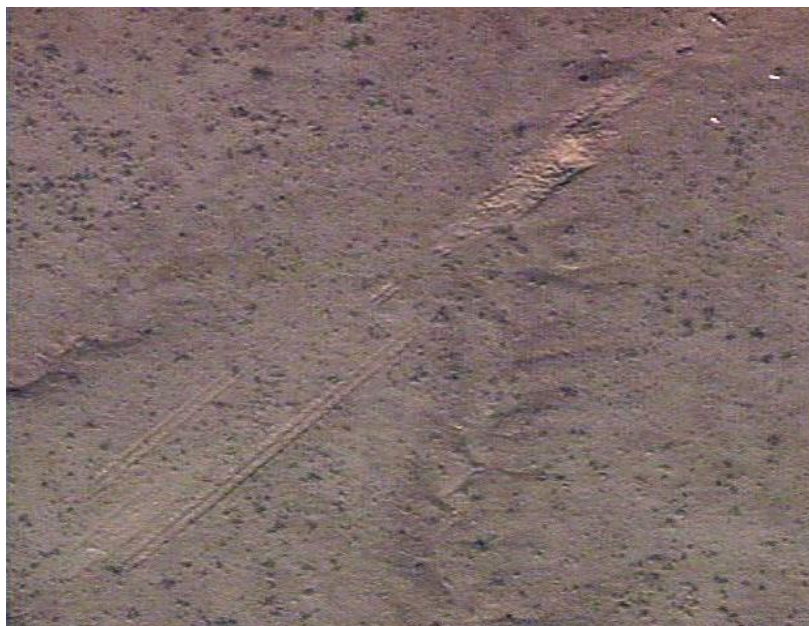
(Landing gear touchdown tracks)

The right main landing gear (MLG) touched down four feet prior to the left MLG. (Tab V-48.3, Tab Z-25) The MA's pitch attitude was less than 14 degrees pitch up at touchdown. (Tab Z-3) The MLG rolled for nine feet prior to the ramp contacting the ground. While the ramp scraped the ground, the MLG continued to roll for another ten feet. The nose gear then impacted the ground and rolled for three feet. The MLG stayed in contact with the ground throughout this time. The MLG made impressions in the sand that were approximately eight inches deep, with the right side MLG slightly deeper than the left MLG. (Tab Z-3, Tab GG-4) The impressions

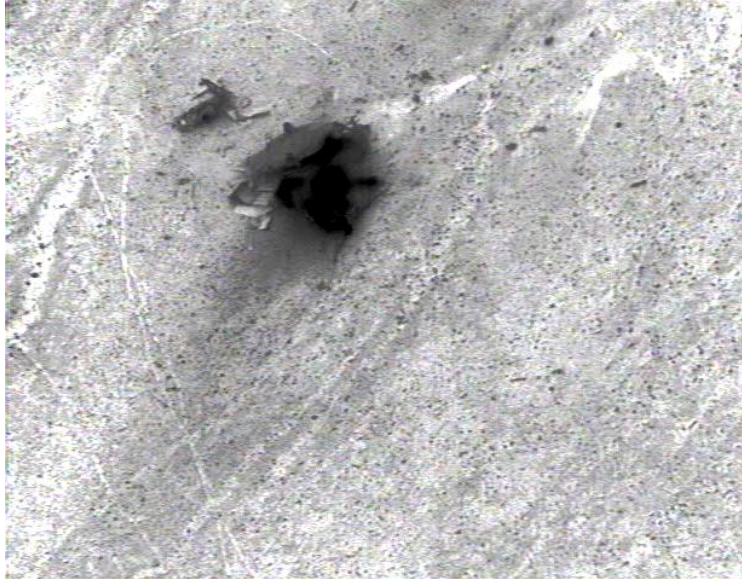
(Post-crash wreckage before kinetic destruction)

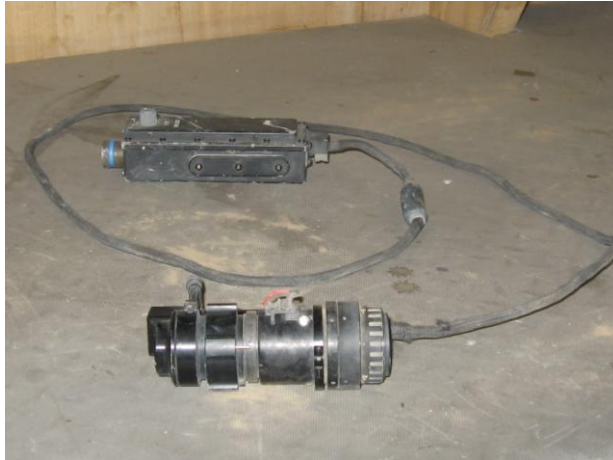
MCP's seat had fallen out of the cockpit during the crash sequence and was located 30 meters away from where the aircraft came to rest. (Tab V-49.5, V-63.11) When MCP awoke, he was still strapped into his seat. (Tab V-1.21) CHK1A unbuckled the MCP. (Tab V-19.6) The MCP's survival radio had a broken battery compartment, preventing him from using it to call for rescue forces. (Tab V-1.21 thru V-1.22, V-49.5) The MP's night vision goggles (NVGs) broke in the crash sequence, separating the two tubes. The HUD was still attached to the right tube. (Tab K-23, Tab V-39.10, Tab Z-21)

(MP's right NVG tube with HUD attached)

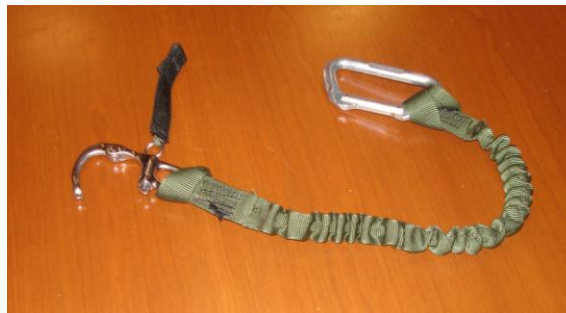
Seats are not mandatory when conducting missions with special operations forces, IAW USSOCOM, US Air Force and Navy instructions, therefore the MA had all cabin passenger seats removed. (Tab BB-51 thru BB-59, Tab II-7) The team members secured themselves to the MA using the standard safety harness attached to their combat uniform belts. (Tab V-3.4, V-4.13, V-4.18, V-4.20, V-5.5) They attached the snap link on the end of this device to either a metal tie-down ring on the floor of the MA, or to the rope attached to the tie down rings on each side of the cabin floor near the bulkheads. (Tab V-3.4, V-4.13, V-4.18, V-4.20, V-5.5) The rope was a new piece of equipment for the 8 SOS, purchased just prior to this deployment. (Tab II-7) The safety lines for some team members broke, while others remained intact, leaving some people dangling from their attachment point since the MA came to rest upside down. (Tab V-19.6, V-20.5, V-21.6) Several sustained abdominal injuries. (Tab X-3 thru X-4) These safety harnesses are designed to keep team members in the aircraft, not necessarily protect them in a crash sequence. (Tab V-4.17, Tab BB-58)

(Safety line used by team members)

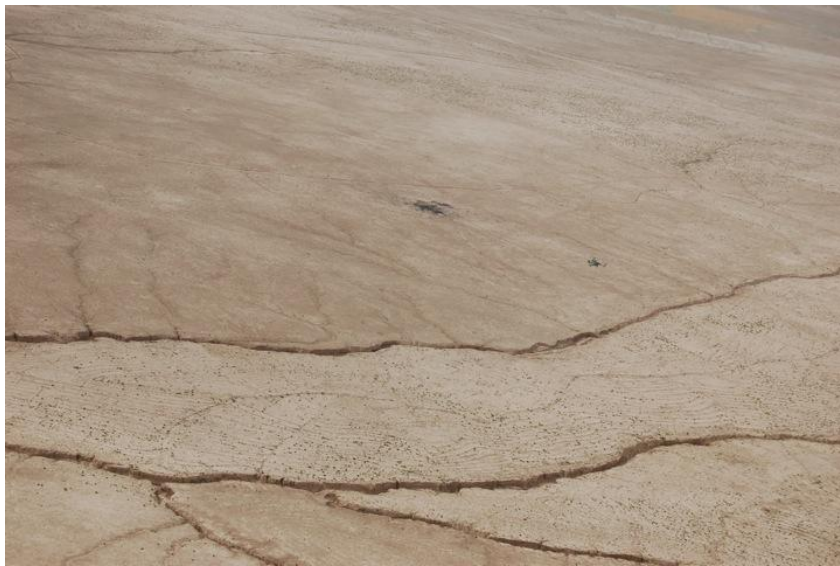
(Wadis and crash site during AIB aerial viewing from an Mi-17, looking northwest)

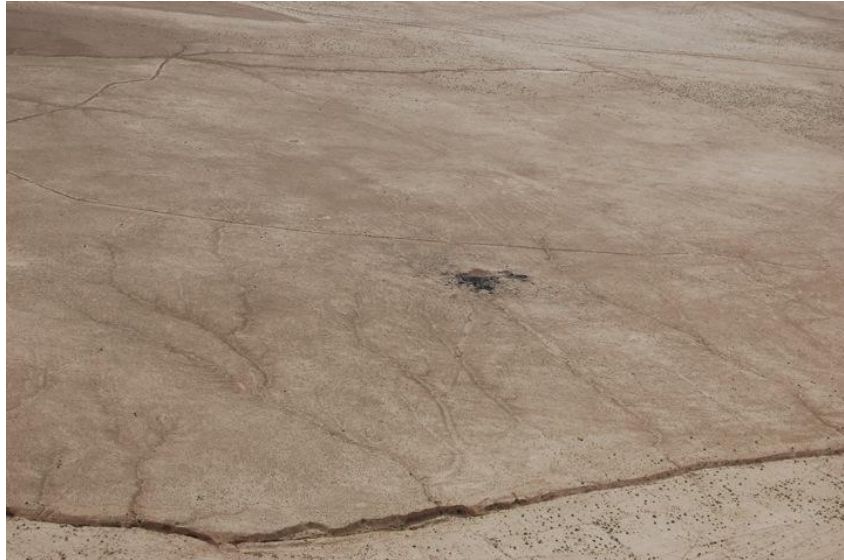
(Wadi and crash site, looking west, the landing direction)

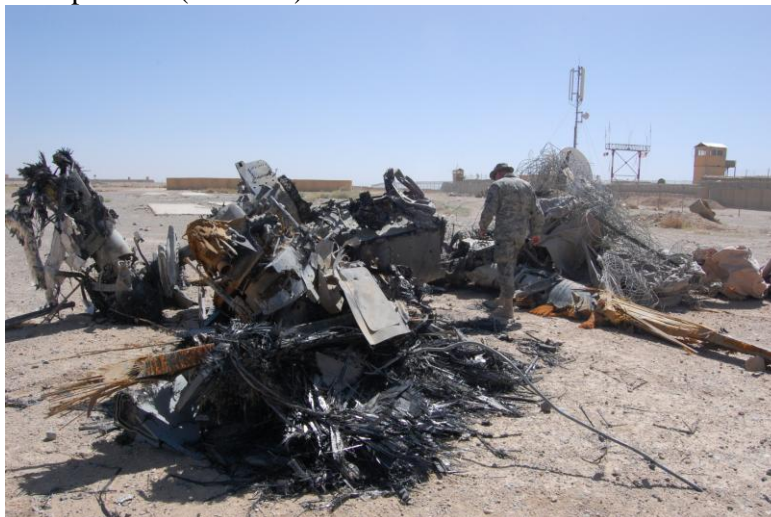
Prior to the mishap sequence, the aircraft, engines, and systems appeared to operate within normal mission parameters. (Tab V-1.11, V-60.7) Due to the MA being destroyed for security purposes, impact analysis was not conducted at the crash site. Several pieces of the wreckage have been removed to FOB Apache.⁷ (Tab II-3)

(Wreckage at FOB Apache)
