UNITED STATES AIR FORCE
AIRCRAFT ACCIDENT INVESTIGATION
BOARD REPORT

F-22A, T/N 06-4125

JOINT BASE ELMENDORF-RICHARDSON, ALASKA

DATE OF ACCIDENT: 16 NOVEMBER 2010

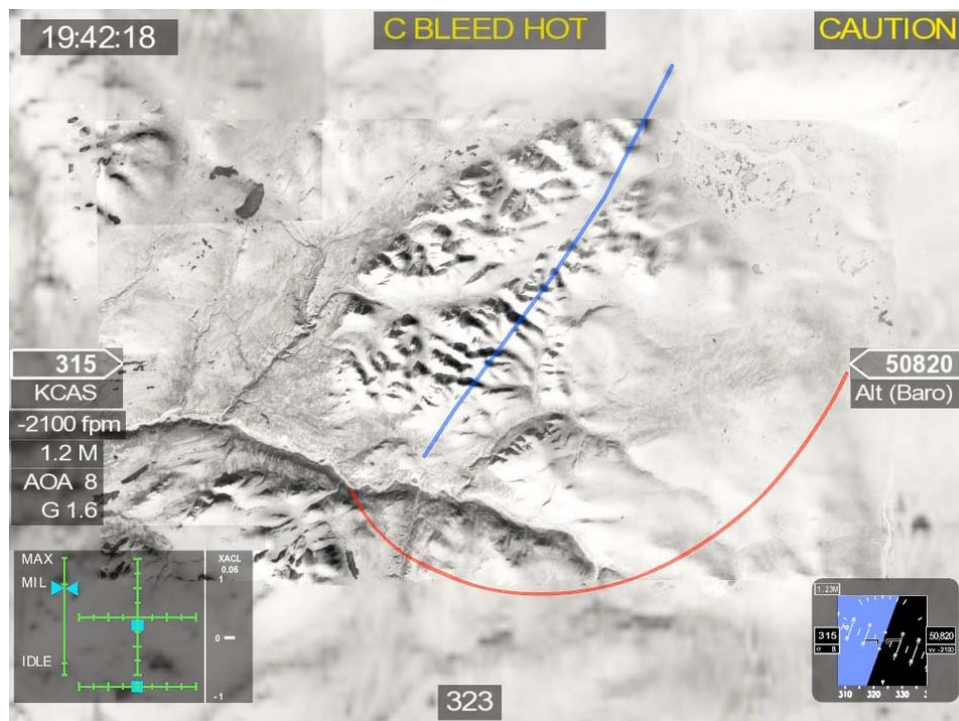
Figure 1 19:42:18L -- Relative position between MFL (blue) and MP (red) at the assertion of the C BLEED HOT caution ICAW. (Tab EE)

At 19:42:18L the fire protection system (FPS) detected a bleed air leak in the center bleed air ducting from both engines. In response to the FPS, the Integrated Vehicle Subsystem Controller (IVSC) asserted the C BLEED HOT caution ICAW while it requested the Environment Control System (ECS) to isolate the center bleed system. “CAUT” was displayed in the heads up display (HUD) advising the MP of the caution ICAW. (Tab J-4) When the C BLEED HOT caution ICAW asserted, the following functions were lost:

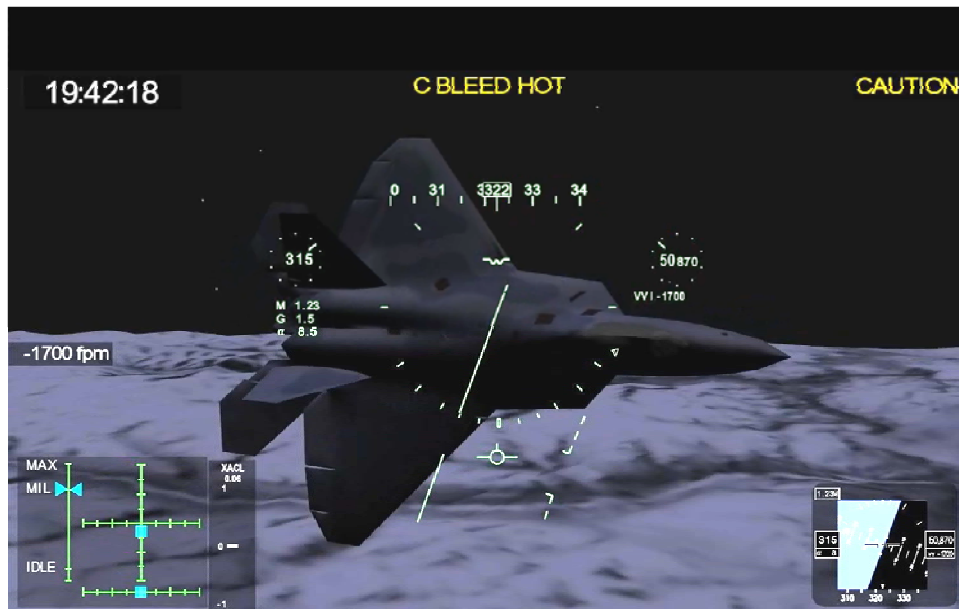
The MA was at 50,870 ft MSL, 315 knots calibrated airspeed (KCAS), 1.23 M, with an attitude of 1 degree nose up, 69 degrees right wing down (RWD), heading 323 degrees, 1.5 g, and with a vertical velocity indication (VVI) of -1,700 ft per minute (fpm). (Tab EE)

Figure 2 19:42:18 -- MA parameters at assertion of C BLEED HOT caution ICAW. (Tab EE) See Tab Z-10 for a diagram explaining the symbology in the Figures.

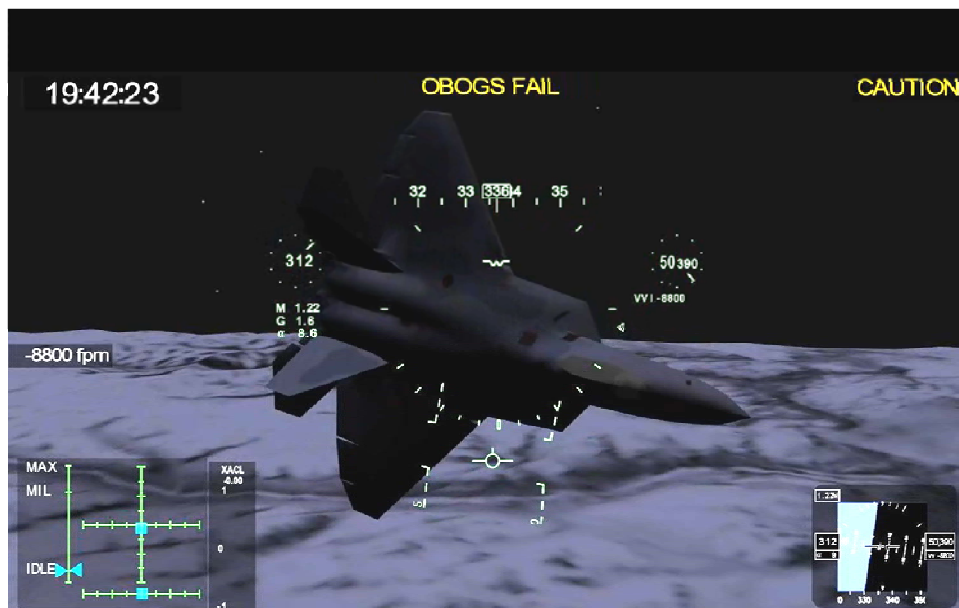
The C BLEED HOT caution ICAW cleared at 19:42:21L indicating the overtemperature condition no longer existed after the IVSC commanded the bleed air ducts to the closed position and stopped the flow of bleed air to the ECS. Due to the ECS no longer supplying pressure to OBOGS, the pressure dropped below the 10 pounds per square inch (psi) minimum threshold and displayed an OBOGS FAIL caution ICAW at 19:42:23L. (Tab J-12 and J-23)

Figure 3 19:42:23 – MA parameters at assertion of OBOGS FAIL caution ICAW. (Tab EE)

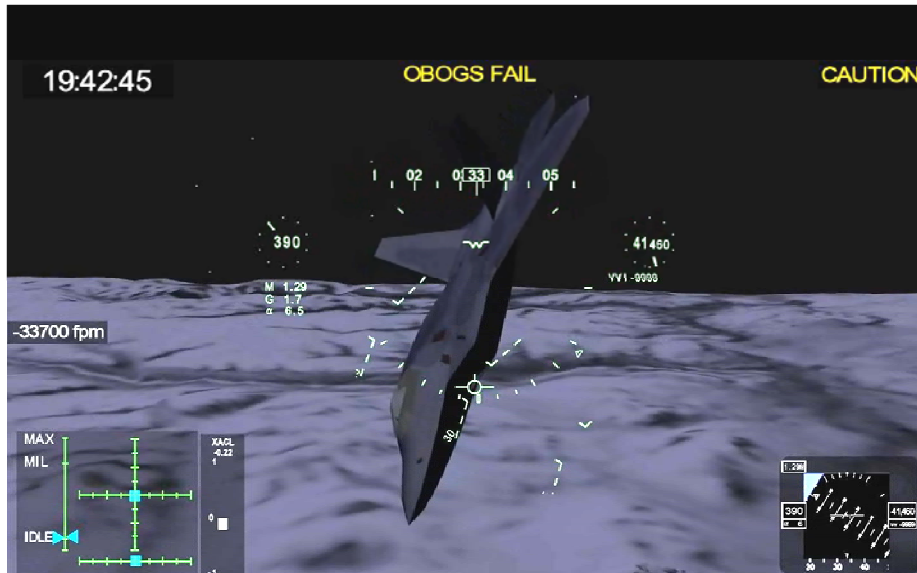
At the assertion of this ICAW until 19:42:45L, the MP retarded the throttles to IDLE power and deliberately continued a controlled, descending right hand turn to descend to a lower altitude IAW the checklist. (Tab BB-29) At this time the MA was at 41,460 ft MSL, 390 KCAS, 1.29M, 30 degrees ND, 44 degrees RWD, 1.7 g, and with a VVI of -33,700 fpm. (Tab EE)

Figure 4 19:42:45 – MP deliberately flew to a controlled attitude of 30 degrees ND and 44 degrees RWD in order to descend to a lower altitude IAW the checklist. (Tab EE)

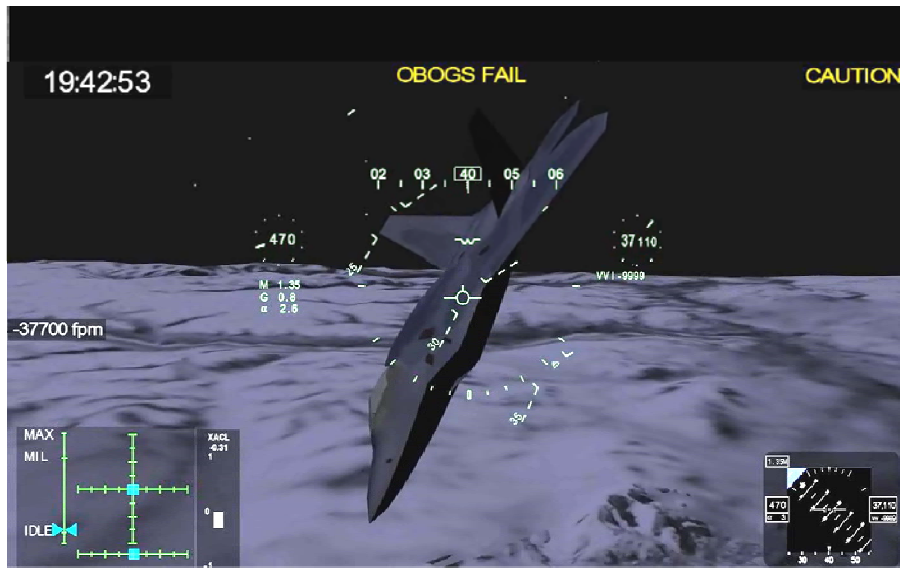
The CSMU mishap data discrete signal showed partial pressure to the MP's oxygen mask stopped shortly after 19:42:37L, which would lead to severely restricted breathing. (Tab J-43) From 19:42:45L until 19:42:53L, the MP made no inputs to the stick, pedals, or throttles, and the MA maintained a relatively stable bank angle and attitude. The MA was at 37,110 ft MSL, 470 KCAS, 1.35M, 30 degrees ND, 46 degrees RWD, 0.8 g, with a VVI of -37,700 fpm. (Tab EE)

Figure 5 19:42:53 – MA parameters after 8 seconds of zero MP inputs to stick, pedals, or throttles. (Tab EE)

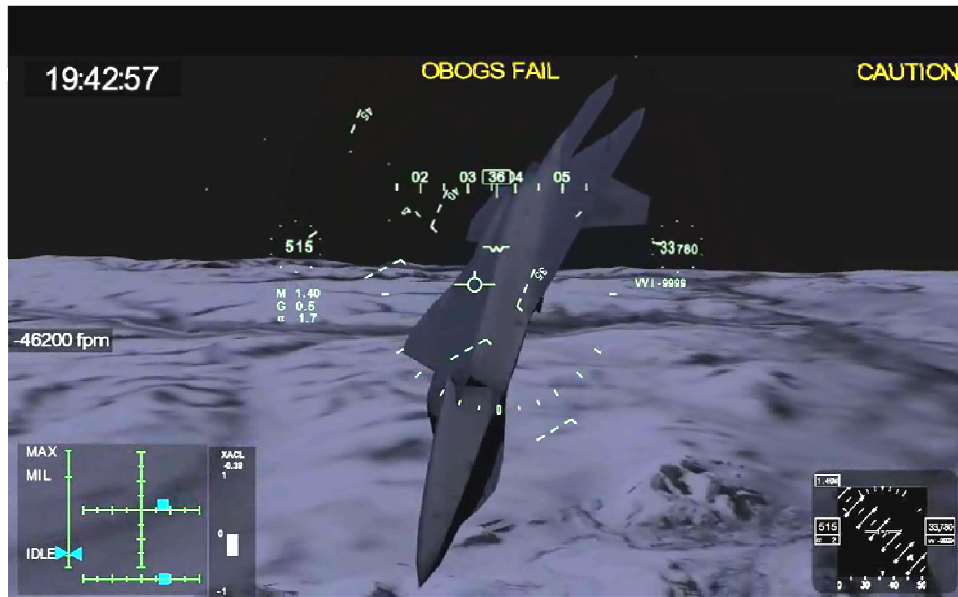
At 19:42:53L, the MP input a combination of right forward stick and right pedal which initiated a 240 degree descending right roll at greater than 45 degrees per second. (Tab EE)

Figure 6 19:42:57 – MA parameters during MA 240 degree roll to the right resulting from stick and pedal inputs. (Tab EE)

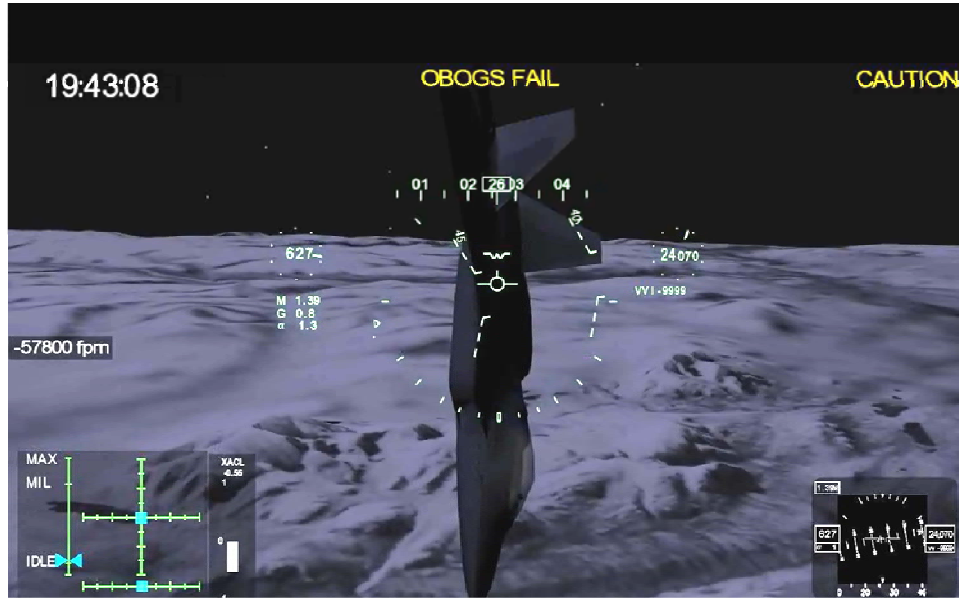
At the completion of these stick and pedal inputs at 19:43:08L, the MA had rolled through inverted, experienced less than 1 g of gravitational force, and went from a RWD to Left Wing Down (LWD) attitude, and the descent rate of the aircraft significantly increased. The parameters at this time were 24,070 ft MSL, 627 KCAS, 1.39M, 44 degrees ND, 81 degrees LWD, 0.8 g, with a VVI of -57,800 fpm. (Tab EE)

Figure 7 19:43:08 – MA parameters when stick and pedal inputs cease after the 240 degree roll. (Tab EE)

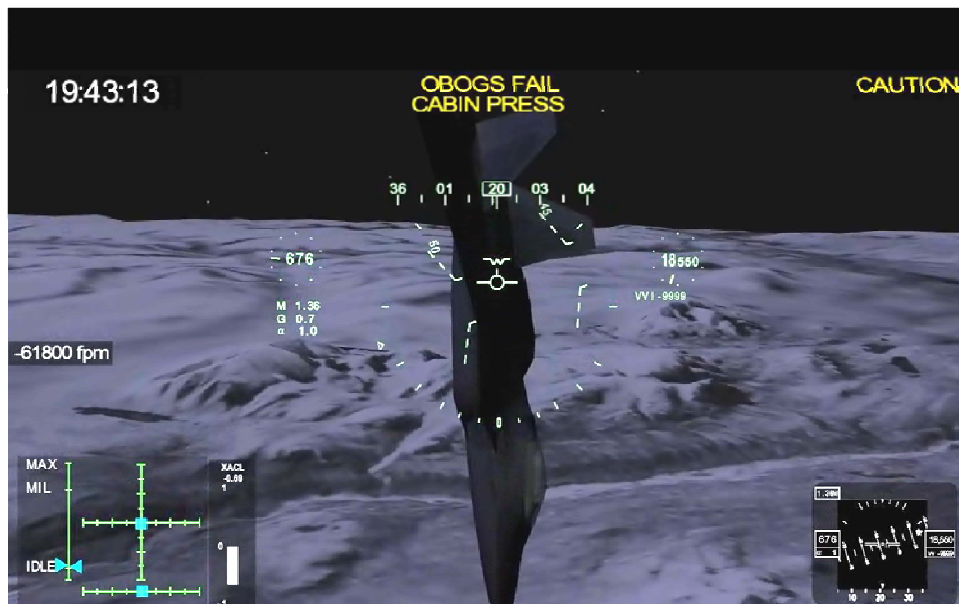
After 19:43:08L, there were no stick inputs and only very minor pedal inputs for the next 15 seconds. At 19:43:13L, passing approximately 19,000 ft MSL, a CABIN PRESSURE caution ICAW asserted based on cockpit pressurization exceeding its normal schedule. (Tab J-13)

Figure 8 19:43:13 – MA parameters at assertion of CABIN PRESS caution ICAW. No stick or pedal inputs. (Tab EE)

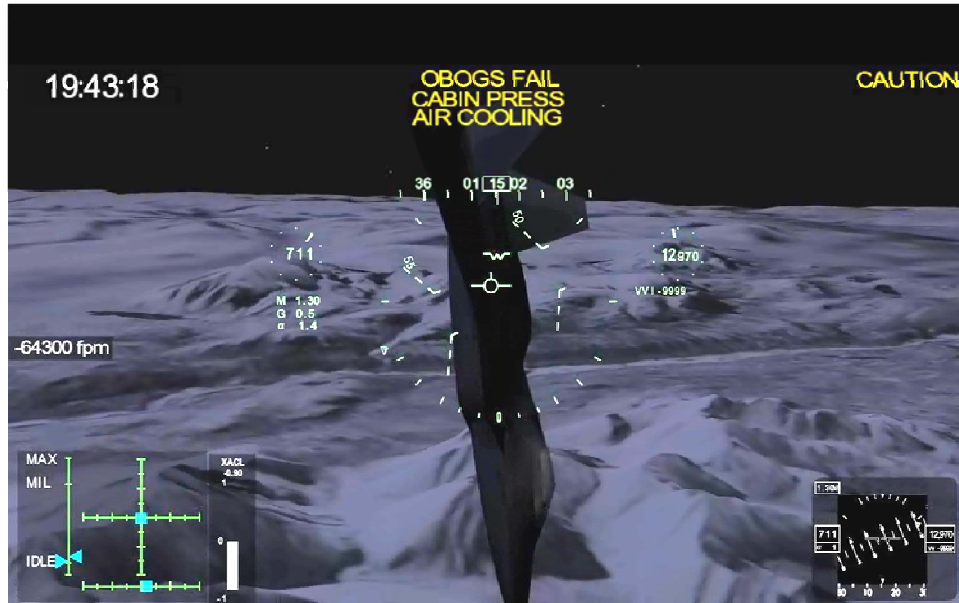
At 19:43:18L, passing 12,400 ft MSL, an AIR COOLING caution ICAW asserted. This ICAW would assert 60 seconds after a C BLEED HOT caution ICAW if the aircraft were not receiving an adequate cooling air source to its avionics. (Tab J-13)

Figure 9 19:42:18 – MA parameters at assertion of AIR COOLING caution ICAW. No stick or pedal inputs. (Tab EE)

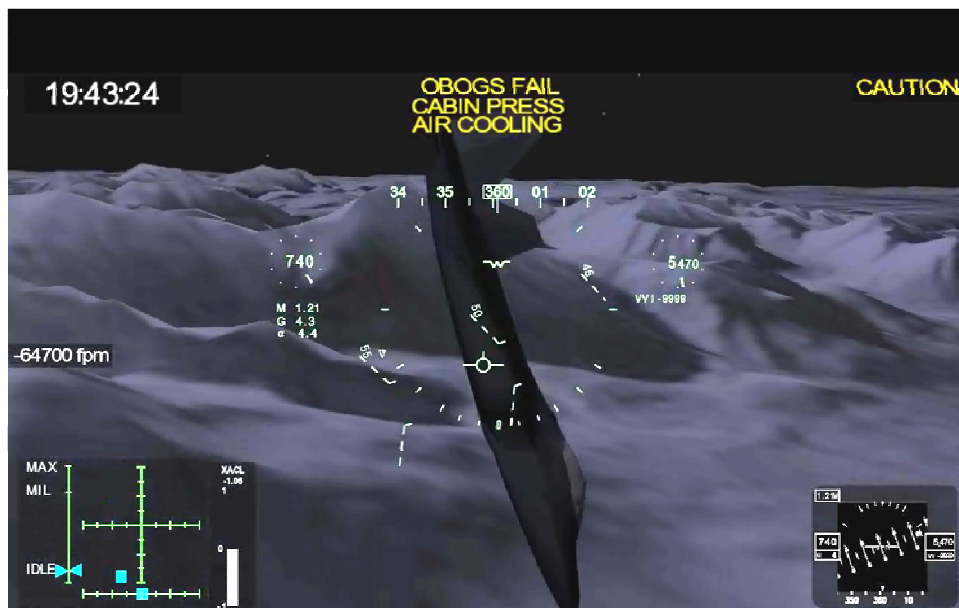
At 19:43:24L the MP performed a dive recovery at 5,470 ft MSL by pulling aft on the stick, producing a 7.4 g pull up maneuver. The MA impacted the ground 3 seconds later, inflicting fatal injuries to the MP and destroying the MA. (Tab EE)

Figure 10 19:43:24 – MP initiates full aft stick pull to start dive recovery at 5,470 ft MSL. (Tab EE)

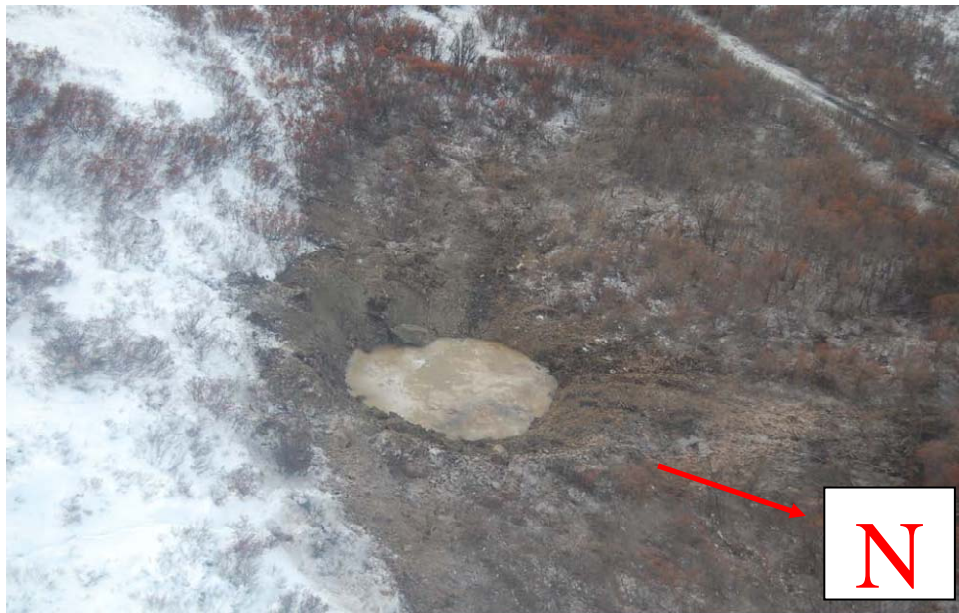
Figure 11 Impact Crater 17 Nov 2010 (Tab S-7)

At 19:43:27L, the MA impacted the ground at 735 KCAS, 1.17M, 48 degrees ND, 47 degrees LWD, 7.4 g, with a VVI of -57,900 fpm. The impact site is approximately 120 NM north of JBER, AK, in the Talkeetna Mountain range. The site is approximately 3,100 ft MSL near the edge of a south-west to north-east running valley. The impact crater is located at the valley floor where it begins to slope upwards towards the southeast. The valley floor is approximately one-half mile wide at this point and has a stream running through it approximately 60 yards west of the impact point. (Tabs J-4 through J-6)

The debris field consisted of small aircraft and engine pieces extending approximately one-quarter mile from the crater. The upslope wall of the crater and aircraft impact angle appear to have focused the debris pattern in a 60 – 80 degree wide arc from west to north. (Tabs J-4 through J-6)

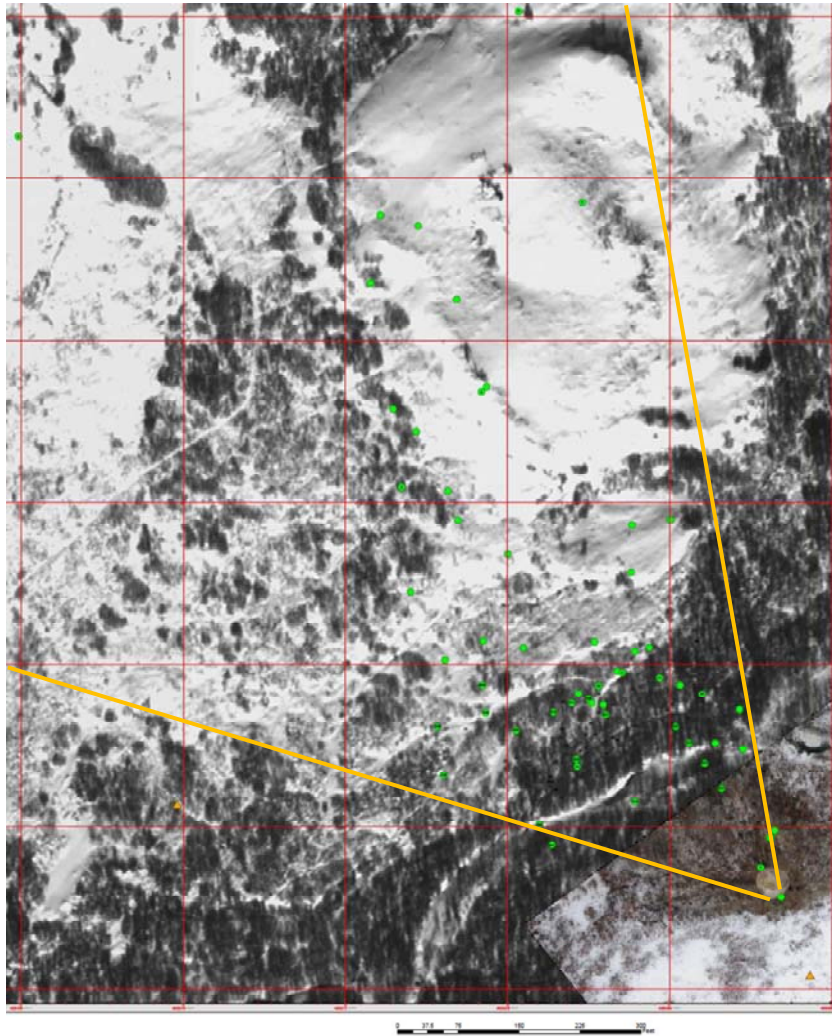
Figure 13 Aircraft Parts Scatter Diagram. Parts represented by green dots. (Tab S-4)

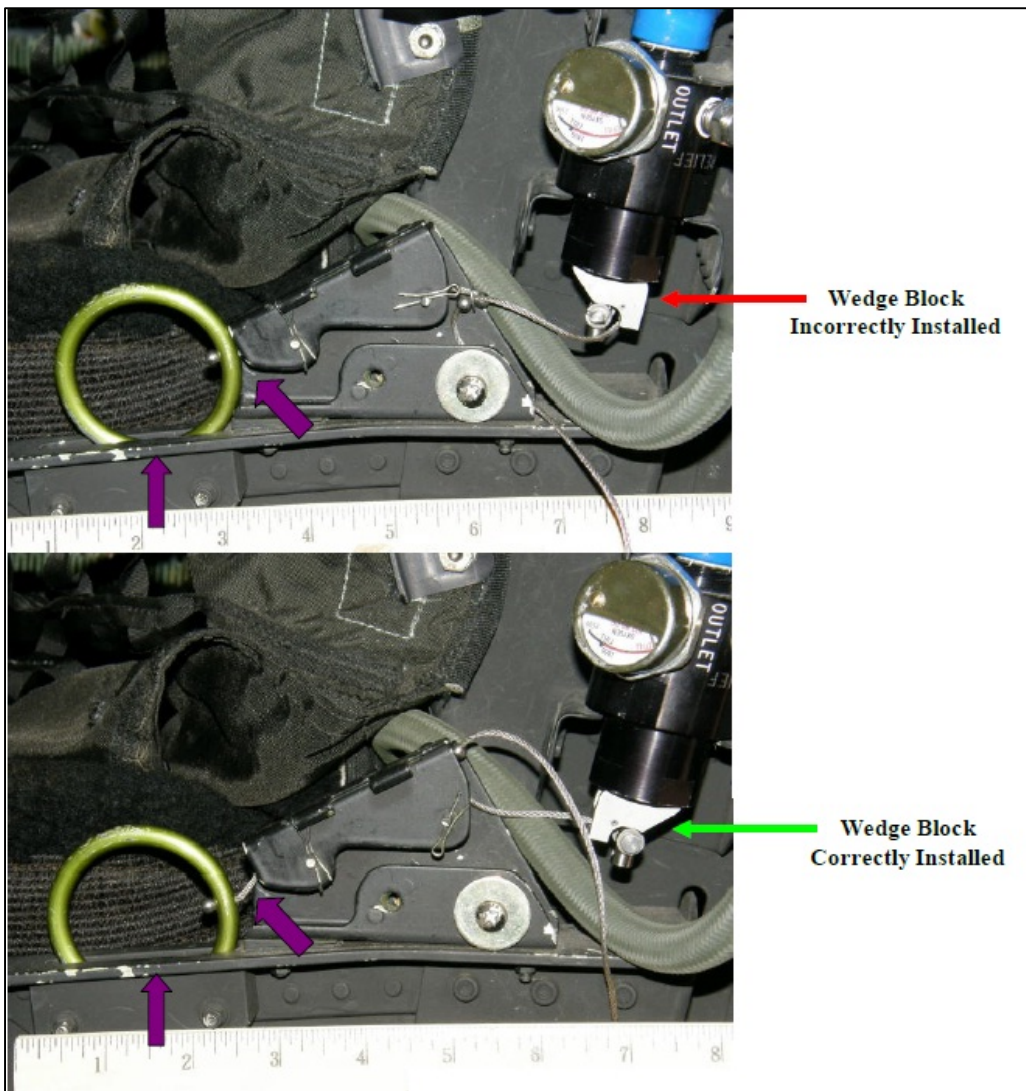
The AFRL report identified that if the EOS wedge block had been incorrectly installed, the wedge block would be unable to move or rotate during manual EOS ring activation. However, during ground simulation the board members were able to initiate the EOS in the incorrectly installed position. (Tab U-4)

Figure 14- The wedge block installed incorrectly (red arrow) and correctly (green arrow). Notice the position of the ring within the seat (purple arrows) based on wedge block position. (Tab Z-6)

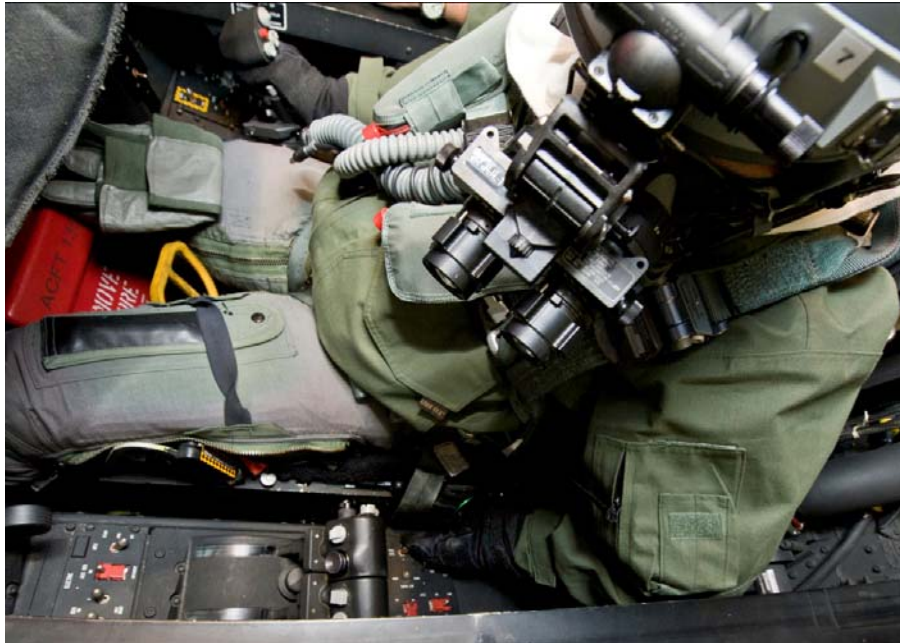
which may have occurred for various reasons, including: the EOS activation ring was dropped or the EOS cable jammed during an attempted manual activation. Retrieval of the ring from between the seat and console would be difficult based on the seat position, night environment, and with personal equipment interference (as discussed in the next section). (Tab CC-5)

Figure 15 - Pilot pulling EOS activation ring. NVG interfering with EOS ring visualization. (Tab CC-5 and Tab Z-7)

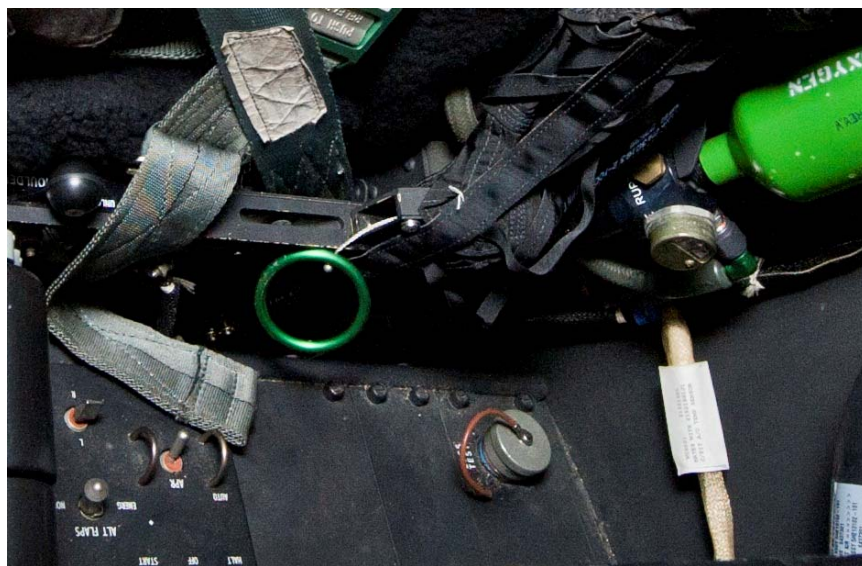
During ground simulation, the manual EOS activation ring was unseated and dropped between the seat and console prior to EOS activation. This was done to simulate a failed initial pull,

Figure 16- Manual EOS activation ring fallen below lip of seat. (Tab CC-5 and Tab Z-8)

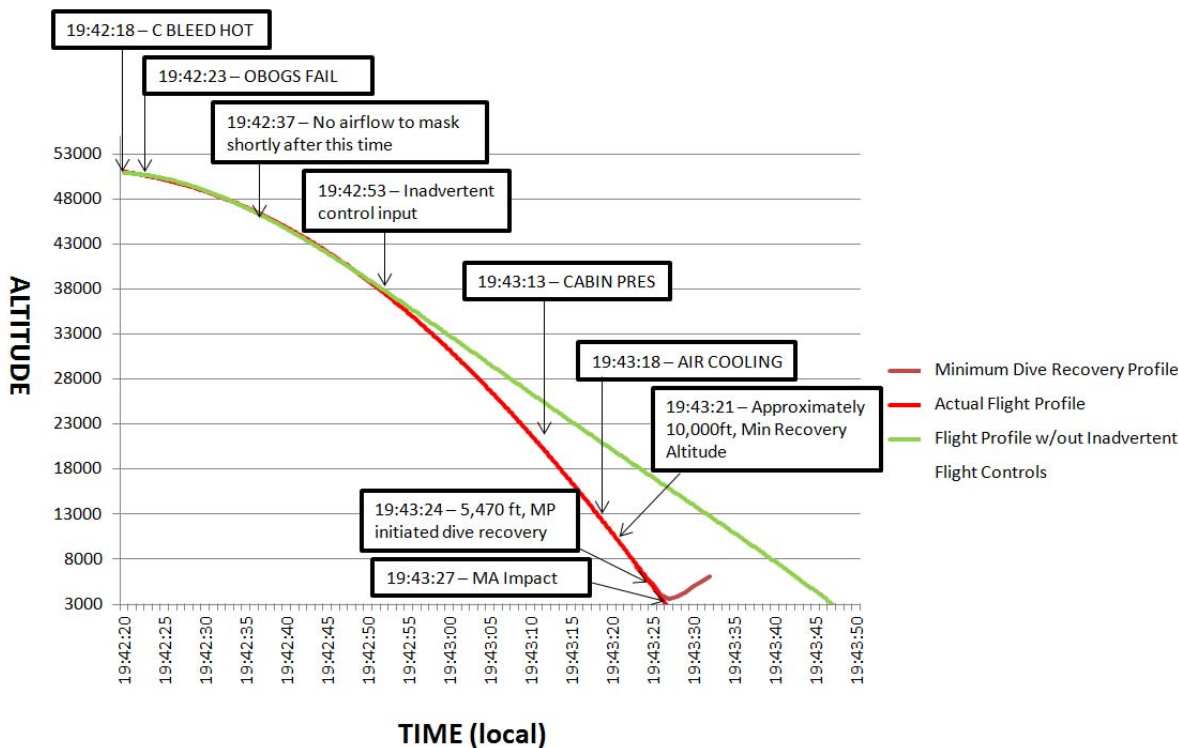
Fifth, the MP was late to recognize the necessity for a dive recovery. At 19:43:27L, the MP impacted the ground because his channelized attention and breakdown in visual scan resulted in unrecognized spatial disorientation. When the MP recognized the MA attitude and altitude, he was below minimum recovery altitude. Figure 17 shows the actual initiation of the attempted dive recovery altitude along with the 1F-22A-1 minimum recovery altitude.

Figure 17 Flight profiles for MS. Actual flight profile (red), flight profile without inadvertent flight control inputs (green), and minimum altitude dive recovery profile (maroon) shown.
