AIRCRAFT ACCIDENT INVESTIGATION
BOARD REPORT

F-16C+, S/N 87-0242

**176TH FIGHTER SQUADRON
115TH FIGHTER WING
TRUAX FIELD, WISCONSIN**

DATE OF ACCIDENT: 7 JUNE 2011

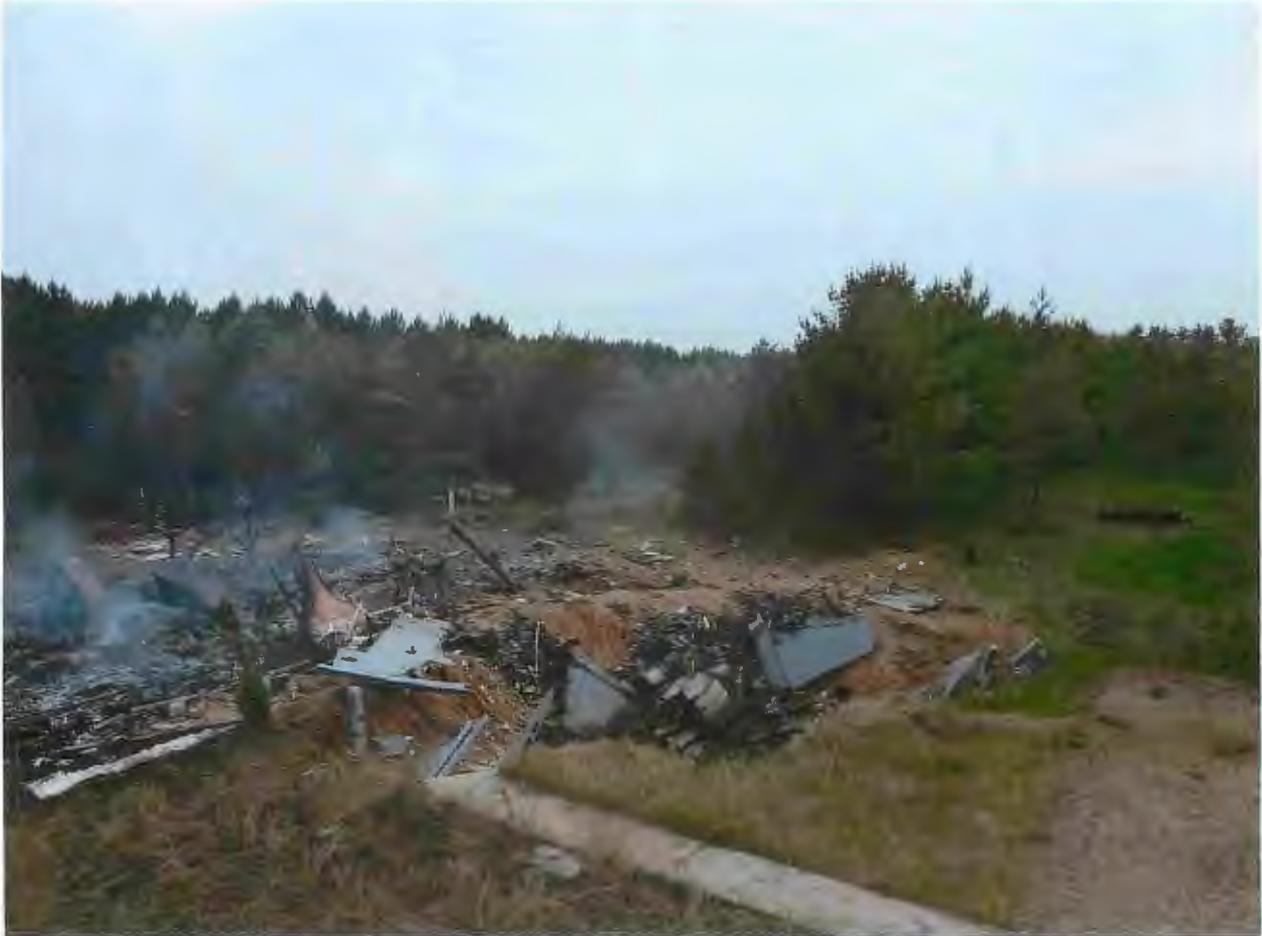
Figure 2: Impact Site

The MA impacted the ground on privately owned land at approximately 1316L (Figure 2), 57 nautical miles northwest (345 degrees True) of Truax Field and was completely destroyed (Tabs S-1 through S-10, H-3). Coordinates were North 43 50' 51.5", West 89 37' 13.7" (Tab S-3). The wreckage field was fan shaped with the majority of wreckage 280-355 degrees True from the crater out to a distance of approximately 820 feet (Tab S-4).

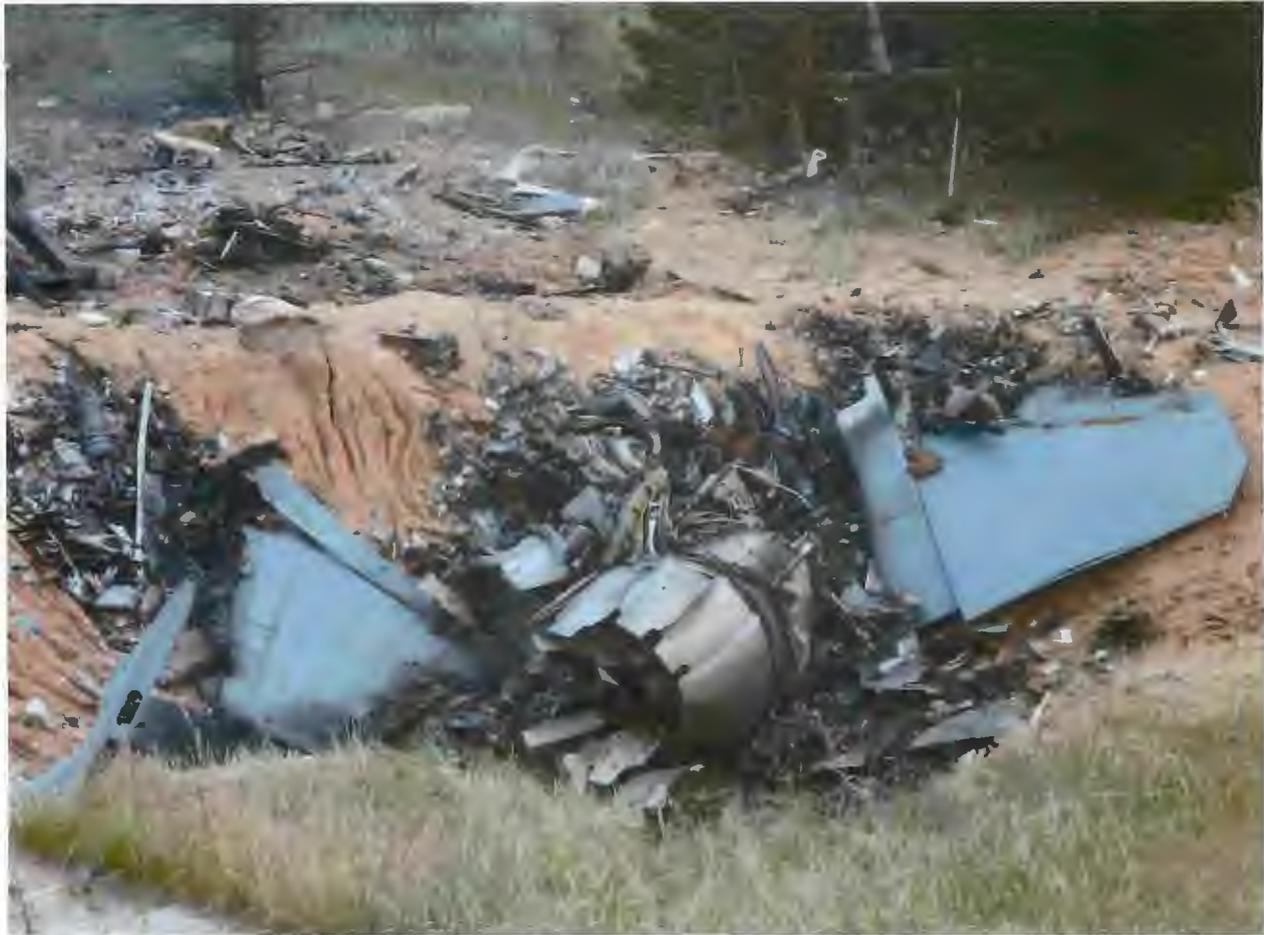
Figure 3: Impact Crater

The MA impact crater (Figure 3) was approximately 9 feet deep and 30 feet in diameter (Tab P-5). The wreckage distribution and condition indicated that the MA was slightly right wing low, approximately 80-90 degrees nose down, and at 285 KIAS on a northwesterly heading at impact (Tab P-5). Following impact, the MA pivoted forward symmetrically about the nose, coming to rest inverted (Tab P-5). Both wings, and the horizontal stabs and vertical tail were separated from the fuselage (Tab P-5). The horizontal stabs remained in the impact crater, the wings were adjacent to the crater and the vertical tail was 117 feet beyond the crater (Tab P-5). Most of the remaining objects from the aircraft dispersed in a fan pattern out to 821 feet from the point of impact covering approximately 6 acres in a 45 degree arc (Tab P-5). Upon impact, fire enveloped the MA and a vacant double wide mobile home (Tab P-5). The vacant double wide mobile home structure was completely destroyed (Tab P-5).

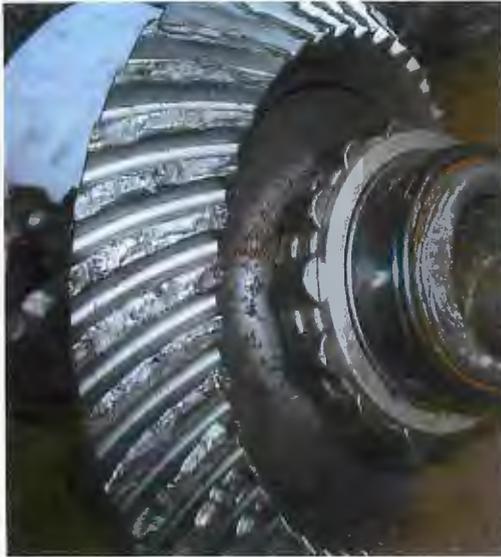
Figure 7: PTO Bevel Gear Teeth

Post-mishap analysis was performed by General Electric Aviation and Tinker OC-ALC Engineers (Tab J-23). The recovered parts were analyzed at the 115th JEIM shop (Tab J-3). Engineering analysis determined that the PTO shaft forward ball bearings were reduced in size allowing PTO shaft movement (Tab J-82). The PTO shaft movement ultimately resulted in disengagement of the mating bevels gears (Figure 7) within the AGB (Tab J-16).

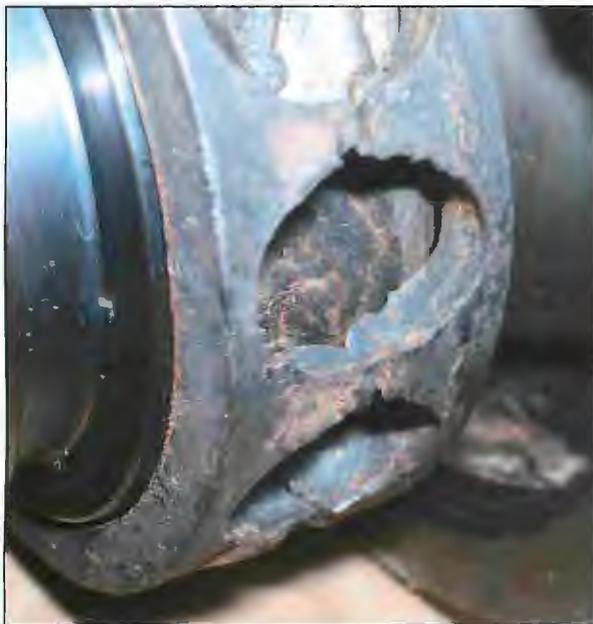
Figure 10: Ball Bearing Cage (Tab J-17)

Analysis of the AGB described the PTO bearing cage damage as a “dull burnt appearance” (Tab J-16). The bearing cage houses the solid ball bearings. The ball bearings were not recovered (Tab J-16). The bearing cage was cracked between the cage pockets (Figure 10), but still intact (Tab J-16). Several pockets on the cage of the ball bearing had raised lips in the direction of rotation indicating bearing decay (Tab J-16). Metal deposits were visible on the surfaces of the cage and the inner and outer races (Figure 11) (Tab J-16). The bearing failure resulted in loss of axial support and the subsequent forward shifting of the PTO shaft during engine operation, allowing the disengagement of the mating bevel gears within the AGB (Tab J-16).

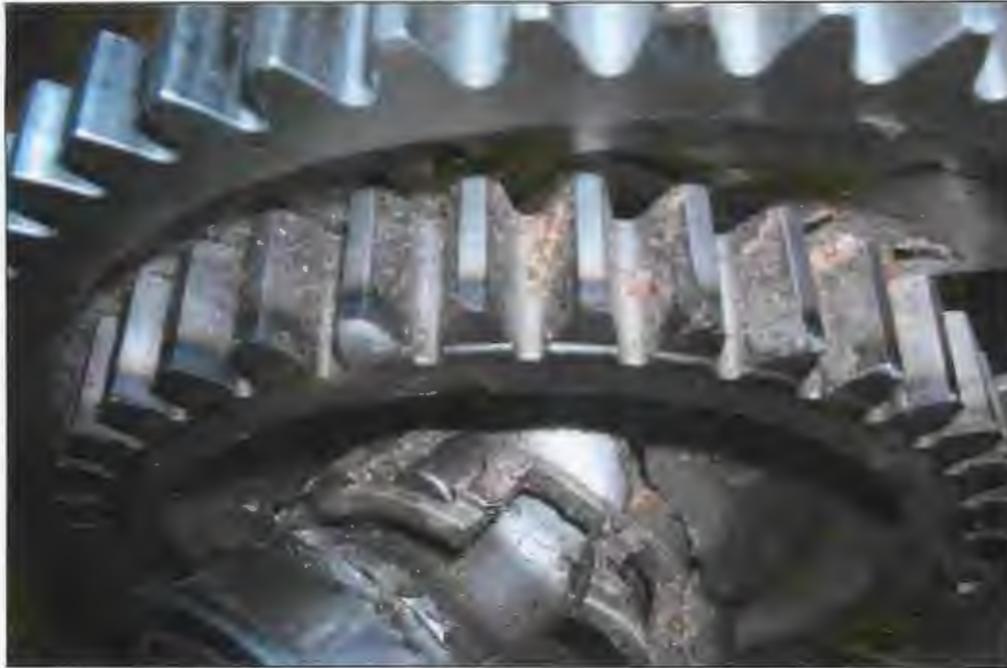
Figure 12: PTO Spur Gear Teeth (Tab J-18)

The PTO shaft bevel gear (Figure 13) had damage to the top lands of the gear teeth, described as a jagged finish and notable material missing that increases at the center of the teeth (Tab J-15). The forward bevel gear had heat discoloration from contact with the 37-tooth spur gear (Tab J-17). The forward half of the spur gear teeth also showed heat damage (Figure 12) (Tab J-17). The PTO Spur Gear teeth also had a groove worn into the forward face (Tab J-17). The PTO

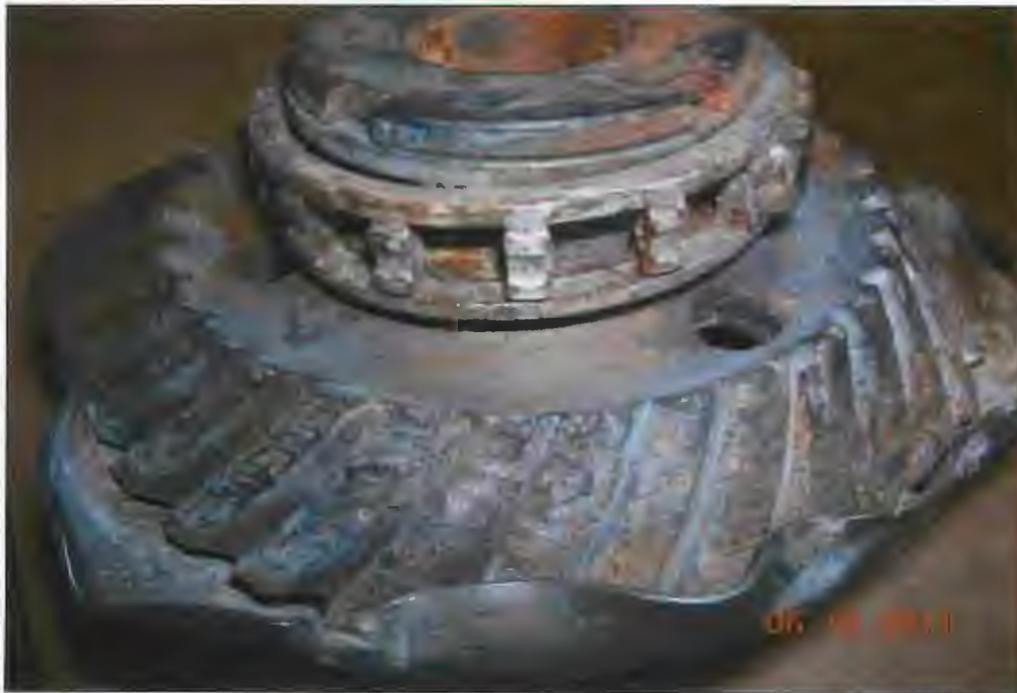
Figure 13: Bevel Gear Teeth (Tab J-19)

shaft bevel gear damage was consistent with improper alignment of the PTO shaft during engine operation prior to impact (Tab J-18).

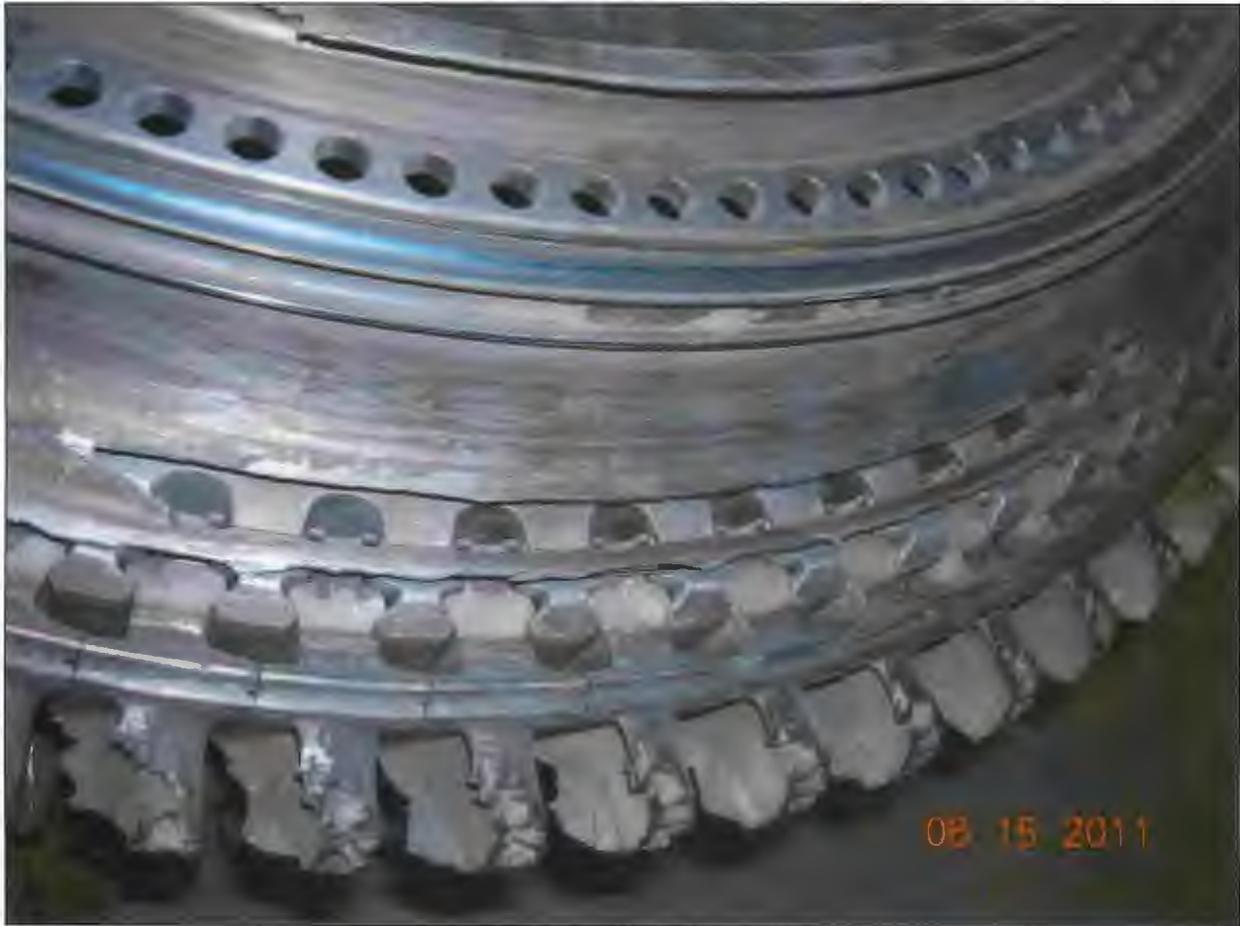
Figure 14: High Pressure Turbine (Tab J-12)

The High Pressure Turbine (HPT) damage to the vanes displayed evidence of some metal splatter and/or slurry accumulation (Figure 14) (Tab J-10). The source of the molten metal is most likely from rotating HPT components damaged late in the mishap sortie by high temperature (Tab J-13). Engineers indicated that the MEC would continue to supply fuel to the engine despite sub-idle positioning of the IGVs and VSVs resulting in exceeding engine operating limits (Tab L-12 @ time 3790, V-8.17).

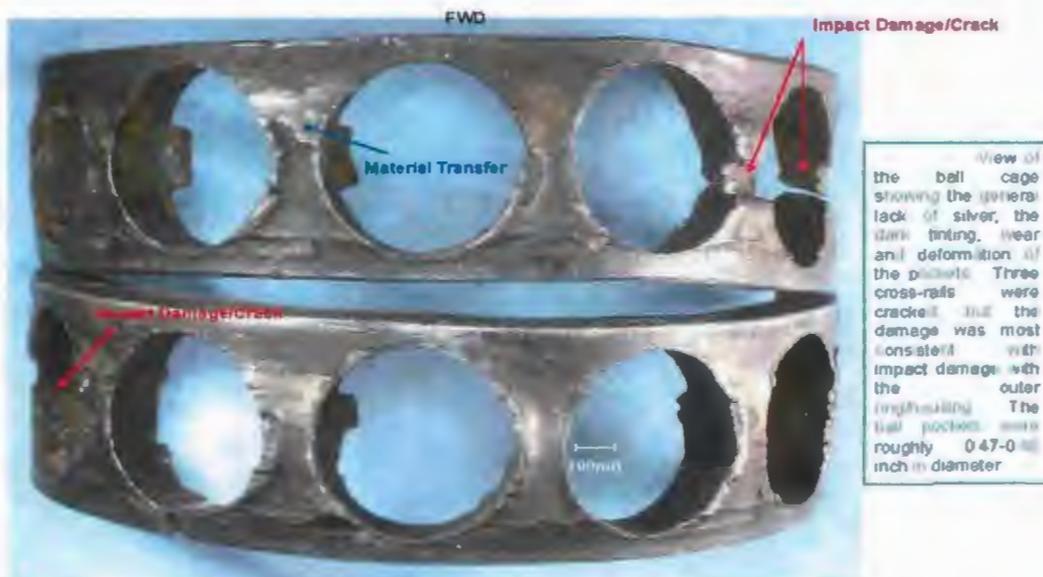
Figure 15: Ball Bearing Cage (Tab J-78)

GE evaluated the AGB components and the HPT Forward Outer Seal (FOS). During analysis of the AGB forward ball bearing assembly, GE reported round indentations on the back side of the inner ring (Figure 21) (the inner portion of the ball bearing cage), consistent with the ball bearings having been present at the time of impact and liberated during the post impact breakup (Tab J-37). The outer ring raceway had indentations consistent with debris roll-over damage (Tab J-37). The overall cage, both inner and outer ring, lost most of the silver plating and the base metal was hardened, consistent with high temperature exposure (Figure 15) (Tab J-37).

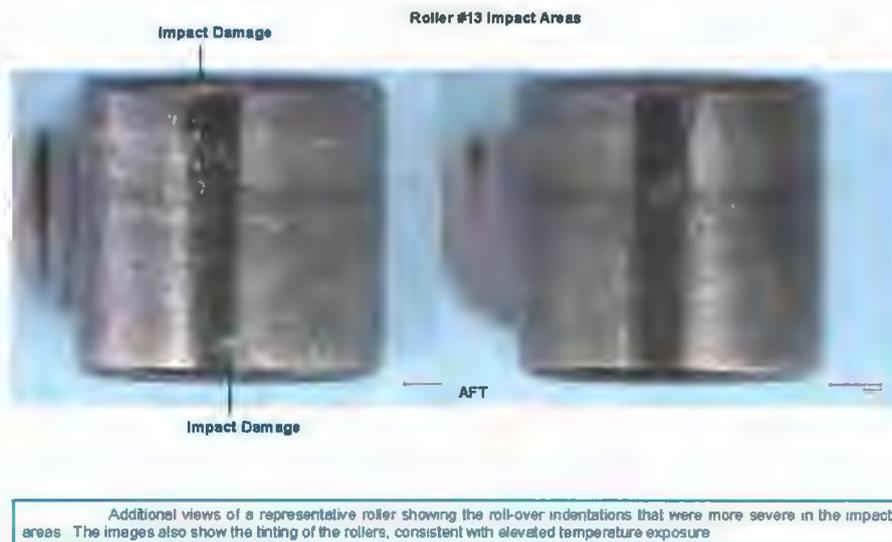
Figure 16: Roller Bearings with Indentations (Tab J-67)

The adjacent roller bearing cage, the bearing forward of the ball bearing, was intact with silver present, but the rollers and raceway showed surface indentations consistent with debris roll-over damage from the adjacent ball bearing (Figure 16) (Tabs J-37, J-39, J-67). The rollers were tinted, consistent with elevated temperature exposure as well (Tabs J-37, J-39, J-67).

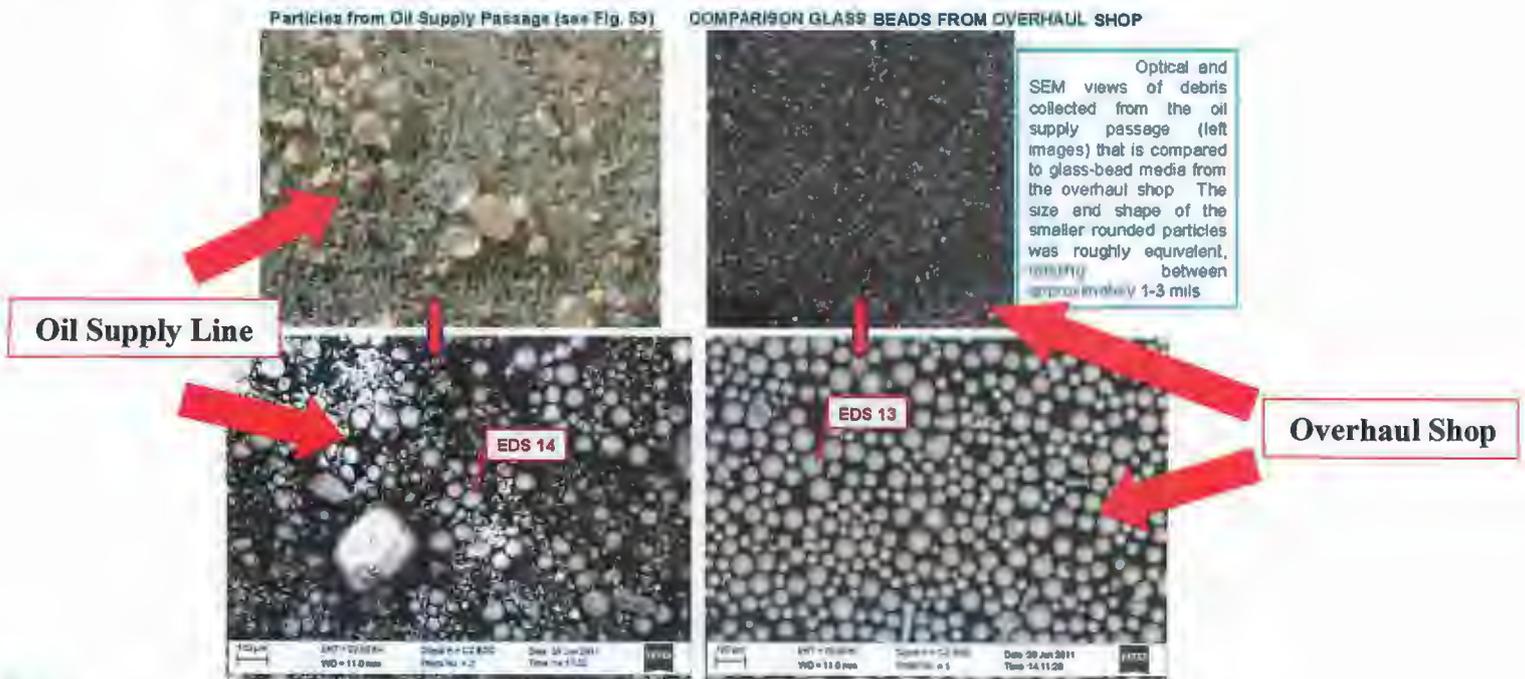
Figure 17: Glass-Bead Media (Tab J-103)

Analysis of filtered debris from the oil supply passage showed that in addition to particles consistent with dirt, sand, and AGB housing material were many particles that had size, shape, and compositional spectra similar to glass-bead media utilized in the AGB overhaul process (Figure 17) (Tabs J-37, J-102).

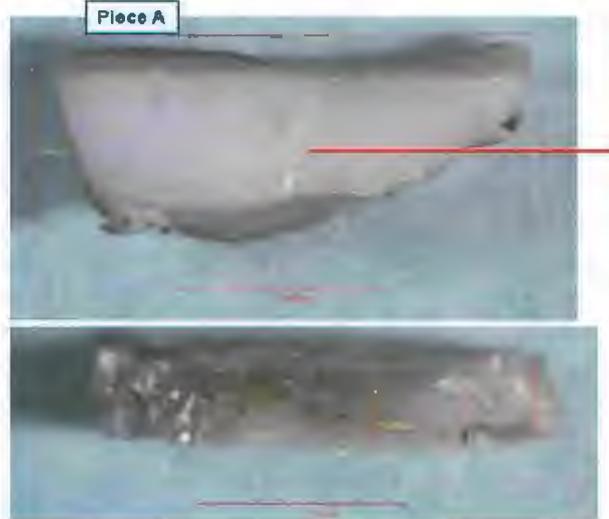
Figure 18: Teflon[®] Piece Close-Up (Tab J-102)

In addition, a piece of white debris consistent with Teflon[®] was found that was approximately 223 millimeters long by 44 millimeters thick and 82 millimeters wide (Figure 18) (Tab J-37 and J-102).

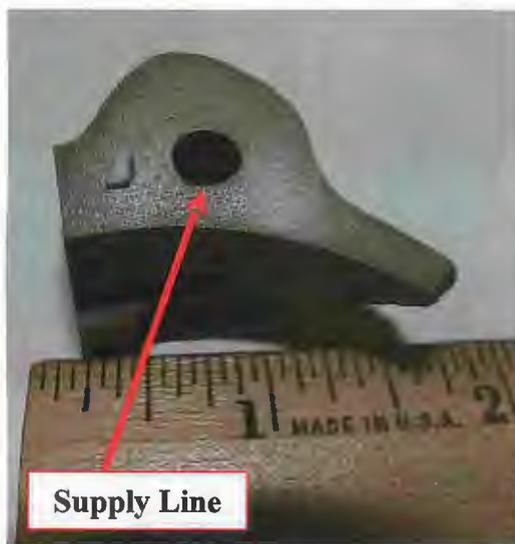
Figure 19: Teflon[®] at Supply Line (Tab Z-5)

As illustrated in Figure 19, the recovered Teflon[®] debris is small enough to travel freely through the 100 millimeter diameter oil supply line. However, the Teflon[®] debris was unable to exit through the 36 millimeter diameter oil supply nozzle as show in figure 20. The Teflon[®] debris is of unknown origin. Engineers testified that the Teflon[®] debris in combination with glass-bead media would be sufficient to clog the oil supply line (Tab V-8.4)

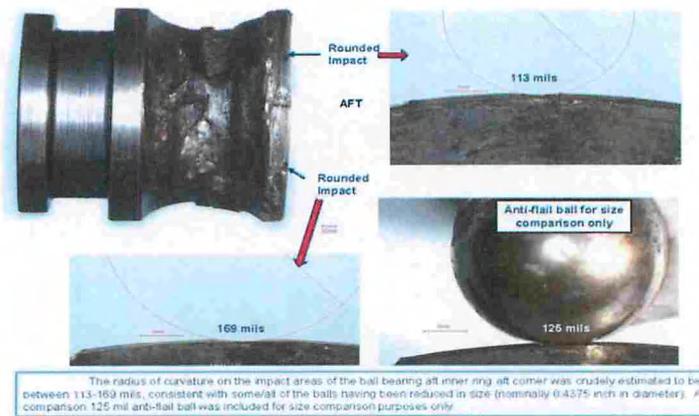
Figure 21: Ball Bearing Impact Comparison (Tab J-82)

GE summarizes their report with the following statement: “The quick bearing degradation time, the lack of observed M50 chips, and the intact cage are characteristics most consistent with having been produced by inadequate lubrication. The intact cage that was found outside of the outer ring assembly and the rounded indentations on the aft side of the ball inner ring were consistent with some/all of the balls having been reduced in size (Figure 21). The loss of ball/inner ring material, the rub damage in adjacent parts, and the fracturing of the bevel gear teeth tips, are all consistent with damage produced by loss of the ball bearing that allowed the shaft to move forward and eventually disengage from the bevel gear” (Tab J-37).
