**UNITED STATES AIR FORCE**  
**AIRCRAFT ACCIDENT INVESTIGATION**  
**BOARD REPORT**

**A-10C, T/N 80-0282**  
**75TH FIGHTER SQUADRON**  
**MOODY AIR FORCE BASE, GEORGIA**

**DATE OF ACCIDENT: 26 SEPTEMBER 2011**

**SUBJECT: Accident Investigation Board Report A-10, T/N 80-0282, 26 Sep 11,  
Moody AFB, GA**

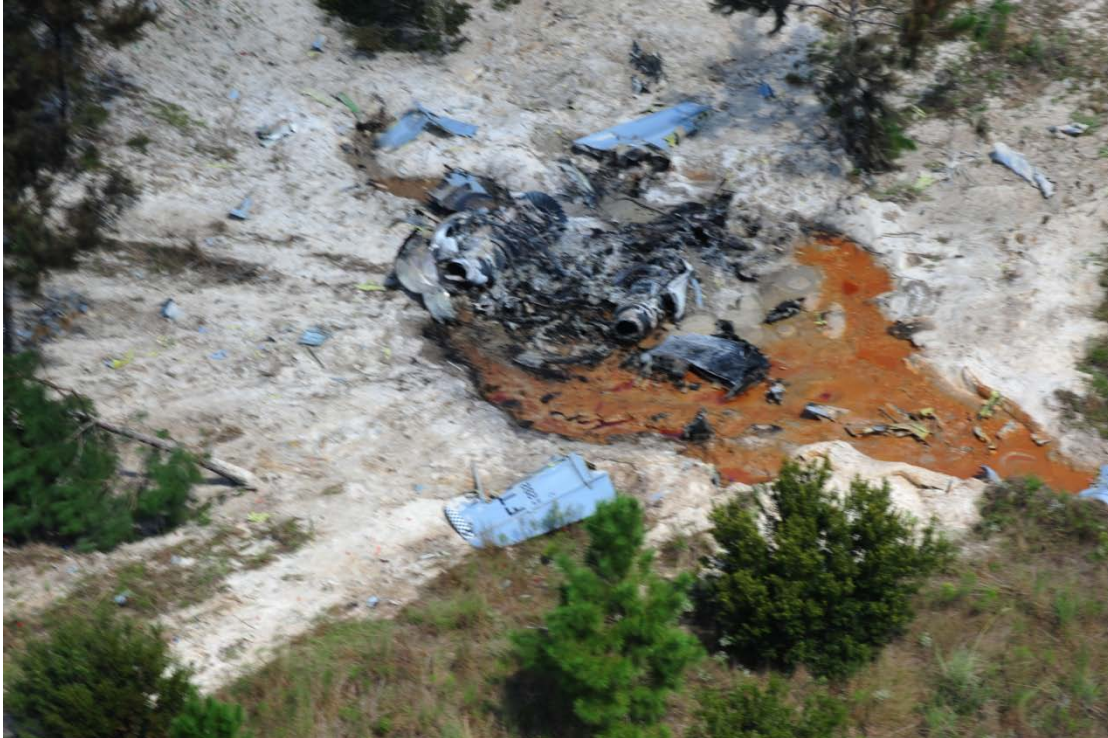
Figure 1. MA at Crash Site

The MA impacted the terrain (See Figure 1) at approximately 1448L about 20 miles northwest of Moody AFB (Tab B-3). The MA was in a clean unarmed configuration for the FCF profile. The impact location was a sandy swamp area, sparsely covered by pine trees (Tab S-5 to S-6).

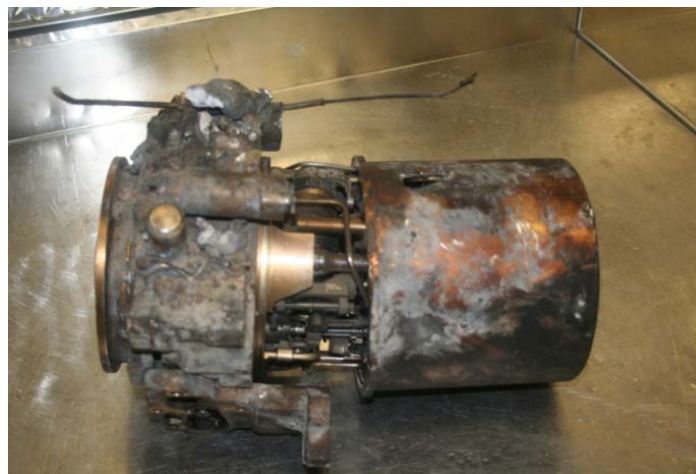
Figure 4. Engine #1 MFC

The accessory gear box fractured in multiple locations with only the Integrated Drive Generator still attached. The starter gear assembly was bent, but no torsional shear was indicated (Tab J-6). The Main Fuel Control (MFC) (See Figure 4) was taken to the fuel control overhaul facility at Fleet Reserve Center Southeast at Jacksonville Naval Air Station, Florida for disassembly and analysis. A analysis of the MFC depicts that there was a core speed of 20-21%, but this data neither conclusively supports nor disproves whether the engine was actually running (Tab DD-5, DD-11 and DD-19).

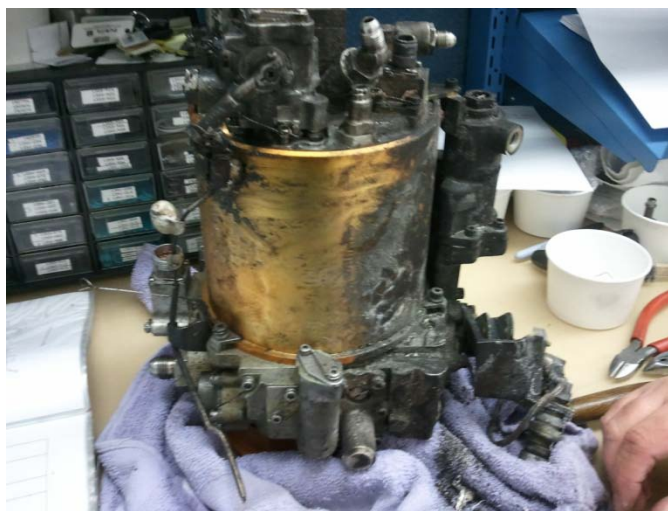
Figure 9. Engine #2 MFC

The starter gear assembly is bent but no torsional shear is noted. The MFC (See Figure 9) was taken to the fuel control overhaul facility at Fleet Reserve Center Southeast at Jacksonville Naval Air Station for disassembly and analysis. A analysis of the MFC depicts that there was a core speed of 36-37%, but this data neither conclusively supports nor disproves whether the engine was actually running (Tab DD-5, DD-16 and DD-19).
