**SUMMARY OF FACTS AND STATEMENT OF OPINION**  
**F-15C, T/N 79-0075**  
**F-15C, T/N 81-0043**  
**GULF OF MEXICO, 44 NM SOUTH OF TYNDALL AFB, FLORIDA**  
**20 FEBURARY 2008**

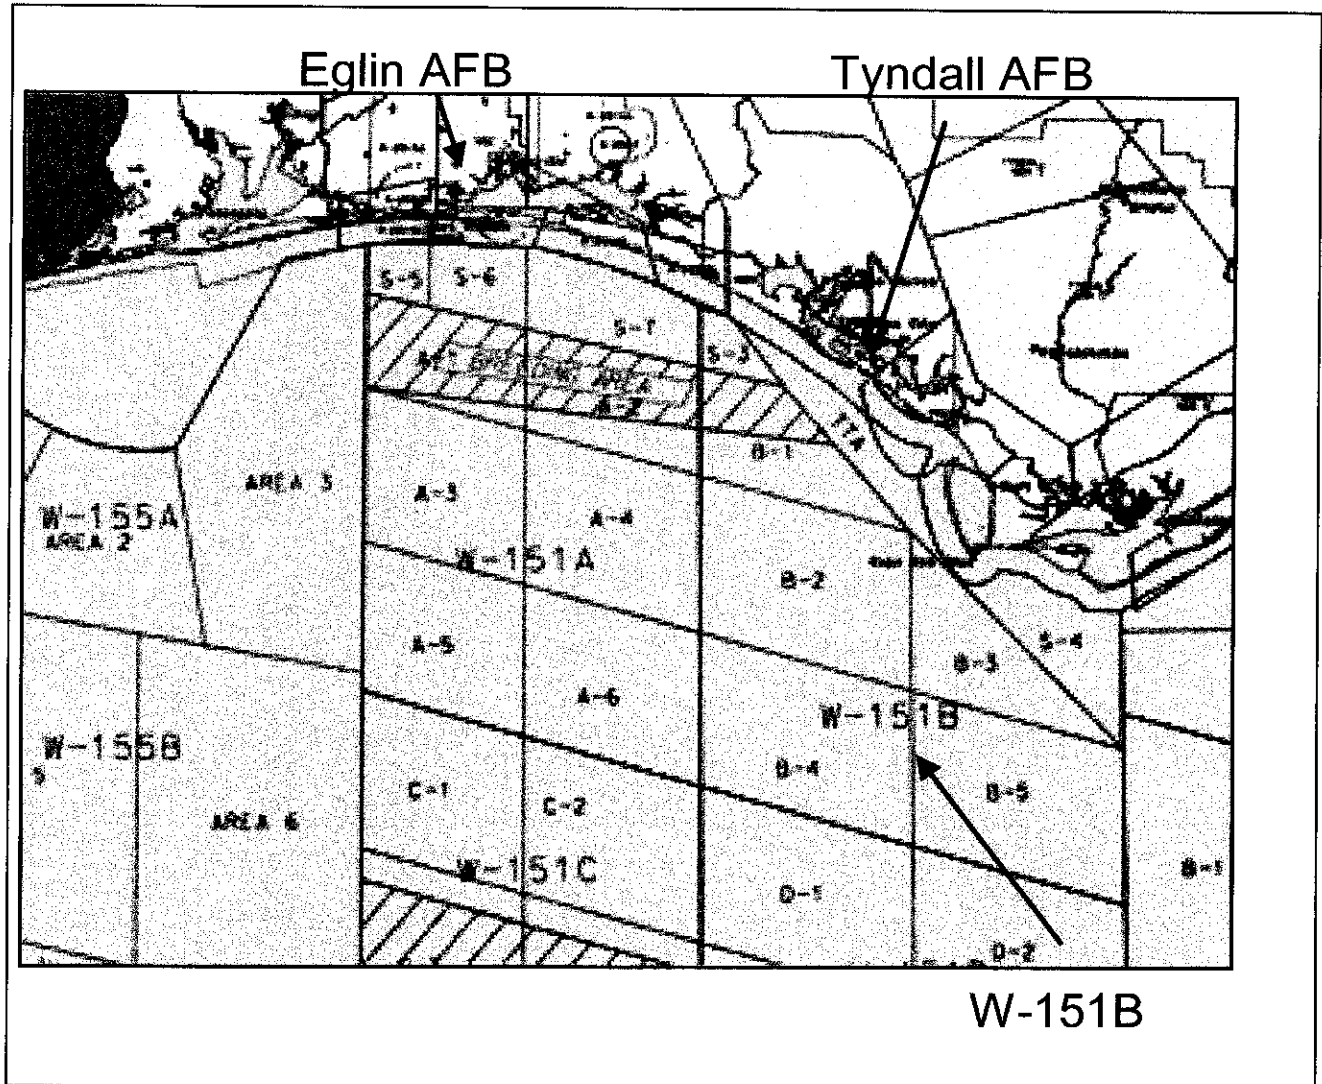
Figure 1

Upon entering the airspace, W-151 B (Figure 1), the MF executed two 180° G-awareness turns. The first turn was performed at 3 – 4Gs to ensure aircraft systems were operating normally. The second turn was performed at 6 – 7Gs to ensure the pilot's anti-G gravity straining maneuver was effective and the pilot was experiencing normal capabilities. The G-awareness was executed normally (Tab V-1.4).

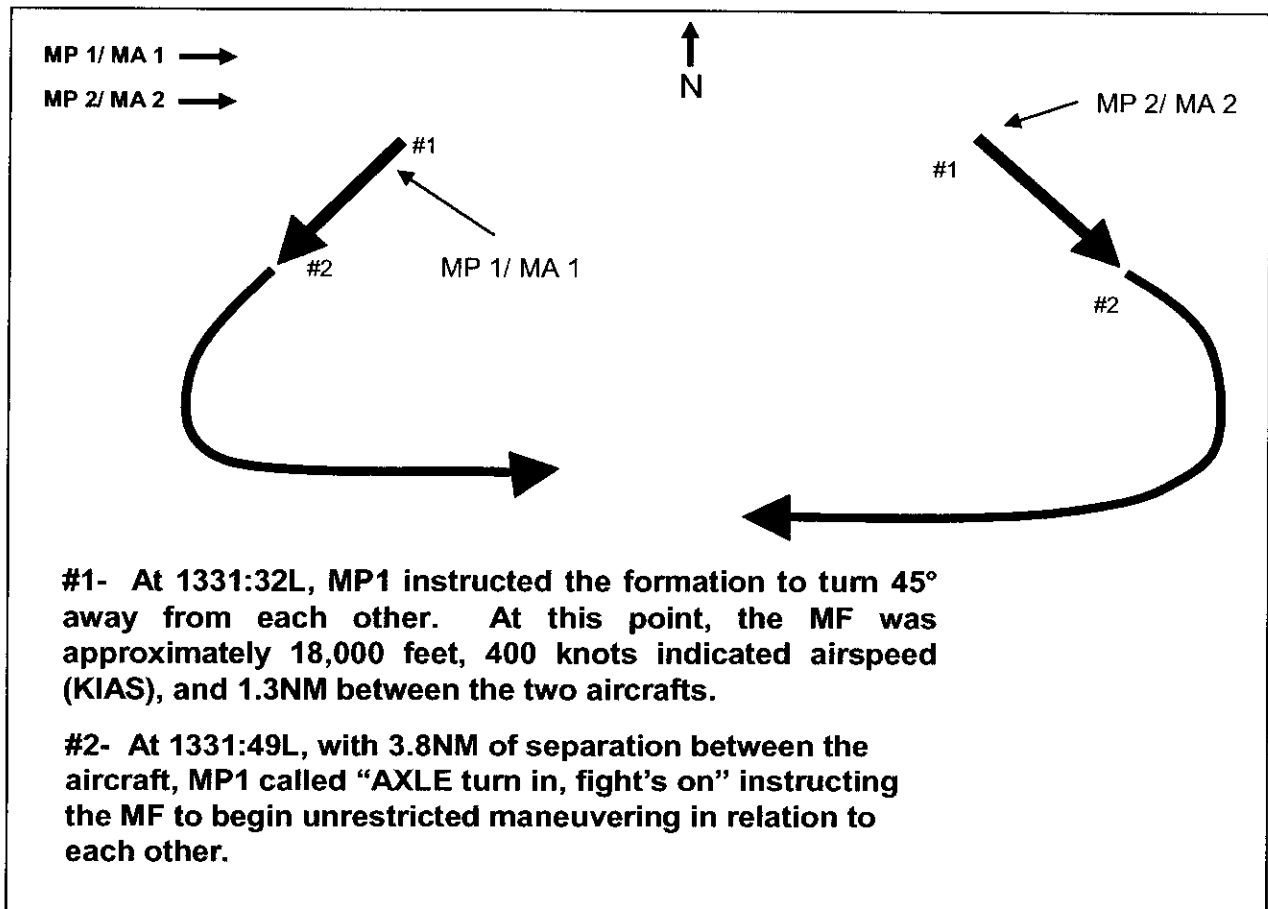
Figure 2

At 1331:32L the initial butterfly setup was executed (Figure 2, #1). The turn back towards each other occurred at 1331:49L with approximately 3.8NM of separation between MA1 and MA2 (Figure 2, #2). Both aircraft descended to approximately 14,000 feet as they merged, MA1 was flying approximately 380 knots indicated airspeed (KIAS) and MA2 was at 400KIAS and slightly lower than MA1 (Tab V-1.4).

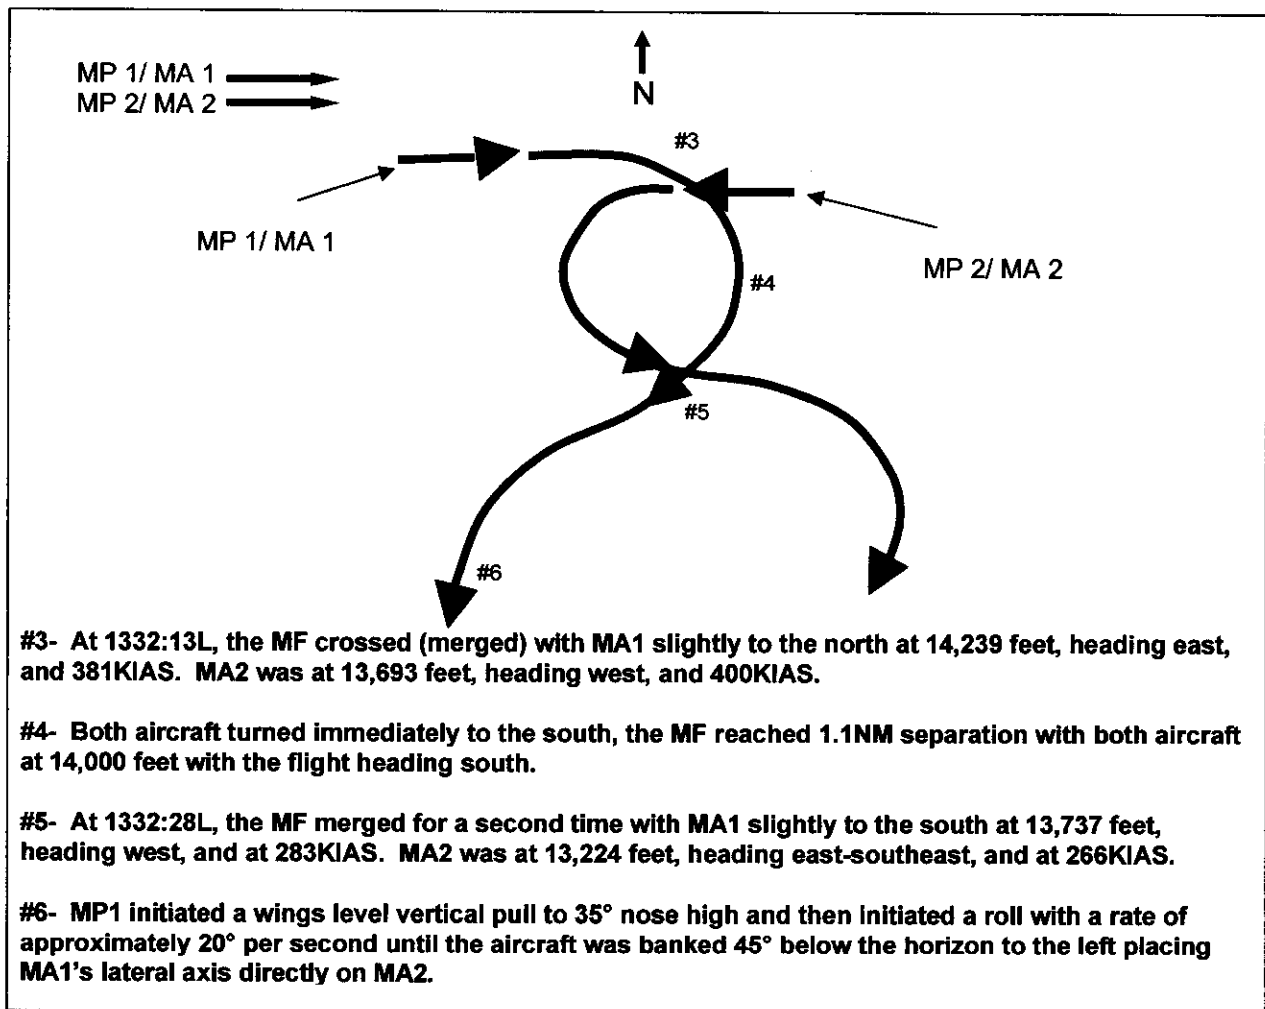
Figure

MA1 was slightly to the north as they merged and both aircraft initiated a turn to the south (Figure 3, #3). The MF reached 1.1NM separation with both aircraft still at approximately 14,000 feet with the flight flowing southerly (Figure 3, #4) (Tab V-1.4). At the second crossing (Figure 3, #5) MA1 was now slightly to the south just below 14,000 feet, heading west, and at 280KIAS. MA2 was at 13,200 feet, heading east-southeast, and at 270KIAS. MP1 rolled to place his wings parallel to the horizon and started a slight climb. Once he got the nose of the aircraft above the horizon, MP1 rolled to the left until he was partially inverted and his nose started to decrease back towards the horizon; MA1 eventually reached a nose low attitude while still in a left bank, moving back towards MA2. After merging the second time, MA2 rolled to the right to place his aircraft in a right hand bank and started a slight climb back towards MA1 (Tab V-1.5 thru V-1.6).

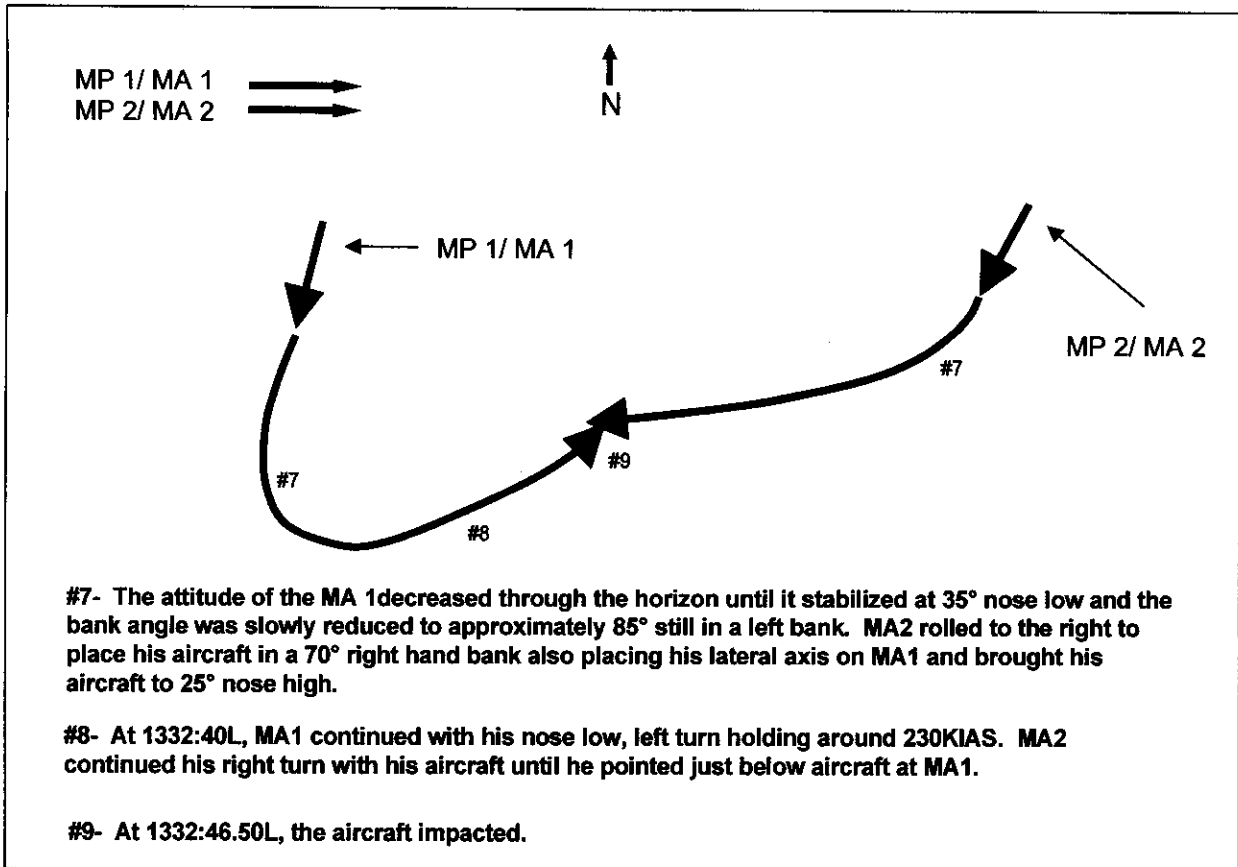
Figure 4

For approximately one to two seconds, MA1 was transitioning from approximately 25° above the nose to 10° above the nose of MA2 (Figure 4, #7); this could place MA1 behind the canopy bow of MA2, causing MP2 to momentarily lose sight of MA1 (Figure 5). MA1 continued with his nose low, left turn holding around 230KIAS (Figure 4, #8). MA2 continued his right turn with his aircraft until he pointed just below aircraft at MA1. At 1332:46.50L, both mishap aircraft impacted (Figure 4, #9) (Tab O-119).

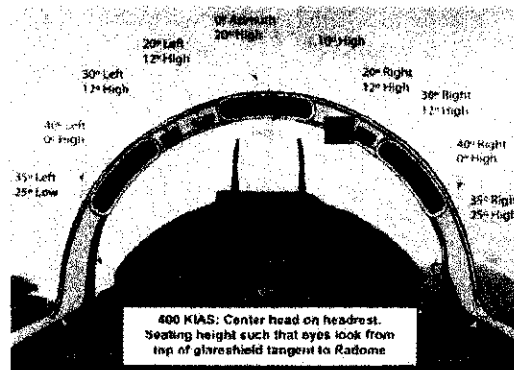
Figure 5: Canopy Bow (Tab O-119)

**Visibility Restrictions** is a factor when the visibility is obstructed creating an unsafe situation (Tab BB-25). A visibility restriction occurred due to the construction of the F-15 canopy with the presence of the canopy bow across the pilot's field of view. The flight paths of the aircraft show that MA1 may have been obscured behind the canopy bow of MA2 for 1-2 seconds as the two aircraft approached each other (Tab O-119).

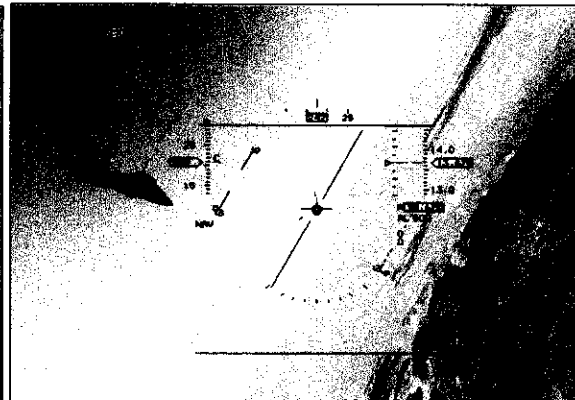
**The above pictures show the estimated cockpit views that MP1 and MP2 would have had. At this point the aircraft are .2 seconds from impact at just inside of 200 feet with 800 feet per second of closure. (Tab Z-6)**

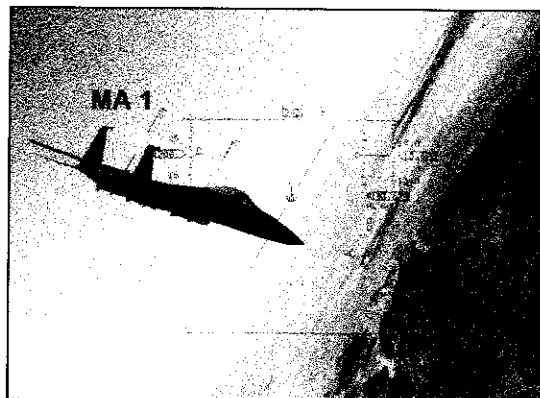
The above pictures show the estimated cockpit views that MP1 and MP2 would have had. At this point the aircraft are .1 seconds from impact at just inside of 50 feet with 800 feet per second of closure. (Tab Z-6)

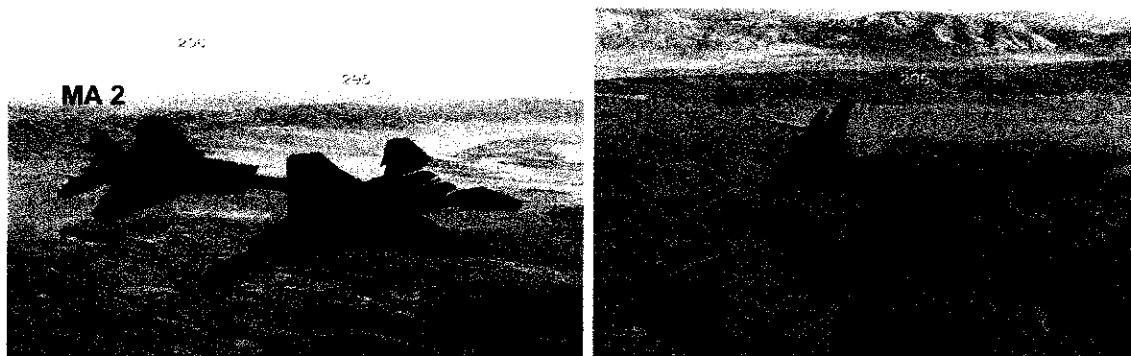
(Tab Z-6)

At 1332:46.50L, the aircraft impacted.
