### AIRCRAFT ACCIDENT INVESTIGATION

#### **F-15C, T/N 80-0034 LAMBERT FIELD IAP, MISSOURI 2 NOVEMBER 2007**

**SUMMARY OF FACTS AND STATEMENT OF OPINION  
F-15C, T/N 80-0034  
2 November 2007**

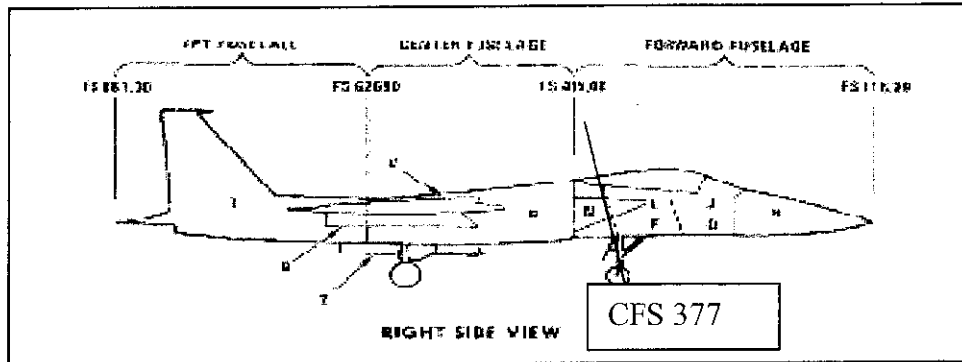
Evaluation of the MA forward fuselage wreckage and main fuselage wreckage in the debris field indicates the MA broke apart in flight at the canted fuselage station (CFS) 377 bulkhead. (Tab J-12, J-13, J-61, J-127)

Figure A, Forward Fuselage separation location, CFS 377.

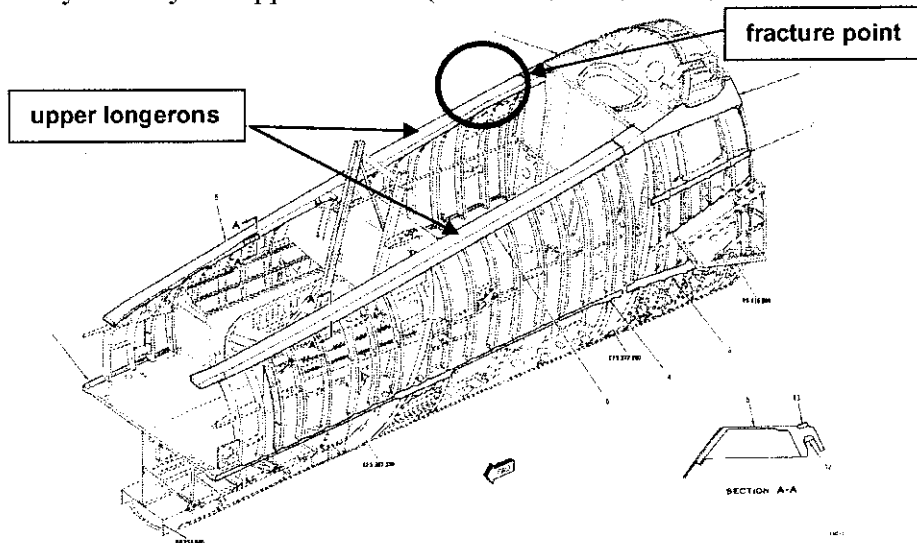
The engineering report states the MA break-up was initiated by failure of the right upper longeron just forward of the CFS 377 bulkhead splice. The upper longerons in the forward fuselage are single load-path structures. Failure of either longeron will result in loss of the structural capability to carry the applied loads. (Tab J-13, J-62, J-130, J-134, J-137 thru J-138)

Figure B, Location of fuselage longeron failure in CFS 377.
