**UNITED STATES AIR FORCE**  
**AIRCRAFT ACCIDENT INVESTIGATION**  
**BOARD REPORT**

**F-16CM, S/N 93-0554**

**55th EXPEDITIONARY FIGHTER SQUADRON**  
**332d AIR EXPEDITIONARY WING**  
**BALAD AIR BASE, IRAQ**

**LOCATION: BALAD AIR BASE, IRAQ**  
**DATE OF ACCIDENT: 12 NOVEMBER 2008**  
**BOARD PRESIDENT: LT COLONEL ROGER A. QUINTO**  
**Conducted IAW Air Force Instruction 51-503**

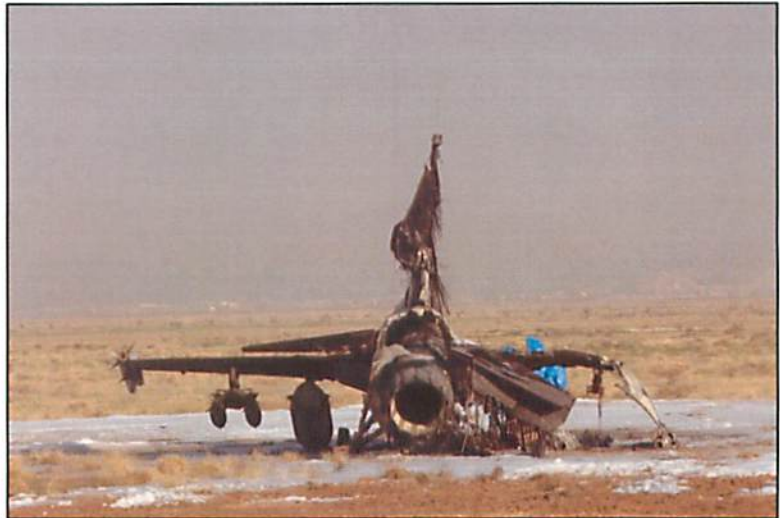
(1) Aircraft and Systems: The structural damage of the aircraft was severe and occurred as a result of the fire caused by the engine failure. The aircraft was consumed by fire. The debris field shows the majority of debris exited the right side of the aircraft at the start of the mishap, with aircraft and engine components scattered across the airfield (Tab Z-6). Crash survivable flight data recorder (CSFDR) and engine systems recording components analysis indicate all systems operated normally (Tab CC-13 thru CC-16). There were no abnormal system indications prior to the mishap (Tab V-1.5, V-1.9).

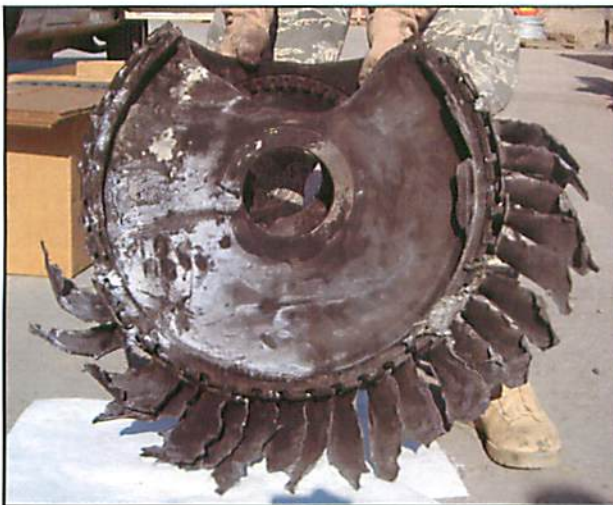
Second stage disk components were recovered in the aircraft, in the engine, and on the airfield (Tab Z-6). There was a large hole on the right side of the MA where a liberated piece of the second stage fan disk exited after failure (Tab S-7 thru S-8, Z-3 thru Z-5). After liberation, the engine debris ruptured the fan case and continued outward rupturing the main engine fuel feed line and damaging the main fuel shutoff valve (MFSOV) (Tab R-38 thru R-52, Z-3 thru Z-4).

Engine's Second Stage Fan Disk  
Following Removal

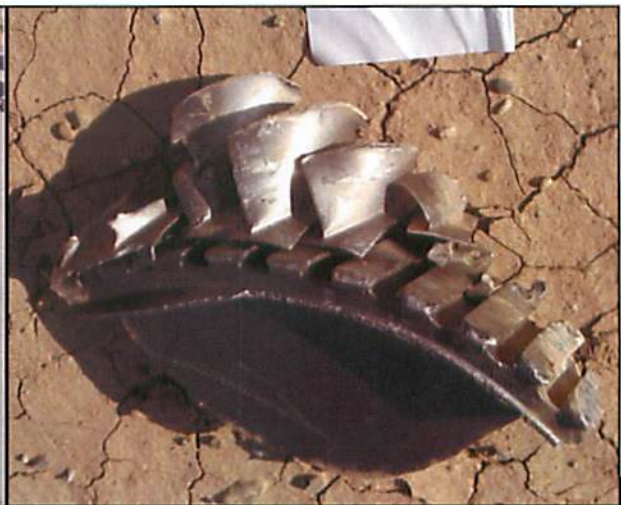
Liberated Portion of Second Stage Fan  
Disk

The mishap occurred when afterburner power was selected for takeoff (Tab V-1.5). The second stage fan disk failure caused the liberation of a section measuring approximately 12.5 inches and multiple fan rotor blade and stator components (Tab J-47).

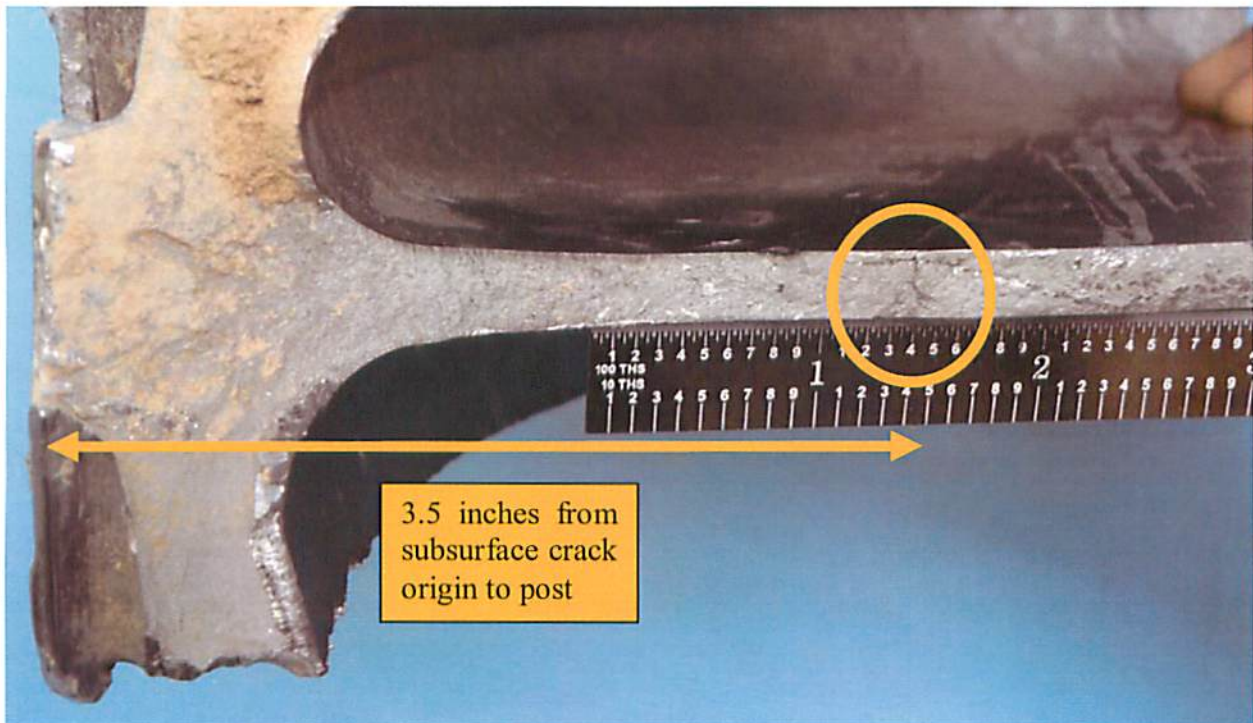
Extracted from 14 January 2009 General Electric Manufacturing Report

(2) Metallurgy: The stereomicroscopic examination of the liberated segment revealed a subsurface crack origin (Tab J-63, J-224, J-246). The second stage fan disk is not solid cast; it is a web design with a diameter of approximately 23 inches and weighs approximately 60 pounds (Tab U-45). The total web area thickness measured at 0.287 inches and met drawing requirements (Tab J-63). The fail point origin occurred at approximately 0.159 inches below the surface (Tab J-265). A subsurface crack developed approximately 3.5 inches inboard of the disk posts in the web and would have been approximately 3.3 inches long at the time of the mishap (Tab J-222, J-246). An abrupt transition from faceted fracture to fatigue was observed; however, there is no way to pinpoint a timeline from the fracture to fail point (Tab J-64).

An approximate 12.5 inch sectional arc of the second stage disk was liberated (Tab J-47). The speed and trajectory associated with this liberation led to the inside-to-out rupturing of the case,

Metallurgical evaluation of the liberated second stage fan disk and the remaining portion of the second stage fan disk determined the origin of a subsurface crack 3.5 inches inboard of the fan disk post. The crack was 3.3 inches long at the time of catastrophic failure, although there is no
